Use of unmanned aerial vehicles to supplement conventional investigation methods for underground open void stability and mitigation

RP Preston *Golder Associates Ltd., Canada*

J Roy *Golder Associates Ltd., Canada*

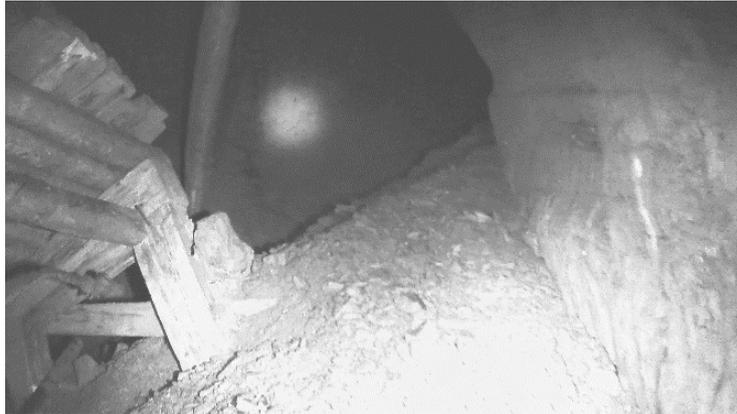
Infrared illuminators were chosen for their low power consumption and compatibility with existing infrared cameras installed in the stope complex for geotechnical monitoring. As a result of using infrared lighting, it was necessary to modify the UAV's on-board cameras to be sensitive to infrared light. The UAV was fitted with two cameras, a highly sensitive (0.0001 lux) board camera to provide real-time video link for navigation and a second, action camera, to record high-definition video (Figure 2).

Figure 2 Video footage from flight

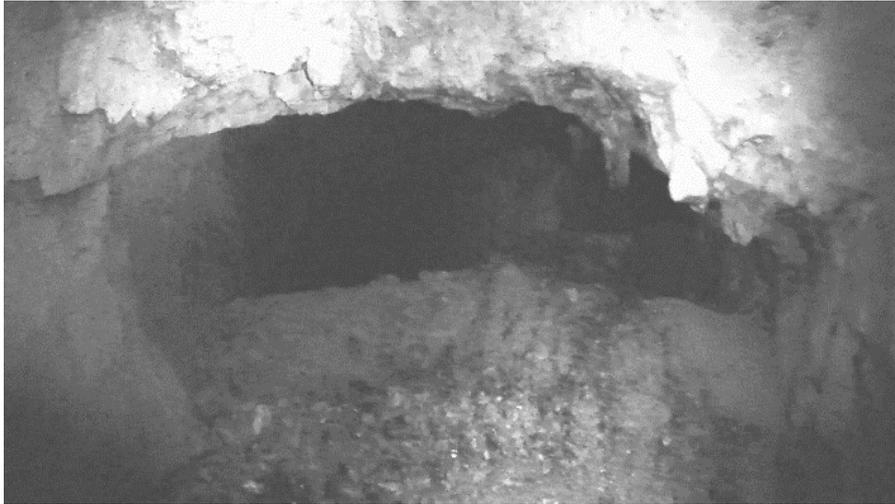
The breakthrough at the bottom of the stope, which was suspected from CMS data, was confirmed during flight one (Figure 5). Flights two and three confirmed the presence of continuous rockfill and did not indicate sinkholes or similar evidence of vertical connections to lower stopes (Figure 6). For flight four, the UAV was flown to the end of the stope where loose, blocky rockfill was observed (Figure 7). The ability to not only confirm the presence of fill, but also assess its constituents and their particle sizes was a valuable outcome from the UAV surveys.

Figure 5 Breakthrough at base of stope (flight one)

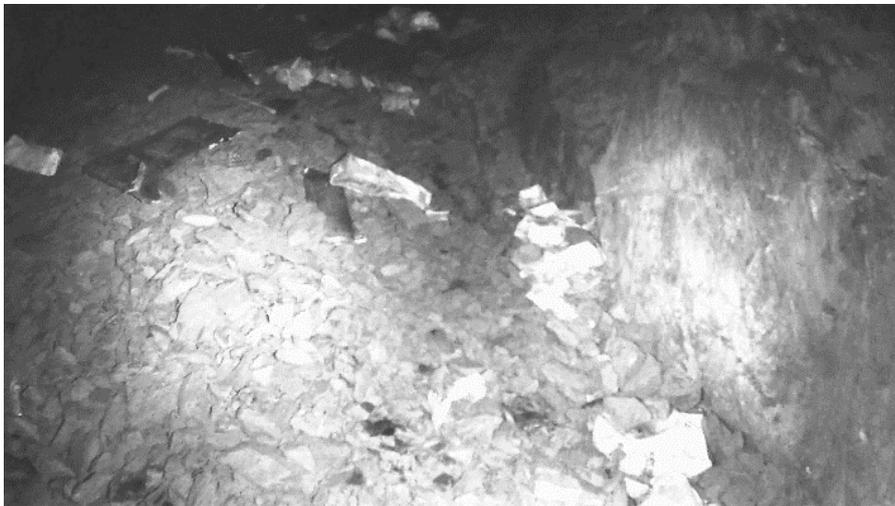
Figure 6 Rockfill and debris at base of stope (flights two and three)
