# Case study – SIMEC Mining Big Baron Pit successful tailings dewatering and management using WaterShed polymer

**F Verdoorn** *SIMEC Mining, Australia*

**K Gibbs** *Nalco Water, Australia*

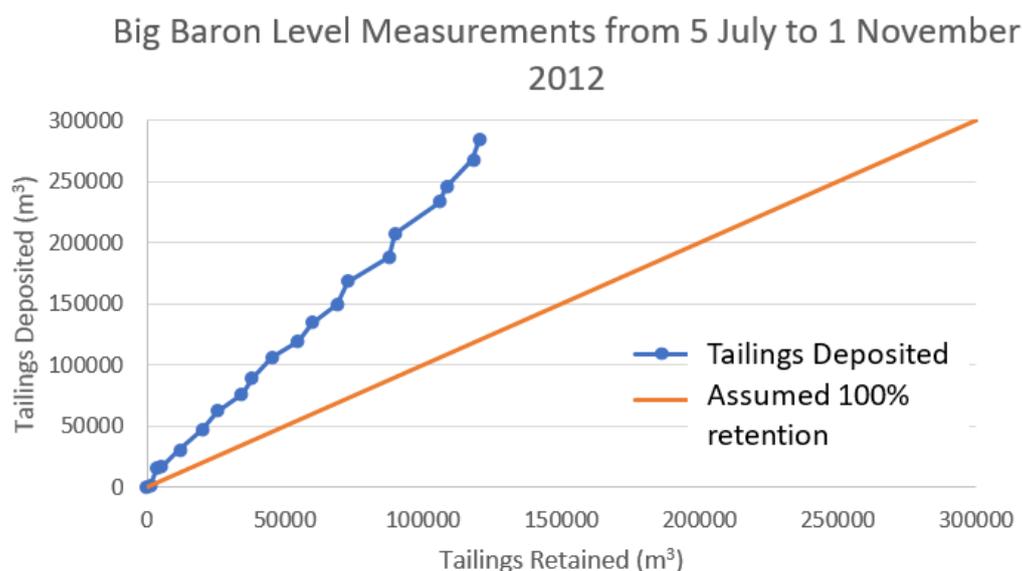
**Figure 2 Volume retained in-pit late 2012 (before polymer trial)**

Figure 2 shows this relationship (Owens 2013). The x axis shows the volume of tailings retained and the y axis shows the volume of tailings deposited into the pit. The orange line represents 100% retention.

After several months of monitoring of the Big Baron Pit, it was apparent that very little water was being released from the slurry and that it was lost to evaporation and/or seepage. Tracking the pit capacity based on the volume of tailings deposited indicated that the pit level was not rising as fast as expected. The plant continued to deposit tailings into the Big Baron Pit and recorded the volume deposited versus the volume retained and the results were worse than anticipated. Using these results and some simple mass balances, knowing the percent solids and dry tailings mass, flow rate, etc., it was discovered that if it was only the water escaping then there should be more volume retained. This was not the case, so it was postulated that potentially some of the fine solids that are suspended in the tailings were escaping with the water.

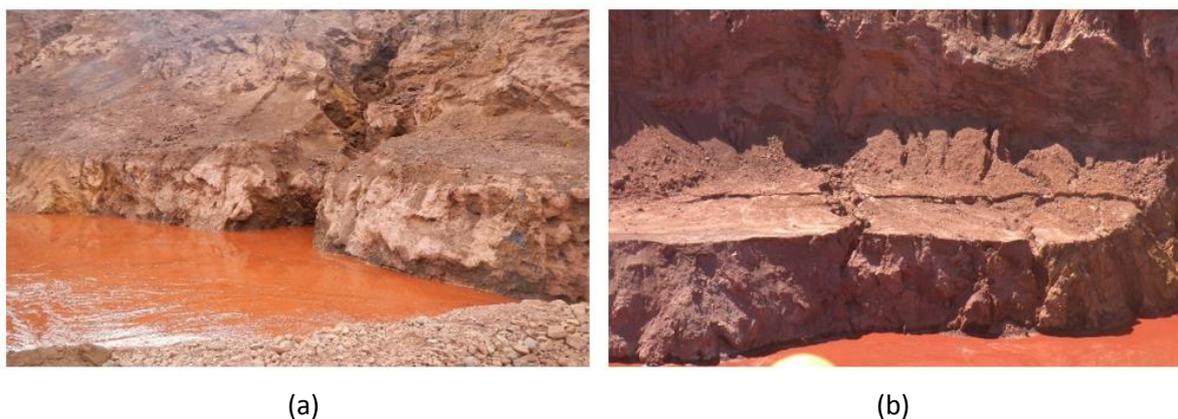
Figure 3 shows typical fissures and faults located along the eastern wall.

Figure 3 Big Baron Pit features. (a) Picture taken August 2012 which shows one of these fissures from ground level, a potential area for seepage; and, (b) Picture taken December 2012 of north–south fault line, another potential area for seepage

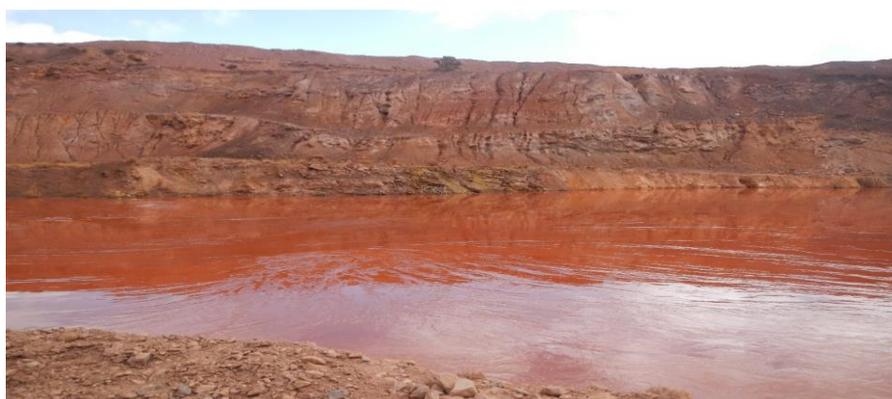
Figure 4 shows no free water separation from tailings deposited prior to treatment.

Figure 4 Big Baron Pit lack of solids/liquid separation

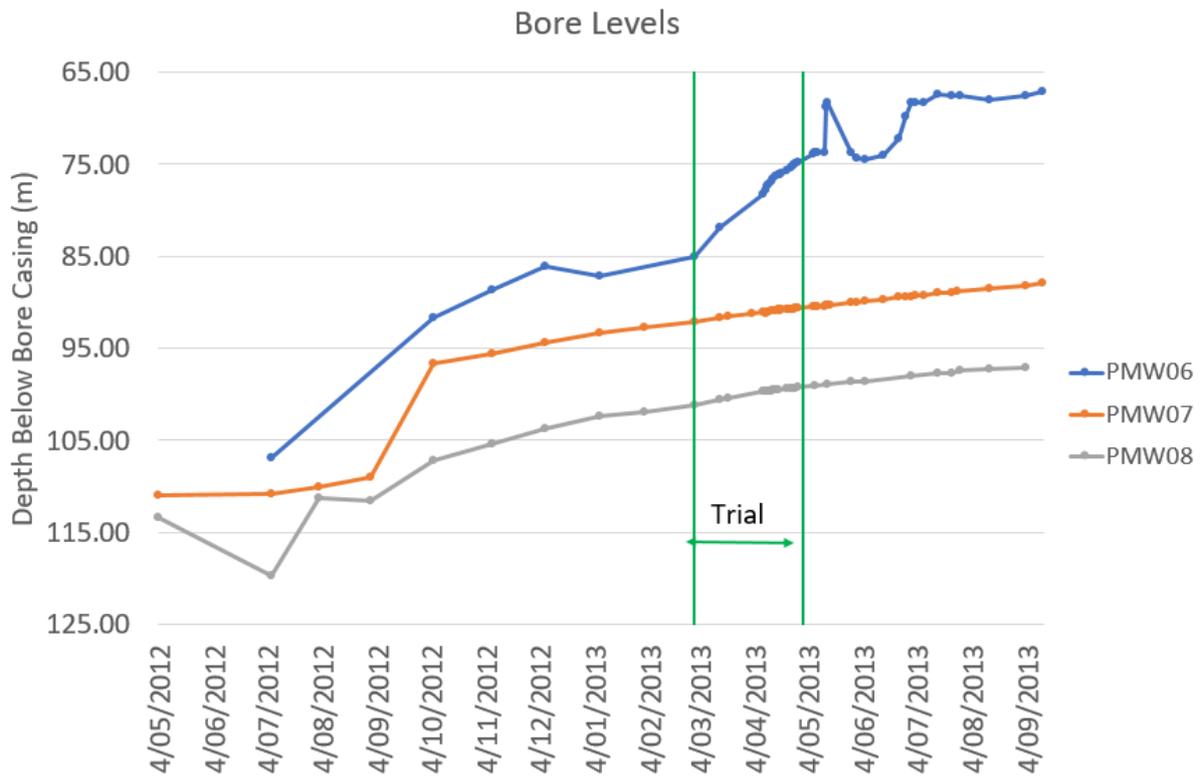
The bore levels are typically monitored by SIMEC Mining's environmental department at the start of each month. This provided some initial data to work from. Figure 5 shows data from May 2012 to September 2013. The area indicated shows the period in which the trial took place. The northern and western monitoring bores (Figure 6) continued to increase at the same rate as prior to the polymer treatment. The southern bore, which is located at the end of the pit where the decant water accumulates, can be seen to increase at a higher rate than prior to the trial. This was to be expected as it was anticipated the pit was not fully sealed prior to WaterShed polymer treatment (Owens 2013).

Figure 5 Levels before, during and after the initial trial period

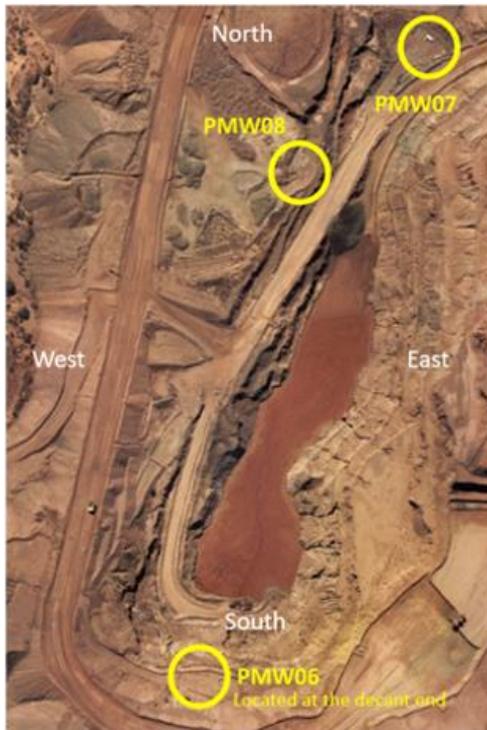
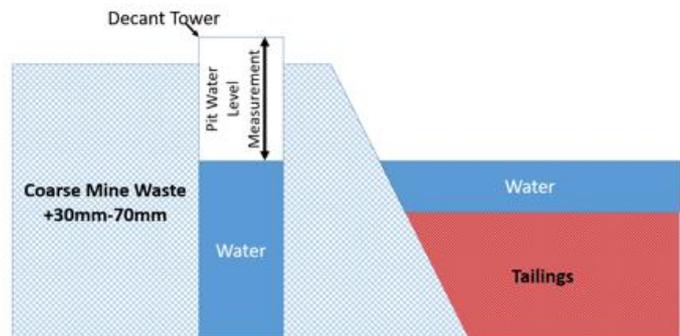
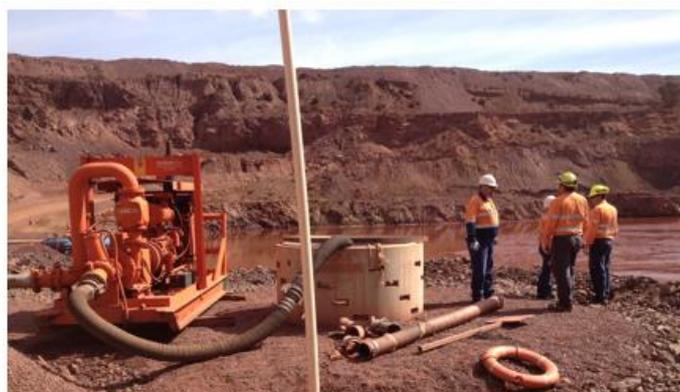
Figure 6 Monitoring bore locations and decant structure. (a) Monitoring bore locations; and, (b) decant tower design

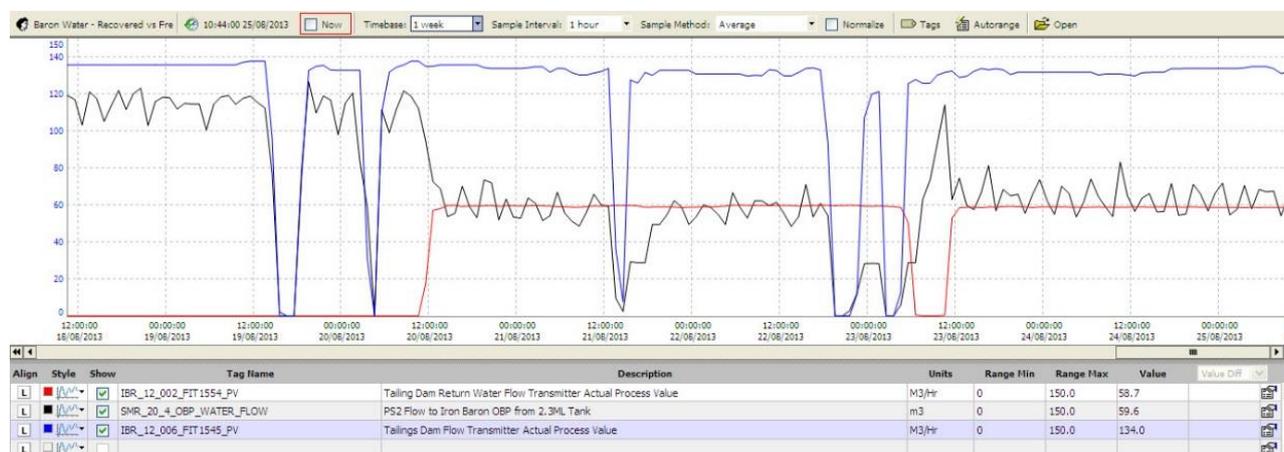
Figure 7 clearly shows that the fresh water make-up addition to the plant is approximately 120 m<sup>3</sup>/hr when the plant is running until the recovered decant water is introduced to the plant (red line) at approximately 60 m<sup>3</sup>/hr. The fresh water addition drops straight away to approximately 60 m<sup>3</sup>/hr, which shows a direct relationship with the recovered water. This recovered decant water is approximately 63% of the available water which was discharged as part of the slurry (Owens 2013).

Figure 7 Trends of water and tailings flows at Iron Baron (August 2013)

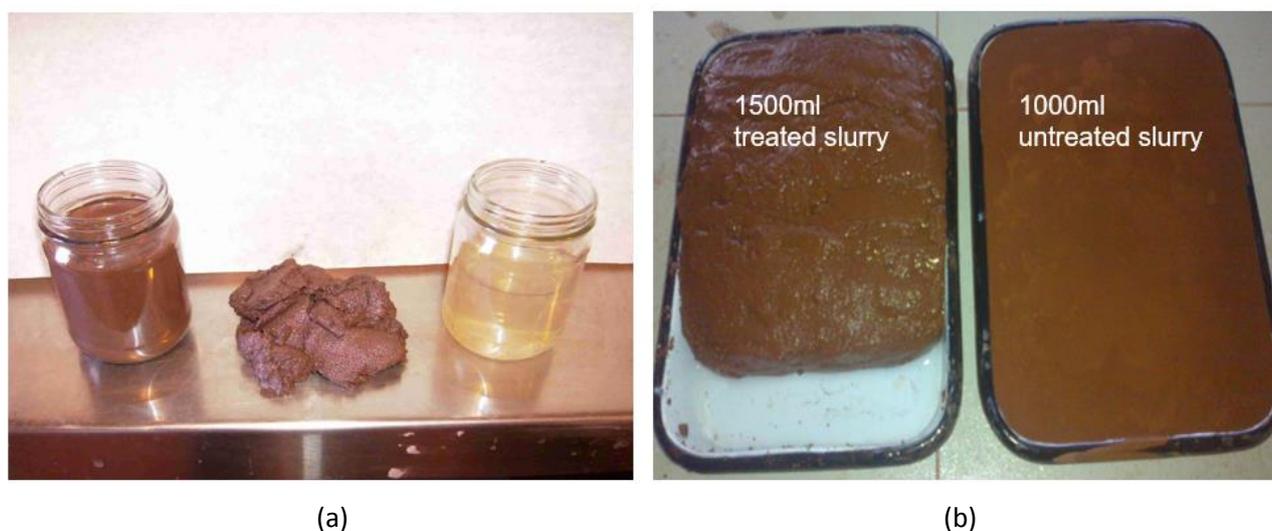
The following photos (Figure 8) demonstrate the WaterShed polymer technical capability to separate solids from water in bench-scale test work.

Figure 8 WaterShed testing. (a) Solids/liquid separation – solids agglomeration and water recovery; and, (b) Consolidation and volume reduction – more solids in less space

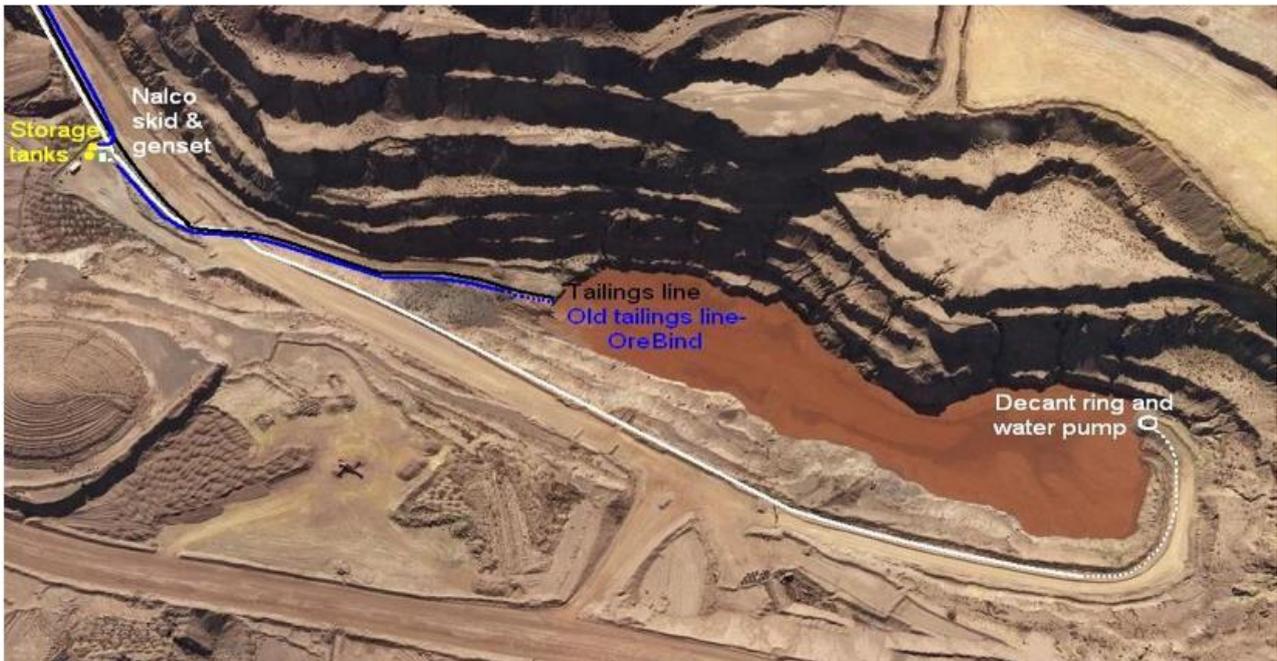
The self-contained trial equipment was set up near the current tailings discharge into the Big Baron Pit (Figures 9 and 10). The equipment was also near the decant water recovery line back to the plant, as a potential water source for polymer dilution.

Figure 9 Initial trial set-up layout

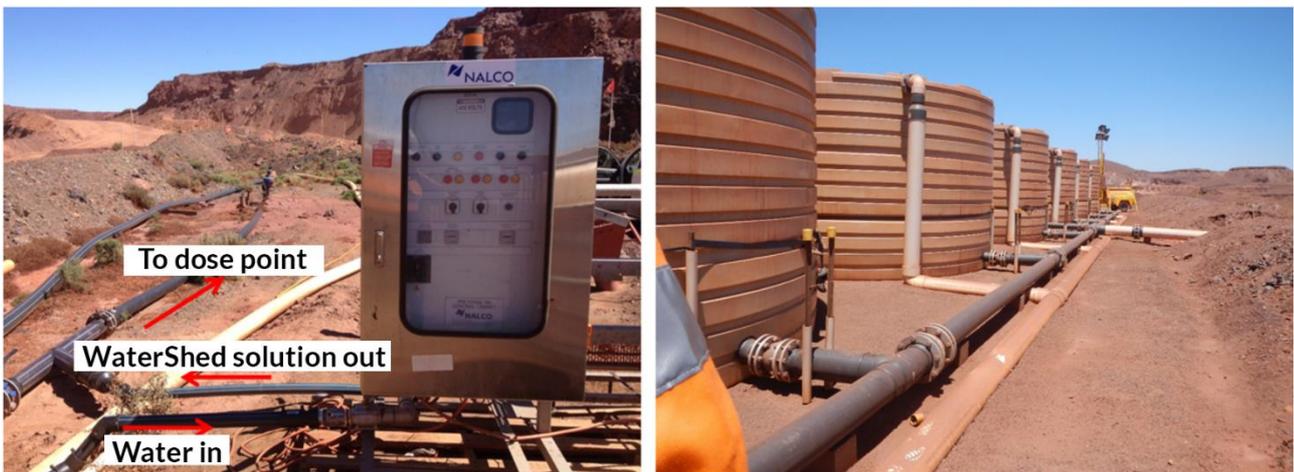
Figure 10 Trial polymer rig and intermediate water tanks used for trial start-up

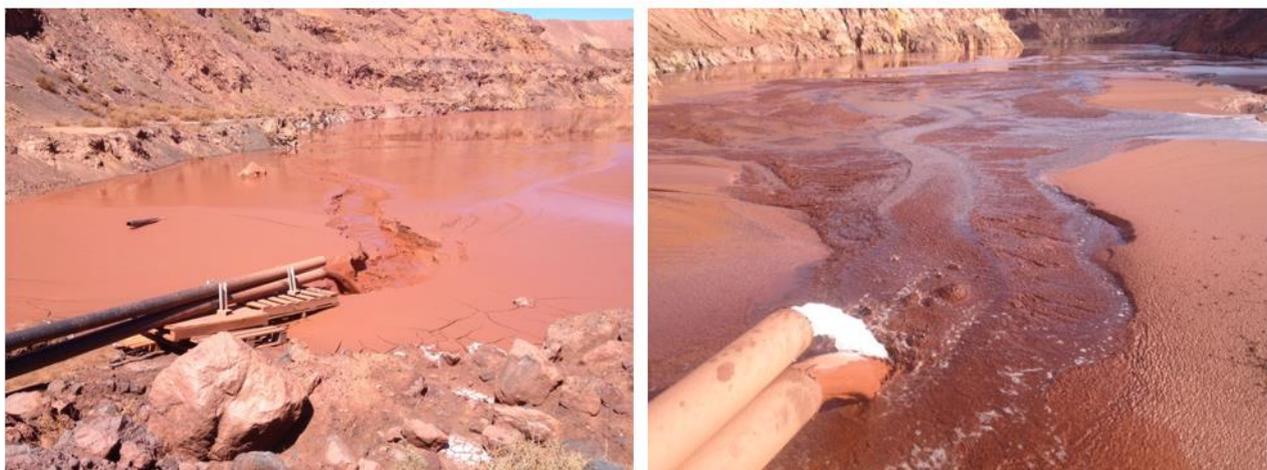
Immediately upon chemical addition, free water became liberated from the slurry and began to flow towards the decant area. The first stages of beach formation were also observed (Figure 11).

**Figure 11 Before and after photos at trial commencement. (a) Prior to start-up, tailings depositing as smooth paste, no beaching, no water release; and, (b) At start-up, WaterShed process starting, water release occurring**

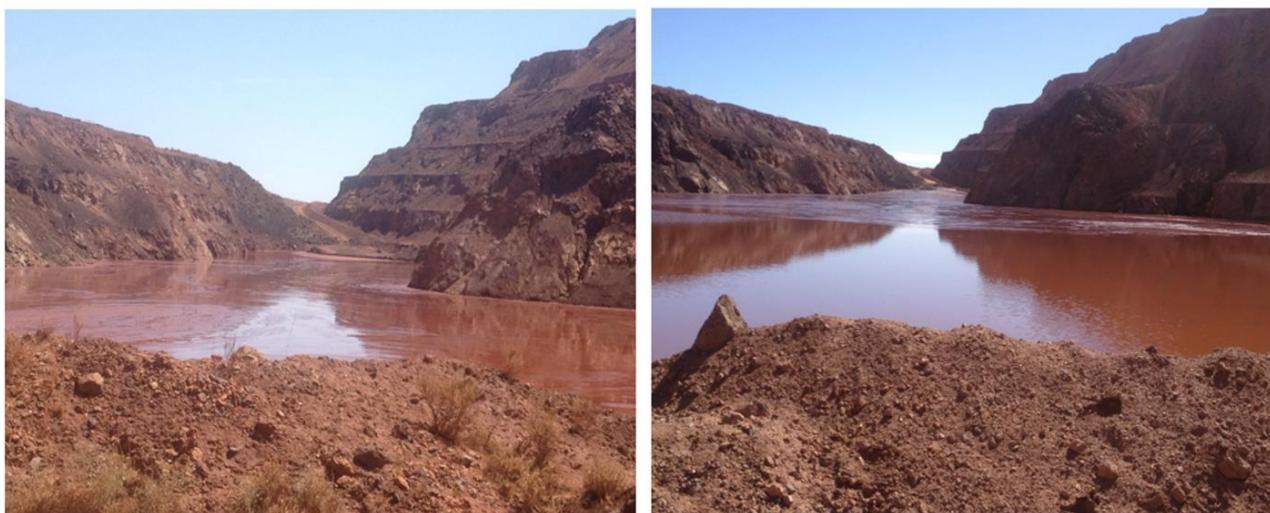
Figure 12 taken from the southern end of the pit (decant end) clearly shows the beach development prior to start-up and at 48 hrs into the trial. It can be seen that a significant beach has been established with dosing and decant water pooling.

**Figure 12 Photo showing before and after released water at decant end of TSF and beach development. (a) Prior to start-up, 'smooth' consistency, no beach or dewatering; and, (b) At start-up (12 to 48 hrs), rapid beach formation, 60%+ water recovery**

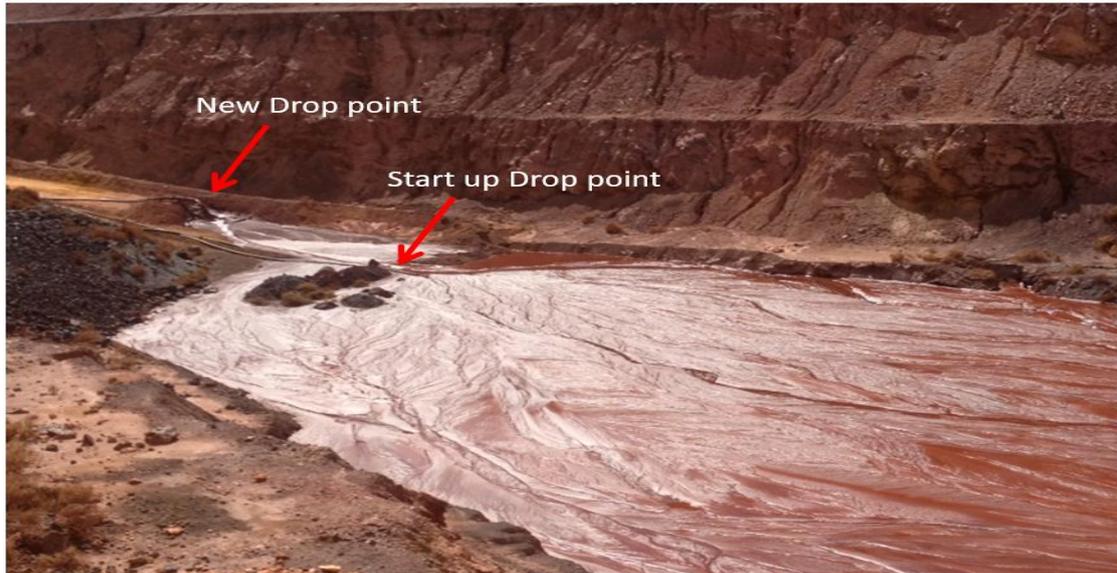
At day three (Figure 13), it was clear that solids were rapidly settling on and building the beach to the point that the drop point needed to be moved back up the access ramp to the pit. This became standard practice as the project developed.

Figure 13 Beach development at day three (drop point raised)

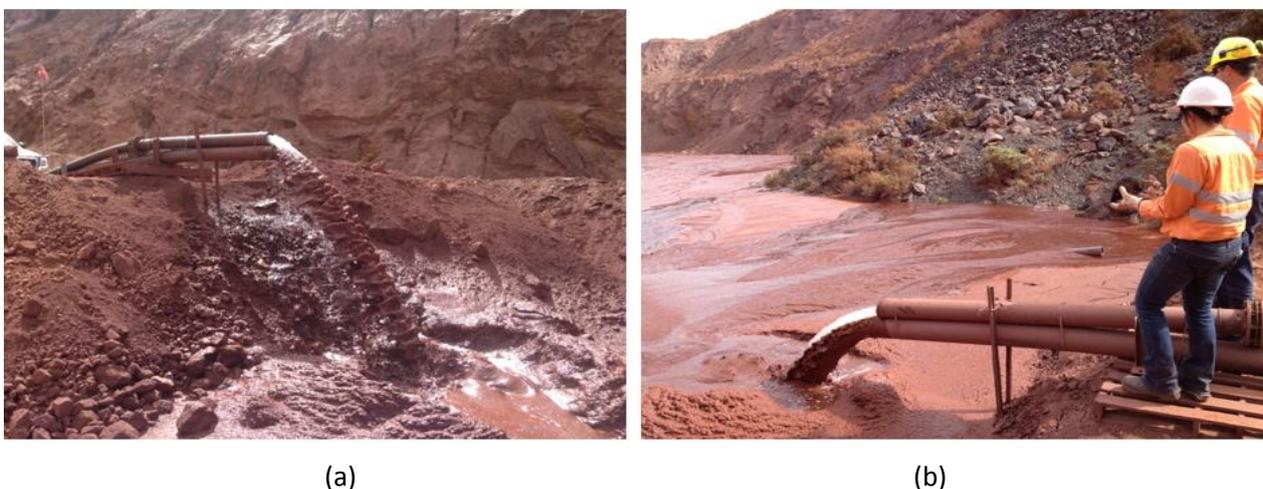
After one month of operation (Figure 14), the beach height at the discharge point had increased by 3 m.

Figure 14 One month of operation; (a) 15 March 2013; and, (b) 16 April 2013

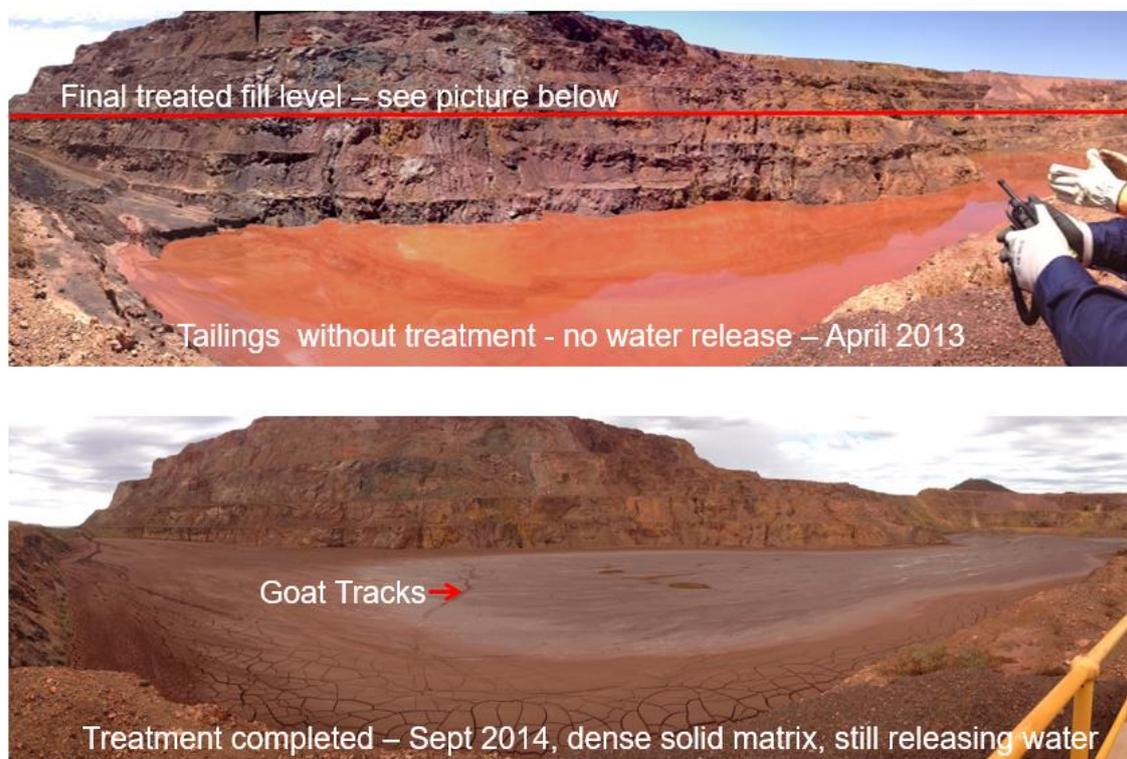
WaterShed polymer dosing continued until the void was declared full in September 2014 (Figure 15). During the life of the application a consolidated matrix of dewatered solids was progressively layered down to a depth of approximately 35 m (RL257–RL222).

Figure 15 Big Baron Pit at start-up showing final reduced level (RL) fill line in red

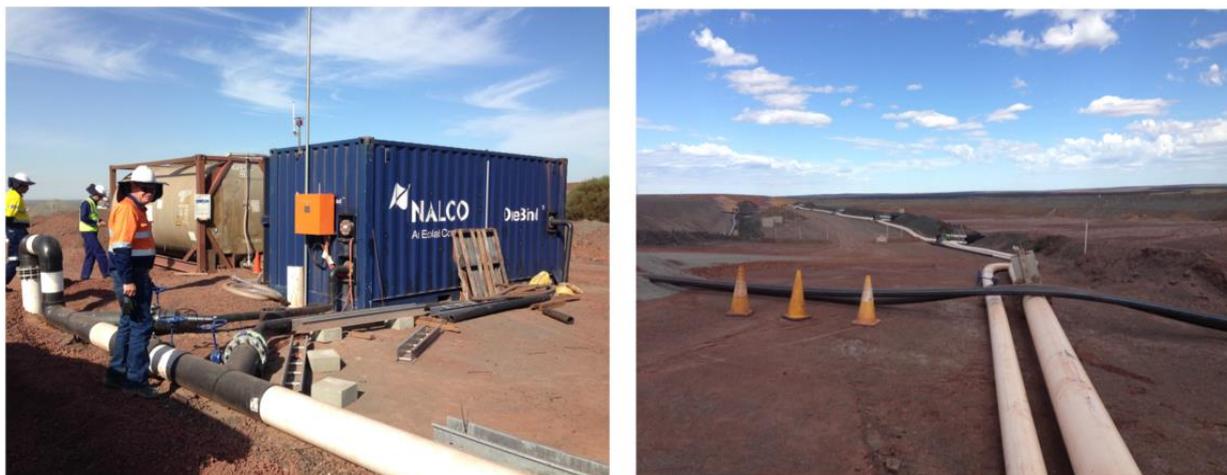
With each new application, the WaterShed equipment package design (Figure 16) has been upgraded to containerised systems with full telemetry to allow relocation of the systems around the sites as required. Figure 16 shows the current system in operation at the Iron Duke application.

Figure 16 Mobile containerised WaterShed system at Duke TSF
