Testing the suitability of radio frequency identification cattle tags for tracking block cave progression

Abstract

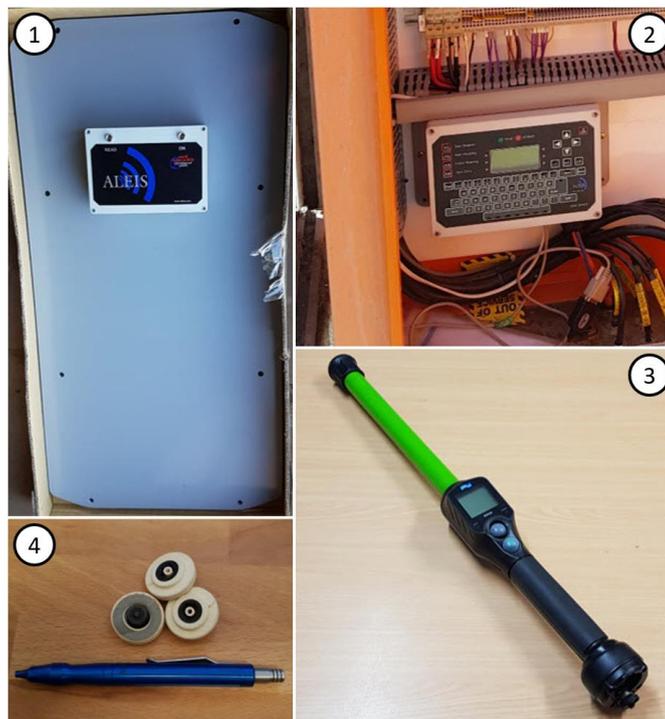
Figure 1 Components used in the trial (clockwise from top left; 1. 610 Multi A&B Dual Automated Race Antennas, 2. Fixed Feedlot Wand 9060, 3. Allflex RD420 Handheld Scanner, 4. Cattle RFID ear tags)

The equipment components selected for the detection part of the system comprised three 610 A&B Dual Automated Race antennas (Aleis 2018a) and a Fixed Feedlot Wand 9060 (Aleis 2018b), all sourced from Aleis. The Fixed Feedlot Wand 9060 logs the detections made by the antennas of passing RFID tags and is connected to the site network using serial-to-IP adaptor hardware to enable remote monitoring of detections.

The other hardware includes an Allflex RD420 Handheld RFID Scanner, so tags can be read and logged prior to deployment, and the RFID cattle ear tags themselves. All items are shown in Figure 1.

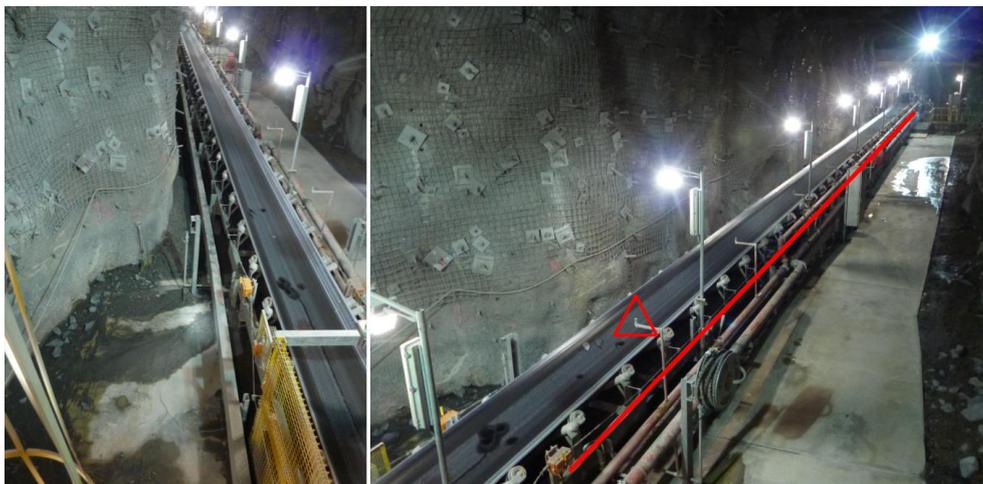
Figure 2 Proposed mounting location for detection system on CV102

The first thought was to install it as close to the bottom of each crusher as possible, either on the CV102 conveyor that services the fine ore bin below Crusher 2 (Figure 2) or on the lower extreme of CV103 just above the CV102/103 transfer station (Figure 3). At those sites, there is access to both sides of the conveyor for maintenance and convenient power supply. Both locations were investigated and eventually dismissed for a combination of reasons, primarily focused around the difficulties that would be encountered during the installation process and conflicts that would arise when shutdown servicing of the conveyors in these locations were undertaken. Furthermore, it was difficult to come up with a frame design that could get around the fire lines (red triangle on Figure 2) and the manual safety shutdown line (red line on Figure 2), whilst also not mounting too close to the rollers and conveyor belt itself.

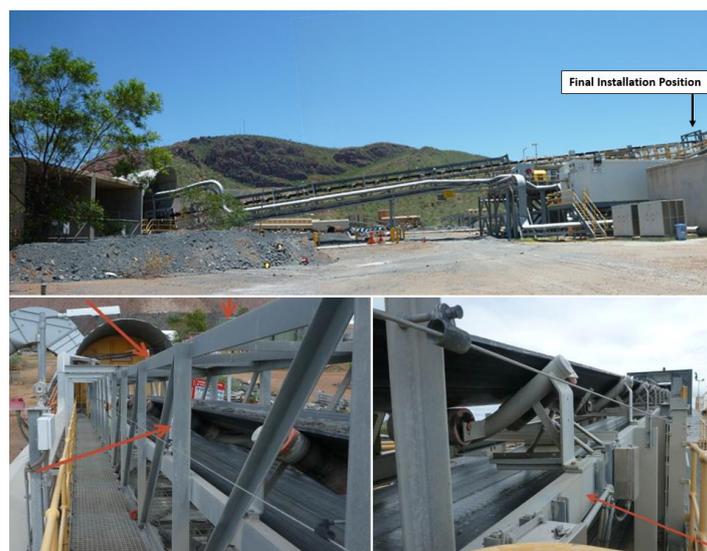
Figure 4 Proposed mounting location for detection system on tail end of CV104 on-surface (top). Bottom left: section with steel lattice work (arrows pointing to steel girders). Bottom right: section without lattice, arrow indicates the stringers onto which the frame can be bolted

Once these two most prospective underground locations were dismissed, surface solutions were considered. There are two conveyors on-surface prior to the secondary crushing circuit, those being the tail end of CV104 (Figure 4) and CV109. Due to CV109 intermittently being bypassed for dumping directly to stockpile, it was excluded at an early stage and works begun on selecting a position on the final section of CV104. The tail end of CV104 was originally excluded due to the high amount of steel lattice work and the concern that the (untested) system components would not be protected anymore within the underground conveyor drives. Outside the conveyor decline, the components will be exposed to the weather elements (heat, dust, high winds and rain) that can be harsh in that part of Australia, raising the probability that some steelwork would be required in the frame to give it some degree of rigidity.

The area immediately to the north of CV104 provides ample space for crane access, and through close coordination with the fixed plant team, a suitable position was decided on and planning work began on the frame. Once the mechanical engineers approved the construction of a frame to attach directly to the conveyor itself (in particular onto the 'stringers', Figure 4 bottom right), the boiler makers could start with building a frame on which to mount antennas. Elexon Electronics recommended not to install the antennas close to the steel girders (bottom left Figure 4) and, therefore, the only option remaining was to mount the system above this section of conveyor structure.

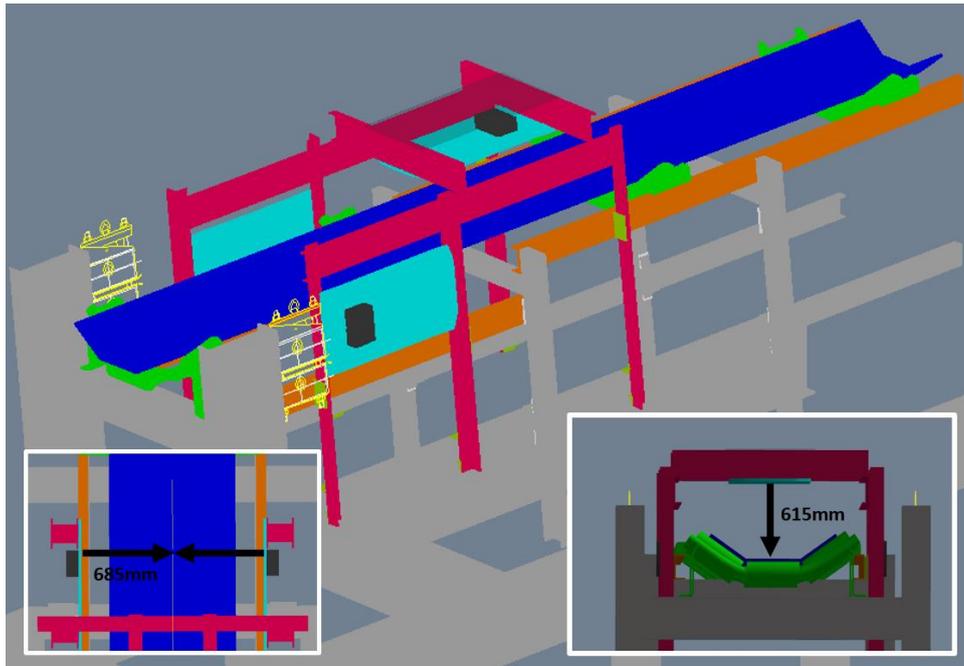
Figure 6 Isometric view of frame design drawings (frame components in red, conveyor belt in dark blue, CV104 structure in grey, antennas in light blue, belt clamp mounting position shown in yellow). Bottom left inset: plan view showing side antenna distance from centre of belt. Bottom right inset: slice view showing vertical antenna distance from centre of belt

As shown on the insert of Figure 6, the actual distance from the top antenna to the conveyor is 615 mm, far below the 1,200 mm mentioned above and still at a safe distance from the rock on the moving conveyor. This horizontal antenna was made sub-frame removable to allow for future belt hoisting. The side antennas are installed such that their face is 685 mm from the centre of the belt.

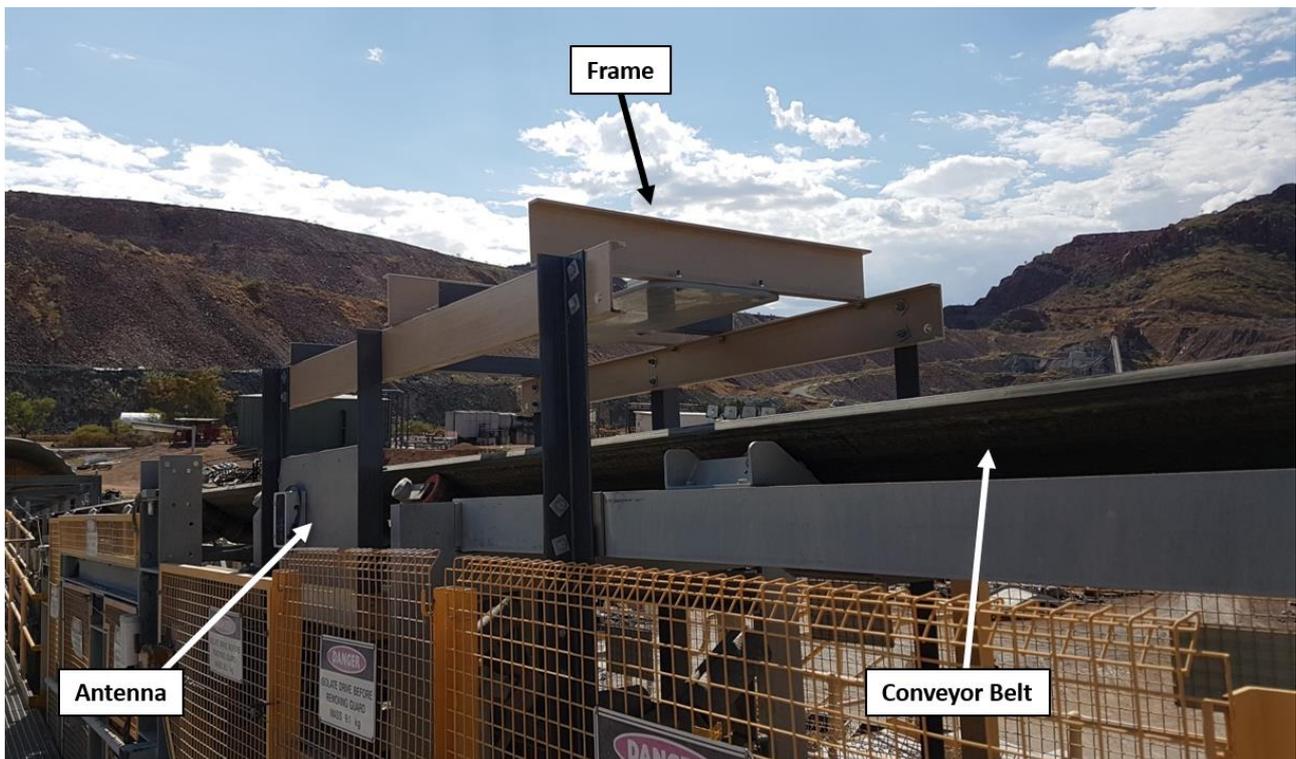
Figure 7 Final frame and antenna setup installed on CV104

Due to the nature of RFID technology, the system frame had to be constructed with as little metal as possible to minimise interference or noise. The use of metal would reduce the chance of tag detection and decrease the effective range of the antennas. For this reason, the frame needed to be constructed out of FRP 'I' and 'L' beams (Figure 6). Due to the construction material, the frame was too flimsy and flexible, causing a number of issues during storage and mounting that required rectification prior to its final installation being achieved (Figure 7).

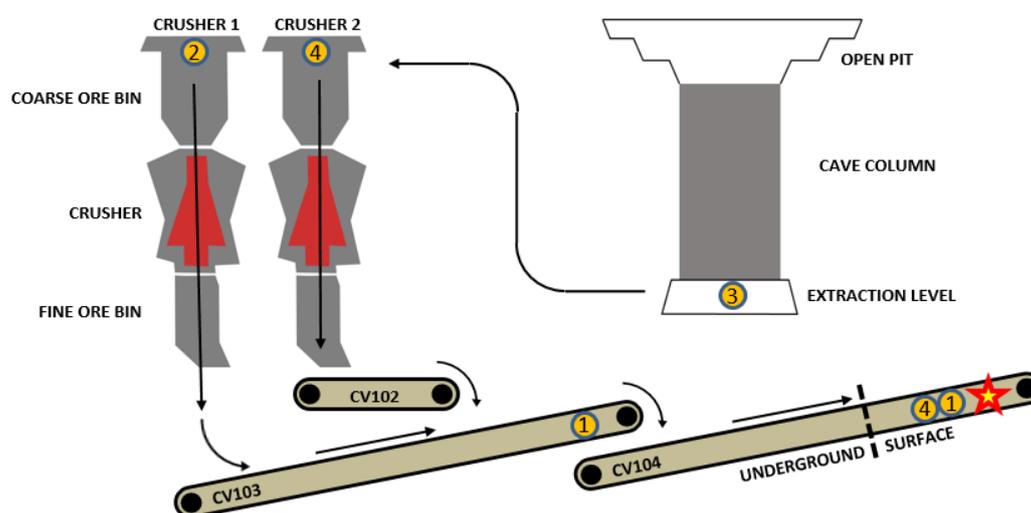
Figure 8 Schematic location within the mining cycle each testing round (number indicated by orange circles) started. Dashed line on CV104 indicates where it emerges on the surface

The first round of testing was split into two subsections (see Figure 8 positions indicated by '1'); the commissioning phase with tags dropped onto the CV104 conveyor, and a second phase to test any detection rate change introduced by tags passing through the CV103/CV104 Transfer Station.

The second round of testing moved to an earlier stage of the ore handling cycle where tags were deployed into the top of the Northern Crusher Extraction Level Tipple (see Figure 8 position indicated by '2'). These tags travelled through the coarse ore bin, through the primary crusher, the fine ore bin, transfers onto CV103, through the transfer station, and up past the antennas setup on CV104 on-surface. Of the 400 tags deployed, 219 were detected; a 55% read rate which is considered a good number, given the fact that the cattle ear tags were not designed for the harsh mining environment.

The third round shifted to testing any reduction in detection rates through the load/haul/dump cycle undertaken on the extraction level (see Figure 8 position indicated by '3'). Two separate bags of tags were scanned and assigned to be dispersed into two separate drawpoints.

A small fourth round of testing was undertaken to assess the detection rate of tags encased in the resin used for rock mass consolidation within the extraction level at the mine (see Figure 8 positions indicated by '4'). Tags were placed into 50 mm diameter cups used for recovering unconfined compressive strength test samples of resin and then dropped in two different locations, those being the CV104 conveyor and the Southern Tipple. The CV104 samples returned a detection rate of 35% while the Southern Tipple samples showed a 20% reading rate. This reduced rate is discussed further in Section 4.1 and will be the subject of further testing works as noted in Section 5.

Table 1 Summary of testing round detection results to end of March 2018. Test round names coincide with location numbers on Figure 8
