Rehabilitation of the Hillendale Mine’s residue storage facility

JA Beukes *Tronox KZN Sands (Pty) Ltd, South Africa*

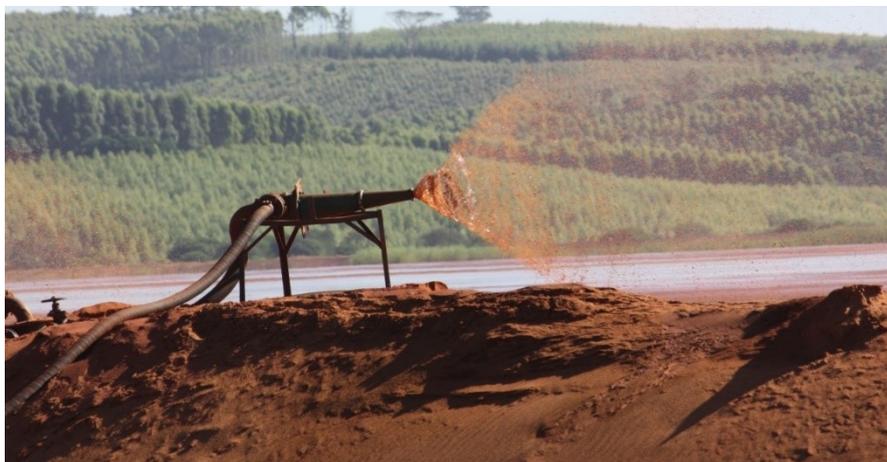
Figure 1 Residue storage facility wall raising using coarse tailings pumped from the process plant

The original starter wall was grassed during the construction phase. The wall was however continuously lifted through adding coarse sand as discussed and illustrated in Figure 1. Due to this continual process grassing of the sand wall could only be executed once the wall reached its final height. The outside of the perimeter wall of the RSF was planted with grass sods sourced from a local supplier. Grass is planted on the RSF walls to form an erosion barrier on the perimeter wall of the RSF. Figure 3 shows the grassing process.

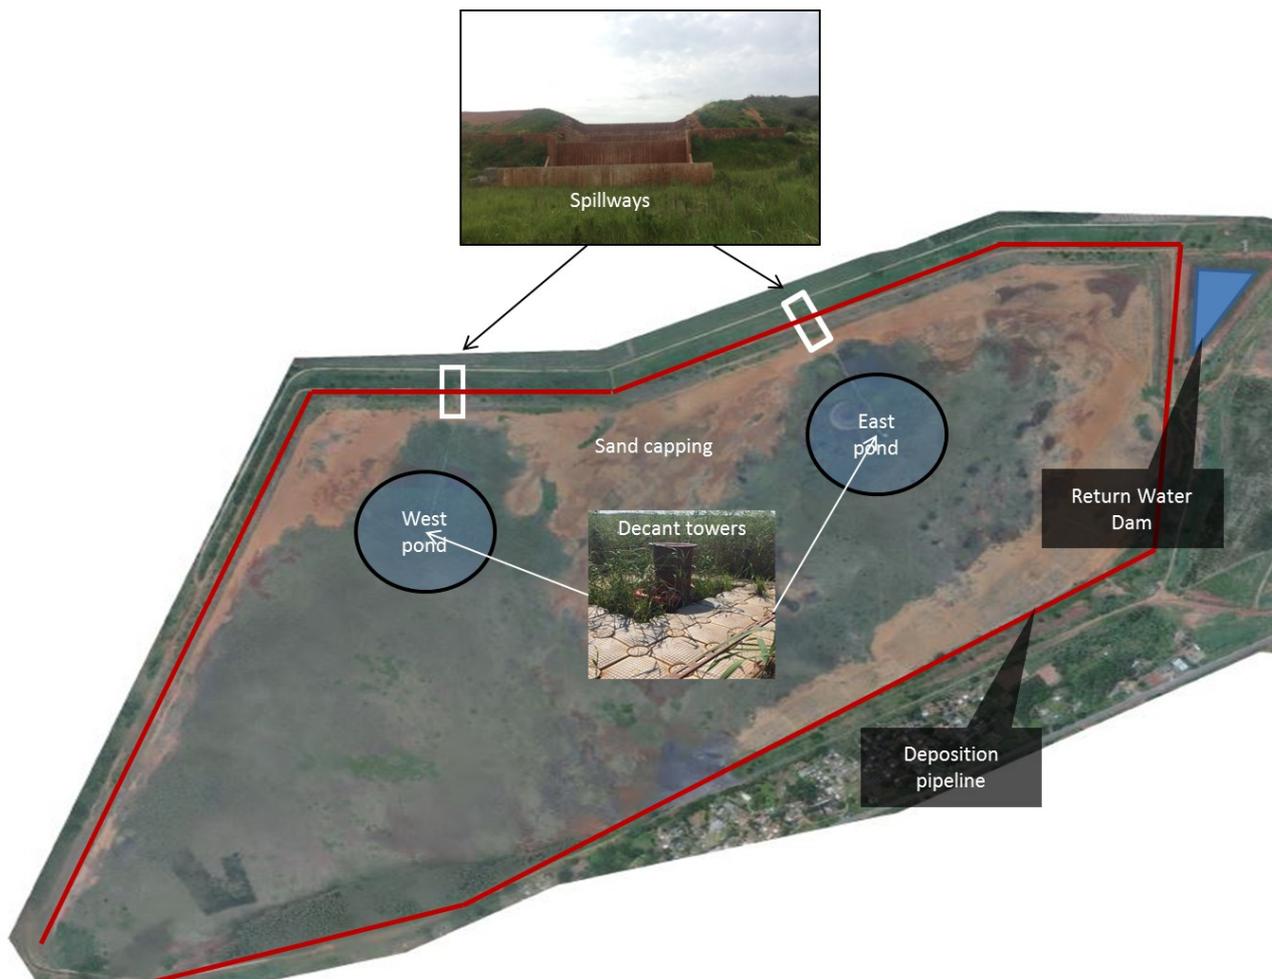
Figure 2 shows the operational features imposed on an aerial photograph of the RSF taken during the rehabilitation phase.

Figure 2 Residue storage facility operational features

The water decant system consists of a gravity emergency system and a pumped duty system on both east and west decant. The decant tower positions are also indicated in Figure 2. The 600 mm diameter decant tower together with the barge pump system was designed to decant the rain water and supernatant water at a rate of 0.7 m³/s, i.e. combined west and east flow capacity of 1.4 m³/s.

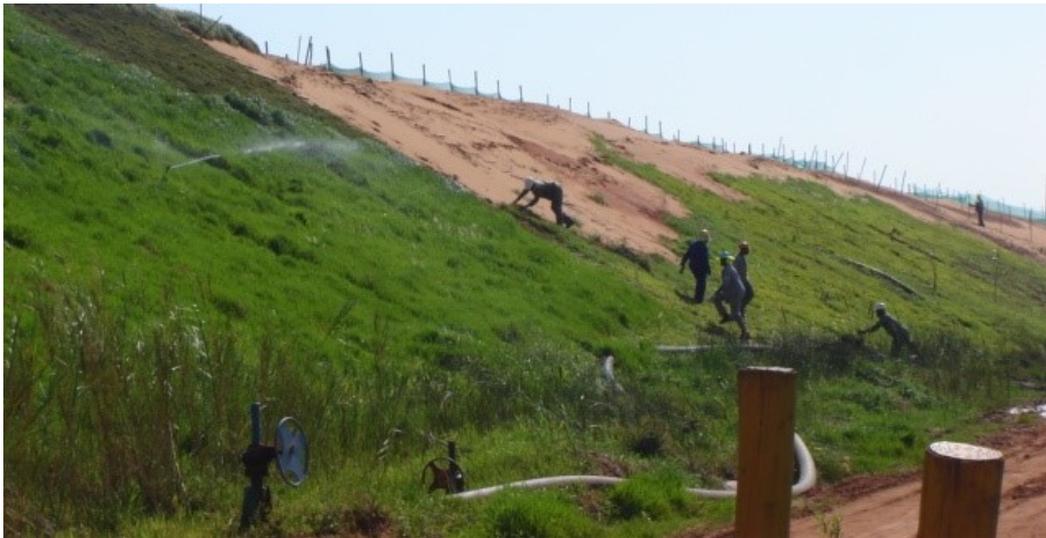
Figure 3 Placing of grass matting on the outside of the residue storage facility sand walls

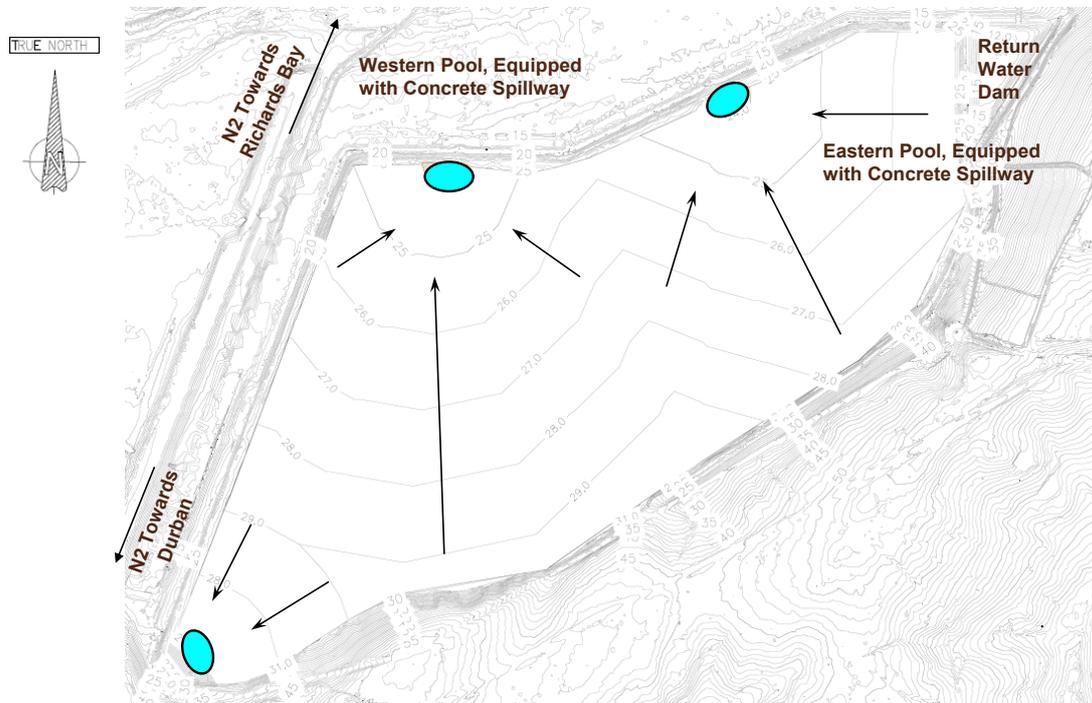
Figure 4 Concept design of the residue storage facility closure drainage pathways

As the plan was for the RSF to drain freely through spillways constructed on its sand walls the operational surface contour needed to be amended. As previously described, during operation residue was discharged around the RSF perimeter in a cyclical fashion. The bleed and runoff water collected at two centrally located penstocks. To achieve a surface that would allow water to drain to the planned spillways, deposition was managed for the final two years of operation with only the southeastern deposition points used. That allowed for a slope to be established running from the southeast to the northwestern wall of the RSF, where the spillways were planned. Figures 4 and 5 show the planned contours as well as an aerial photograph taken during the selective deposition phase respectively.

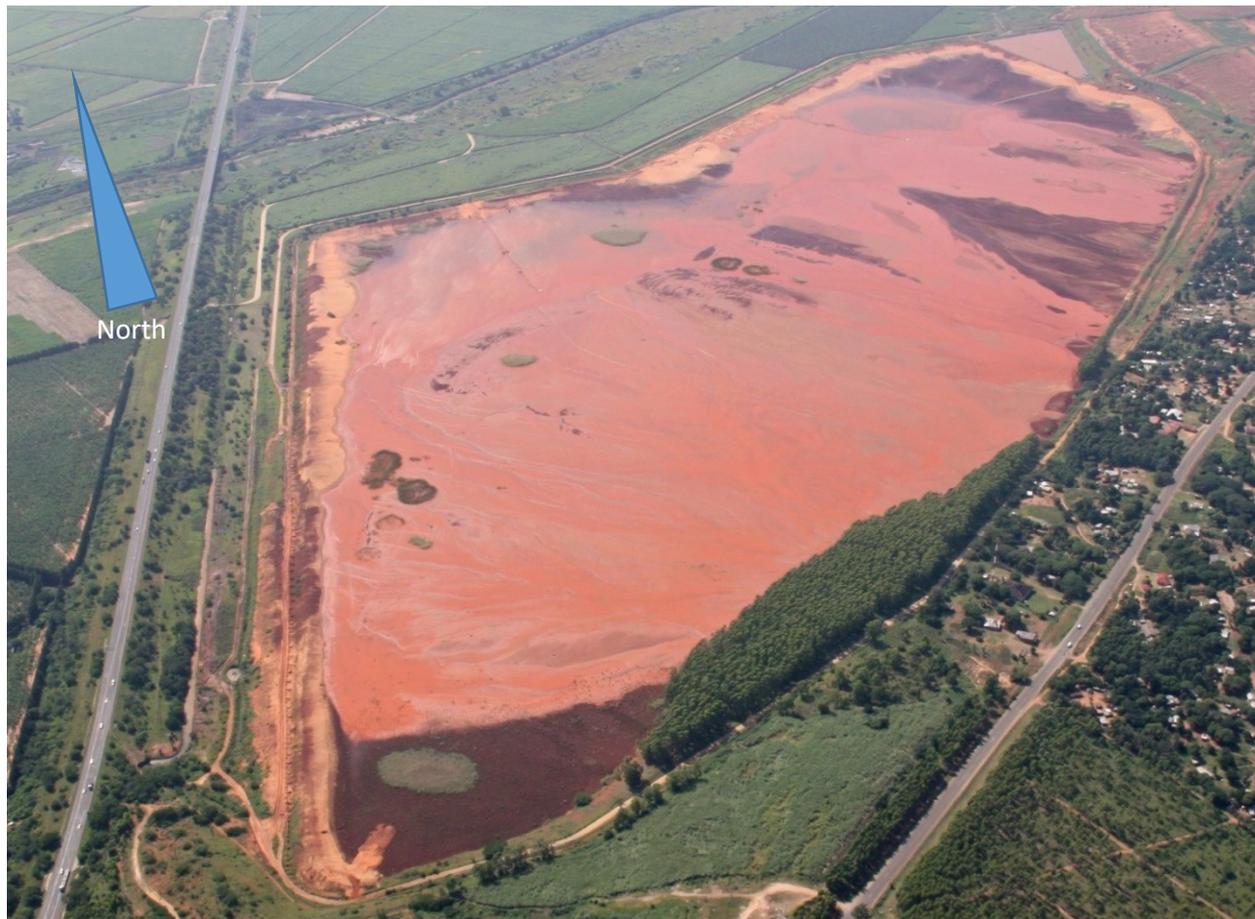
Figure 5 Aerial photograph showing the depositing of fines from the southeastern side of the residue storage facility

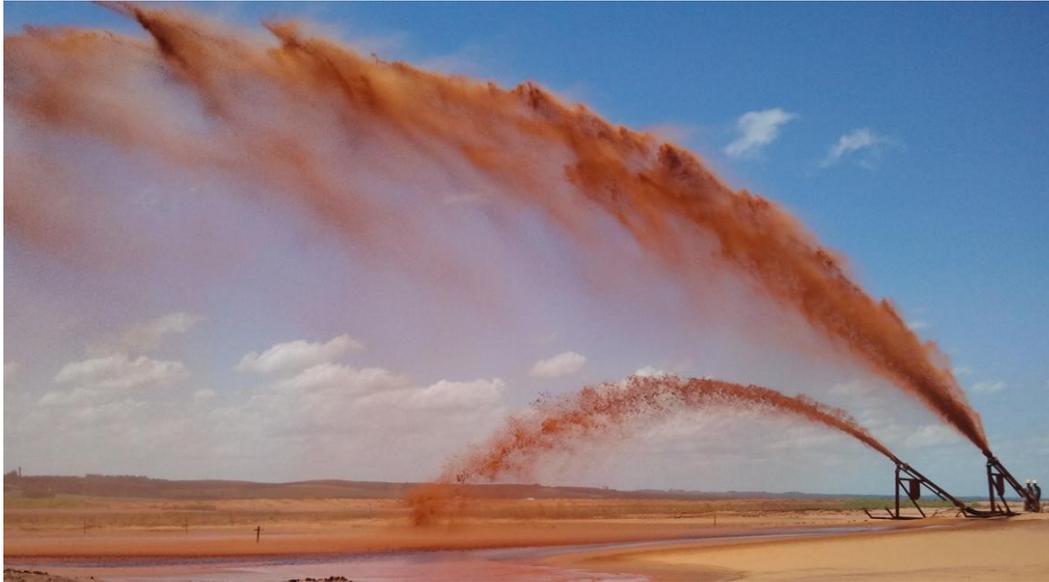
Figure 6 Coarse sand sprayed onto the residue storage facility surface in the capping process

As one of the closure criteria for the Hillendale Mine is to have sustainable agriculture, one of the goals was to develop a trafficable surface on the RSF for typical farming equipment. The residue material deposited following the cessation of operations formed a crust of dried clay but in the process isolated the underlying wet residue from further significant drying. The permeability of the wet residue is also very low requiring some form of intervention to achieve the goal of a trafficable surface. The first attempt to achieve this goal was to cap the facility with a sand layer of 1–1.5 m thick. The capping, if slowly applied and evenly spread, would assist by distributing any point load to such a degree that access would be safe. This strategy had mixed success. Initially, while the mining operation was still in progress, sections of the facility could be capped at a good rate. Once mining ceased however, the hydraulic transport of sand to the facility became ineffective due to low sand densities and was suspended.

Around 30 hectares of the site was capped with sand and some sugar cane was successfully established on the material. Good moisture retention was achieved in the sand due to the impermeable layer at around 1 m depth. The sections capped could support traffic and travel routes could be established. Figures 6 to 8 show the deposition process, area covered and an aerial view of the RSF following the capping and sugar cane establishment on selected sections.

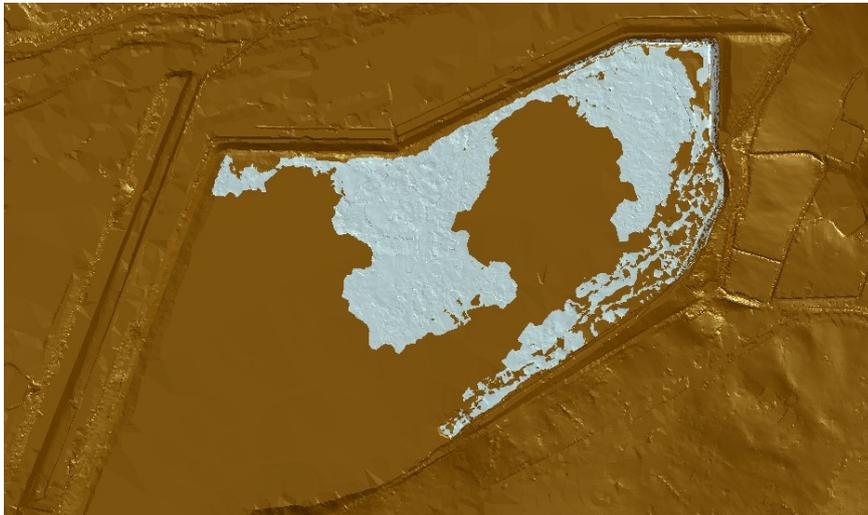
Figure 7 Survey of the areas capped with coarse sand

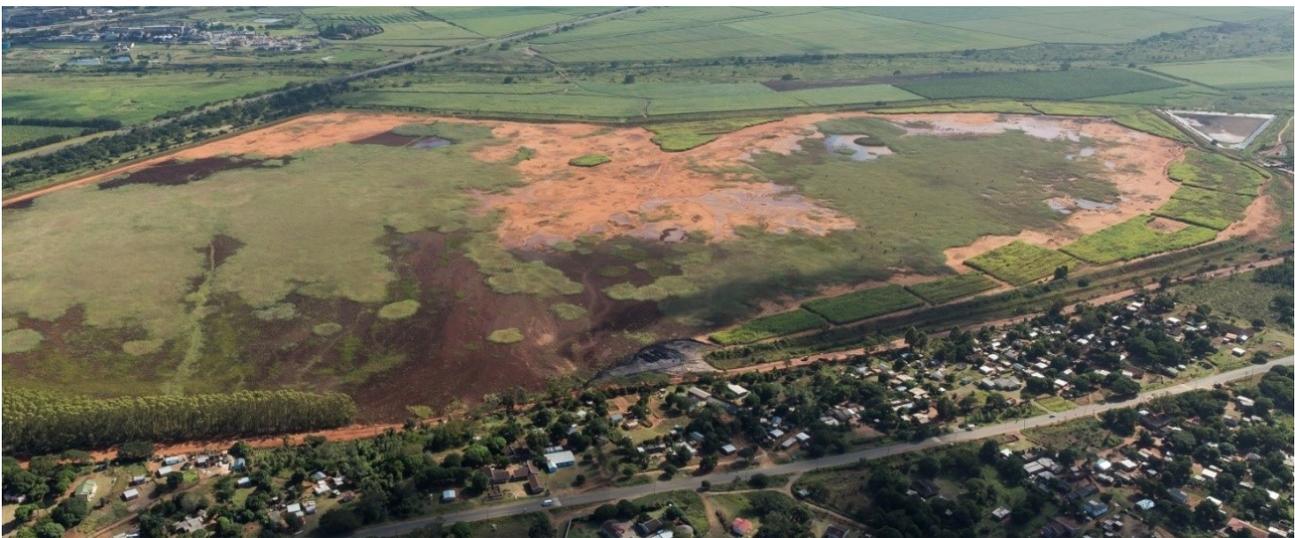
Figure 8 Aerial view of the residue storage facility where the areas capped with sand are visible

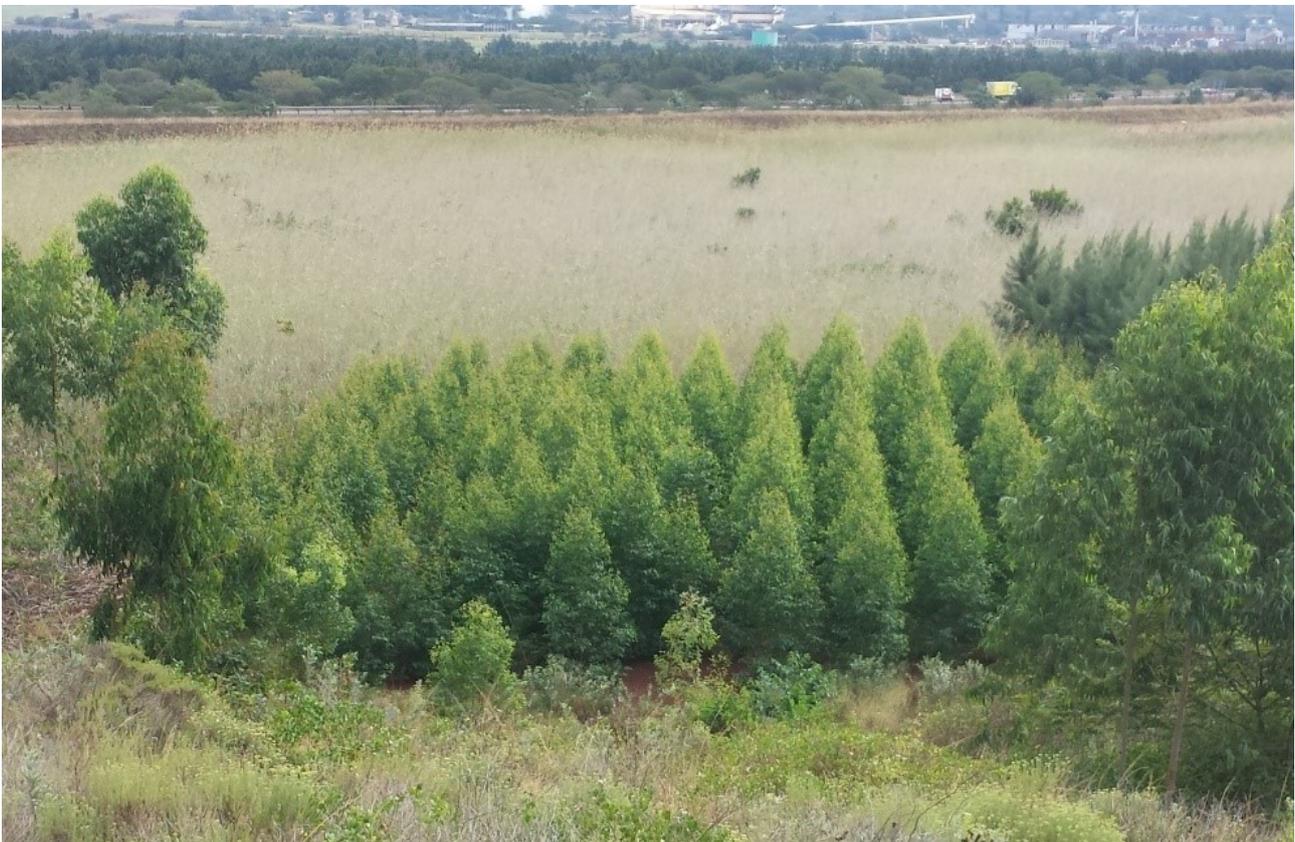
Figure 9 Trial area with eucalyptus trees

As discussed, some initial attempts were made to deposit coarse material over the RSF to create a stable surface layer. This dumping has had localised effects and has allowed access to plant sugar cane in sections along the northeastern and southeastern periphery of the RSF. Trials were subsequently initiated to promote desiccation through the establishment of casuarina and eucalyptus trees. These trials, located in the southwestern portion of the RSF have served to dramatically increase surface desiccation, resulting in large cracks forming under these tree stands. These cracks appear to slowly fill in naturally over time and therefore appear to be a solution to dewatering the fine residue deposited in the RSF. This has led to the expansion of planting programs, with eucalyptus seedlings now planted in the drier sections of the RSF.

The tree stabilisation was monitored by a forestry consultant who confirmed acceptable performance of trees on the RSF. The plan is to expand the establishment of trees to the majority of the RSF surface to assist in reducing the retained moisture/water levels in the upper layers to provide the required stability. Factors to be monitored are the impact if rainfall returns to typical levels and if dewatered layers re-absorb significant quantities of water or if structures are maintained.

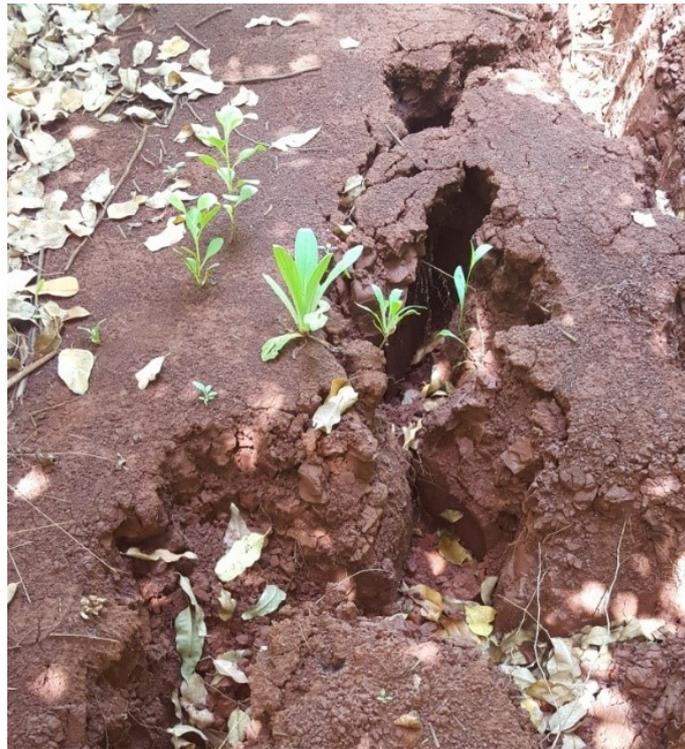
Figure 10 Effect of moisture reduction in the fines in the eucalyptus trial block on the residue storage facility

Figures 9 and 10 show the trial establishment and crack development in the fines.

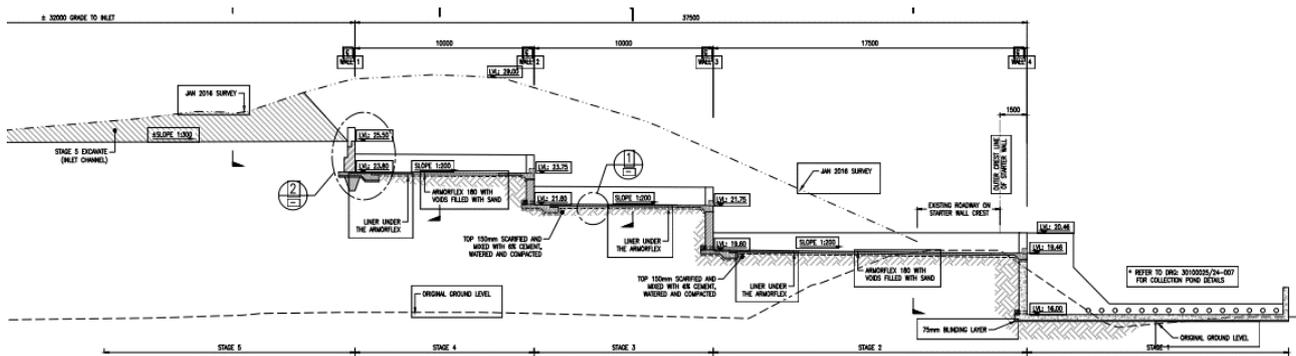
Figure 11 Side view of the spillway design to take water from the top of the fines level to the outside of the starter wall position through several drops

During the operational life the RSF was drained through two penstocks. As these facilities would require maintenance in the long-term, an alternative safe drainage pathway was established for the RSF. Two spillways were constructed to allow safe water discharge over the sand wall of the RSF. The design consisted of concreted steps with Armor flex protection and lined flow sections between the steps. Figure 11 shows a side view of the basic design while the final constructed facility is shown in Figure 12.

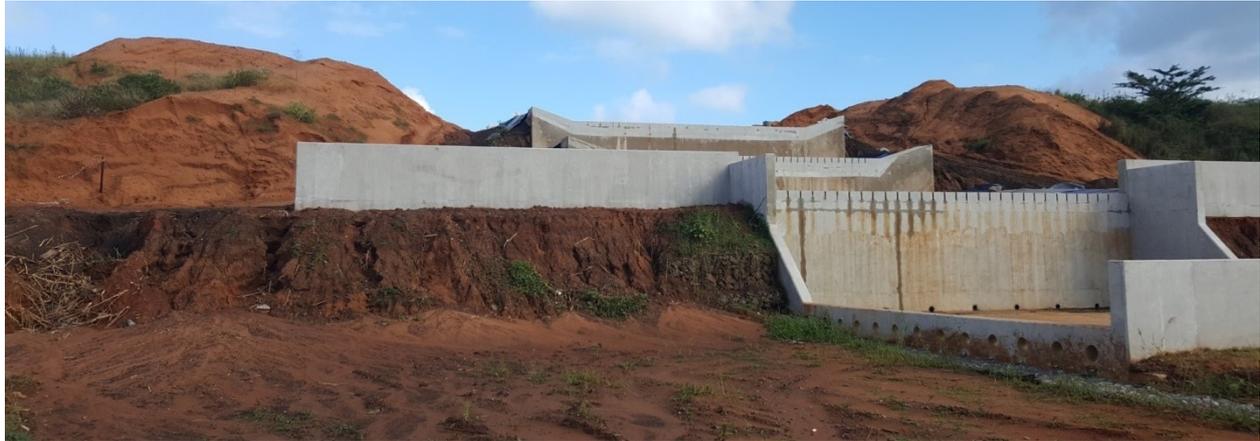
One of the lessons learned from the spillway construction is that the levels of the residue reduced over time. The fine residue settled in the RSF and as a result there was an elevation difference of approximately 1 m between the design level and the level at completion of the construction. Provision was made for future reduced surface levels; however, this could have been more since the fine material has settled significantly more than predicted.

Figure 12 Completed concrete spillway showing the consecutive drops and release on the natural ground level outside the wall footprint

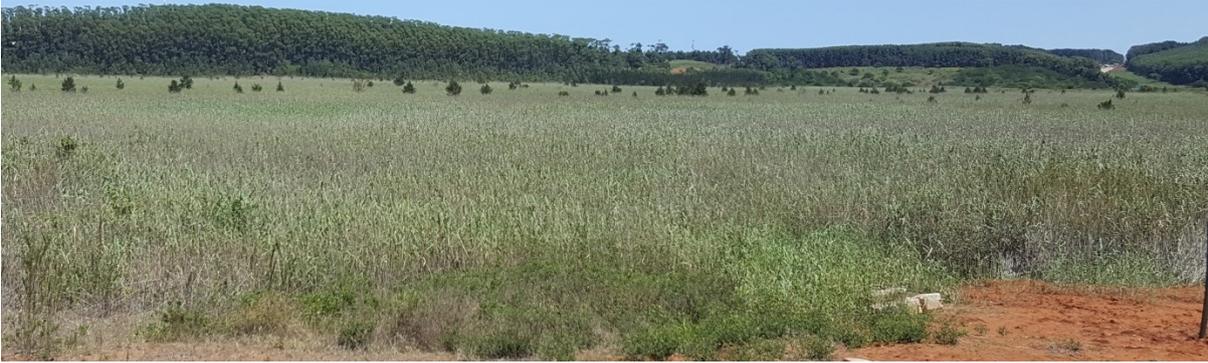
Figure 13 Significant areas with established reeds

A dense cover of wetland vegetation now occurs across most of the RSF. Vegetation communities were mapped. *Phragmites australis* is clearly the best adapted to the conditions and is dominant over much of the RSF. This includes areas that are regularly inundated around the penstocks as well as less saturated areas towards the periphery of the site. *Typha capensis* is another common species although it appears to be outcompeted by *Phragmites* under most circumstances. A small area is dominated by *Andropogon eucomus*, another obligate wetland species. Whilst diversity of plant species is generally low, depressions add diversity to the habitat and 21 plant species were recorded.

The areas around the penstocks would remain as depressions and would be the zone where water accumulates. It is thus foreseen that even though the current widespread of wetland vegetation may reduce and be replaced over time that some areas may remain and develop in wetlands in the long-term. These will be monitored in terms of natural succession and increased diversity over time. Figure 13 shows large areas of *Phragmites* reeds.
