Stabilising an underground void: monolithic construction using self-consolidating concrete

A Pakula *Golder Associates Ltd., Canada*

Abstract

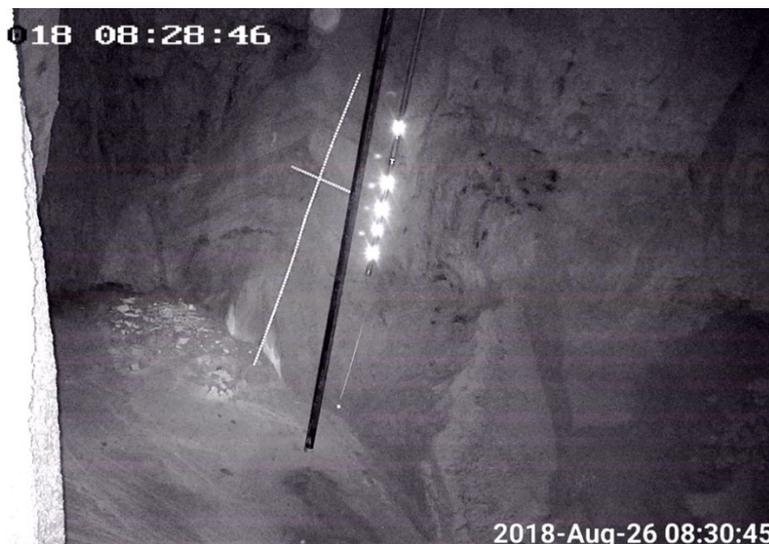
Figure 7 Reflective strips shown as bright white marks on the PVC in the infrared camera picture

During SCC pouring, the PVC sleeve was lifted using a hydraulic casing jack on surface to ensure that the PVC did not become lodged in the SCC (Figure 7). At times, the PVC temporarily caught on the extensometers, creating false displacement that quickly corrected itself upon completion of jacking.

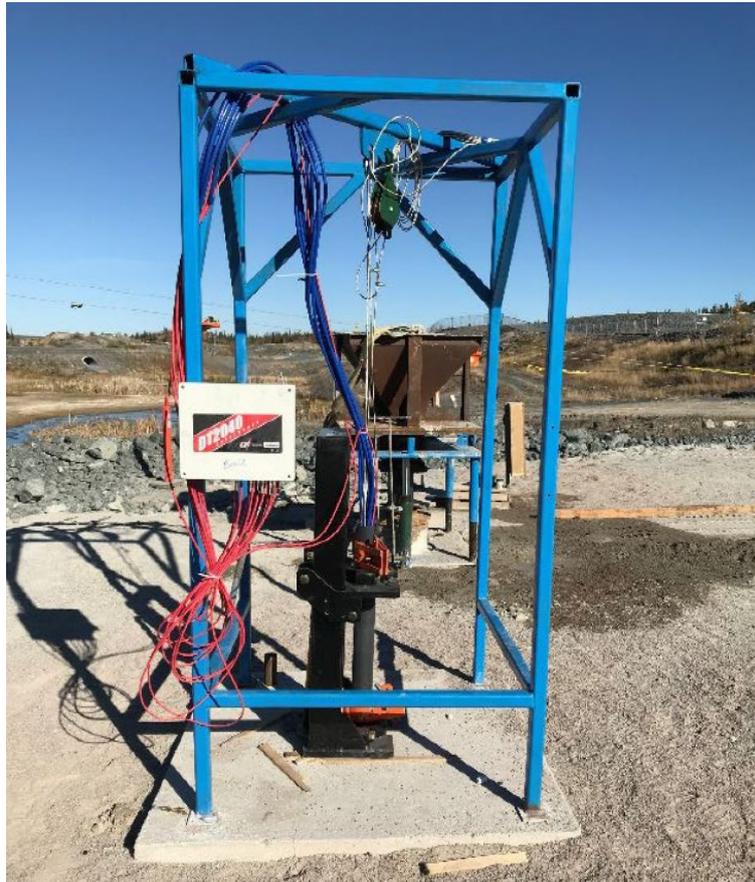
Figure 8 Extensometer support stand (blue) with data logger and casing jack (black)

The extensometers were wired into data loggers and set to collect data every 1 minute during pouring operations (Figure 8). The data were downloaded daily and reviewed. Interpretation of the data is discussed in Section 6.
