# Quality management during closure works at the Telfer mine: a case study

**E Smedley** *Mine Earth Pty Ltd, Australia*

**B Stokes** *Newcrest Mining Ltd, Australia*

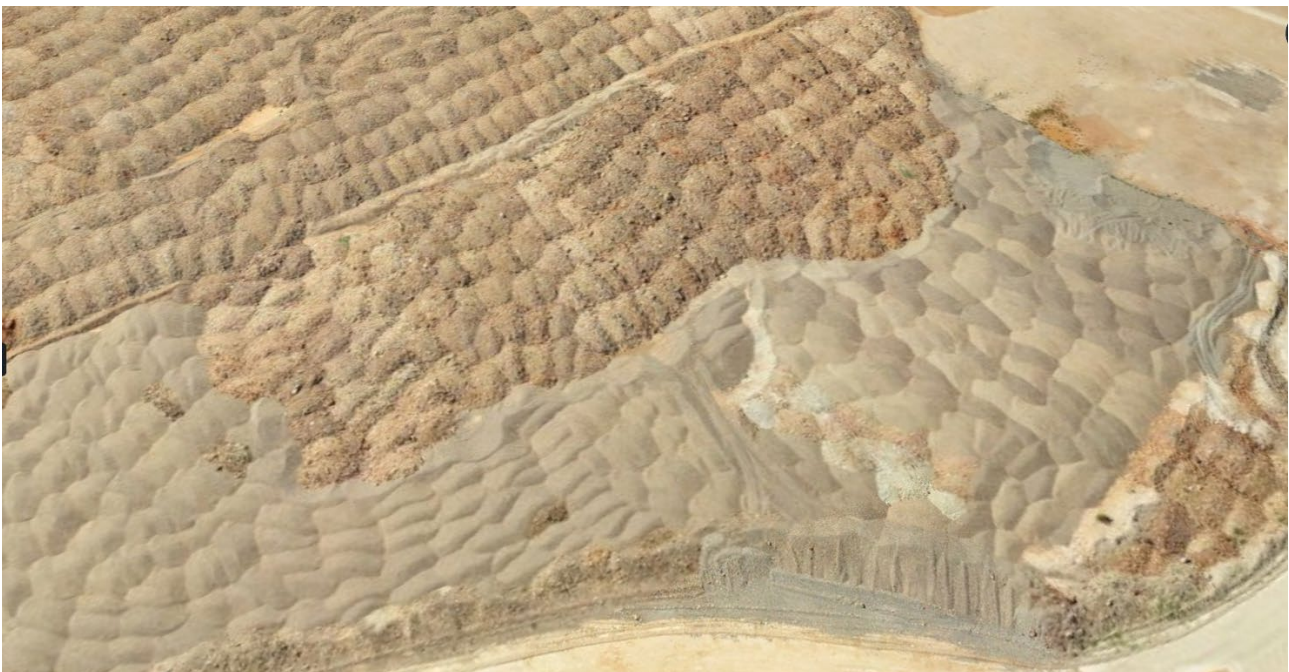
**Figure 1** Example of variability in as-dumped mine waste

Mine closure earthworks typically include a higher degree of unknowns than many other civil works. Given the remote location of many mine sites, closure works are typically undertaken using locally sourced materials and existing mine waste, as opposed to materials sourced from a quarry to meet a given specification. Mine waste is often placed in an ad hoc manner (Figure 1), and there can be a high degree of variability in material types that can present additional challenges to mine closure works and require changes to the design. It is therefore prudent to allow a degree of flexibility within the quality management process to enable an agile response to changing or unexpected conditions, while ensuring that works still meet the design intent.

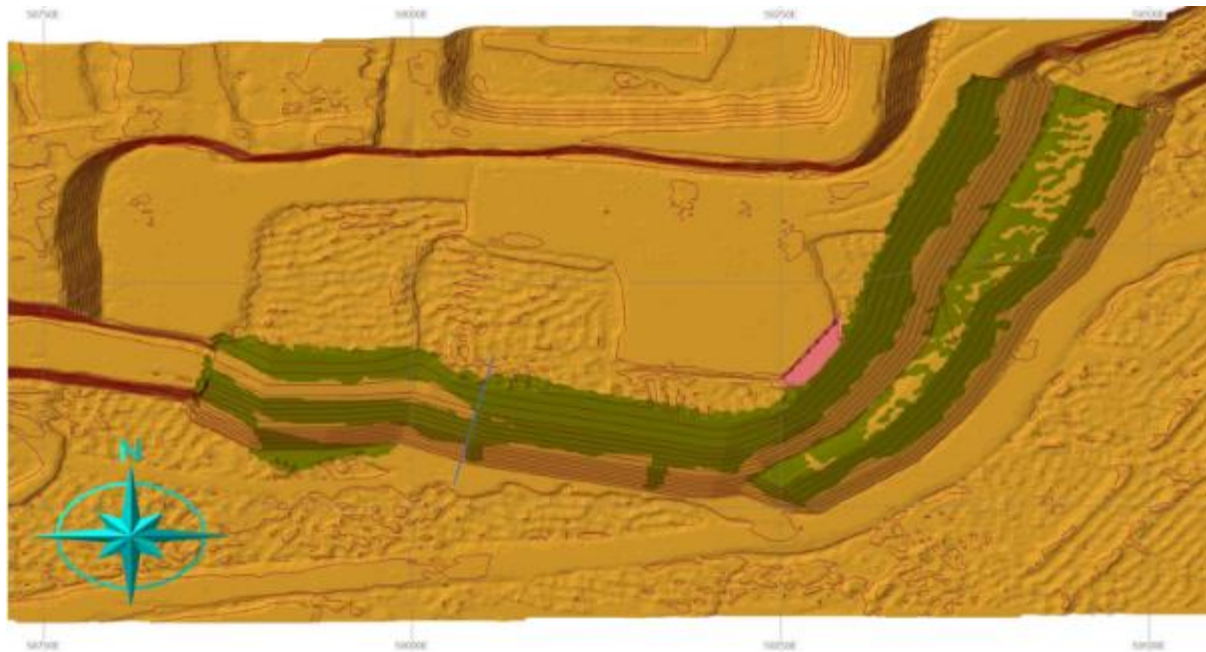
Figure 2 WD6L-E batter and berm closure design

Progressive closure works have been undertaken across three WRDs at Telfer. This case study focuses on the closure works undertaken at waste dump 6 (WD6) and specifically at the WD6L-E panel on WD6 (Figure 2).

A closure design was developed for WD6L-E. Drainage modelling was completed to inform the sizing of drainage controls. Using the results of the drainage modelling as design parameters, earthworks modelling was completed using the existing surface to develop a design surface for the WRD batter and berm. Designs were developed for different surface treatment trials and drainage control sections and details were prepared. A work breakdown structure (WBS) was developed for each individual task that allowed for detailed cost estimation and tracking. The workpack specified the detailed requirements for each WBS item including relevant construction standards.

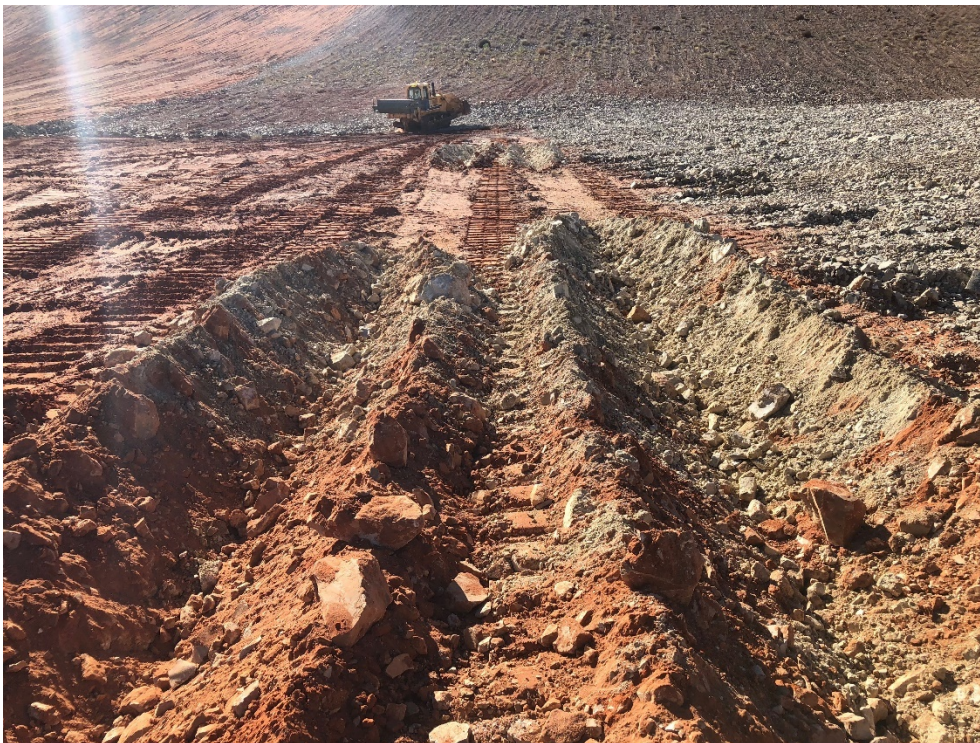
Figure 3 Test ripping at various depths to assess the optimal depth

A wide range of field measures were deployed to manage quality during the earthworks. Field measures included survey layout, survey pickups, laser-levelling, clinometers, test ripping (see Figure 3) and seeding calibration. Quality assurance field measures for the major activities are presented in Table 3.

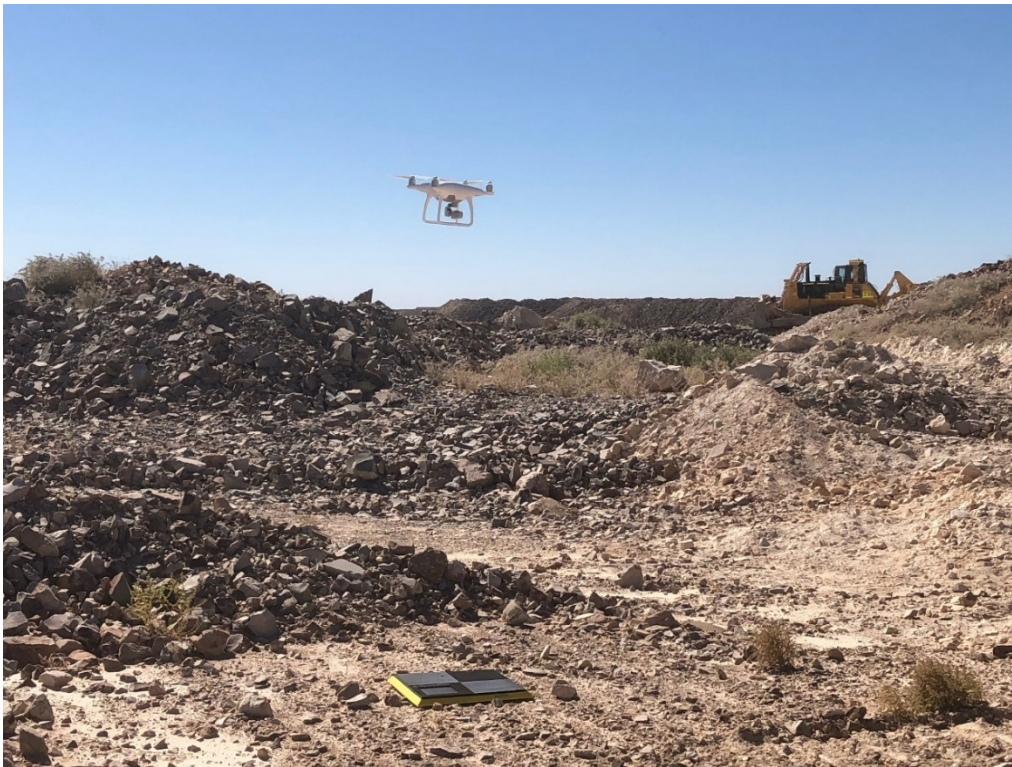
Figure 4 UAV and Smart Ground Control Point

Survey pickups were undertaken using an unmanned aerial vehicle (UAV) with Smart Ground Control Points to reduce the reliance on Telfer survey resources and to ensure a fast turnaround time (Figure 4). Utilising a UAV and Smart Ground Control Points also minimised the amount of machine downtime associated with traditional ground-based surveying techniques. UAV survey data was processed using photogrammetry software and uploaded to a spatial data analytics platform (the platform). The platform was a cloud-based system, meaning that the orthophotos, digital elevation models and other spatial datasets were viewable by the entire project team and could be used to clearly demonstrate where remedial works were required to be undertaken by the contractor.

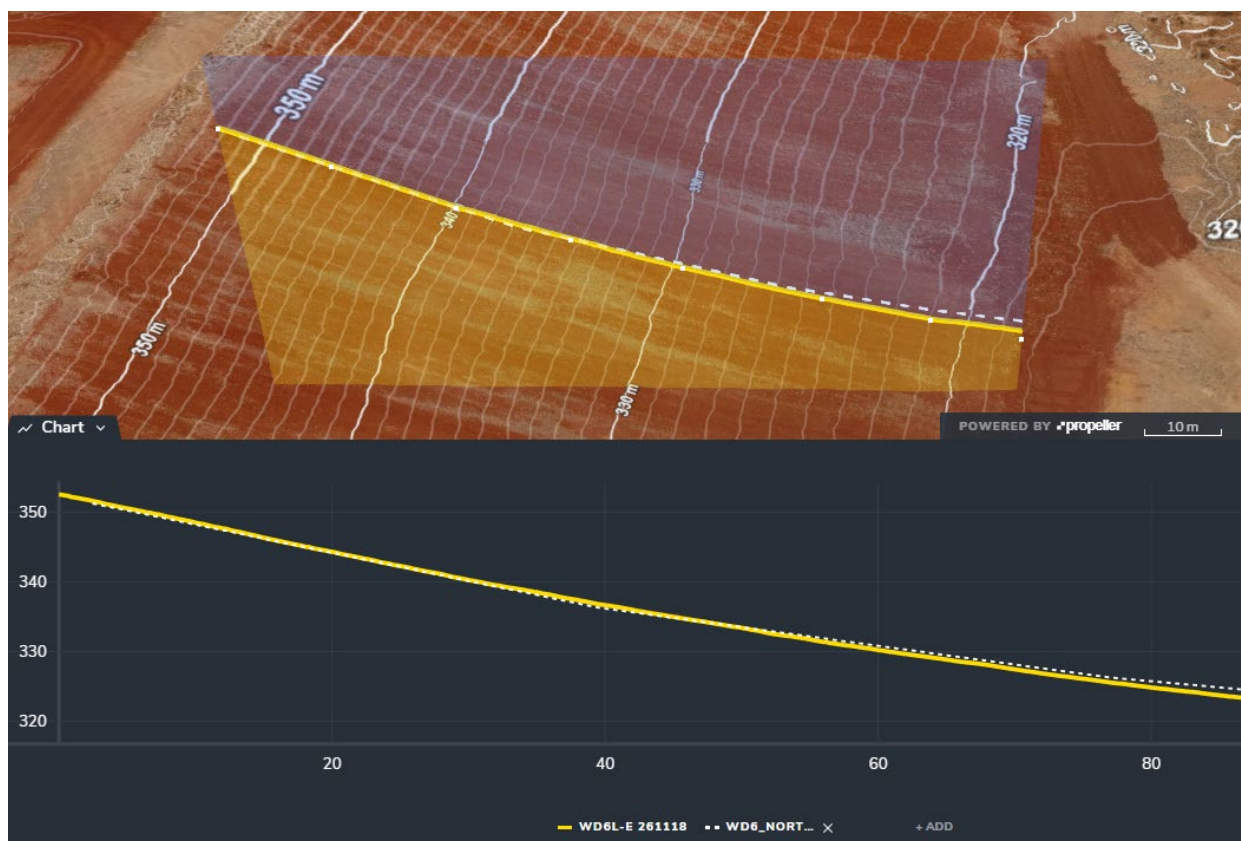
Figure 5 Example cross-section assessment of a reprofiled WRD at WDL6L-E

The platform included a range of inbuilt tools that are well suited to construction assessment and verification of works (Figure 5 and Figure 6). These tools were utilised to undertake compliance assessments of each step of the closure works.

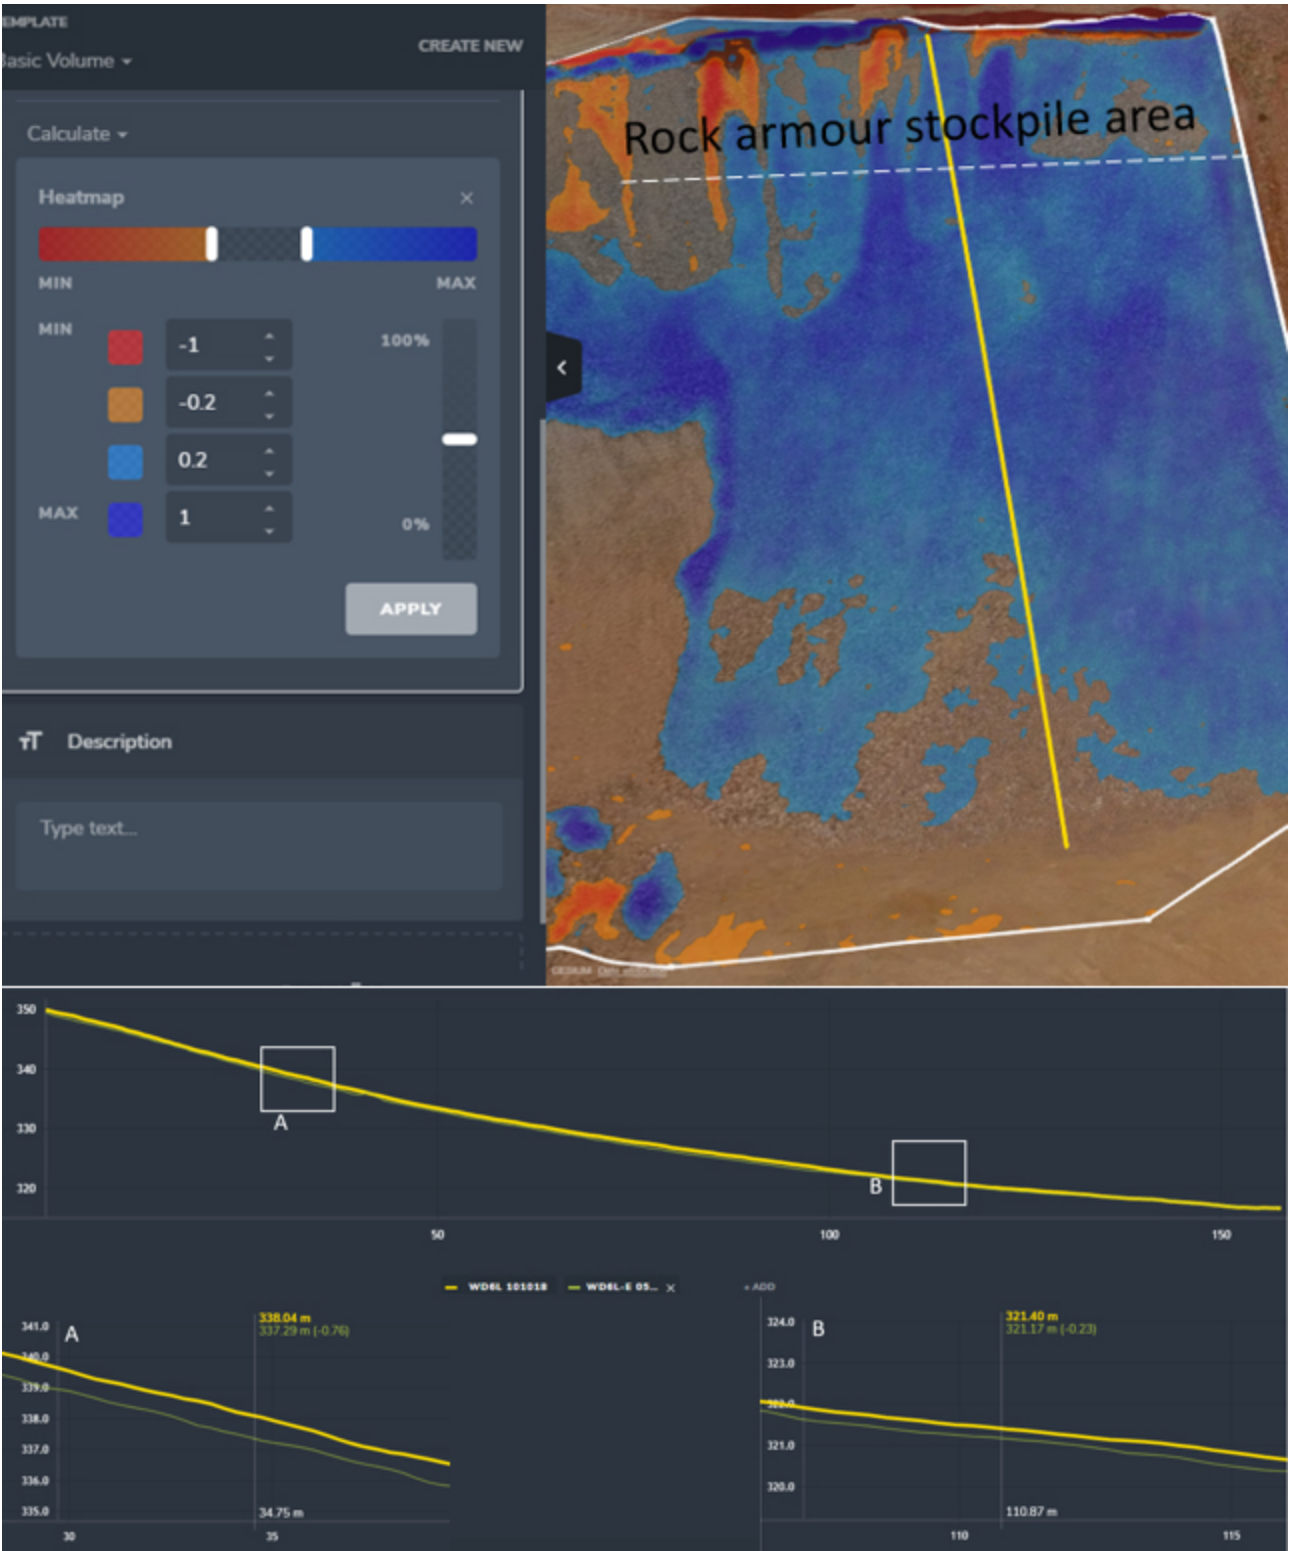
Figure 6 Example cross-section assessment of armour thickness. The assessment identified that there was a shortfall of armour at the lower half of the WRD batter and additional material was required

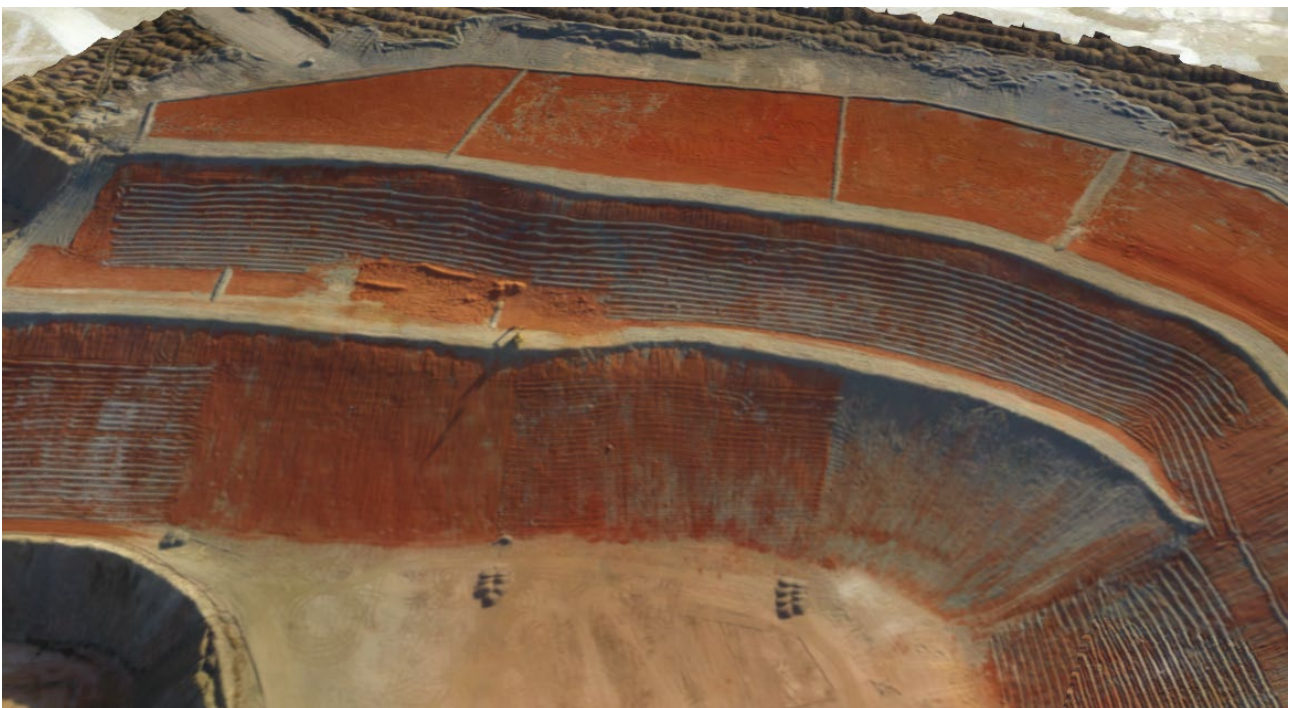
Figure 7 Orthophoto of largely completed works at the eastern side of WD6L-E

The quality management measures implemented by Newcrest at WD6L-E were effective to ensure that closure works met the required standards (Figure 7). The contractor was aware of the construction standards that it was expected to meet. The contractor, in turn, was able to advise Newcrest when inspections and surveys were required to avoid impact to critical path. Defects were identified and addressed in a timely manner.
