# Ground support from a corporate perspective

M Board Hecla Ltd., USA

*This paper describes the role of the corporate ground control function within Hecla Ltd., a mid-tier US precious metals producer. The position of the ground control function within the corporate structure and the primary responsibility of evaluating and communicating geotechnical risk at company operations and during acquisition is emphasised. A case example is given of how the corporate ground control function was involved in recent ground support issues encountered during the sinking of a 3,000 m deep shaft at the Lucky Friday mine.*

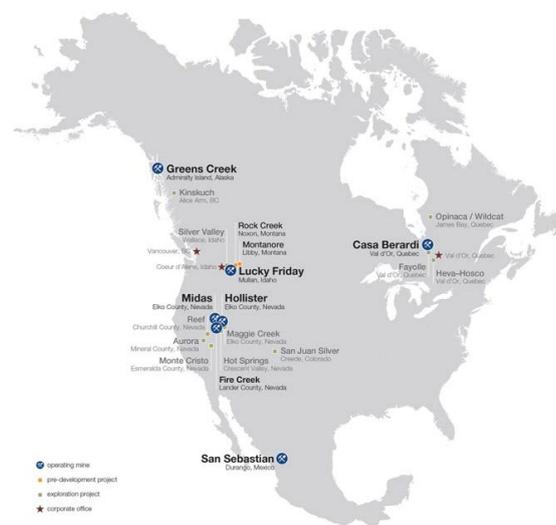
Figure 1 Hecla mines, pre-production and exploration projects

Hecla Mining Company is a mid-tier precious metals producer headquartered in Coeur d’Alene, Idaho, USA. The company, founded in 1891, is the oldest incorporated mining company and the largest silver producer in the USA. The company operates seven primary silver and gold mines in the USA, Canada and Mexico (Figure 1).

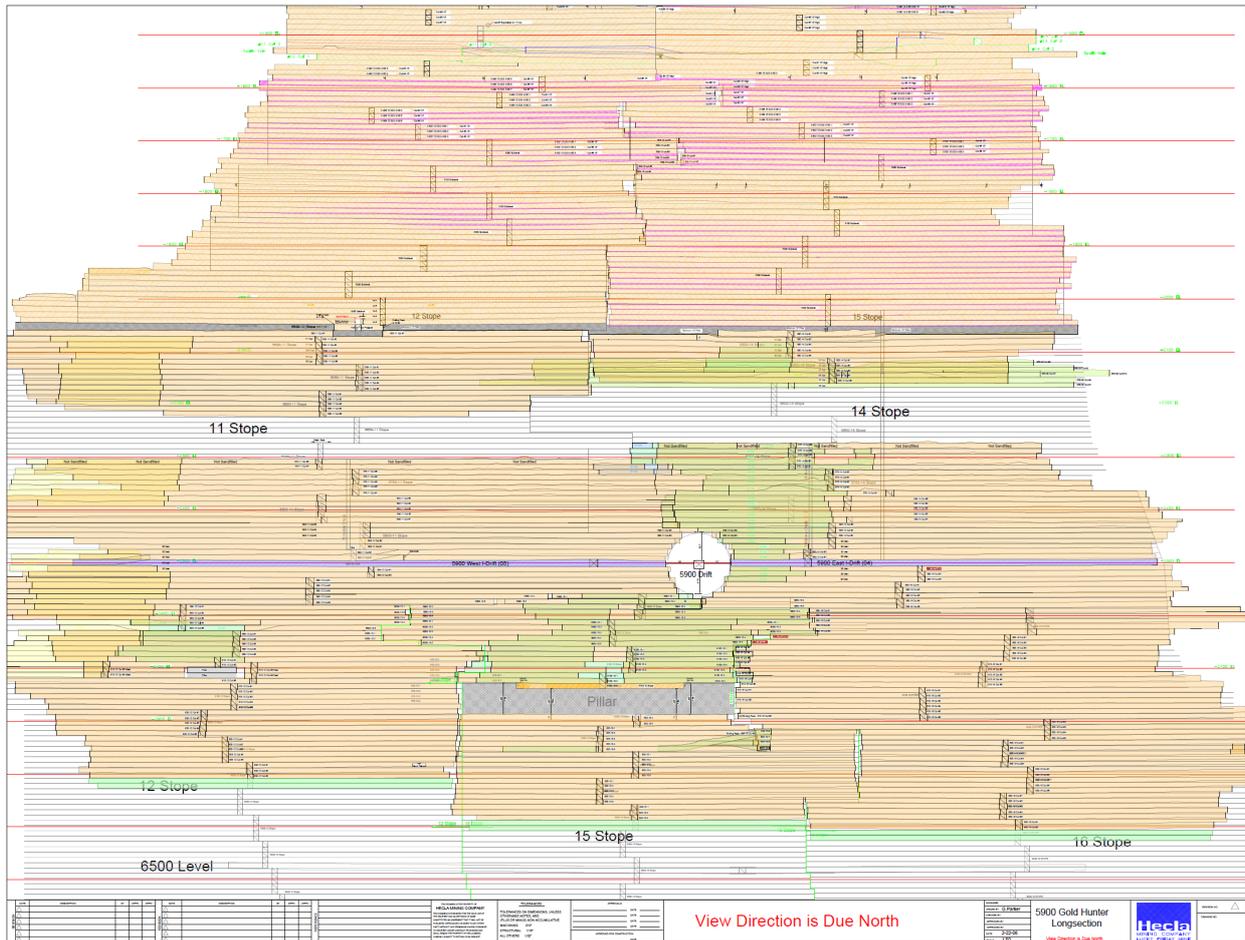
**Figure 3** Longitudinal view of the Lucky Friday mine showing 3 m high underhand cut-and-fill stopes. The vertical depth of the 6500 level is roughly 2,300 m below ground surface. Tan colour are paste-filled stopes, white and grey are unmined

Lucky Friday is an 800 t/day operation that uses an underhand cut-and-fill mining method with cemented paste backfill to extract silver, lead and zinc ore from several narrow, vertical veins. The primary vein extracted is 30 Vein, which strikes roughly east–west, has a mineable strike length of approximately 770 m and average stoping width of about 4 m (Figure 3).

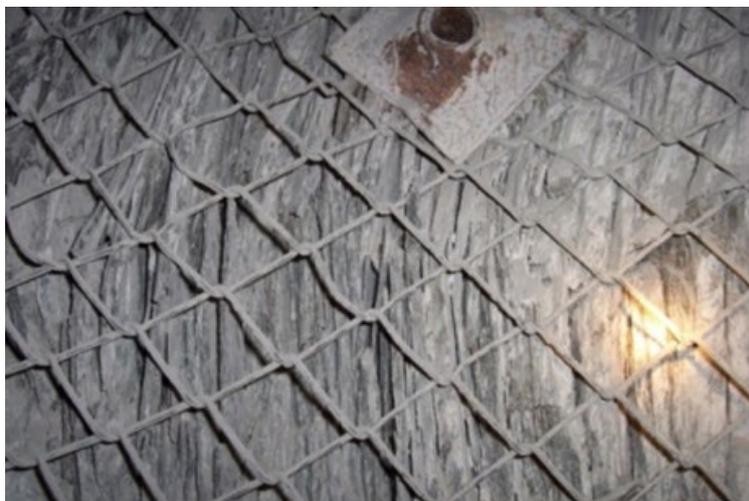
**Figure 4** Heavily foliated argillite host rock at the Lucky Friday mine

The host rock is a highly foliated argillite where the intact rock has an unconfined compressive strength of approximately 70 MPa, but the closely spaced talc-coated foliation (<1 cm – see Figure 4), which parallels the strike of the vein, results in a highly anisotropic mechanical response. The current depth of stoping is approximately 2,300 m, with a maximum in situ horizontal stress component striking northwest with an approximate k-ratio of 1.5.

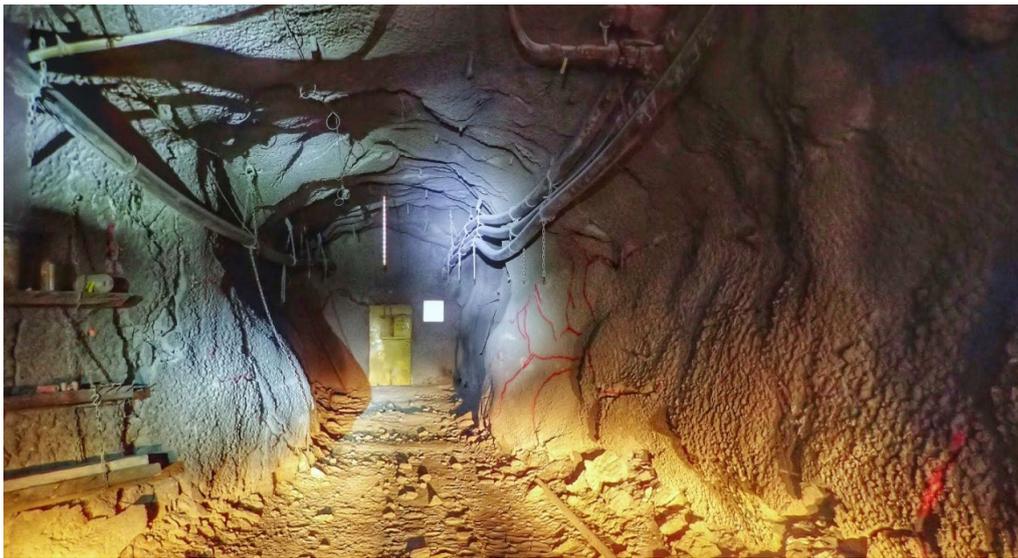
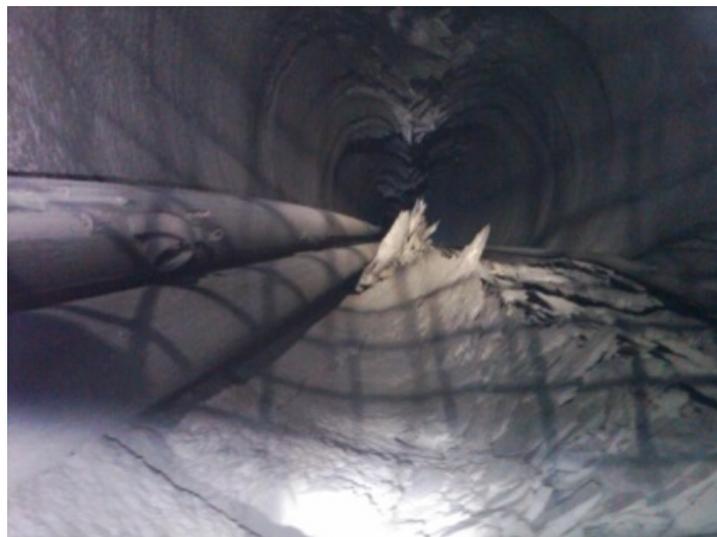
**Figure 5** Typical effect of foliation on failure mechanism and large deformations at the Lucky Friday mine. (a) Drift sidewall deformation and fracturing of shotcrete; (b) Breakout in a 1.8 m diameter unlined raisebore. These deformations are the result of buckling of the thin foliation when excavations are driven parallel to foliation strike

As mentioned, the host argillite responds to excavation in a highly anisotropic manner, depending on the orientation of the excavation with respect to the foliation. When excavations are driven parallel to foliation (e.g. parallel to the veins), buckling of the foliation results in large, time-dependent deformations (Figure 5). When excavations are driven perpendicular to foliation, they are generally stable with minimal support. The depth of foliation buckling into the wall rock is typically around 1 m but can be greater at heading intersections where there is less confinement. Typical ground support in development headings (3.65 m wide by 4 m high) is 1.8 m long friction bolts on 1 m centres with chain link mesh supplemented by 2.4 m, #7 resin-grouted Dywidag bars 'five-spotted' between the friction bolts in the roof and walls. Shotcrete (10 cm thickness) is used, where required, as additional surface support in combination with wire mesh. Recently, resin-grouted D-bolts have replaced Dywidags in drifts driven parallel to foliation to accommodate larger deformations and seismic loading. In drifts where excessive deformation has interfered with passage of mine equipment, the walls have typically been slabbed to widen the opening followed by new support application.

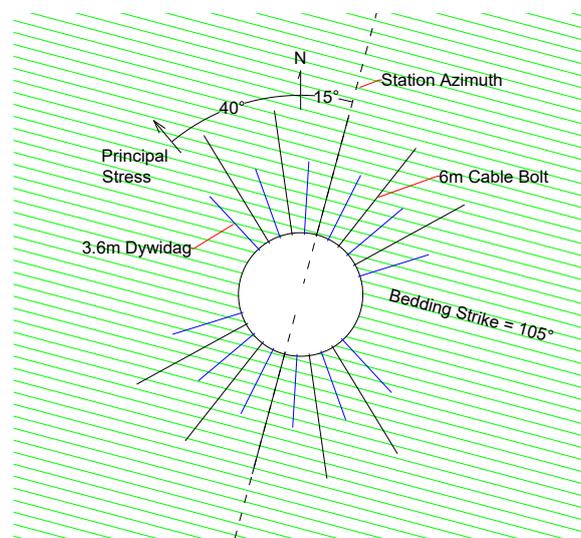
Figure 6 Additional ground support installed at 7580 level to suppress the foliation buckling. Direction of foliation shown striking at an azimuth of 105°

When the shaft reached the 7580 loading pocket level, extensive vertical cracking of the liner on the north shaft wall above the 7500 level was observed. Shaft ground support was increased to five 6 m cable bolts per row on the north and south walls spaced on a 1.2 m × 1.2 m pattern, with 3.6 m resin-grouted #7 Dywidags placed midway, or 'five-spotted', between them (Figure 6). Shortly after the initial cracking was observed, extensive concrete spalling and vertical fracturing of the concrete on both the north and south walls occurred from above 7500 level to the shaft bottom below 7580 level (about 25 m vertical distance). Despite the heavier ground support, cracking of the liner continued. The cracking and wall deformations were significant enough that future problems with guide alignment would undoubtedly occur, resulting in the need to remove the lining from 7500 level to the shaft bottom. At this point, it was necessary to determine a course of action for construction of the final 650 m of the shaft.

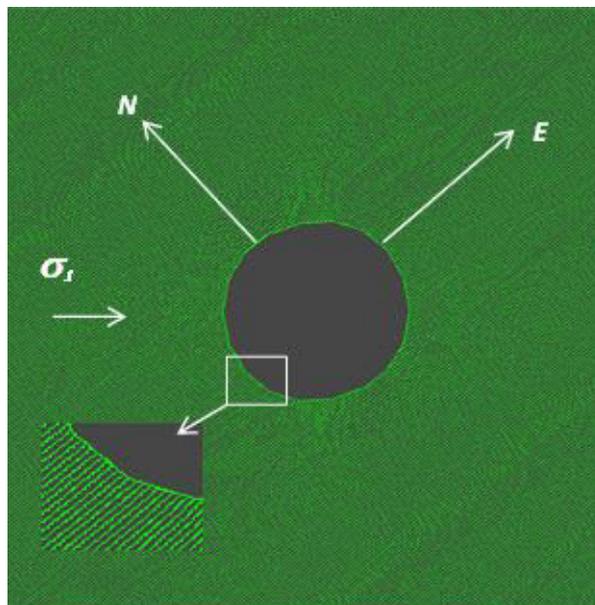
**Figure 7** UDEC two-dimensional model of the circular shaft and maximum principal stress orientation. Inset shows discontinuum, platy blocks formed by foliation that are vertical in dip and strike roughly east–west

The intact rock mass was treated as a Mohr–Coulomb material characterised by a UCS of 70 MPa, and the foliation planes were assumed to be planar and have zero cohesion and 20° angle of friction (resulting from the talcy coatings). The circular shaft geometry was modelled initially, indicating the observed buckling mechanism of failure where the shaft walls are parallel to the foliation strike.

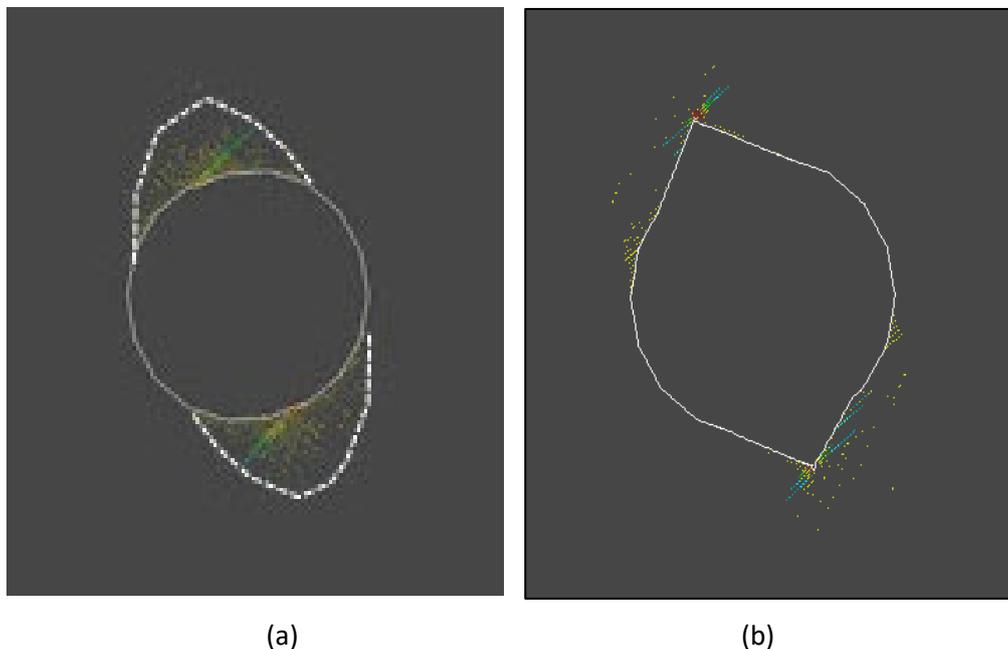
**Figure 8** (a) Failure mechanism of the circular shaft showed buckling of the foliation leading to formation of a wedge-shaped failed region of dilation and shearing on the beds at the north and south sides of the shaft to a depth of nearly 1/2 of the shaft radius. Excavation of an elliptical shape indicates a stable configuration is reached. (b) This plot shows dilation and shearing mechanism is suppressed due to the increased confinement to the foliation created by the notched shape

The resulting wedge-shaped failure region (Figure 8) on opposing sides of the shaft was about one-half the shaft radius in depth and the model indicated unstable deformations in these areas. This modelling appeared

To verify this conclusion, the model was again run using a notched elliptical shape roughly equivalent to the estimated failure shape. The results (Figure 8) indicated that foliation shear and dilation are suppressed due to the greater confinement provided by the elliptical shape of the shaft and that equilibrium was achieved with unsupported conditions. Based on these results, it was determined that: (a) the shaft would be blasted roughly to the elliptic shape based on the modelling (Figure 9) and supported using the baseline friction bolt and Dywidag support, and (b) displacement and liner stress instrumentation would be installed for verification of rock mass and liner response for the remainder of the shaft sinking. Figure 10 shows a typical instrumented shaft section consisting of three 10 m long, six-anchor extensometers (Mine Design Technologies) oriented perpendicular and parallel to bedding, and tangential and radially oriented concrete pressure cells (Geokon). The pressure cells and extensometers were installed after the shaft bottom had been excavated 6.6 m beyond the instrument elevation (i.e. deformation had occurred due to face advance prior to installation of the instruments).

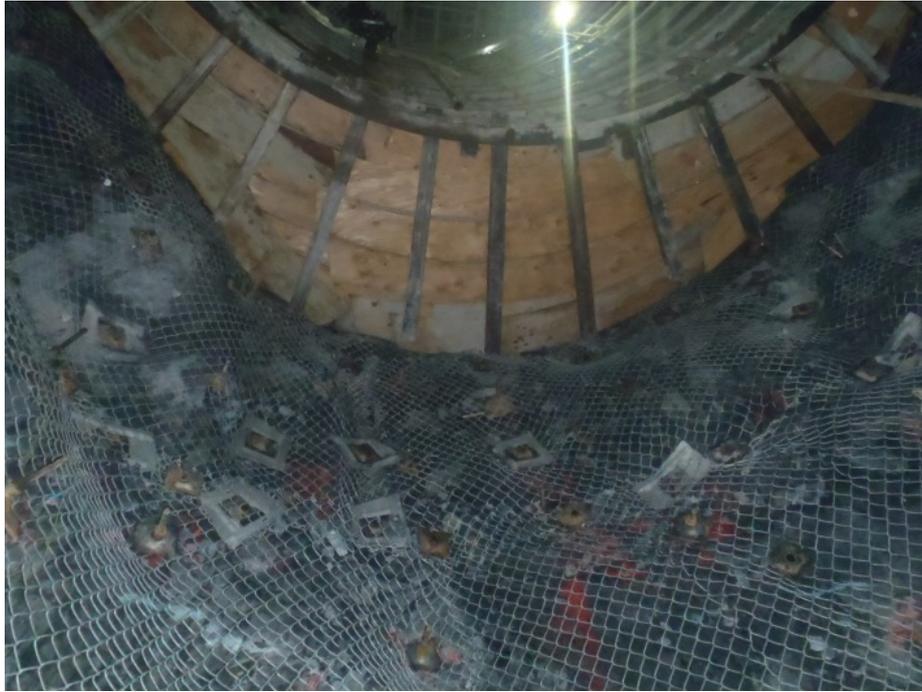
Figure 9 View up from shaft bottom showing the base of the liner after excavation of an elliptical shape for the shaft

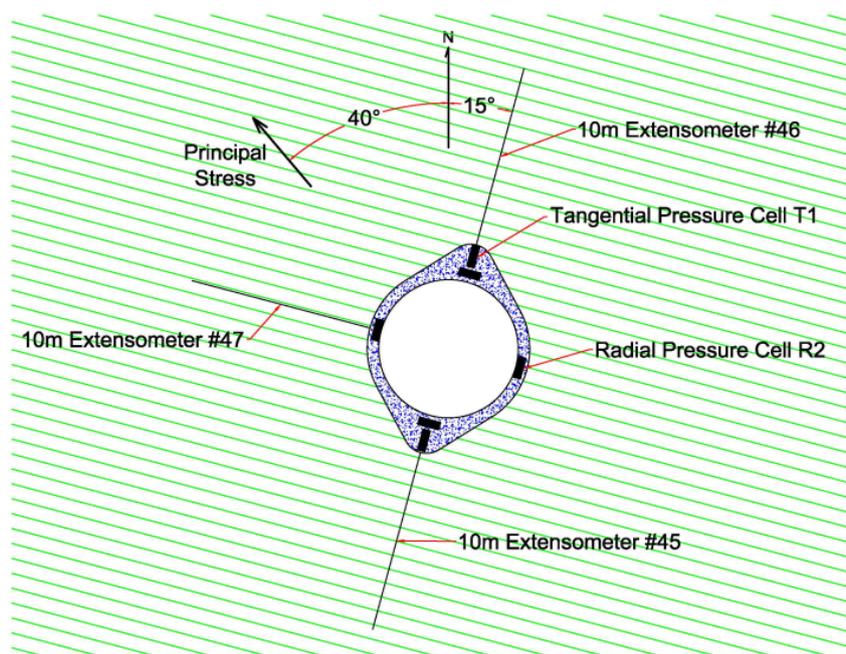
Figure 10 Typical instrumented shaft section showing three 10 m, six-anchor rod extensometers perpendicular and parallel to foliation and tangential and radially oriented concrete pressure cells

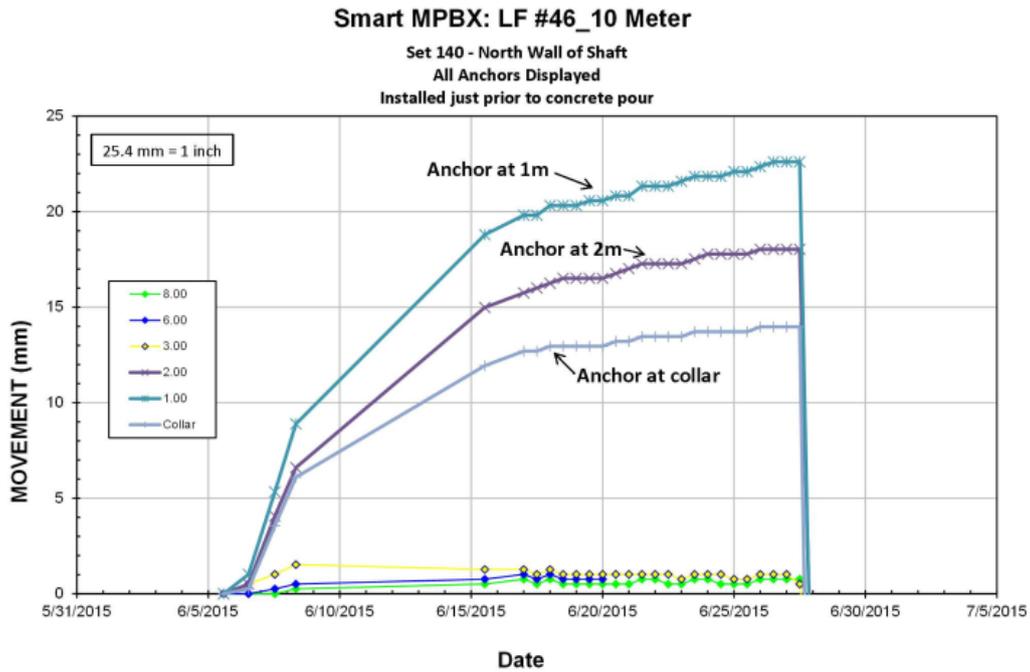
Figure 11 Extensometer displacement as a function of time for foliation-perpendicular orientation

Typical displacement results from an extensometer collared in the notch and oriented perpendicular to foliation is given in Figure 11, while sample tangential and radial stress gauge results shown in Figure 12. The abrupt loss in data after approximately one month of recording of the extensometer was due to loss of the instrument.

The radial displacement perpendicular to the foliation strike equilibrated at about 25 mm after roughly one month as the face advanced beyond the range of influence. Deformation is occurring within the first ~2 m of the shaft wall with rapid decay thereafter. There is a small time-dependent deformation mechanism as seen (also seen on subsequent instruments), however the rate of change became insignificant with time, and has not proven to be an issue in liner loading. The tangential stress change (liner thrust direction) increased by about 10 MPa, primarily as a function of contraction as the liner cooled and time-dependent deformation occurred over several months. Curiously, the greatest radial deformation in the foliation-perpendicular direction occurred at the 1 m anchor depth, and not immediately at the collar of the hole (the rock surface). This observation was repeated in the other extensometers installed as the shaft was deepened. The probable explanation for this observation is shown in Figure 13 (Walton et al. 2018). Since the liner was installed 6.6 m behind the installation of the extensometer, the buckling mechanism, with associated foliation dilation had already begun near the shaft surface prior to liner installation. After liner installation, the liner resisted further inward surface movement of the wall. With continued radial deformation of the rock mass toward

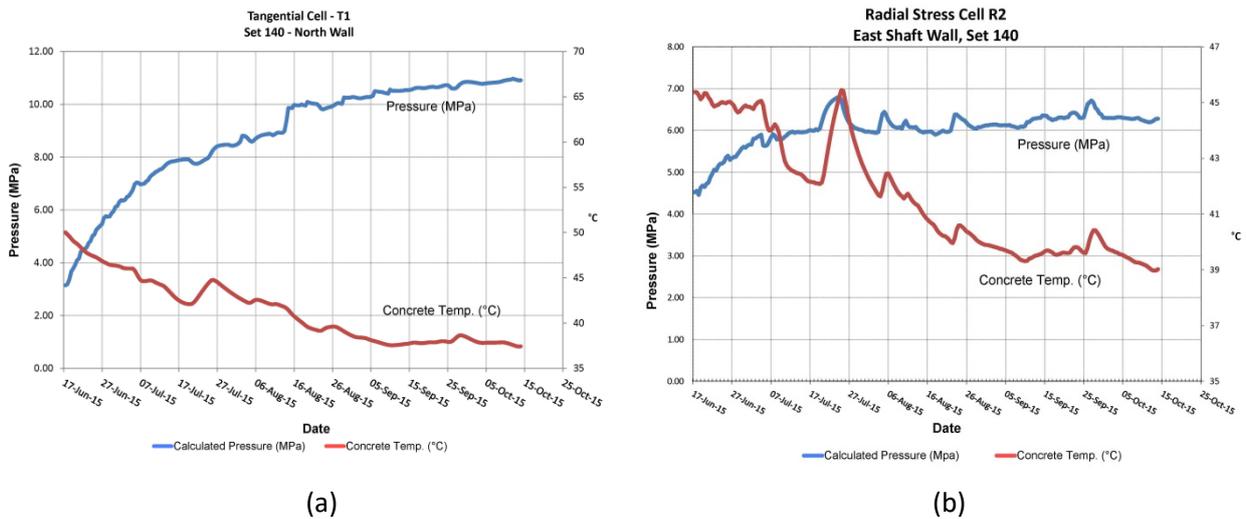
Figure 12 (a) Tangential and (b) radial concrete pressure cell measurements as a function of time

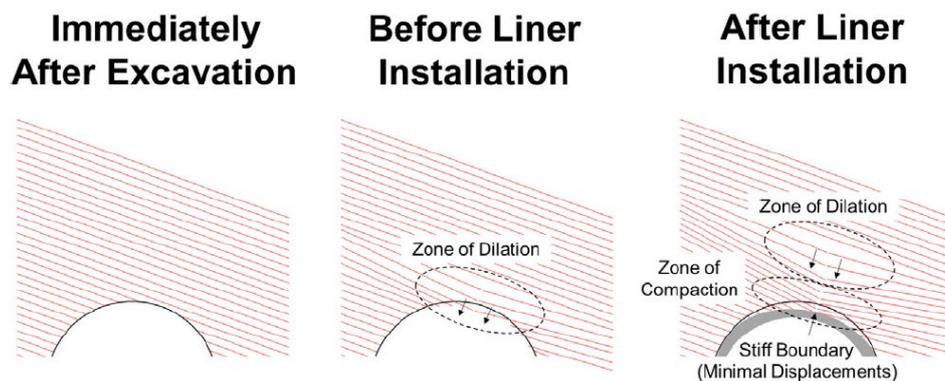
Figure 13 Radial extensometers installed perpendicular to foliation indicated that foliation dilation resulting from buckling at the shaft surface is suppressed by the shaft liner after installation, resulting in compaction of the near-shaft dilation with continued face advance (Walton et al. 2018)

The shaft was completed to the planned depth of approximately 3,000 m with no further observations of liner cracking and with equilibrating inward deformations as shown by extensometers installed at regular intervals. At the time of this writing, approximately four years after the initial observations of liner failure, the shaft has been completed and is in service with no observation of significant crack development or guide misalignment. The primary conclusion of this process is that the change of shaft shape, although resulting in 15% additional excavation, 11% additional ground support (including a 15% increase in concrete), resulted in stability of the shaft and assurance of long-term serviceability. This is particularly important considering the potential cost of continued shaft repair, production downtime, etc. The ‘moral of this story’ is that sometimes use of simple approaches, such as change of excavation shape, are preferable to use of ever-increasing ground support density or exotic ground support solutions for stabilising deep excavations.
