Advanced geotechnical monitoring technology to assess ground support effectiveness

LP Gélinas *Agnico Eagle Canada Inc., Canada*

Abstract

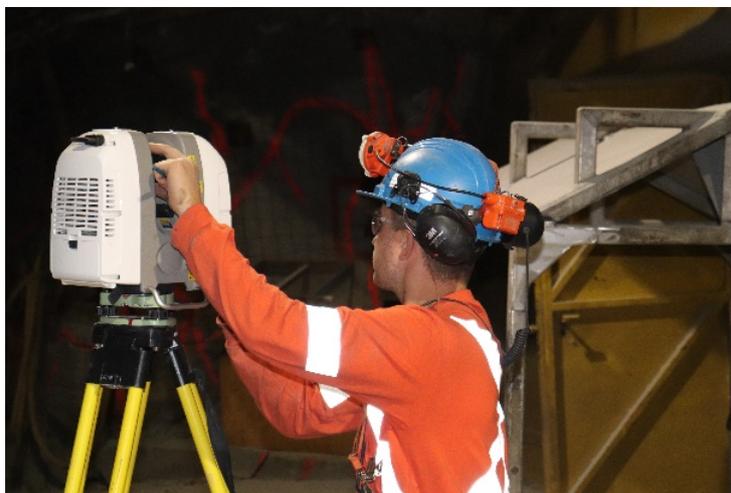
Figure 1 A GML setup at the Goldex underground mine

For periodic monitoring, the GML is positioned on a tripod (Figure 1) and geo-referenced using three to five targets previously installed on the surface of the excavation. Care and precision in the setup allow for higher resolution and fewer errors in the measurements. A good setup takes 10 minutes, and scanning the targets for geo-referencing requires another 10 minutes. The GML is then ready to start the 360° scan, during which a high-speed transmitted and reflected laser beam is emitted from the laser scanner. This scanning step lasts seven minutes, during which millions of points are recorded in the 3D space with coordinates relative to the position of the scanner. Finally, the data is transferred to a computer via Wi-Fi in three minutes. The total time for a complete scan from setup to transfer is 30 minutes in total, without processing. Each scan generates a point cloud with a time and date stamp.

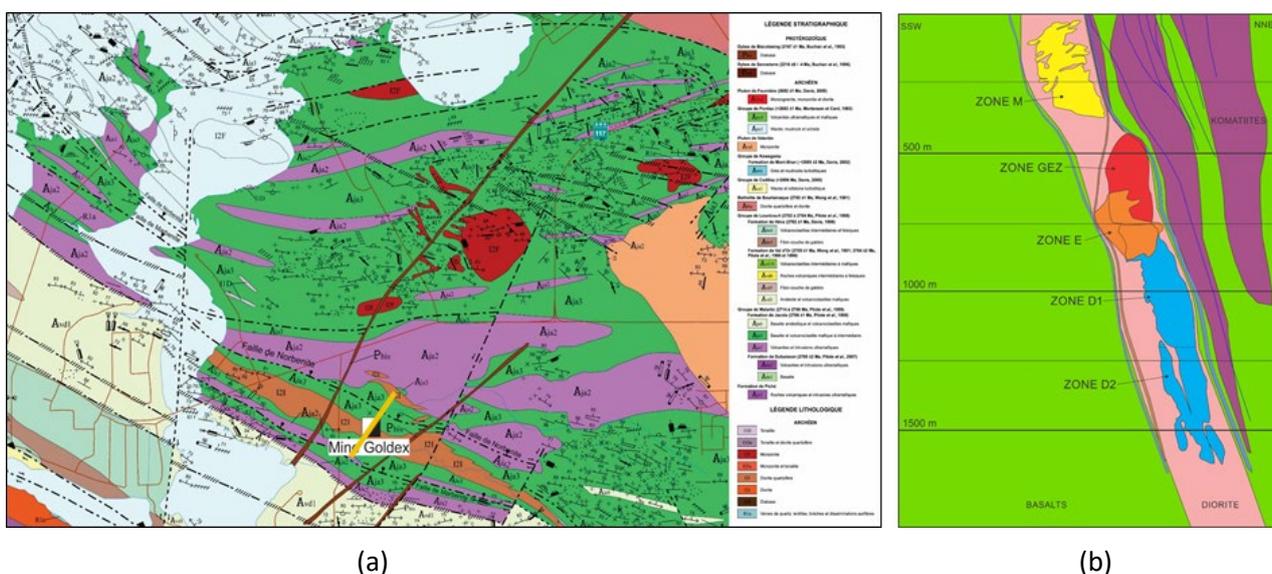
Figure 2 (a) Regional geology at the Goldex mine; (b) Cross-section showing the geology and different mining zones: GEZ, M and E Zones, and Deep 1 and Deep 2 Zones (AEM 2018)

The Goldex mine is an underground bulk mining gold operation located near the town of Val-d'Or in the Abitibi region of north-western Quebec, Canada. The Goldex deposit is hosted in a diorite sill intruded within a package of mafic to ultramafic rocks. Late stage diabase dykes, of variable thickness, crosscut all the lithologies (Figure 2a). The ore is associated with quartz tourmaline veining in the diorite sill. Ore zones shown in Figure 2b include the GEZ Zone, which was partially mined from 2009 to 2011; the M and E Zones, which were started in 2013; and the Deep Zones (D1 and D2). The bulk of the production currently comes from the Deep 1 Zone, and it is hauled to the shaft loading station via a RailVeyor™.

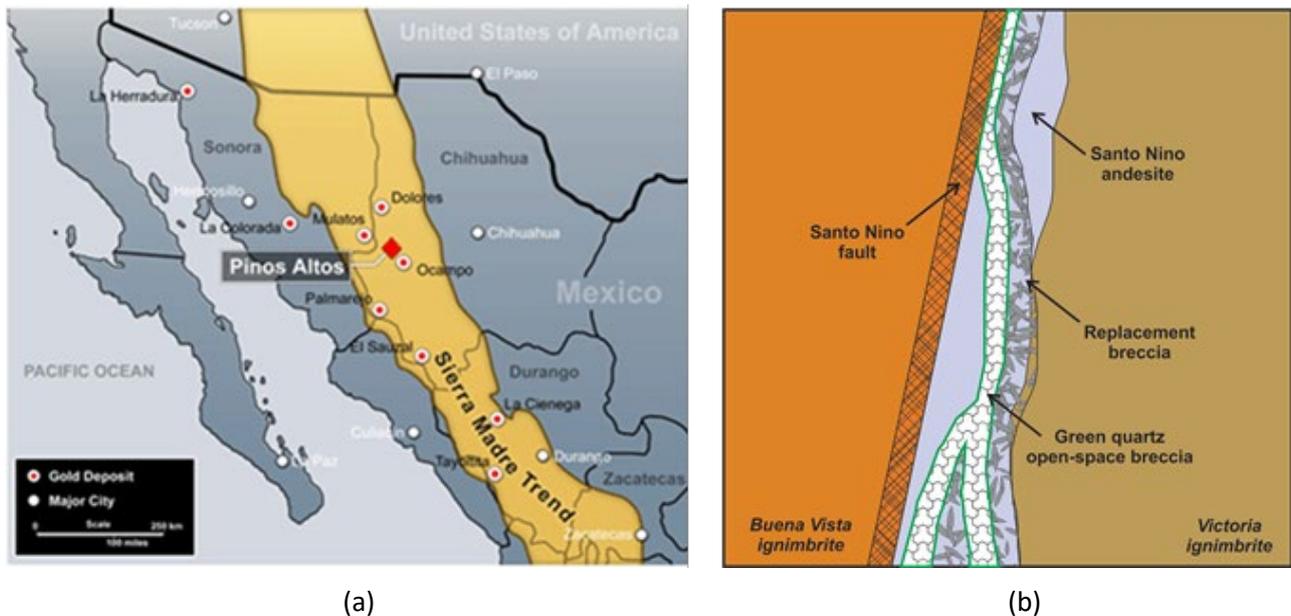
Figure 3 (a) Location of the Pinos Altos mine in Mexico; (b) Cross-section showing the geological units at the Santo Niño orebody (AEM 2007)

The Pinos Altos mine is located in the state of Chihuahua in north-western Mexico within the Sierra Madre geologic province (Figure 3a). The Pinos Altos complex includes both open pit and underground operations producing gold and silver. Underground mining, by sublevel stoping with cemented paste backfill, is currently used to extract the ore from the Santo Niño, Cerro Colorado and Oberon de Weber deposits. Satellite deposits Sinter and Cubiro are presently under development. The Santo Niño, Oberon de Weber and Cerro Colorado orebodies are associated with the Santo Niño Fault system, a 300 km long west-northwest trending structural zone (AEM 2007). The host rocks are young (<38 Ma) compared with Canadian Shield rocks at

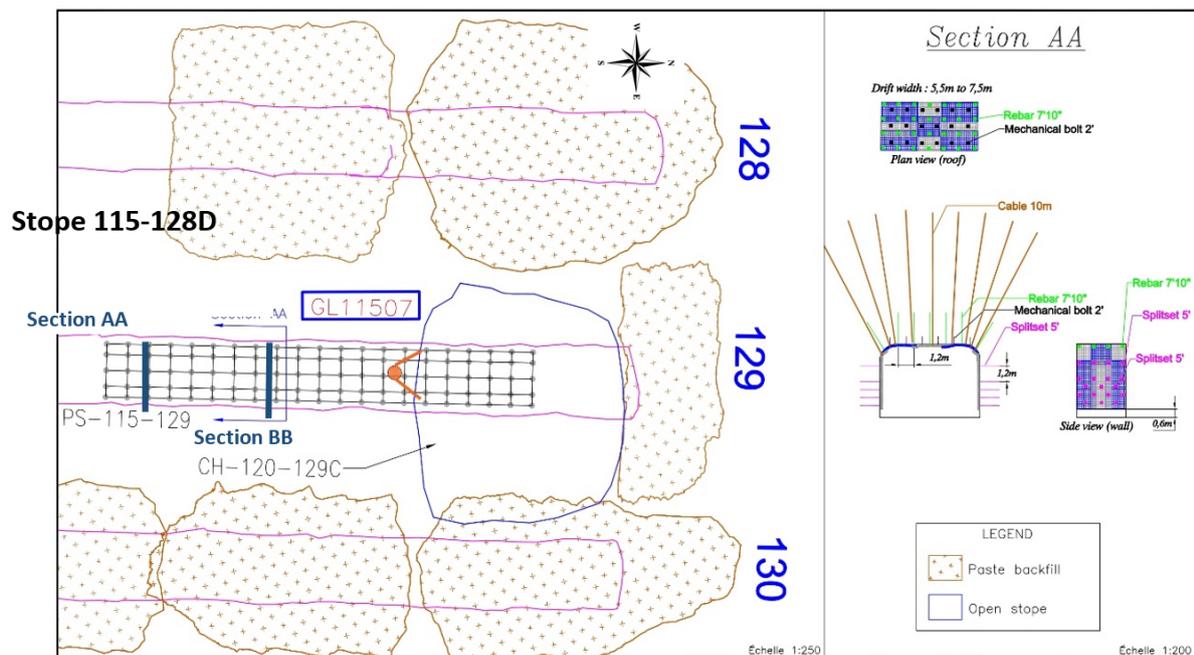
Figure 4 Position of the GML station GL11507 on plan with a cross-section showing the ground support and cable-bolting pattern in the Stope 120-129C overcut on Level 115. Sections AA and BB are referenced on this plan

The GML station was set up within the overcut in front of a secondary stope at a depth of 1,150 m. Figure 4a shows a plan of the scan location in front of the future Stope 120-129C and the backfilled primary stopes on either side. During the monitoring period, activities included the backfilling of Stope 115-128D and blasting of Stope 120-129C. Figure 4b shows the complete primary ground support and cable-bolting pattern in the stope overcut. Double bulge cable bolts in the stope backs are tensioned and plated. The deformation response of each type of ground support element was measured and analysed over a series of periodic scans from the same location, identified as GL11507.

Table 2 presents measurement points selected close to Stope 120-129C and located on Section BB from Figure 4; positive values indicate movement into the drift while negative values indicate movement away from the drift. The deformation results presented in Table 2 were obtained by subtracting the fourth and the fifth scans from the first scan. These fourth and fifth scans are of interest because they were taken before and after the last blast of the secondary Stope 120-129C, at the overcut Level 115. The cable bolts in the roof

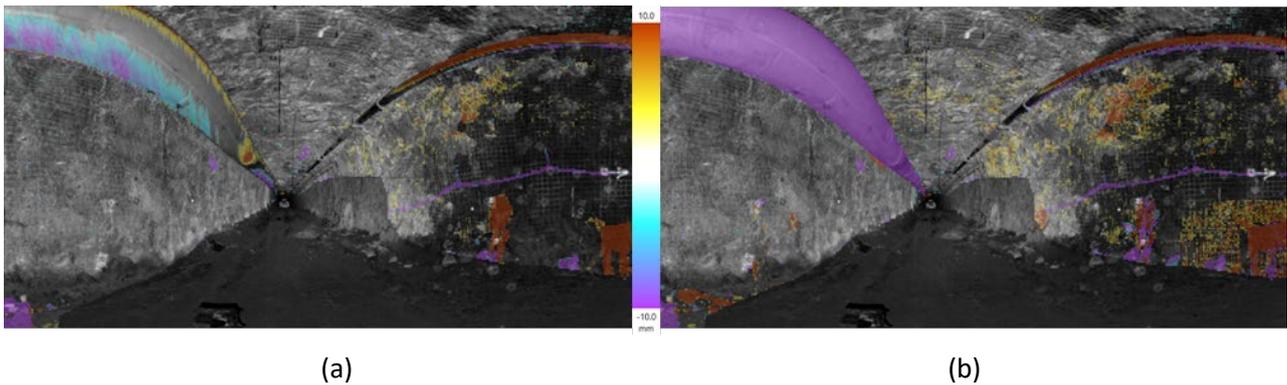
Figure 5 Section of a 360° scan at the station GL11507. The image represents the total deformation measured between 30 January and 14 February 2019 (a), and between 30 January and 20 February 2019 (b). The scale of deformation is in millimetres and the same for both images

After the backfilling of Stope 115-128D had commenced, it was noticed that the west wall and bolts in the 115-129 drawpoint showed a higher rate of deformation than the east wall. This effect was also directly linked with the observation of water draining through the west wall. As backfilling continued in Stope 115-128D, water could be observed draining through the pillar with the Stope 115-128D into the drive where the GML station is located. Figure 5 shows the measured deformation between 30 January and 20 February, before the first blast of the Stope 120-129C. As there was no blast-induced stress change during this period, the observed positive deformation of approximately 10 mm is related to the transient water pressure within the drawpoint pillar. Hot colours in the images represent positive deformations with the wall moving towards the scanner. Cold colours indicate negative deformations and are related to loss of material from the wall surface.

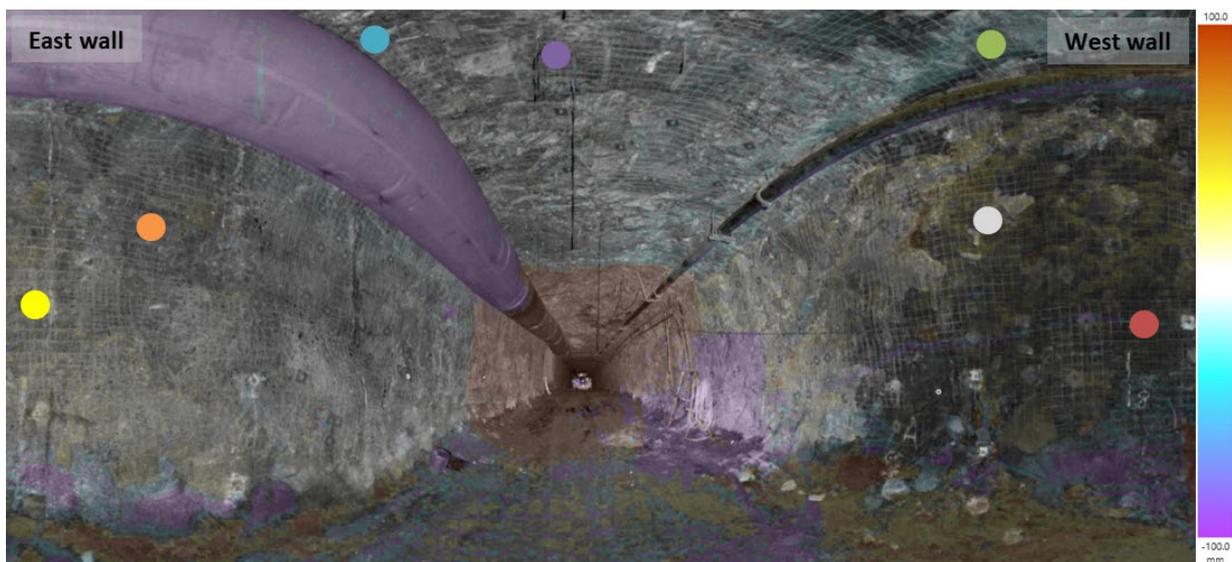
Figure 6 Section of a 360° scan of the station GL11507. The points in the photograph are located on Section AA in Figure 4. This image represents the total deformation measured between 30 January and 15 March 2019, with the deformation scale in millimetres. Note the scale is 10 times that in Figure 5

Figure 6 shows the location of the point measurements that were selected on the walls and roof to track the deformation history of the excavation over the entire duration of the scans conducted at this station from 30 January to 15 March 2019. As repeated scans were conducted at this station, the measurement points had to be carefully selected to avoid obstruction of cables, pipes, machinery and fences and to avoid multiple screen overlap. Two Split Sets were chosen in each wall, one wall measurement and three bolts on the roof.

Figure 7 shows a graph of the deformation history of the bolts and wall surfaces at the locations identified in Figure 6. The scans concur with visual field observations that the west wall deformed more than the east wall. Examination of Figure 7 shows that the west wall of the drive clearly deforms significantly more than the east wall on the selected section and there is a step change in deformation with the third and last blast in Stope 120-129C. The last scan, more than two weeks later, shows no further deformation post-blast.

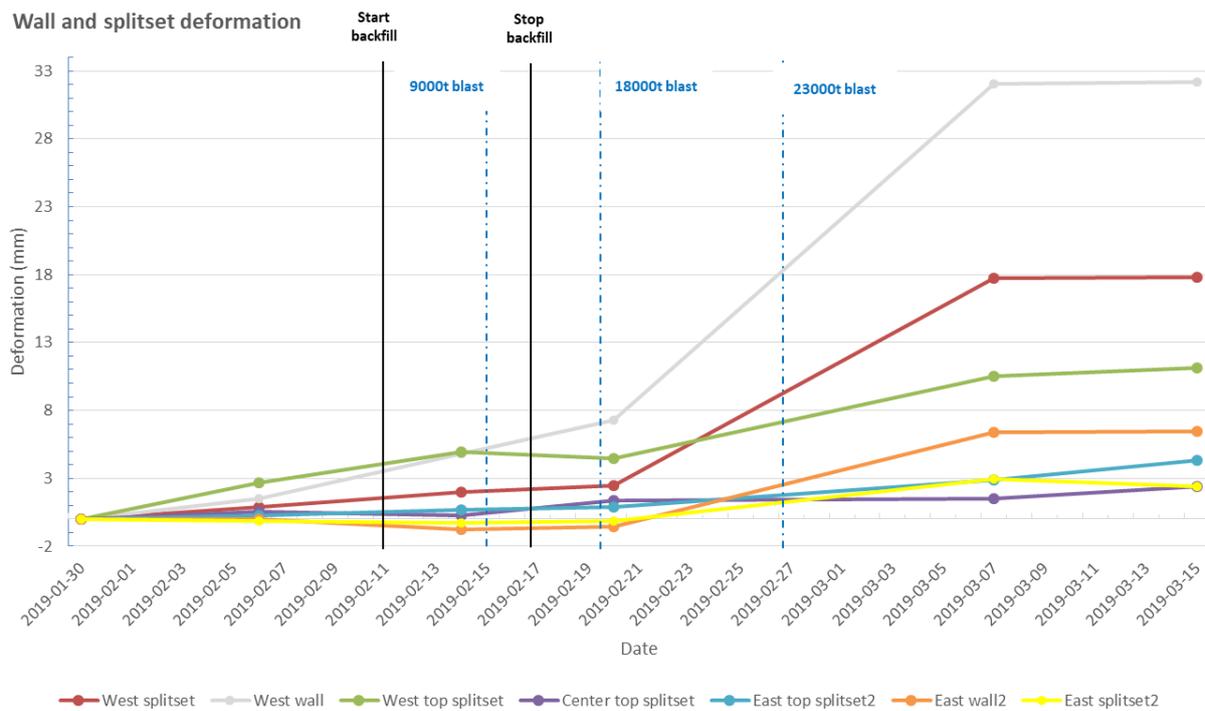
Figure 7 Graph showing wall and Split Set deformation with times at the locations indicated in Figure 5

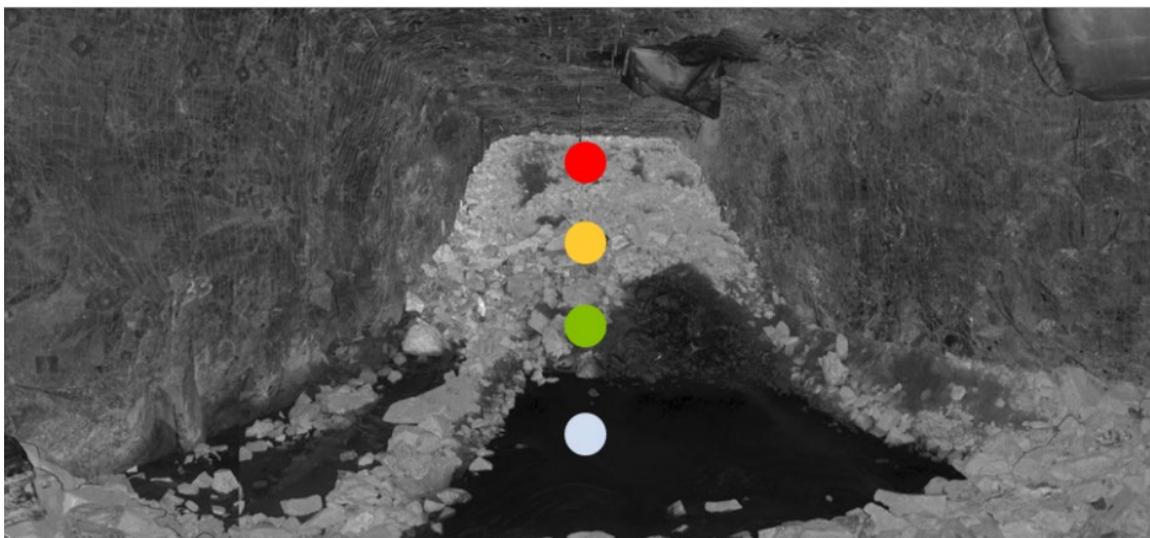
● *Point of measure – top of the barricade* ● *Point of measure – bottom of the barricade*
● *Point of measure – middle of the barricade* ● *Point of measure – drainage pond*

Figure 8 Measurement points on the muck barricade and on the drainage pond

A continuous monitoring station was set up in front of a 12 m-long muck barricade built to retain paste backfill during the curing period. The stope that was backfilled is the 115-128D presented in Figure 4. The stope was continuously backfilled at an average rate of 350 metric tonnes per hour with a recipe of 3% binder (80% slag and 20% general use cement) for a total of 6 days. Problems at the paste plant caused a stoppage in the backfill requiring a 45 m³ water flush shortly after start-up. The monitoring period extended over 18 hours after the beginning of the pour. A scan was made every hour for a total of 17 scans. The results of the scans confirmed that the barricade is well built and that it does not move significantly during the pour. Examination of sequential scans and images prompted a more detailed analysis. Figure 8 shows three different locations selected for tracking the deformation (with an area ± 0.1 m²) directly on the muck barricade and one in the centre of the drainage pond. It was observed from the sequential scans that water was accumulating in the pond. Since the water in the pond could freely drain and was undisturbed because access to the drawpoint was closed, a measurement area (± 0.1 m²) could be used in the centre of the pond as a proxy to monitor the water draining from the barricade.

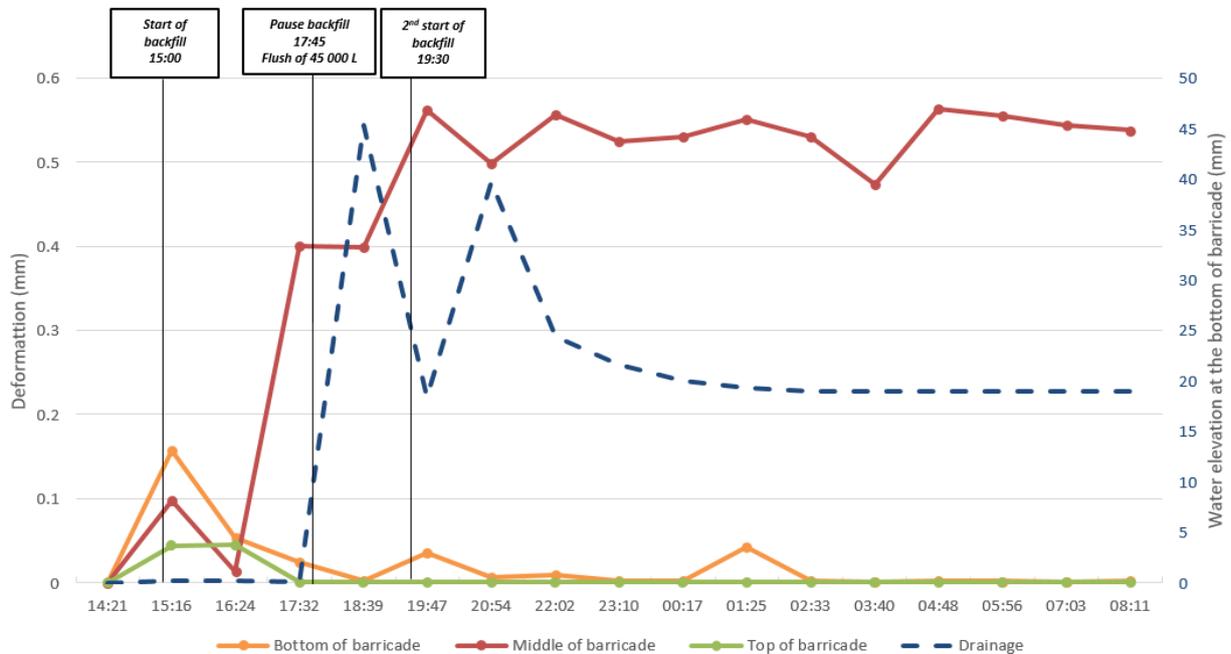
Figure 9 Graph showing the deformation and water elevation measurements in front of the muck barricade

Figure 9 is a plot of the measured deformations at three areas (top, middle and bottom) on the face of the barricade with respect to filling activities and water level in the drainage pond. The deformations are very small, sub-millimetric, confirming that the 12 m barricade design is effective and no deformation would be noticeable from visual inspection however, assuming that the continuous scan is providing accurate results some additional information may be extracted from the data. The graph shows that the deformation is

greater in the middle of the barricade compared to the top and bottom, the barricade drains as intended by design, and the early flush of water had a small but nonetheless detectable effect on the central portion of the barricade. After the paste restarted at 19:30, the deformation in the barricade stabilised, the water in the pond rose again and then subsided. The water elevation in the drainage pond does not return to its original level due to the accumulation of fine particles that migrated through the barricade into the drainage pond. The original goal of the continuous scan was to validate the barricade design; however, the results obtained are interesting and motivate further scans with complementary measurements of paste height and more precision on the paste plant data.

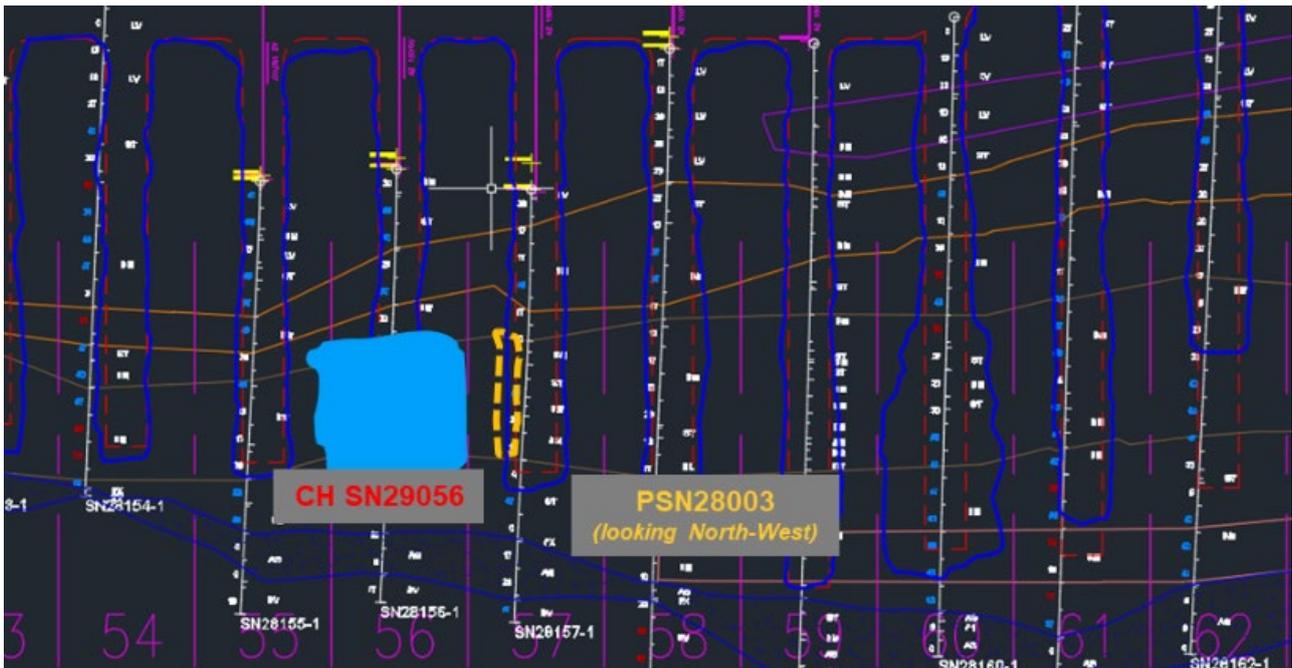
Figure 10 GML station setup in SN28057 to monitor the mass blast in the adjacent Stope SN29056. The 180° scan targeted the west wall of the drive

A GML station was set up in the adjacent drive to the overcut of a longhole stope blast in SN29056. The station was located to the east of the blast in drawpoint SN28057, as shown in Figure 10. Ground reinforcement in stope overcuts consists of resin-grouted rebar (in waste) or inflatable bolts (in ore) in the roof and Split Sets in the walls. Mesh is used as surface support and cable bolts are installed in the backs of all stopes.

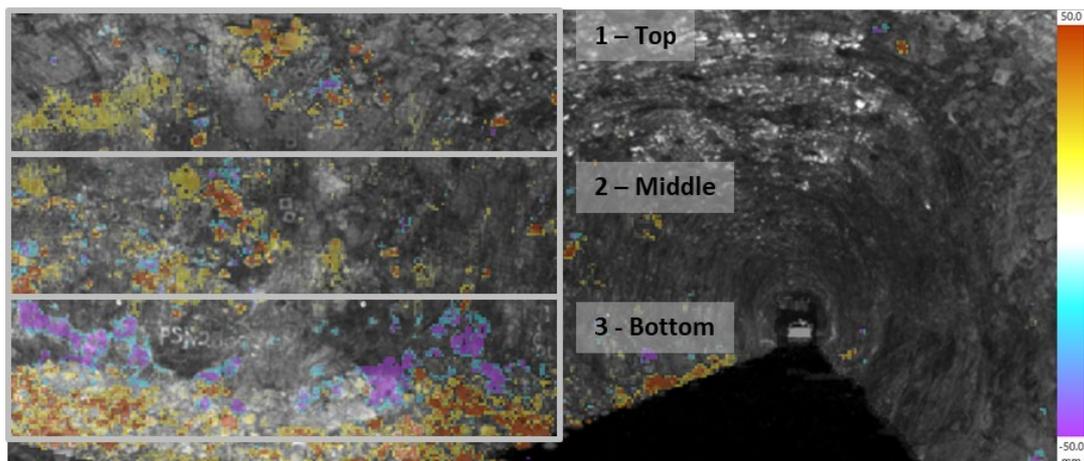
Figure 11 Positive and negative deformation in a drawpoint adjacent to a stope blast on 7 December 2018. The picture date is 8 December, and the image was obtained by subtracting the scans from 8 December and 5 December 2018

Scans were made before and after the stope blast on 7 December 2018. The deformation induced by the blast in the wall of the adjacent drive is presented in Figure 11. The scanned wall is divided into three sections highlighting the differences between the top, middle and lower parts of the rock surface. In the top third of the wall, the positive deformation varies from 20 mm to 80 mm. Visual inspection of the results indicates that larger deformations seem to occur between the bolts while the Split Sets appear to be limiting the deformation. Furthermore, the deformation is seen to increase, with the spacing between the bolts and pieces of rock that were already loose behind the mesh before the blast displaced with the vibrations. Finally, some negative deformation (blue and purple) is visible on the image, indicating that pieces of rock smaller than the size of the screen fell through during the blast.

The middle section of the wall experienced larger deformations than did the top third. This may be related to the stress regime, the increased confinement in the drift corners compared with the flat wall surface, and/or the effect of the rebar or inflatable bolts in the roof and into the drift corners compared with Split Sets only in the walls. The larger deformations are again observed to occur preferentially between the bolts. On the lower section of Figure 11, the deformation is mostly negative (averaging 30 mm) on the wall itself and positive on the floor. This phenomenon is observed in nearly all the GML scans; below the last row of bolts, pieces of rock are seen to detach from the wall with either a blast or seismic events and accumulate at the bottom of the wall. It is important to note that the GML measures deformation at the surface of the excavation; therefore, loose pieces of rock retained by the mesh, as shown in Figure 12 for example, can mask the deformation and affect the results. Loose material is frequently seen to accumulate behind the mesh at Pinos Altos (Figure 12). The phenomenon is attributed to a combination of factors, including the rock mass weathering characteristics, drift blasting practices and ground support selection and installation quality (bolt installation and mesh characteristics). As the mine continues to progress deeper, and conditions

To assess and quantify the ground support effectiveness in response to the blast, the results were analysed by zones, as shown in Figure 11 and compiled in Figure 13 and Table 3. The wall deformation measurements are averaged from pixels within a consistent $\pm 0.1 \text{ m}^2$ area (approximately $30 \text{ cm} \times 30 \text{ cm}$), whereas the bolts measurements are averaged over consistent areas of $\pm 0.01 \text{ m}^2$ (approximately $10 \text{ cm} \times 10 \text{ cm}$ or roughly the size of a bolt plate). A similar approach of averaging the deformation over a fixed area is used with the radar and SSR software in open pits to reduce the effect of local deformations and obtain an overall rate of deformation for areas of interest (Kalenchuk et al. 2018).

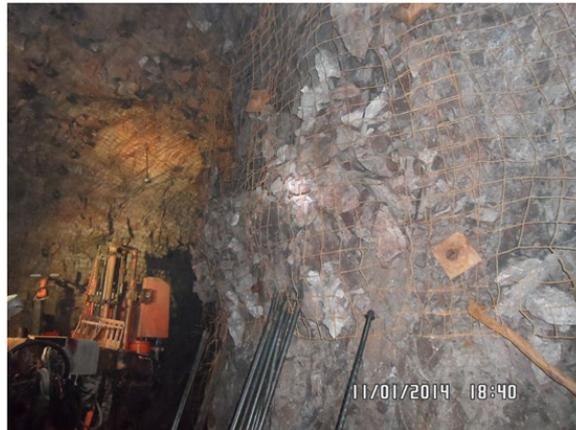
Figure 12 Example of loose material accumulating behind the mesh at the Santo Niño mine. The phenomenon is frequently observed at the site and is attributed to a combination of factors

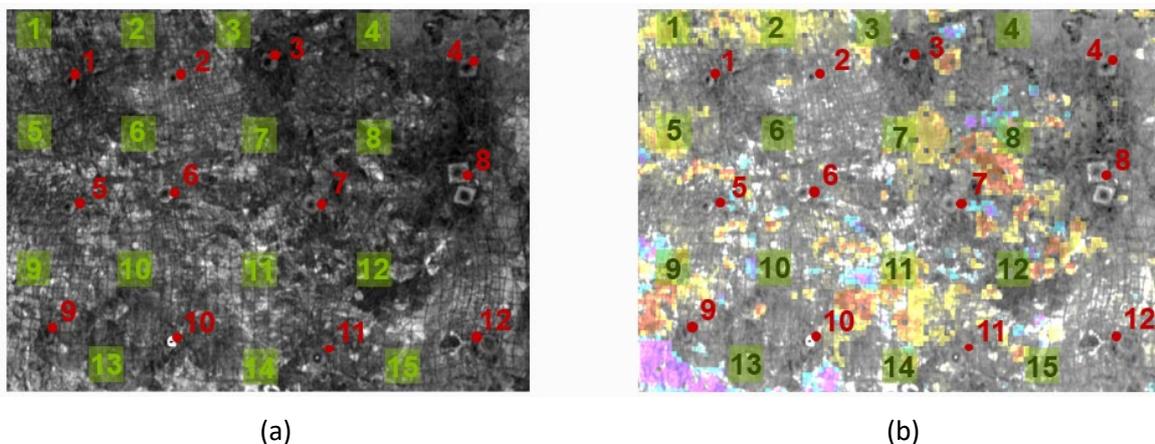
Figure 13 Zoom-in of the wall image in Figure 11, showing the top and middle sections only. For reference, Bolt 8 (with two bolts side by side) can be seen in the middle section of Figure 11. (a) Photograph with the selected areas; (b) The scan results

Table 3 shows that the average deformation of the split set bolts is about $+2.0 \text{ mm}$, and the absolute average deformation for the wall between the bolts varies between $+2.5 \text{ mm}$ and $+60 \text{ mm}$. Negative deformation representing rocks falling from behind the mesh can reach -15 mm . The average deformation of the top-row bolts (Bolts 1, 2, 3 and 4) is $+1.8 \text{ mm}$, whereas the average rock mass deformation above the bolts (Wall 1, 2, 3 and 4) is $+10.3 \text{ mm}$. By comparison, the middle row of bolts (Bolts 5, 6, 7 and 8) moved on average $+2.3 \text{ mm}$. The wall above the middle row of bolts moved on average $+21 \text{ mm}$ (Wall 5, 6, 7 and 8). Below the middle row of bolts, Wall 9 recorded negative deformation of -10 mm , but on average, the other three areas (Wall 10, 11 and 12) displaced by $+13 \text{ mm}$. It is possible that some rock fell below the entire middle row of bolts. Finally, the last row of bolts (Bolts 9, 10, 11 and 12) moved by $+2.3 \text{ mm}$, and all wall deformation was negative, averaging -10 mm (Wall 13, 14 and 15).

Table 3 Bolts and wall deformation compiled from the results shown in Figure 13

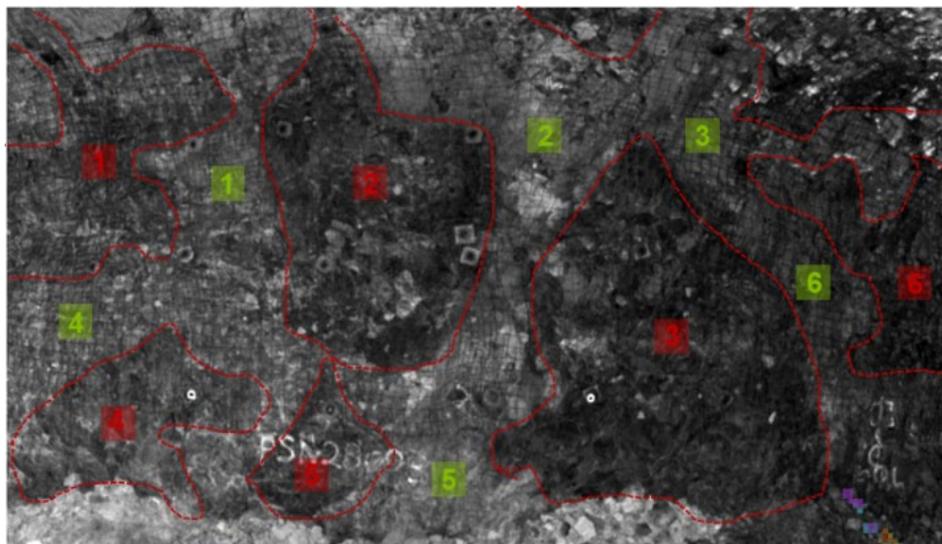
Figure 14 The same scan with enhanced image treatment to highlight the alteration halos contoured in red

It is possible to use the SSR software to measure the effectiveness of the bolting pattern by measuring the deformation in the area between bolts. The measured bolting pattern in the scanned area varied from 0.74 m² to 1.48 m² and the higher wall deformations can be associated with the wider bolting pattern; however, the differences can also be attributed to geological factors. Figure 14 was generated using image treatment in the SSR viewer software to modify the opacity, brightness and contrast in order to highlight differences in the rock mass alteration pattern. With the image treatment, the alteration halos become more visible, enabling them to be used to measure the deformation in relation to the geology. The light-coloured alteration shown in Figure 14 is penetrative silicification (green markers), which makes the rock less deformable than the surrounding more clay-rich tuff (red markers).

The average deformation within the silicification areas is 1.6 mm compared with 8.5 mm for the clay-rich tuff. The deformation in the silicification halos is in the same range as that measured for the Split Sets. The detailed measurements are presented in Table 4; positive values are moving into the drift, and negative values indicate movement away from the drift.

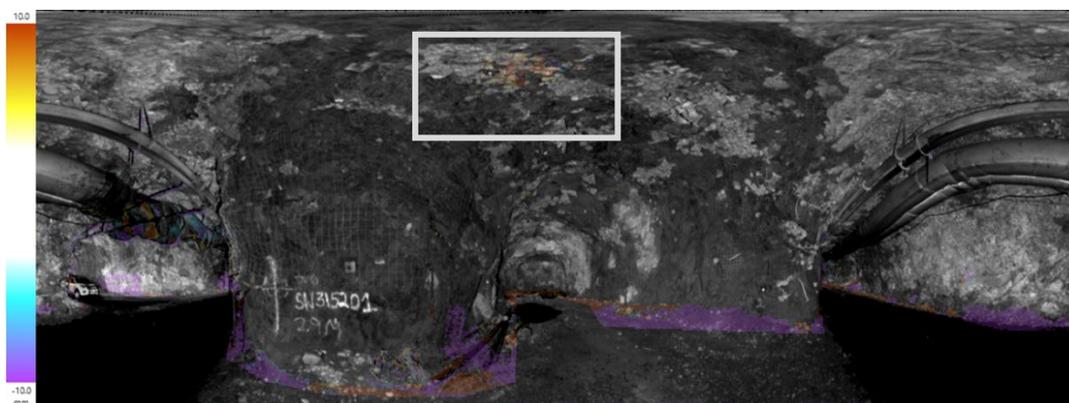
Figure 15 360° scan of the station SN315201; the zone of interest is inside the grey rectangle. This image was obtained from the subtraction of the scans on 18 December and 6 December 2018, with the results shown on the 18 December photograph. The 360° image is unrolled

The GML station SN315201 was set up to monitor a large intersection on Level 31 (1,550 EI) of the Santo Niño orebody at approximately 650 m below the original ground surface, in front of the drawpoint of Stope SN31052. There were no major developments or stope blasts near this intersection during the two-week interval between scans. Figure 15 shows the results of 360° scans taken on 6 December and 18 December 2018. A zone of local deformation can be seen in the roof. The deformations on the floors were masked because they are not informative due to equipment traffic.

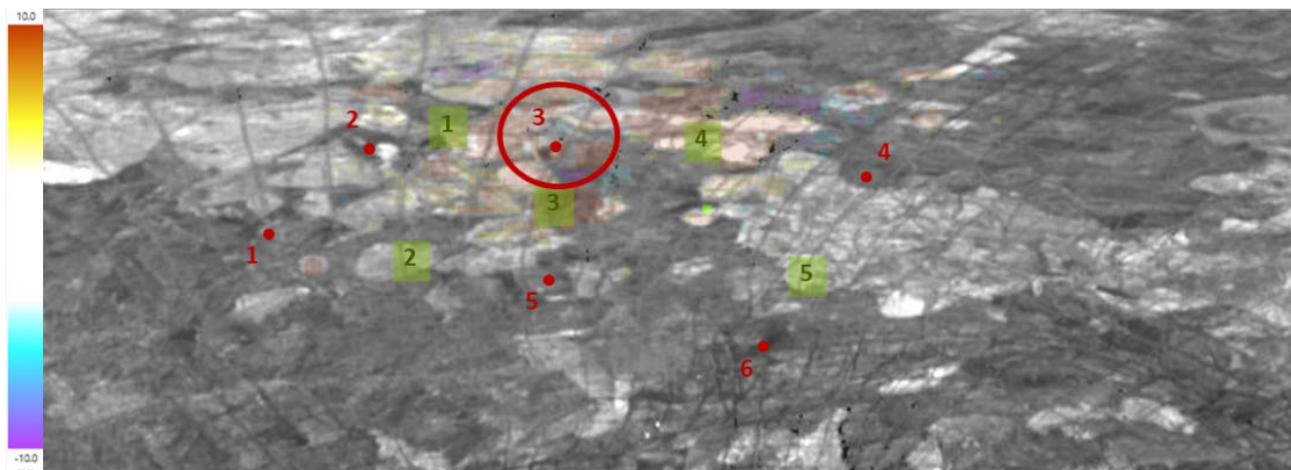
Figure 16 Zoomed-in view from Figure 15 showing area of deformation around an ineffective rebar in the roof

Figure 16 is a zoomed-in view of the area of interest, with the measurement points selected for analysis. Within the SSR viewer software, pixels can be selected either individually or grouped to extract deformation measurements. Using this feature, pixels were selected on the ends of the rebar bolts (red points) and within small areas of approximately 0.1 m² around the bolts. The data is presented in Table 5; positive values are moving into the drift, and negative values indicate movement away from the drift. The maximum positive deformation measured with the scan is 140 mm on the rock and 40 mm at the end of the rebar #3. Upon inspection of the results in Table 5, all bolts except rebar #3 show minimal deformation, and areas 1, 3 and 4 around rebar #3 deformed by 80 mm to 140 mm around this bolt. By comparison, minimal movement was

recorded in areas 2 and 5 around bolts that did not move. An underground visual inspection was conducted after the image was generated, and it was clear that the plate of rebar #3 was loose and not in contact with the rock. Variability in the quality and effectiveness of ground support installation has been observed for some time at Pinos Altos, particularly with respect to hole size, lack of resin encapsulation of the rebars near the hole collars, and loading of the mesh. The exact explanation for the lack of effectiveness of rebar #3 is not known; the bolt installation may have been inadequate or, less likely, the bolt may have been broken. Nonetheless, the impact of the increased effective support spacing is clear from the measured rock mass deformations, with larger positive deformation (warm colour) and even small rocks detaching from the roof (cold colour).

Table 5 Rebar and roof deformation in reference to Figure 16
