# Response of a support system to seismic events: a case study of Mina Uchucchacua, Peru

*The Geomechanics Research Centre (GRC) of MIRARCO at Laurentian University, was contracted by the Chief of Geomechanics at Buenaventura's Uchucchacua Mine to assist in the development of a Seismic Hazard and Geomechanics Risk Assessment Study. This paper defines guidelines and appropriate practices in accordance to MIRARCO expertise as reflected in the Canadian Rockburst Support Handbook (Kaiser et al. 1996) that has assisted the mine in reducing mining-induced hazards, which may also improve the mining performance. The objective of this research was focused on a review of the current state of many mine aspects such as geology, rock mass characteristics, rock support systems, seismic data systems and data collection; all of them directly related with the rock mass behaviour and geomechanics hazards, in order to provide key good practices to add, implement or develop better control of the operation and prevention or mitigation of those hazards. The mine is composed of three production zones: Socorro, Carmen and Huantajalla. The Socorro zone was the focus for this study.*

*This paper provides

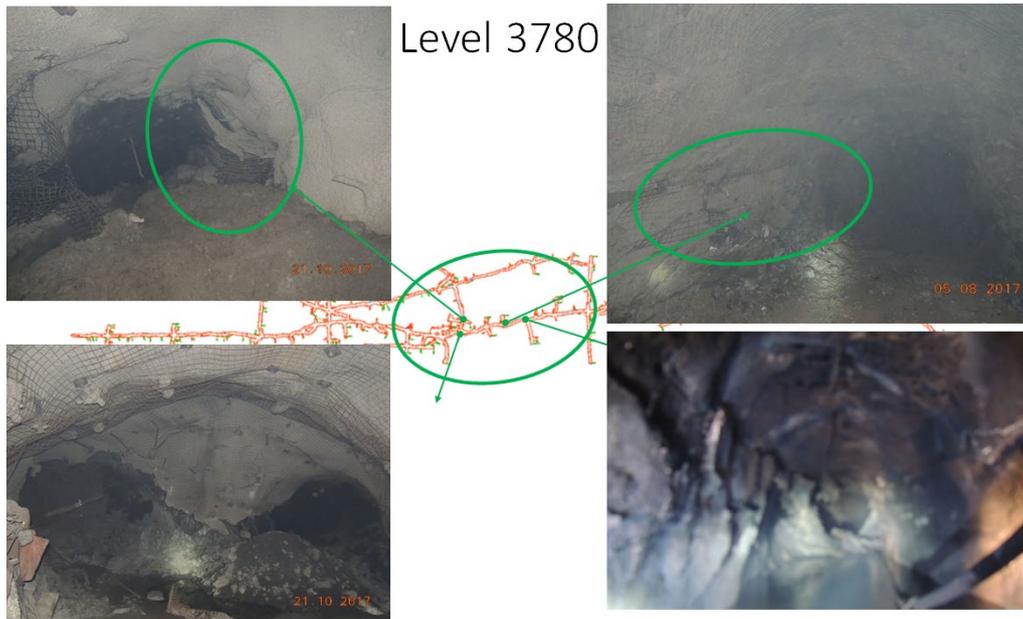
Figure 2 Inspection at Level 3780 Gallery NE

The zone was affected by a seismic event of moment magnitude 3.1 Mw and an epicentre at 250 m from the damaged locations. The damaged zone extends along 100 m of the drift, as indicated in green (Figure 2) in the plan view. Rockburst damage at the base of a pillar was observed (bottom left picture, Figure 2). Tangential wall strain, likely due to mining induced deformation was observed (top left picture, Figure 2). Along the 100 m of damaged drift, broken rock at the top corners appeared more pronounced as a consequence of a sudden strain in walls. At the time of the visit, deformation continued gradually which was evidenced in the repaired shotcrete (top right picture, Figure 2). In this particular area, the presence of calcite veins is denser.

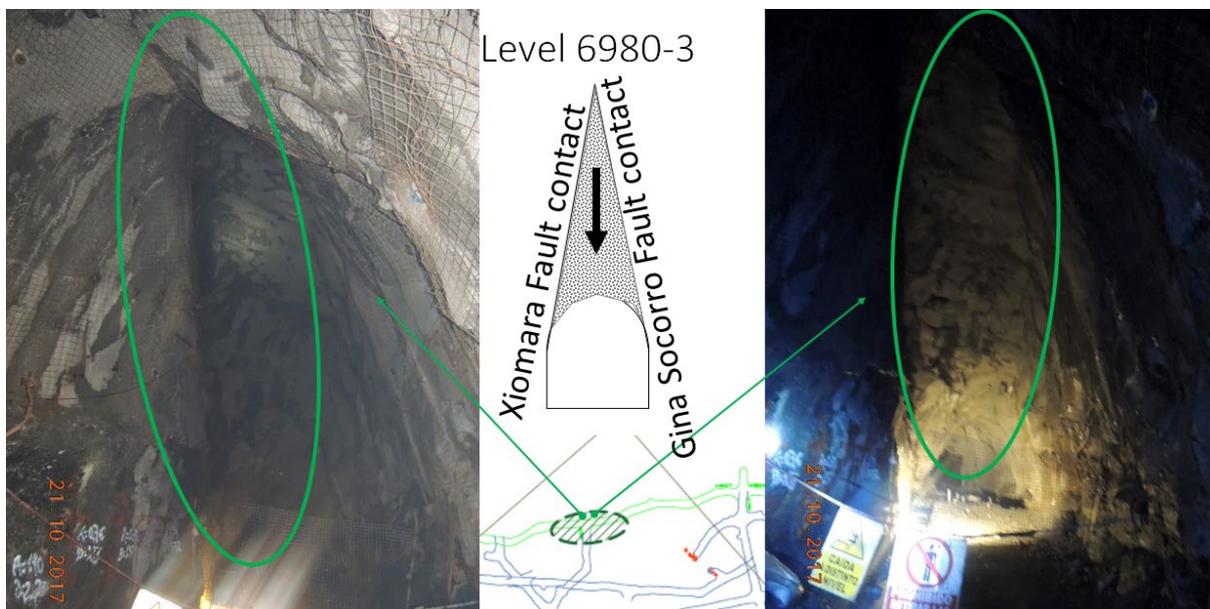
Figure 3 Inspections at Sublevel 6980

An intersection between two mineralised fault systems occurs above this sublevel. This has generated a natural structural wedge above the drift roof, as shown schematically in Figure 3. Damage occurred as a result of the same seismic event of moment magnitude 3.1 Mw. The drift roof collapsed along more than 100 m length of the drift, resulting in a 4–6 m high structurally controlled cavity. Ongoing, active deformation at this location is identified by fresh cracking of the shotcrete applied during rehabilitation.

Rock damage associated with rock mass structure (joint persistence and spacing of joint sets), is a driving mechanism identified at Level 6980 at 1,140 m depth (section 2.1.2). The types of damage typically associated with stress-generated damage would include: preferential crushing or deformation along drift corners, spalling, rock noise ('working ground', described as cracking or popping), and systematic accumulation of loose rock behind screening Diederichs (1999). The support components that were in use to form the overall support system is detailed in Section 4.

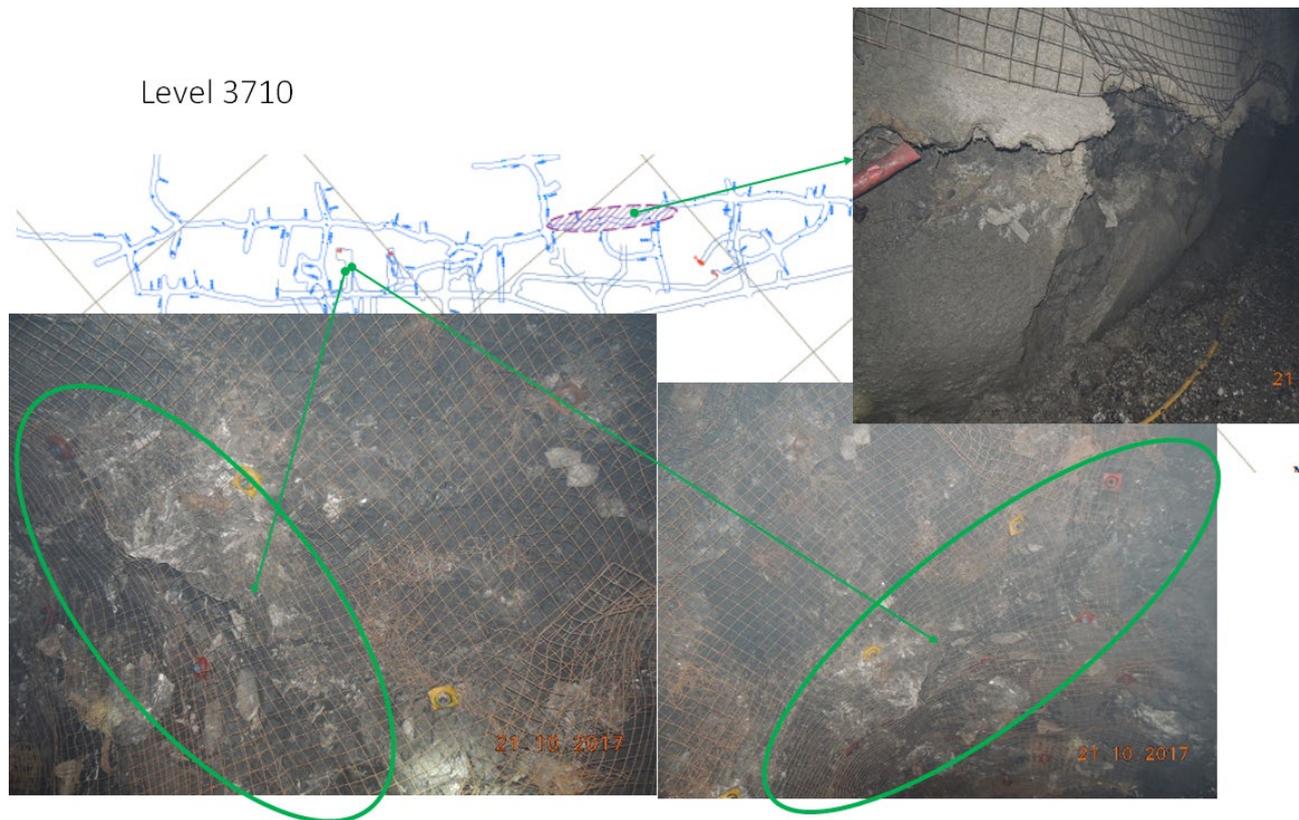
Figure 4 Inspections at Level 3710

Damage at this level is associated with seismicity. The drift, primarily at the base of the walls was damaged. Active bulking (lateral deformation) of the walls was observed, along with cracking of recently placed shotcrete, as shown in the top right picture of Figure 4. A well-defined structural wedge intersection was identified during the site inspection, requiring scaling and rehabilitation by the mine operation.

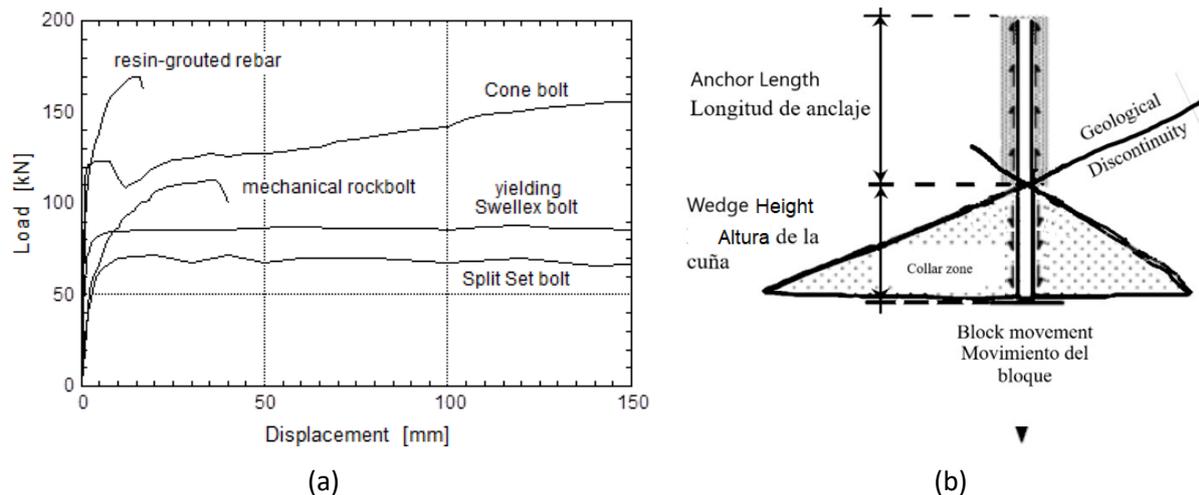
Figure 6 (a) Classification of rockbolt types as a function of load-deformation trends (Kaiser & Cai 2018); (b) example of a SplitSet bolt installed through a structural wedge (Hoek et al. 1995)

The function of rockbolt support is to provide reinforcement to the rock mass against both structurally defined wedge instability (moderate to large wedges) and stress-driven spalling. Taking the load-deformation capacity (Figure 6a) into consideration, there are essentially four classes of rockbolts: resin-grouted rebar; mechanical rockbolt with a mechanical point anchor; friction bolts (Swellex or SplitSet) and cable bolt (tendons).

Tendon refers to flexible support elements whereas rockbolt is used for the class of rigid elements. Swellex and SplitSets are normally considered to be the same class as both use mechanical friction to resist applied loads. The friction bolts SplitSet stabiliser is a slotted steel tube, with one end tapered for easy insertion into a drillhole. The other end has a welded ring flange to hold the bearing plate. SplitSet bolts and bearing plates should be made in accordance with the standard ASTM F432-13. Rebar and Swellex both require approximately 300 mm of contact between the bolt and competent rock to mobilise full support load capacity. By comparison, SplitSet capacity is related to the total length of the bolt that is in contact with competent rock. For the example shown in Figure 6b, where a bolt extends through a structural wedge, SplitSet capacity is related to only the bolt length above the wedge (‘anchor length’), or ~50% of maximum capacity.

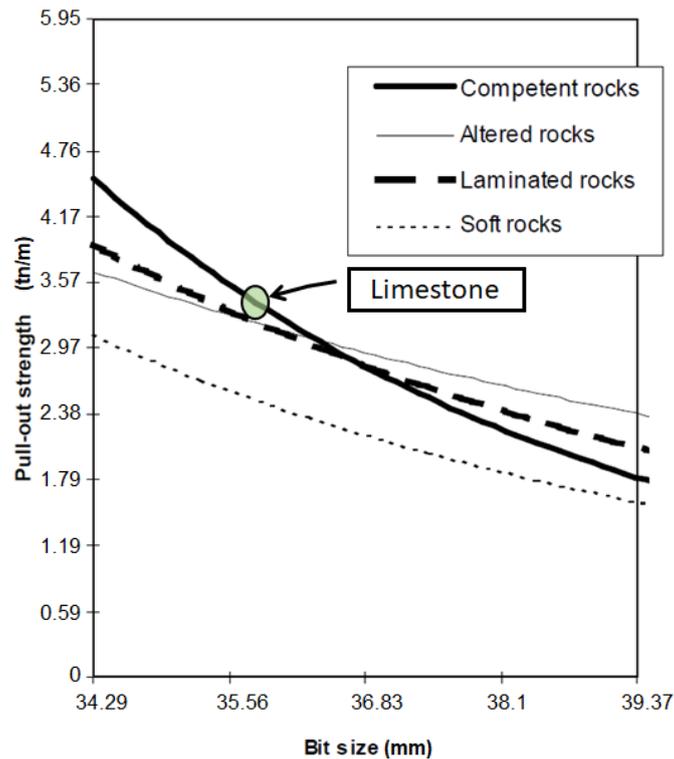
Figure 7 Comparison of 40 mmØ SplitSet pull test results (5.72 t / 1.52 m) against published results (modified from Tomory et al. 1998)

Test results are within expected ranges. Figure 7 shows relationships between pull-out capacity, rock characteristics and borehole diameter from a wide range of documented testing of standard SplitSets. Values obtained from pull testing in Type 3 rock mass are comparable with anticipated values for competent rock.

- Extensive testing (343 individual tests) has been performed with 1.52 m SplitSets, installed in Type 3 rock mass. Average capacity of 5.72 t (3.87 t/m) was obtained.
- Very limited pull testing (eight tests) of standard SplitSets has been performed in Class 4 rock (labelled as Class 3–4), where an average capacity of 5.44 t (3.57 t/m) was obtained.

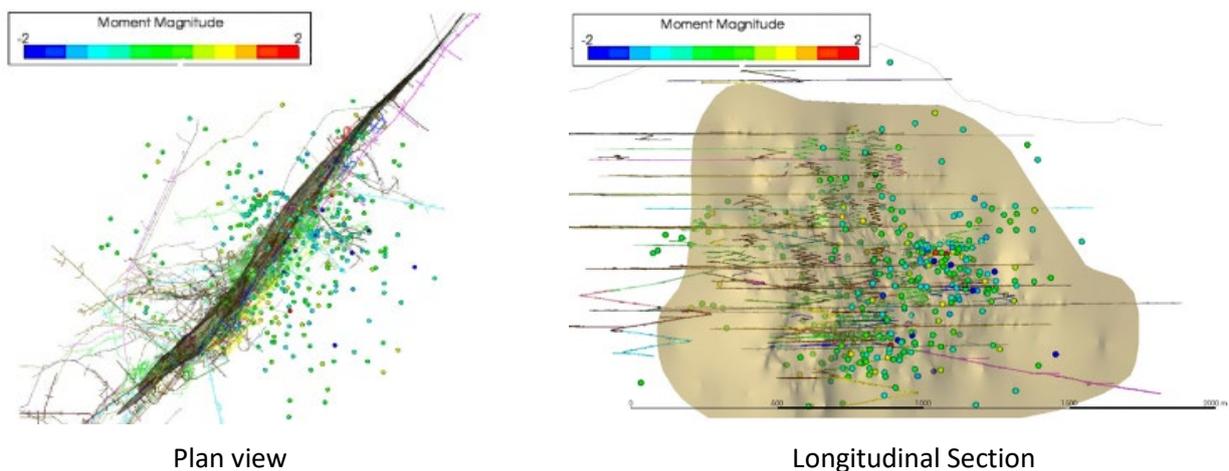
**Figure 8** Scatter of microseismic activity (all events, November 2017). Moment magnitude range: -2 to +2 Mw

A microseismic system in Uchucchacua Mine is composed by a paladin panel which is a digital microseismic recorder and a set of geophones which are the seismic sensors that detect and measure small ground vibrations caused during mining operations. They can be deployed in various configurations around a zone of interest to provide the best possible detection coverage. All of them can be connected to a laptop by using an optic fibre. The sensors were found installed in close proximity (typically within 25 m) to the stopes. Since installation, sources of seismicity at distances up to 300 m from the mine workings have been detected. However, accuracy of the source locations is negatively affected by the limited lateral extent of the seismic sensor array. For example, the scatter of microseismic events shown in Figure 8 contains numerous questionable event locations with far beyond the sensor array (shading area).

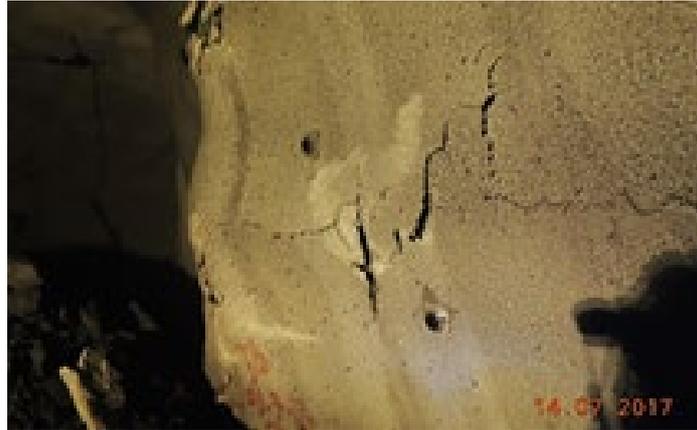
Figure 9 Excavation damage associated with magnitude 1.9 event, June 2017. Ground support includes Super SplitSets and shotcrete. Photo source: Uchucchacua Mine

Larger events were recorded in June 2017 with moment magnitude +1.97 Mw and +1.56 Mw. Some of them located in close proximity (within a  $\sim 250$  m envelope) to each other. Based on photos provided (Figure 9), the primary ground support practices applied in Gallery 6980 were adequate to maintain excavation stability for an event of this magnitude located at  $\sim 280$  m from that gallery.

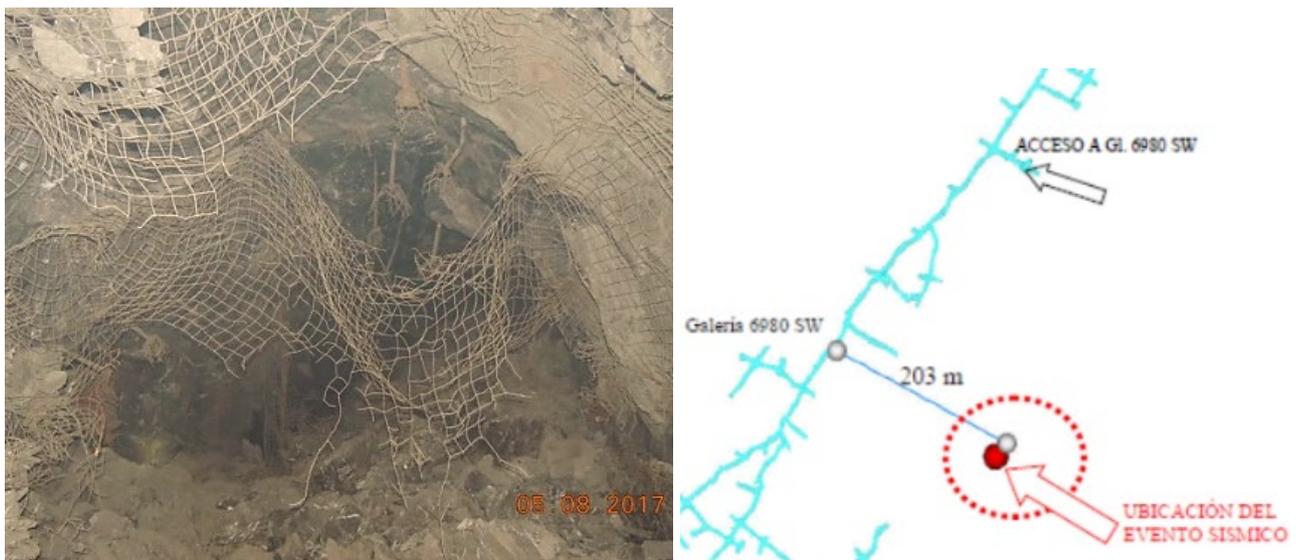
Figure 10 Gallery 6980 showing estimated seismic epicentre (3.15 Mw). Excavation damage associated with the event

In August 2017, a significant seismic event with magnitude moment 3.15 Mw occurred. The seismic system located the epicentre of this event at 203 m relative to Gallery 6980 as shown in Figure 10. Excavation damages associated with this event were extensive. Common damages included falls of ground of depth up to ~1 m from around the SplitSet rockbolts. Unravelling occurred as the capacity of the 12 gauge mesh was exceeded.

One support option that may be appropriate for Uchucchacua Mine, would involve 0-gauge Screen Straps, installed with either Super SplitSets or 6 m-long cable bolts to reinforce the mesh. The 12 gauge weldmesh that was in use in locations of potential seismic impact likely provided inadequate retaining capacity.

Static load-deformation capacities of weldmesh screening indicate that for bolting pattern (1.2 m × 1.2 m), #12 gauge mesh can support ~1.36 t of broken rock, while #6 gauge mesh would support ~3.18 t. At Uchucchacua Mine, a change from the current 12 gauge screening to a larger strand mesh (~#8 gauge, or ideally #6 gauge) for temporary (non-shotcreted) development at depth was advised to be considered.

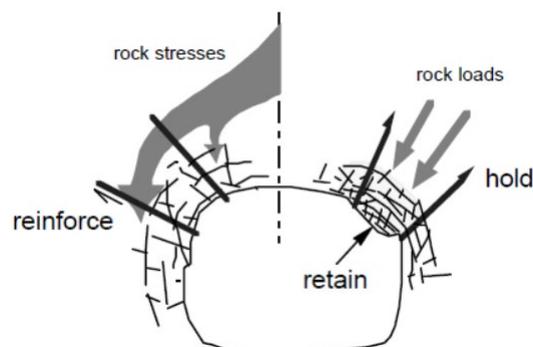
Figure 11 Three primary functions of support elements (CAMIRO Mining Division & Mining Research Directorate 1995)

According to the Rockburst Research Handbook (CAMIRO Mining Division & Mining Research Directorate 1995) rockburst damage is caused by one or more of the following mechanisms: rock bulking due to fracturing, rock ejection due to seismic energy transfer and rockfalls induced by seismic shaking. Evidence indicates that recent damage at Uchucchacua Mine is associated with these three mechanisms. Figure 11 presents a simplified view of three primary support functions: to reinforce the rock mass; to retain broken rock; and to securely hold or tie back the retaining element(s) (McCreath & Kaiser 1992). While each element of a support system may simultaneously provide more than one of these functions, it is convenient to consider each function separately.

The goal of **reinforcing** the rock mass is to strengthen it and to prevent loss of strength, thus enabling the rock mass to support itself (Hoek & Brown 1980). Reinforcing elements such as SplitSet bolts, yielding Swellex or conebolts, may behave as ductile or yielding elements under high deformation conditions. Alternatively, fully grouted rebars behave as stiff support elements.

While **retaining** broken rock may be required for safety reasons, it becomes essential under high stress conditions to prevent progressive failure processes leading to unravelling of the rock mass. At Uchucchacua Mine, the retaining function was limited by the relatively small gauge of weldmesh screening (12 gauge). The retaining function is enhanced with shotcrete application.

The **holding** function is needed to tie the retaining elements of the support system back to stable ground, and to prevent gravity-driven falls of ground both during and after a rockburst. Under conditions of large imposed (relative) displacements between the anchor and the head of the holding element, a yielding element is required. In some cases, as long as the holding element can yield sufficiently, it will not be required to absorb much energy -- just being able to move is all that is required. At Uchucchacua Mine, the holding function was generally not addressed with second-pass reinforcement.
