Ground support challenges in arctic mining conditions

V Falmagne *Agnico Eagle Mines Ltd., Canada*

Abstract

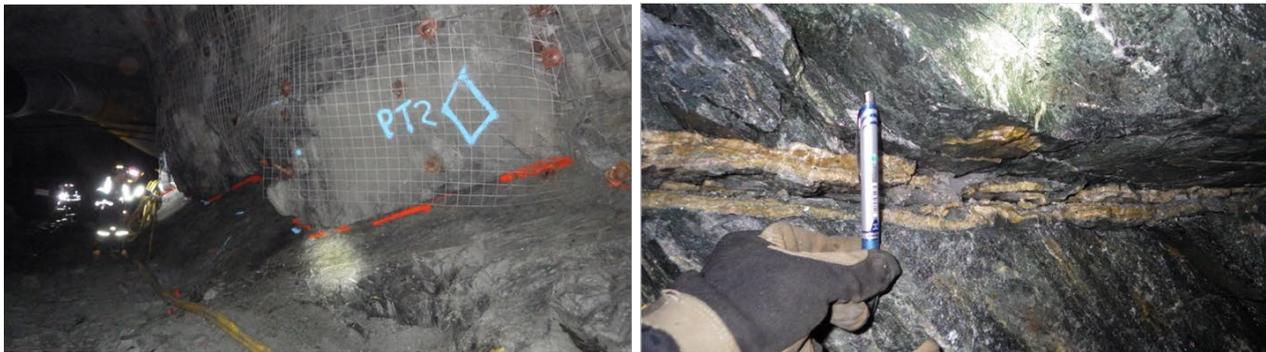
Figure 2 RM175 Fault with gouge and ice encountered during ramp development

Large-scale structural features at Tiriganiaq include the east–west trending Lower Fault and east-northeast trending Lower Fault splays within the Upper Oxide mineralised package. Other faulting orientations have been encountered in the mine development, namely the east-northeast trending undulating RM175 Fault and the west-northwest trending VT-125 Fault. Both these faults contained gouge and ice (Figure 2).

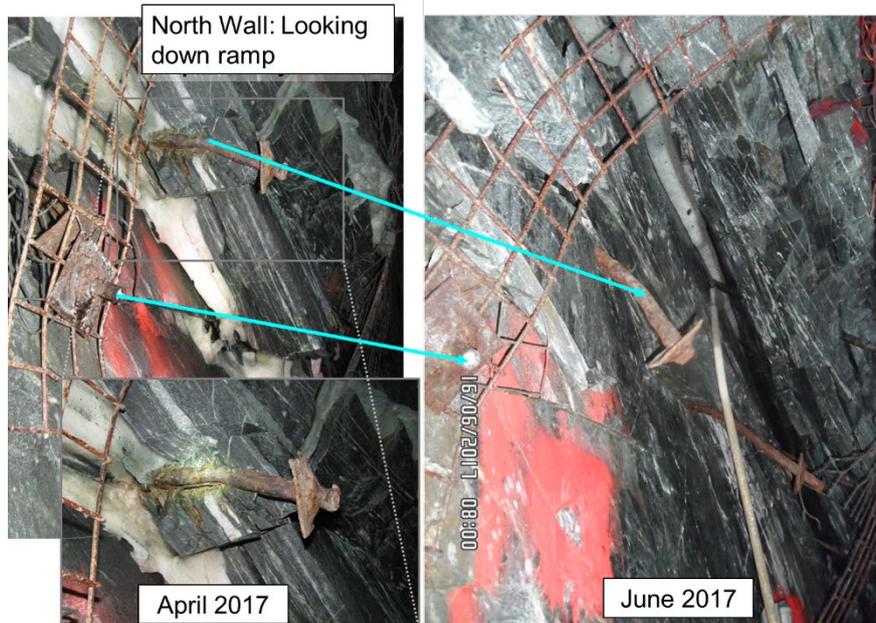
Figure 13 Ice build-up along the foliation (thick white bands) causing dilation and degradation of the wall

The ice build-up due to water infiltration and cold temperature affected the same ramp down dip from the previous fall of ground. In this case, the ice build-up affected the walls of the excavation, causing dilation of the foliation (Figure 13). As the ice melted, the walls became destabilised and required significant rehabilitation. The ramp was closed for 10 weeks while ground support was installed and a wall buttress built to support the estimated 110- to 200-tonne wedge in the wall.

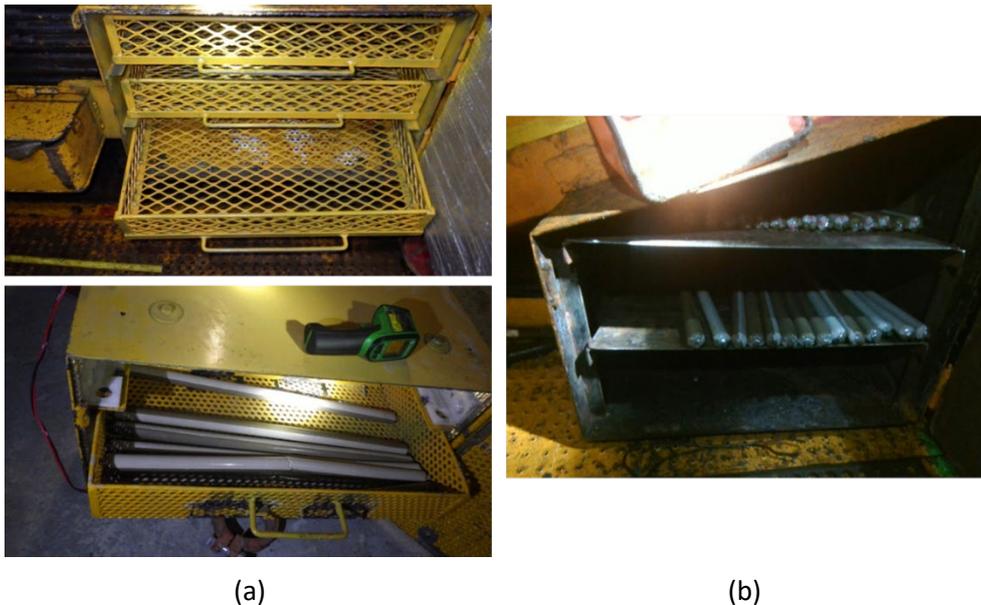
Figure 15 Resin heater boxes installed on bolting machines: (a) drawer model, (b) floor model

Once at the mine site, the resin pallets are left in sea cans and stored outside, where they remain frozen for about eight months per year. Before being sent underground, the resin pallets are transferred to the heated warehouse where they are left to thaw for at least 72 hours. Once underground, the resin pallets are stored in specifically designed heated sea-can storage. Custom resin heater boxes have been designed and installed on all the bolting machines to keep the resin at the right temperature before the installation of the rebar. Two different oven models have been designed to fit onto the two different types of bolting machines used onsite (Figure 15).
