Raiseboring in difficult rock conditions

Abstract

Virtually all long ventilation shafts and orepasses in the Boliden mines in Sweden are excavated using raiseboring. With increasing mining depths and hence, increased virgin rock stresses, it has become difficult to keep the shafts intact after boring and until reinforcement or other stabilising measures have been implemented.

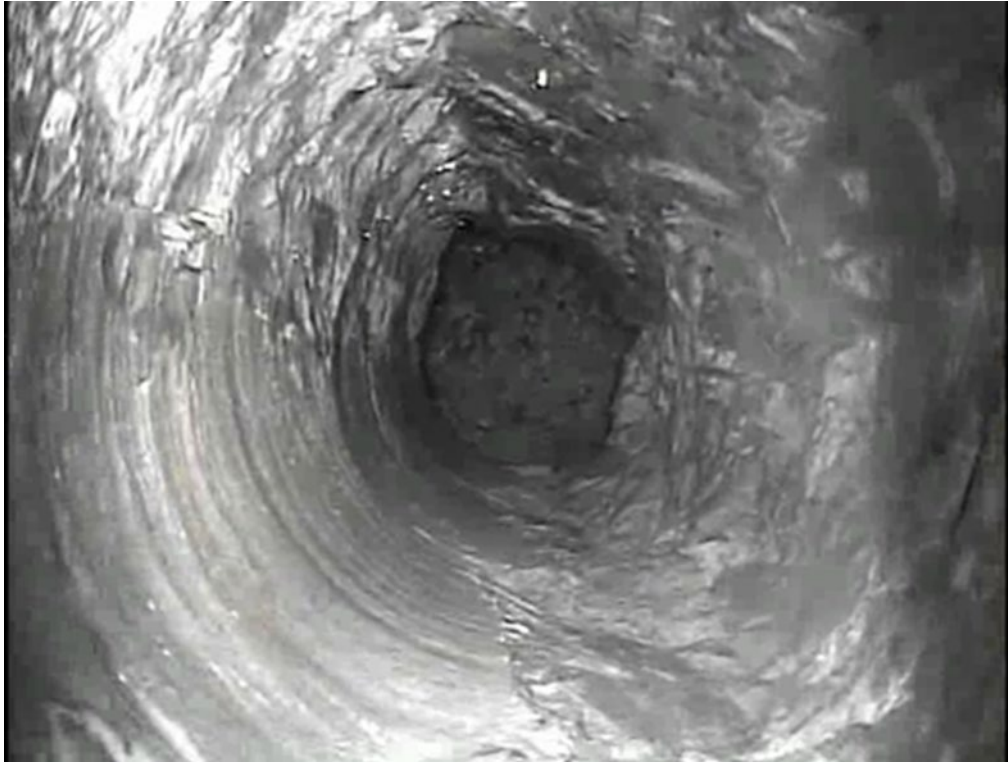
Figure 1 Stability problem after reaming, with difficulty to take down the reaming head and change cutters due to large convergence

- Convergence in the pilot hole or in the shaft (Figure 1).
- Stability problems at the face and/or in the wall.
- Stability problems in nearby drifts.
- Hard rock – uneven load on the reaming head.

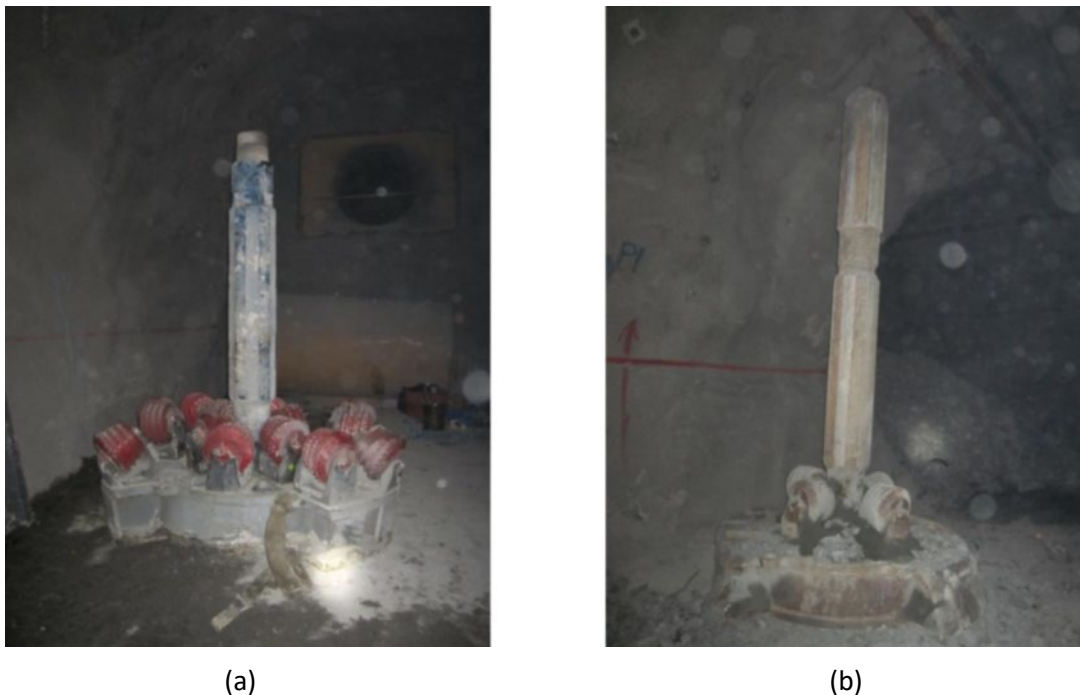
Figure 3 Reamer head before (a) and after (b) 35 m reaming

At Mine A a 750 m long ventilation raise with bottom at 1,300 m depth was raisebored in heavily veined Quartz Monzodiorite. The diameter of the raise was 3 m. The reaming stopped after 35 m due to poor ground conditions. Subsequent mucking produced significantly more tonnes than expected. A remote loader was used to clear the raise several times, however the raise would fail again within hours. After a short period of stability, the raise was fully mucked and the reamer head removed, with 10 cutters found to be missing, see Figure 3. The raise failed again after removal of the reamer and was left choked to help with rehab grouting. Probe drilling was carried out to determine the shape of the overbreak. These holes were then used to grout a 3–4 m high plug in the raise base. The remaining grout placement was done from the collar with lean mix in an attempt to fill void. The pilot hole was re-drilled once grouting was completed, and 2.4 m (as opposed to 3 m) diameter reaming recommenced. The overbreak was attributed to locally low rock block strength from intense veining/microdefecting relative to high in situ horizontal stress.

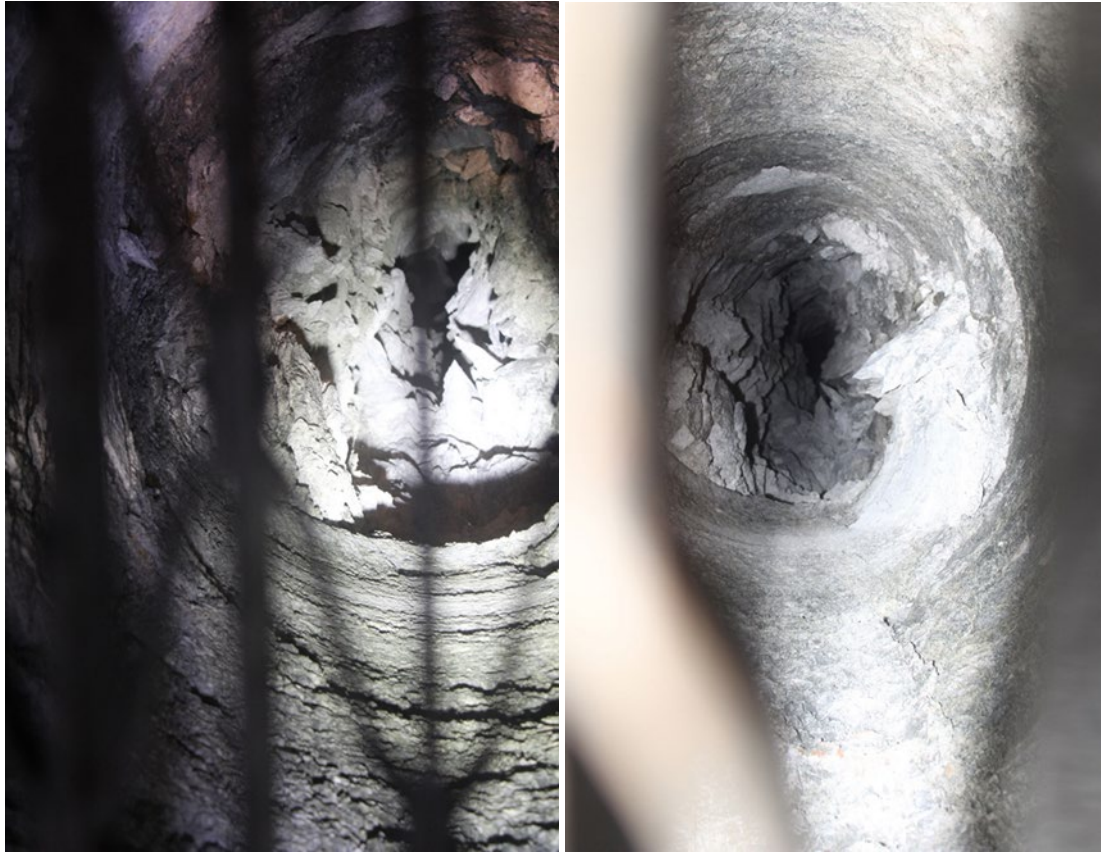
Figure 4 Views down slot raise soon after completion, showing severe crushing and squeezing close of raisebore

The raise pilot hole began to squeeze on the rods during downdrilling. Operators had to trip rods multiple times to maintain pilot hole diameter, prior to attaching the reamer. During reaming, due to anticipated high rates of closure, the reamer was lowered out of the raise between afternoon and day shifts, and then 'reamed' back up to the 'face' to ensure the reamer would not be stuck in the raise. Multiple surveys were done in the raise, which showed large pockets of caving approximately 2 to 3 m below the overcut elevation. The orientation of where crushing occurred (Figure 4) was mapped to estimate the stress field orientation for future model updates during mining. Multiple seismic events with local magnitudes up to 2.8 during mining of the stope resulted in badly damaged rock mass around the raise, complicating drilling and mining processes.

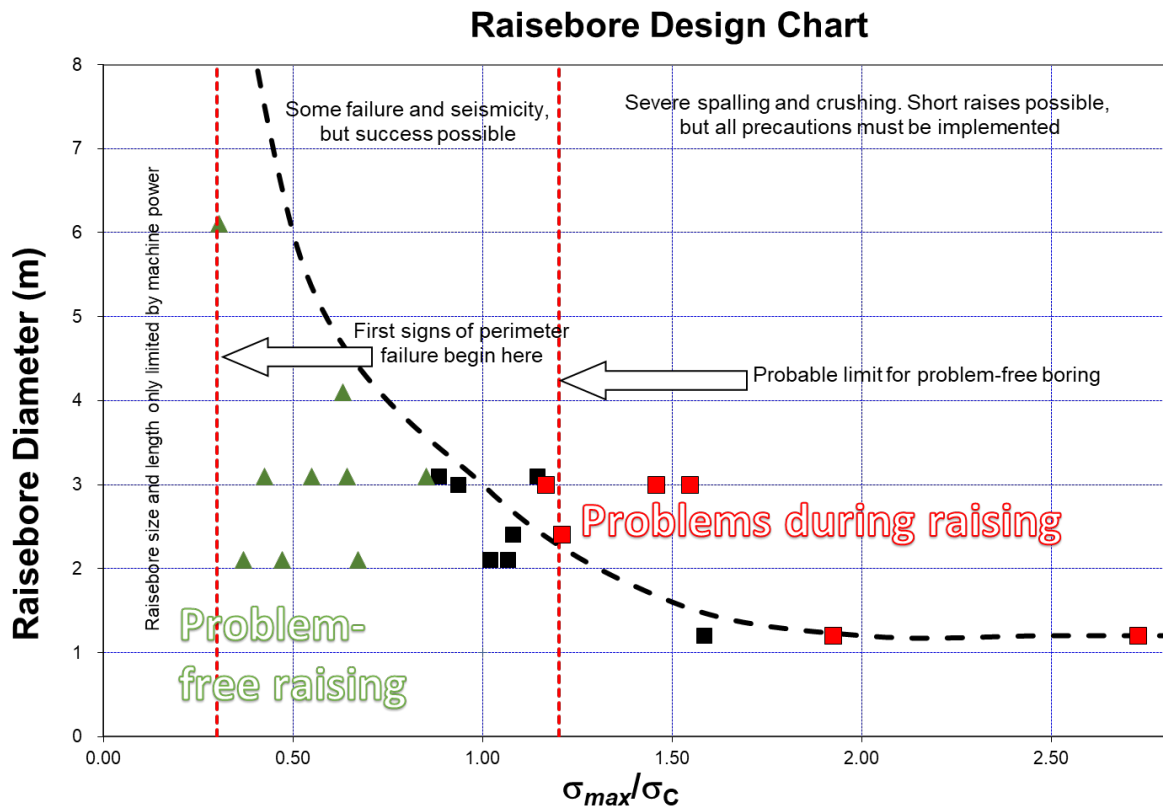
Figure 5 Raisebore design chart relating σ_{max}/UCS ratio to raisebore diameter. Red squares represent severe problems, green triangles no problems and black squares some problems. The black dashed curve defines the approximate limit for problem-free raising

The data obtained from the previous study (long-term stability) by Brummer (1998) together with data from the current study (short-term stability) allowed the further development of a Raisebore Design Chart relating the maximum tangential stress ($\sigma_{max} = 3\sigma_H - \sigma_h$) to UCS. It was apparent that this ratio could be plotted against the size of the raisebore (Figure 5) as well as the length of the raisebore (Figure 6). This enabled establishing what appeared to be limits for what can be achieved using today’s technology. One of the important limits is the stress ratio at which the perimeter of the raise or pilot starts to fail because of the induced tangential stress around the raisebore. Based on failure observations this occurs at a σ_{max}/UCS ratio of about 0.3, see Figure 5. The next limit, when severe spalling and crushing occurs, is at a σ_{max}/UCS ratio of about 1.2–1.5, based on industry experience. It can be further noted that for low σ_{max}/UCS ratios, in particular for the chart in Figure 6, the length of the shaft has less influence on the results. This is neither unreasonable, nor unexpected; however, for high ratios, the opposite is true, and both length and diameter are strongly restricted by the stress-strength conditions.

All cases presented in Table 1 are plotted in the charts together with cases which had no problems during raising. The problem-free raises are marked with green triangles and the cases with severe problems are marked with red squares. These charts can be applied to all type of raises as they consider the short-term condition. Like other empirical geomechanical design techniques these charts are intended to provide an indication of the potential for problem-free raising.

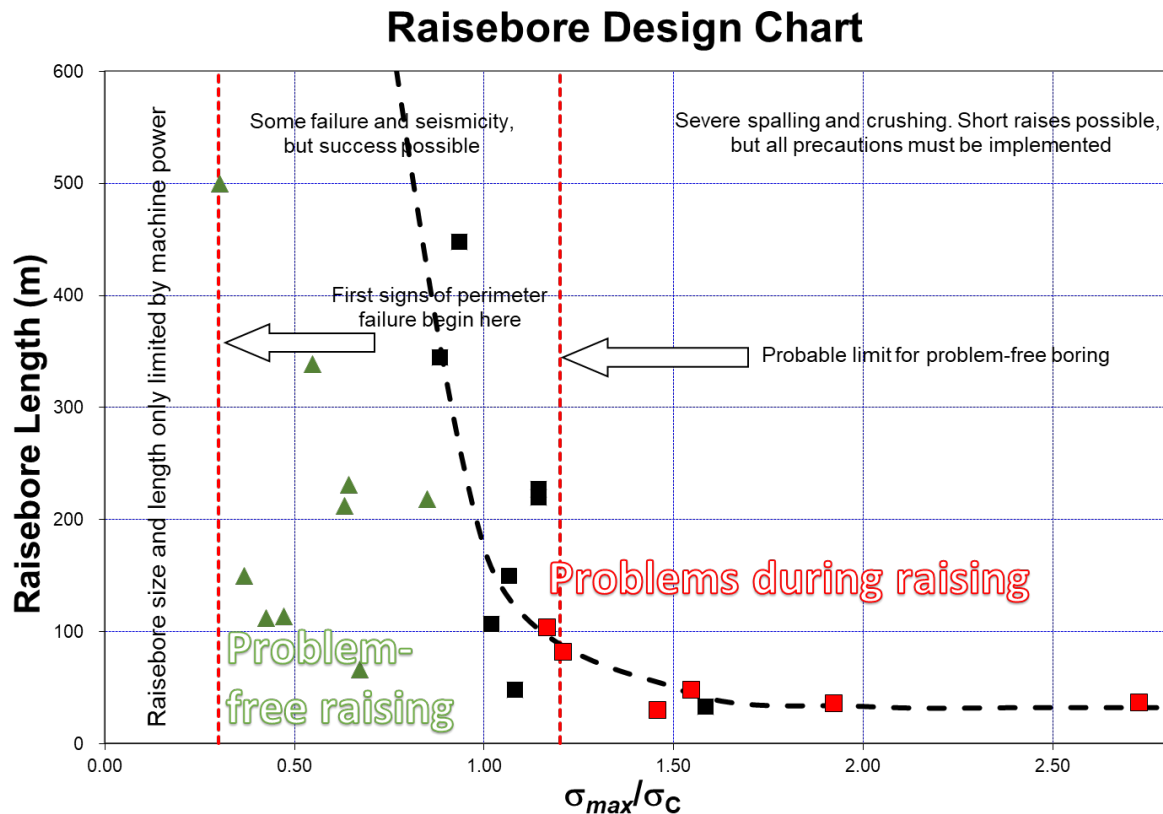
Figure 6 Raisebore design chart relating σ_{max}/UCS ratio to raisebore length. Red squares represent severe problems, green triangles no problems and black squares some problems. The black dashed curve defines the approximate limit for problem-free raising

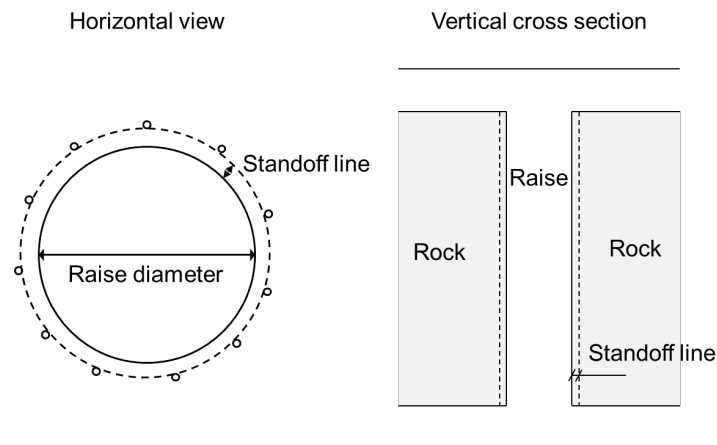
Figure 8 Example of layout of the vertical reinforced piles along the whole length of raise

There were no published case studies with pre-reinforcement in rock conditions with a combination of high stresses and weak and strong rock, similar to those of the Boliden mines. However, as vertical pre-reinforced holes have been trialled with success in many other mines, a ring along the whole length of the shaft is suggested as an idea for the future for the Boliden mines (Figure 8). The inner ring can be complemented with an outer ring (or several rings) with shorter holes, in the top and bottom of the shaft (Figure 9).

The holes could be reinforced using, for example, bolts (which are linked) or cable bolts and concrete (i.e. components with high tensile capacity as not to fail due to lateral movements). This set-up may work well also under high-stress conditions, but it may be questioned whether it could also sustain large strain bursts. For such conditions, additional studies, for example using numerical modelling, would be required.

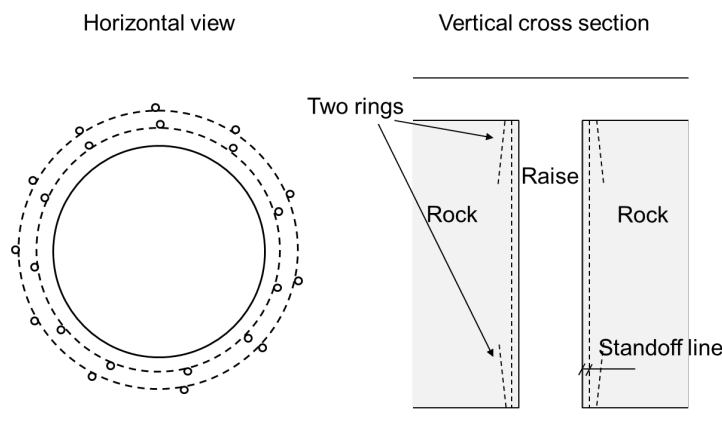
Figure 9 Example of layout using an inner and outer ring in the top and bottom of raise
