The evolution and performance of the Henderson Mine's C-arch shotcrete drawpoint support

NA Shea *Climax Molybdenum Co., USA*

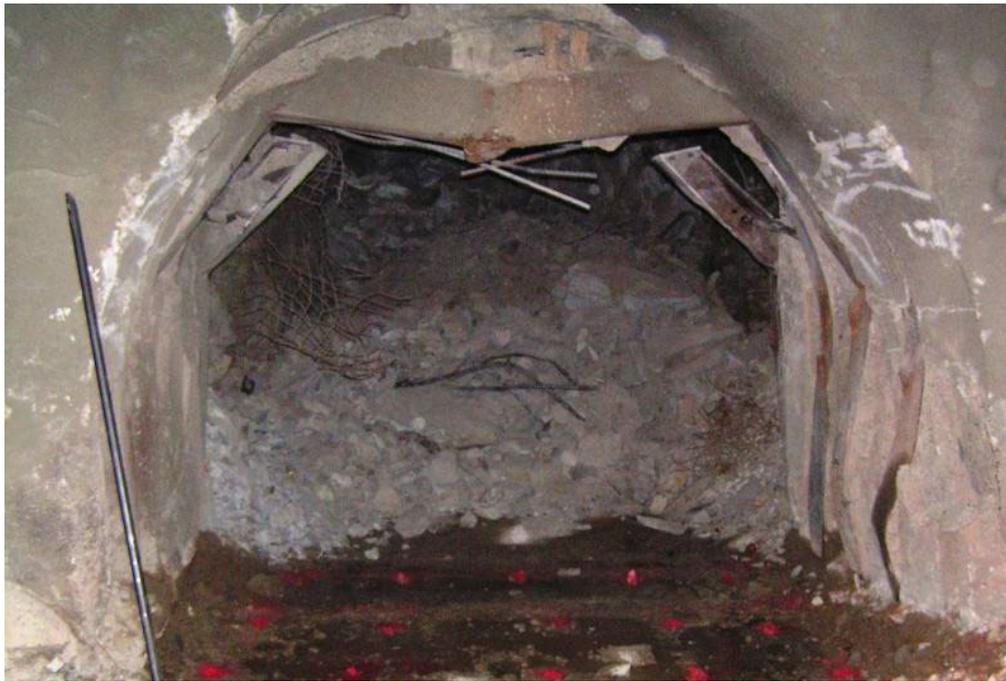
Figure 1 Drawpoint damage after abutment loading on the 7210 level. The brow set and arch support legs are buckled (Johnson & Loring 2010)

Traditional steel and concrete brows were installed on the 7210 level as caving began in 2005. Early in the caving process, it was recognised that this lowest level would require modification of support practices from the previous 7700 level (Golden & Fronapfel 2008). Weak ground and increased depth resulted in increased deformation on the extraction level, including in the drawpoint brow. The steel in the brows would buckle under abutment loading prior to substantial production. The initial response to this brow damage was to increase the steel support, with up to three additional steel arch sets in addition to the brow. However, damage continued to occur with abutment loading (Figure 1). This resulted in significant repair effort, including installing new steel sets and cast-in-place concrete after abutment loading (Golden & Fronapfel 2008).

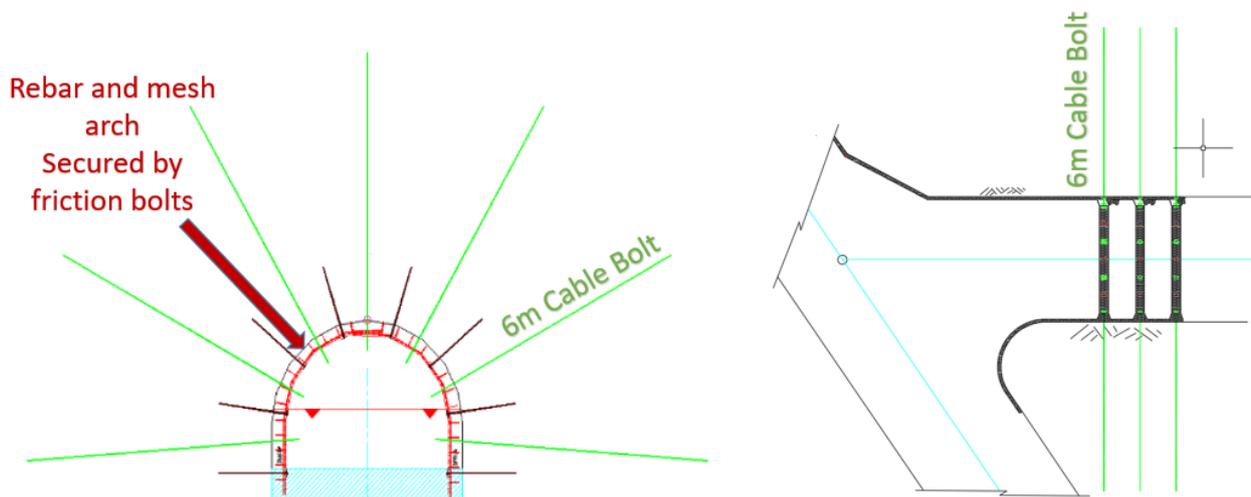
Figure 2 Initial C-arch support design; three rings of cable bolts are installed with a reinforced shotcrete arch for surface support

The operation was managing this deformation and repair cycle, while continuing to develop and cave the 7210 level, when a concept was seen in a site visit to the Sudbury basin that would change the approach to drawpoint support. The C-arch concept uses grouted cable bolts to secure the in situ rock, rather than adding more steel and concrete underneath it. Reinforced shotcrete arches provide the surface brow support. To see if this reinforced shotcrete arch could handle the abutment loads, and subsequent production, the first Henderson C-arch design (Figure 2) was developed and tested in 2007.

Drawpoints were mined to a smaller arch profile to leave as much rock in place as possible and to provide the necessary flow control for extraction. Then, three rings of 6 m cable bolts were installed with 1.2 m bolt spacing on 1.2 m ring spacing, in the normal brow location. Three rings were used with the assumption that two rings could wear and fail, leaving one in place to control muck flow. Following cable bolt installation, light re-bar frames were placed over the cables and shaped to fit the rock arch. Welded wire mesh was then placed

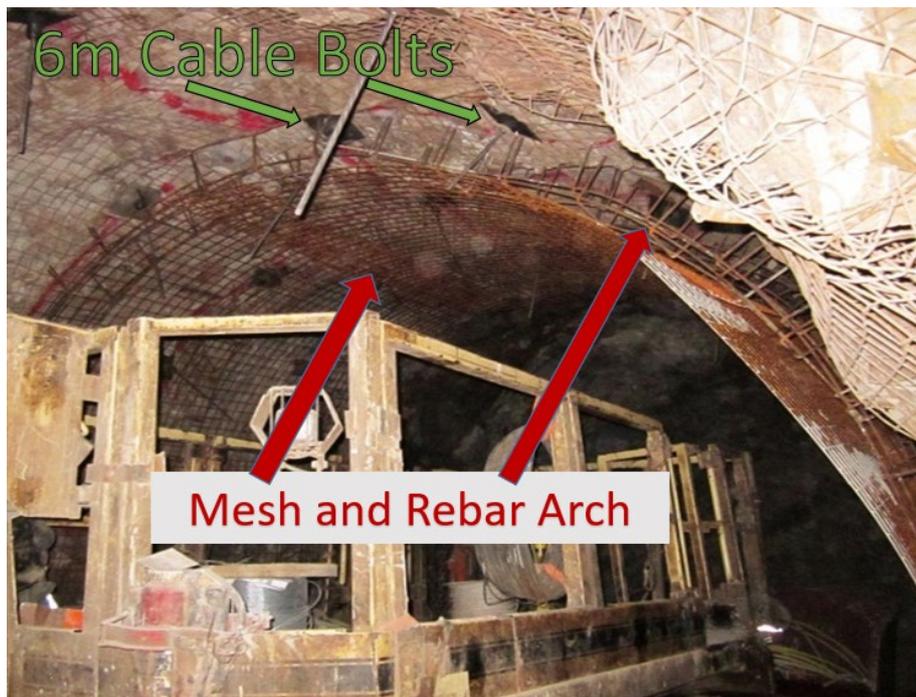
Figure 3 C-arch installation; welded wire mesh is placed on re-bar frames to form an arch below the three rings of cable bolts

over all three arch rings and secured in place with friction bolts (Figure 3). To complete the support, shotcrete was then placed on the entire structure, filling in the arch.

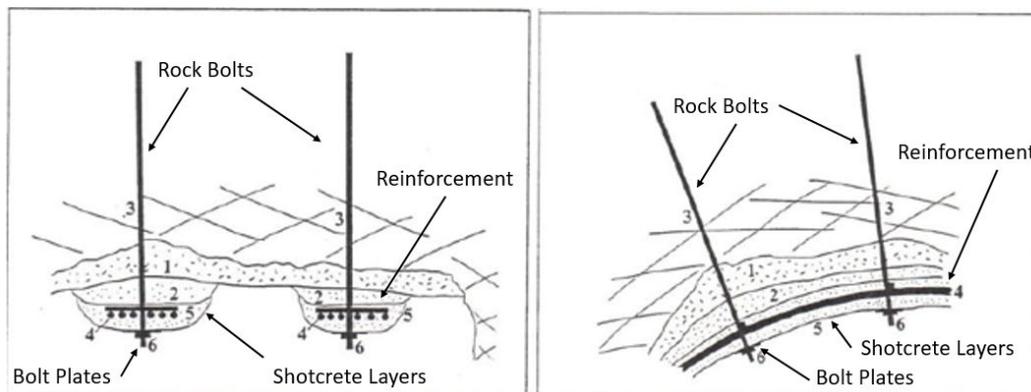
Figure 4 Rib Reinforced Shotcrete (RRS) arches (from Barton 1996); shotcrete layers create the required thickness, while rockbolting passes through the arch reinforcement to create an interactive system

Dr. Barton describes Rib Reinforced Shotcrete (RRS) arches used in modern versions of the Q-system to address poor ground conditions (Barton 1996). The similarities between RRS arches and C-arches led to opportunities for improvement identified from the RRS design. With RRS arches, shotcrete reinforcement is arranged in a flat section, using shotcrete layers to create the required thickness, additionally, rock reinforcement bolting is secured through the shotcrete reinforcement to create an interactive system (Figure 4).

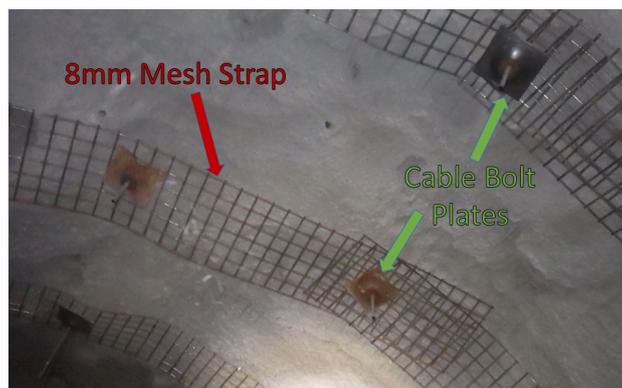
Figure 5 Arch reinforcement mesh straps in the updated C-001 arch design; initial shotcrete builds the arch thickness, cable bolt plates secure the arch straps, creating an interactive support system

Working with the operations group to develop the installation process, a new design was agreed upon which incorporated these features from the RRS arches. In this new design, dubbed the C-001 Arch, 100 mm of shotcrete is applied after drawpoint mining and primary support installation. Then, three rings of cable bolts are installed at the same 1.2 m spacing as in the original design. Next, 8 mm welded wire mesh straps, 45 cm wide, are secured with the cable bolt plates during cable bolt tensioning (Figure 5). A final pass of shotcrete covering the mesh straps completes the process.

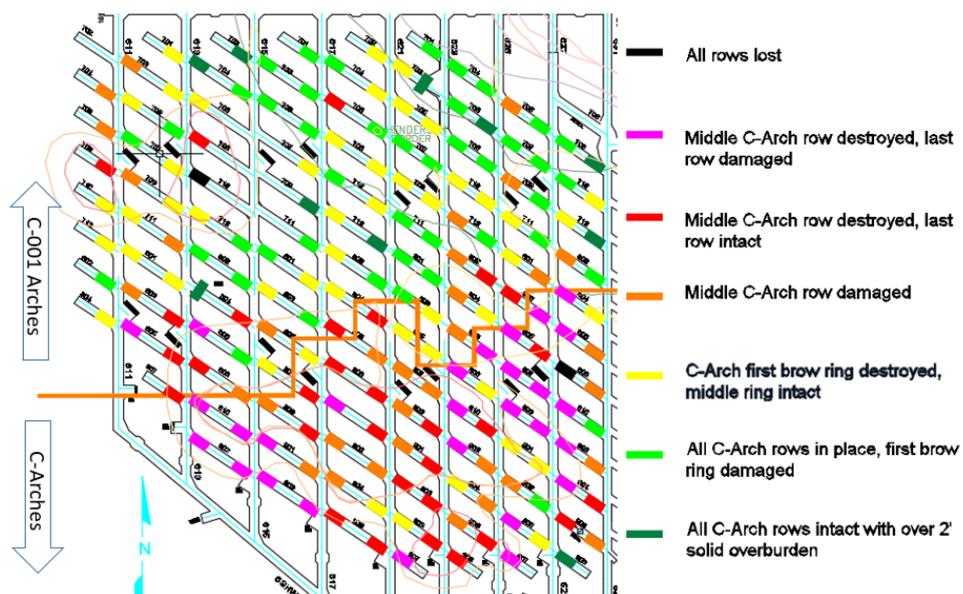
Figure 6 Observed drawpoint brow condition from December 2017; higher levels of wear are seen in the southern portion of the panel

Damage observations were made roughly twice per annum from 2014 to 2017 to understand the performance of the brows over time. The condition of the brows was then plotted on a map to identify problem areas and look for potential patterns in wear (Figure 6). From these maps, it was apparent that the drawpoints in the southern portion of the panel had more wear than those in the northern portion.

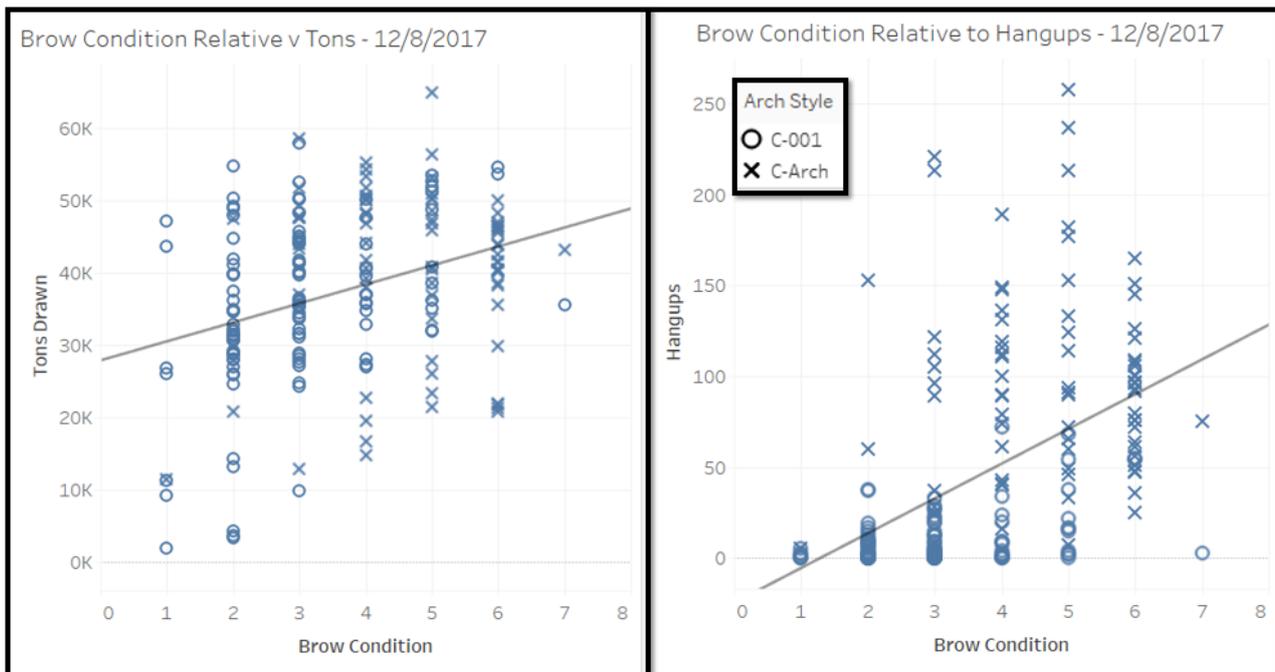
Figure 7 Observed drawpoint brow conditions relative to tons drawn and reported hangups. Hangups show a greater correlation to brow condition, with wide scatter in both datasets

Brow wear data was compared to total tonnage extracted from the drawpoint. A simple correlation between brow wear rate and tonnage would be helpful in validating the effectiveness of the C-arch over the lifespan of the drawpoints, and provide useful guidance for future designs. A scatter plot shows brow condition in relation to tonnes drawn from each drawpoint (Figure 7). As expected, an increase in damage was seen with increased tonnage drawn. However, the slope of the trend was shallow, and there was a wide scatter in the data. This indicates that there is not a simple linear relationship between tonnes drawn and brow wear.

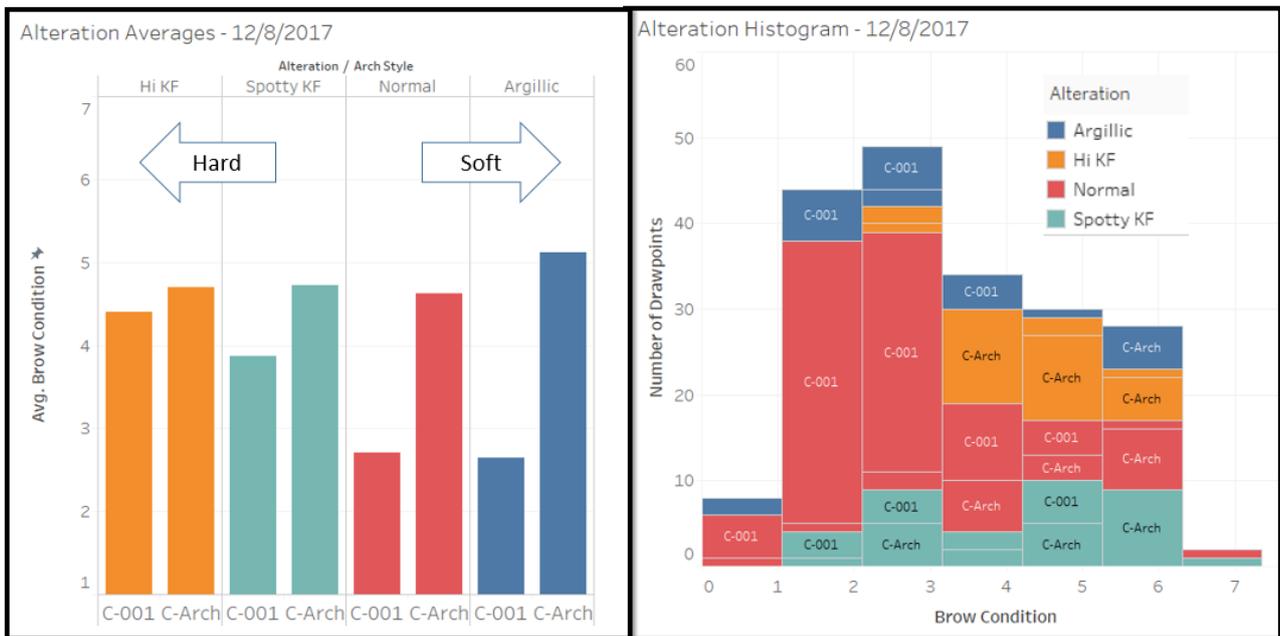
Figure 8 Brow condition related to alteration type. The original C-arch brow shows roughly equal damage across all alteration types. The C-001 updated arch style shows less overall damage, performing especially well in normal to softer alteration zones

As the in situ rock effectively forms the brow with C-arch drawpoint, geology must be considered. In only two drawpoints on the panel were all three rings lost. In both of these cases, molybdenum faults at unfavourable angles had allowed the surface support to be sheared away from the brow. In both cases, enough rock was left in place that the drawpoint is in functional condition with repair. Alteration type can be used as an indicator of general rock mass quality as it influences the intact rock strength. Data collected from Henderson drillcore show compressive strengths ranging from 60 MPa in weaker argillic altered rock to greater than 170 MPa in harder potassic rock. Less altered 'normal' rock strength averages between 100 and 120 MPa. A combined histogram of drawpoint condition coloured by alteration type show the influence of alteration on brow performance (Figure 8). The C-001 arch performed very well in normal to softer conditions but less so in the harder conditions. The original C-arch design performed roughly the same across the range of alteration types, showing more wear than the C-001 arch in all conditions.

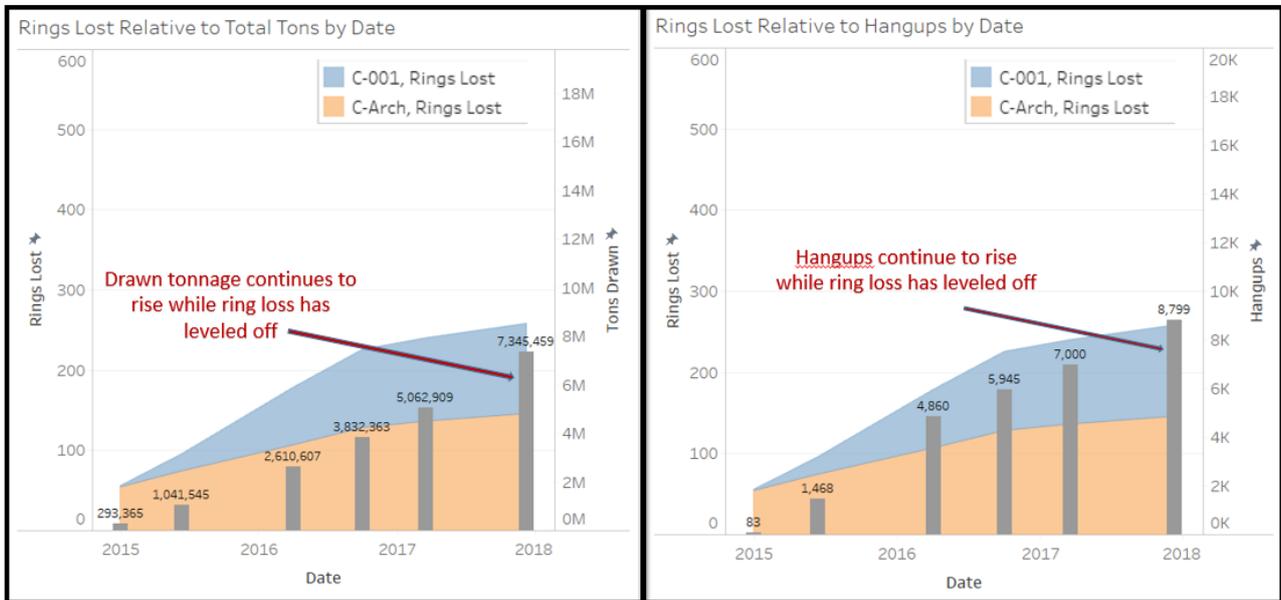
Figure 9 Rings lost over time compared to drawn tons and hangups. While draw and hangups continue, the rate of ring loss has slowed

In order to assess this, it was first necessary to look at the overall data as it was collected over the life of the panel. The brow condition data was then converted to rings lost to reduce ambiguity. There are three rings per drawpoint, and 600 total rings on the panel. By plotting observed rings lost per observation date with the total tons drawn from the panel (Figure 9), it is possible to see that the rate of damage is not a linear function. The majority of damage occurred between May 2015 and May 2016 during the cave initiation process, with the damage rate dropping dramatically after that point, even though tonnage drawn continues to increase.

This indicates that much of the damage seen occurred early, and damage through the remaining life of the drawpoints will likely be minimal. By scaling this plot to the total number of rings on the panel and the total tons to be drawn, it is apparent that the total tonnage will be reached well before the brows are lost.

The ring loss over time can also be compared to the hangups over time. Hangups over time better tracks the damage rate, with a reduction in hangup frequency after mid-2016. However, it does not track exactly, with some damaged brows seen early on, before a substantial number of hangups. In later periods, hangups continue at a greater frequency than is reflected in the brow damage data. This supports the analysis that additional factors beyond hangup frequency contributed to drawpoint wear, especially in early periods. Some factors that could not be captured but would affect early performance would be bell development blasting, abutment loading, fragmentation, and installation quality.

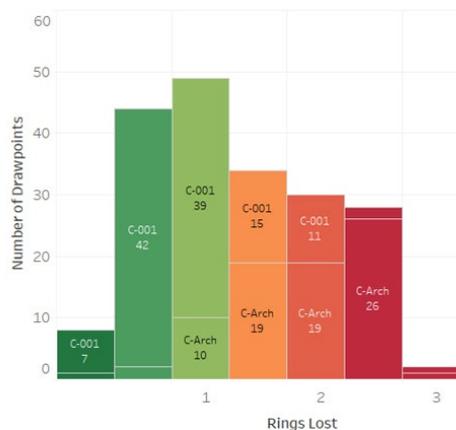
Figure 10 Overall brow condition at the end of 2017. Most of the brows are in good to fair shape with two brow rings remaining. Of the brows in good condition, most are the updated C-001 arch design

The final plot shows the overall condition of brows across the panel at the last observation date (Figure 10). This plot groups drawpoints by condition in terms of rings lost out of three, showing the number of drawpoints in each condition by arch type. From this plot it can be seen that a majority of drawpoints are in good to fair condition, with two brow rings remaining. Of the drawpoints in good condition, most are the updated C-001 arch. With the low rate of new damage, and the generally good condition of the drawpoints, they are expected to continue to perform through the life of the panel.
