# How convincing is the quality of our resin rebar installation?

## A case study

**O Gibbons** *SRK Consulting (Canada) Inc., Canada*

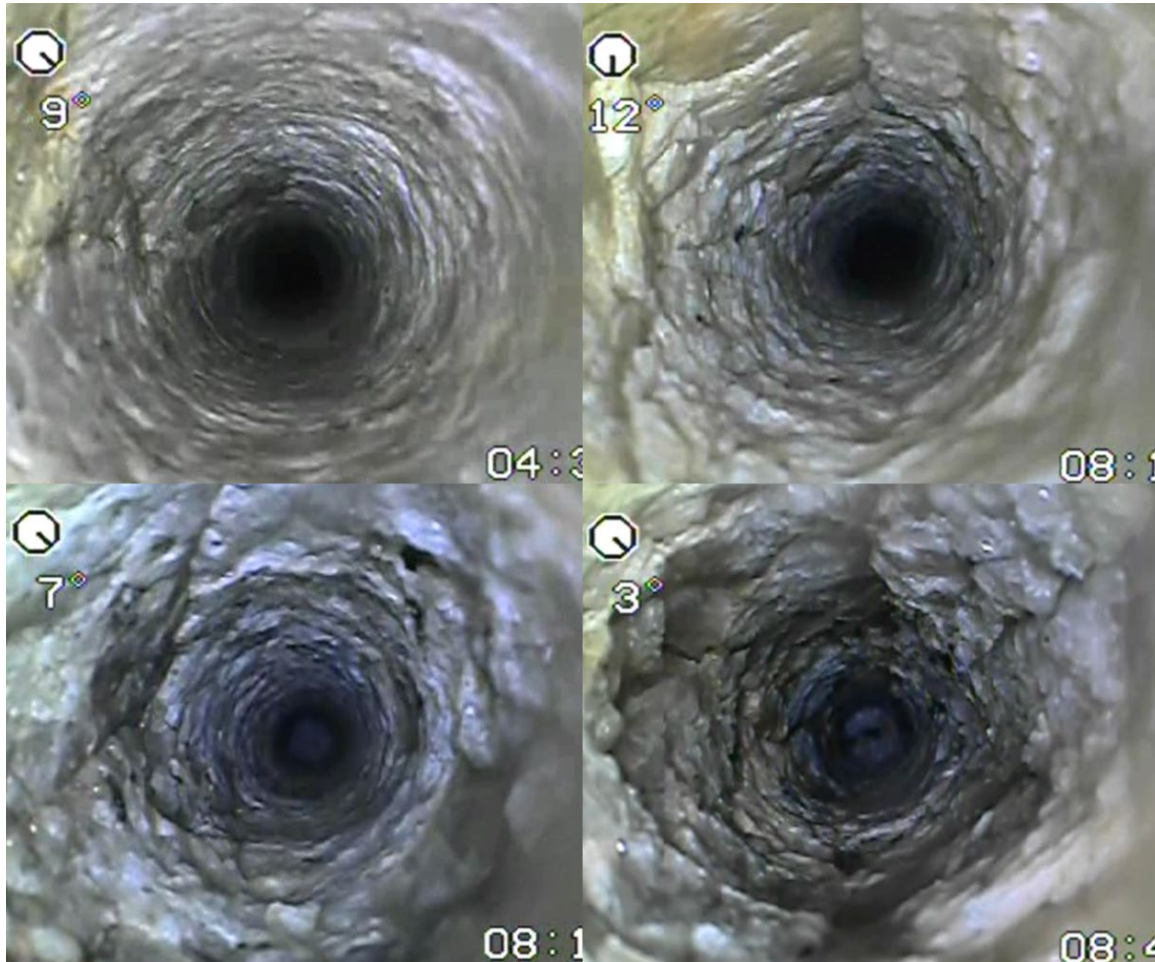
Figure 1 shows borehole camera images from four different drillholes that were drilled using a mechanised rockbolter with a 33 mm drill bit. Although the holes were drilled in the same rock type, the wall condition and the hole diameter were variable in the presence of geological features such as discontinuities.

Figure 1 Variability of drillhole conditions; all holes were drilled using 33 mm diameter drill bits in the same rock type

Test holes should be drilled and inspected to ensure the hole condition is adequate and the diameter is as expected. If the rock mass varies across a site, testing should be done to ensure all rock types are represented. In this case study, a borehole camera was used to inspect the test holes that were drilled with varying bit

sizes and it was found that a bit size of 33 mm was required for an average hole diameter of 34 mm. A 34 mm bit was found to produce a hole that was too large, causing an annulus that was too large.

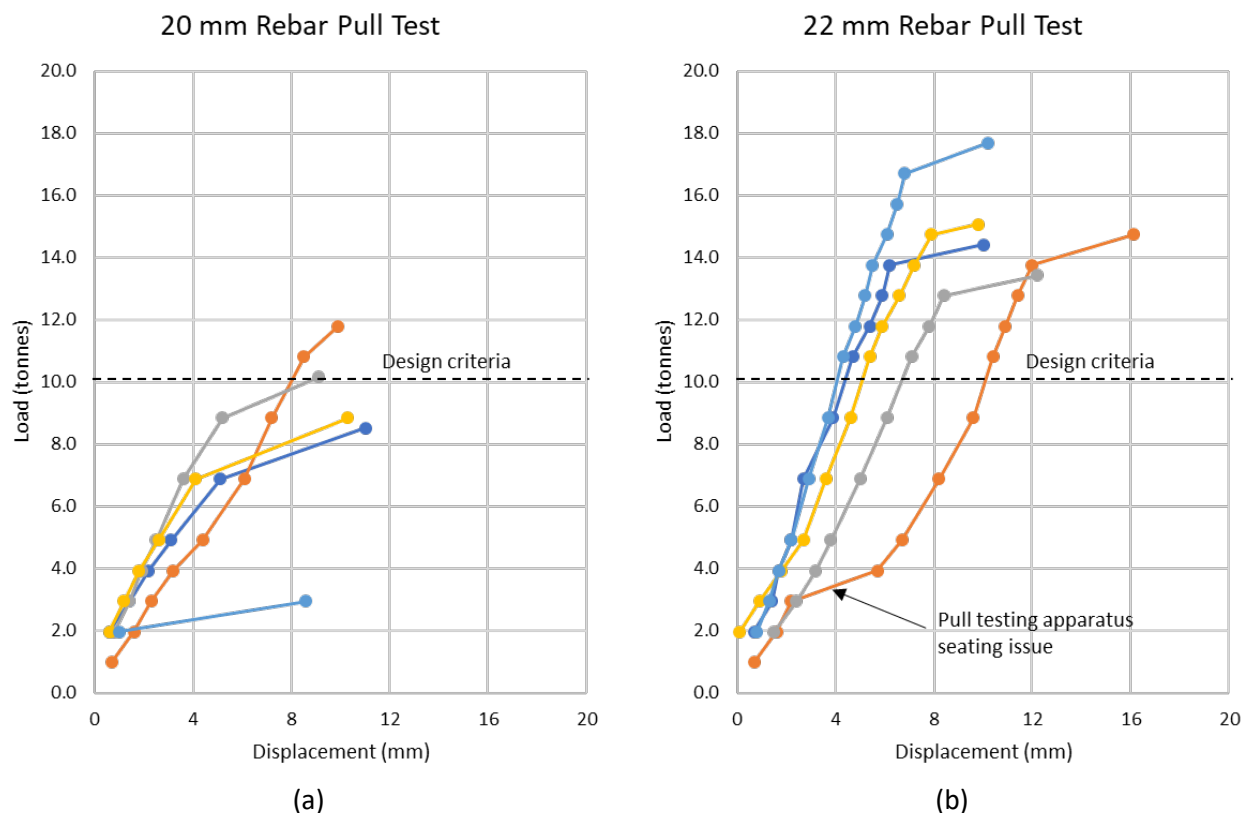
In the case study, the resin rebar configurations were confirmed by short encapsulation pull tests where only the fast-setting resin is installed at the end of the hole to provide one foot (305 mm) bond with the rebar. Figure 2 presents example pull test results of five 20 mm rebar bolts and five 22 mm rebar bolts that were installed in 34 mm holes using the mechanised rockbolting machine. The five 22 mm rebar bolts were capable of holding loads that exceeded 13 t, whereas four of five 20 mm rebar bolts failed prior to loads reaching

**Figure 2** Pull test results of (a) 20 mm and (b) 22 mm rebar bolts installed in 34 mm drillhole using mechanised rockbolting machine

10 t. The 20 mm rebar bolt installation test was considered inadequate and additional tests were conducted to determine suitable installation configuration and procedures. As a reference, former US Bureau of Mines' extensive study of resin bolt anchorage considered 90% passing rate as adequate for determining the minimum anchorage lengths (Mark et al. 2002).
