Support and reinforcement damage initiation and design adjustments in a deep mine environment

Case study: Cuiabá Mine, Minas Gerais, Brazil

L.C.B. Costa, R.C. Padula, L.M.V. Pimenta, R.S. Pereira, and D.T. Peterle

Anglogold Ashanti, Brazil

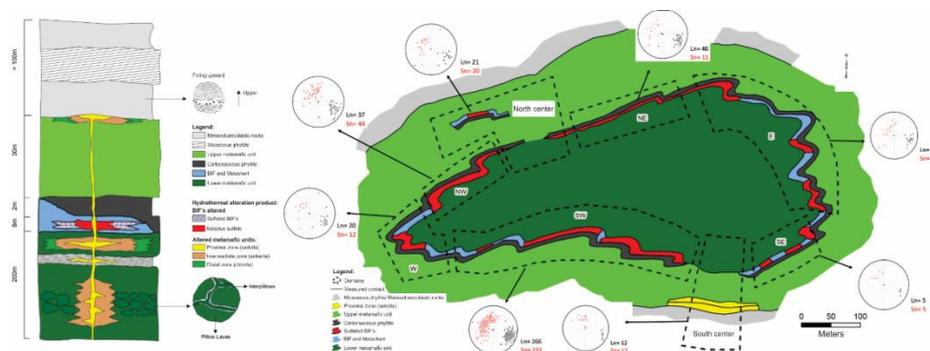
Figure 1. Lithostratigraphic column of the Cuiabá deposit, with associated alteration hydrothermal and Cuiabá deposit map with structural domains and defined stereograms: Ln - folding axis D1/D2; Sn - Polar point of foliation S1/S2 (modified by Fernandes et al (2016))

The Cuiabá Gold deposit consists of meta-sedimentary and meta-volcanic rocks, with typical mineral paragenesis of metamorphic conditions associated with greenschist facies. As shown in Figure 1, the local lithostratigraphic horizons include a lower meta-mafic unit (MAN), discrete hydrothermal strata in the proximal zone (X2), intermediary zone (X2CL) and distal zone (MANX), BIF and metachert (carbonate, carbonaceous and ferruginous), carbonaceous phyllite (XG), a metamafic superior unit (MBA) also divided into hydrothermal proximal zone (X2), intermediate zone (X2CL) and distal zone (MBAX) and at the top of the column, metavolcanoclastic rocks (XS) micaceous phyllites (X1), Rodrigues et al (2007).

According to Fernandes et al (2016), the final shape of the fold in which the orebody occurs (See Figure 1), is linked to three deformational phases; and each presents its associated main structures. The phases are: a) phase D1 with inclined and closed folds with rakes to east south-east and generation of the foliation S1. It has gold mineralization associated with deformed pyrrhotite; b) phase D2 with tight inclined coaxial folds to phase D1 with rakes to east south-east and generation of the foliation S2. It has gold mineralization associated with subhedral pyrite in quartz-carbonate venules parallel to the axial planes of these folds; c) phase D3 with mild folds of subhorizontal axis and vergence to the west, whose axial planes define as a spaced crenulating cleavage in a north-south direction. This phase only segments locally the structures previously generated.

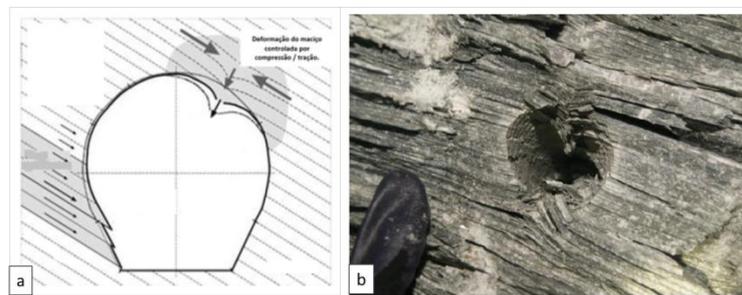
Figure 2. (a) Failure mechanism of excavations of foliated rock masses (b) Buckling mechanism in a borehole in a foliated rock at Cuiabá Mine (Pimenta, 2018)

In underground excavations situated in anisotropic hard rocks, large deformations are controlled by the presence of foliation and their respective orientation in relation to the opening direction, Karampinos et al (2015). Figure 2 a shows stress induced failures tend to occur in regions where the foliation is sub-parallel to the excavation walls. In these regions, there is a high concentration of shear stresses, leading to contraction along the foliation planes and dilation in the orthogonal direction, towards the opening. This dilation increases the deflection of the foliation planes, resulting in the buckling mechanism that also leads to rock mass bulking (See Figure 2b). In some sections of the ramp, one can also observe a complete shear failure of the rock mass causing a convergence of the excavation.

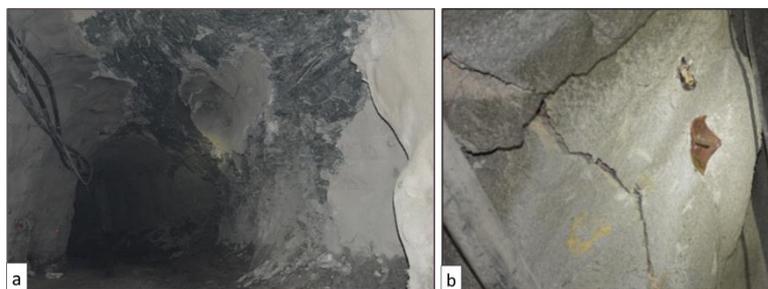
Figure 3. Damage in the support system observed underground in the Serrotinho ramp. (a) Failure of the shotcrete. (b) deformed plates. In some regions, the plates were completely sheared from the rock bolts

The failure mechanisms presented above caused ground displacements in the order of 15 cm, and this movement led to substantial damage to the support and reinforcement in the Cuiabá mine (See Figure 3). The support system initially installed at the Serrotinho ramp consisted of shotcrete and rockbolts spaced 1,5 m x 1,5 m and 2 m from the floor.

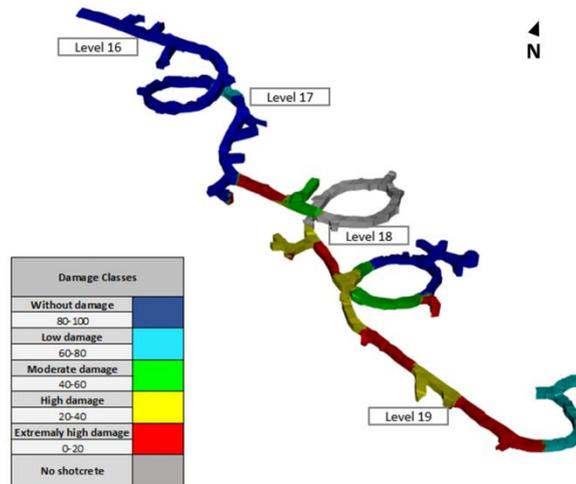
Figure 4. Damage mapping of the Serrotinho decline generated in GEM4D (Basrock)

By summing the rating obtained from each of these parameters, it is possible to obtain the level of damage to the support system as shown in the Table II. By applying the methodology described above, damage mapping was carried out as shown in Figure 4. It served as an important tool to calibrate the numerical modelling presented in the sections below.

The convergence measurements were executed on a weekly basis and the mean velocity of the convergence sections (mm/week) is presented in Figure 5. The areas with a higher damage in the support system (See Figure 4) correlates with the area that presented a higher velocity in the convergence monitoring (See Figure 5). Figure 6 presents the results of the borehole camera monitoring. It is observed that the thickness of the failed material varied from 1,0 m to 0,5 m.

Although the magnitude of displacements might be underestimated by the model, it is possible to correlate the major displacement regions with those with the highest support damage (See Figure 4) and higher displacement rate in the convergence sections (See Figure 5). The results show that the sectors of the decline that are perpendicular to the major horizontal stress, more precisely around 120° azimuth, tend to be subjected to the greatest displacements after the nearby stopes were mined. This correlation of the damage zones with the induced displacement in the excavations was useful to obtain a more accurate criterion to analyze the planned geometry of the ramp and to avoid similar issues in the future.

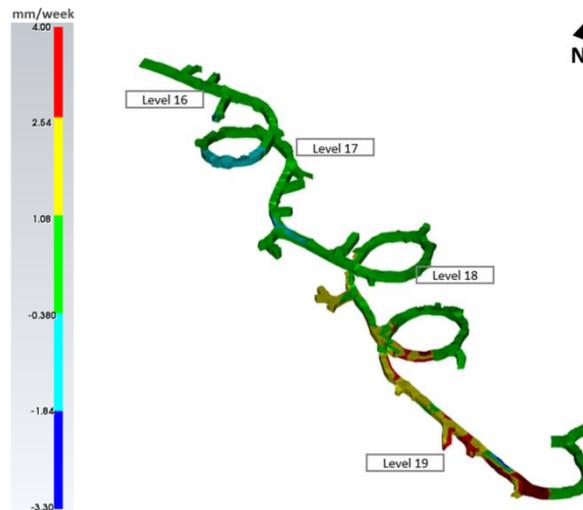
Figure 5. Velocity (mm/week) of the convergence sections of the Serrotinho ramp interpolated using GEM4D (Basrock)

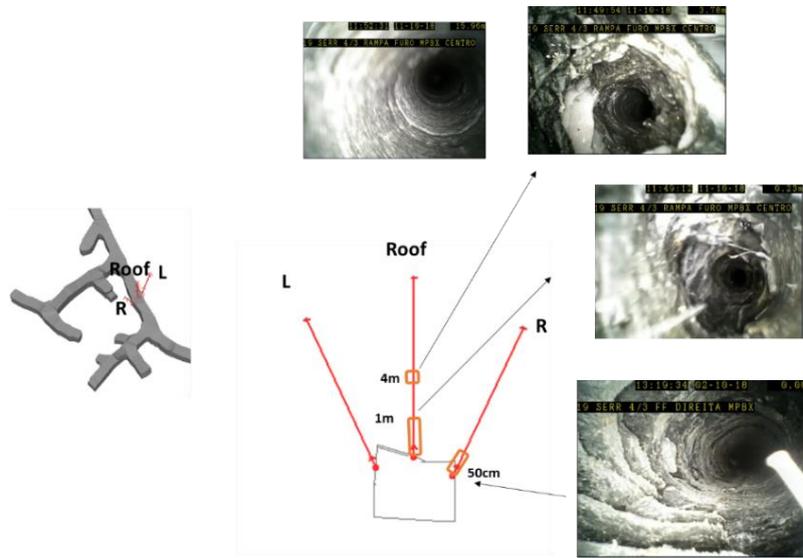
Figure 6. Failures zones obtained by the borehole camera monitoring [4]

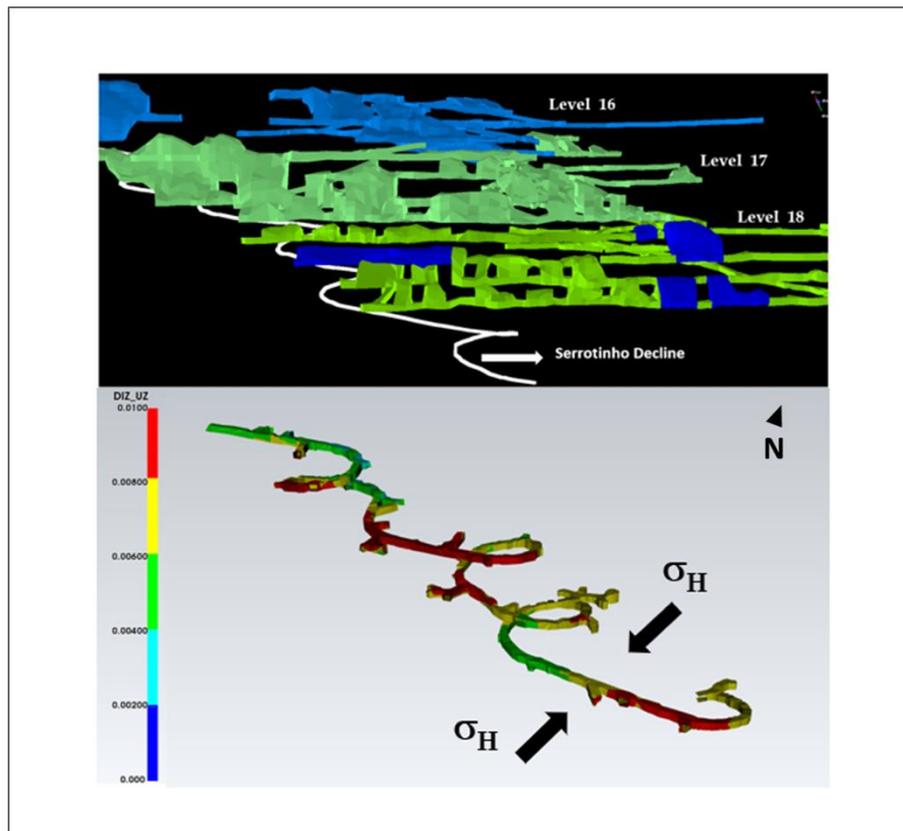
Figure 7. (a) MAP3D model with stoping areas around Serrotinho decline (b) Vertical displacement increase at the decline after mine of the stopes

Figure 7 (a) shows the 3D model, comprising the excavations around the decline. Grid lines for results calculation were placed at the top of the decline, and the model was staged in two steps: prior to and after the excavation of the stopes in the level 16, level 17 and level 18. As shown in 7 (b), the maximum induced displacement after the stoping was 1 cm, considerably smaller than the real displacements observed in field and obtained by the convergence measurements (Up to 15 cm). According to Kaiser (2010), continuum models are limited on correctly reproducing the unidirectional bulking process and tend to underestimate the displacements acting on the support due to the stress fracturing.

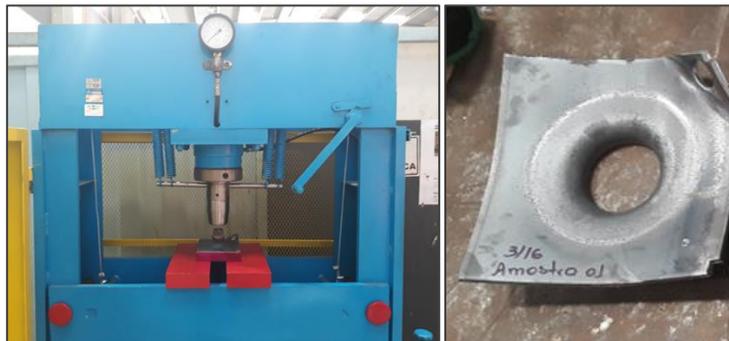
Figure 7. Laboratory tests carried out to obtain the capacity of the plate

As some plate failures were observed in the field, indicating that this element could be the reinforcement weakest link, laboratory tests were done at Cuiabá to obtain the capacity of the different types of plates (See Figure 7). The test consists of pressuring the nut through the plate with a hydraulic jam until the nut had completely penetrated the plate. Plates with a thickness of 4,8 mm and 8,0 mm started to deform at 6 t and 12 t, and the nut penetrated the plate at 8 t and 18 t, respectively.

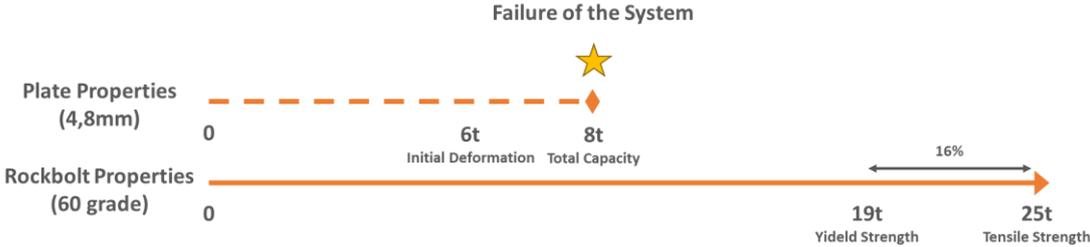
Figure 8a. Flowcharts to illustrate the load and displacement capacity of the current reinforcement system with a plate with 4,8 mm and a rockbolt with 60 grade steel

In order to understand and illustrate the compatibility of each of the elements of the reinforcement system, two flowcharts were elaborated: one associated with the current support system (See Figure 8a) and the other related to the recommended assembly (See Figure 8b). The capacities presented in these flowcharts correspond to the rock bolt steel and plate capacities and are not related to the bond strength. This assumption is considered adequate because the portion of the rock bolt inside the stable ground (Around 2 m) is sufficient to cause the rock bolt to fail. Based on these diagrams, one can see that the current reinforcement system would fail at 8 t and would not allow the rock bolt to yield. However, the recommended reinforcement system provides a total capacity of 17 t and the rock bolt will yield completely before the failure of the system. In addition to the thicker face plate, the proposed assembly would also have a more ductile rock bolt with an elongation of 33%.

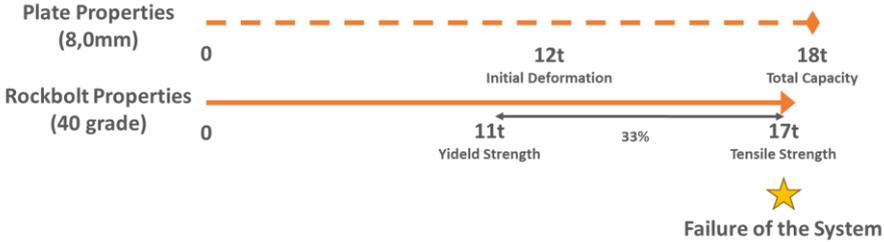
Figure 8b. Flowcharts to illustrate the load and displacement capacity of the recommended reinforcement system with a plate with 8,0 mm and a rockbolt with 40 grade steel

The recommended spacing between the rockbolts was 1,2 m x 1,2 m. According to Potvin et al (2008), there are clear advantages in employing tight reinforcement patterns as they result in a stronger reinforced shell and more uniform surface deformations.

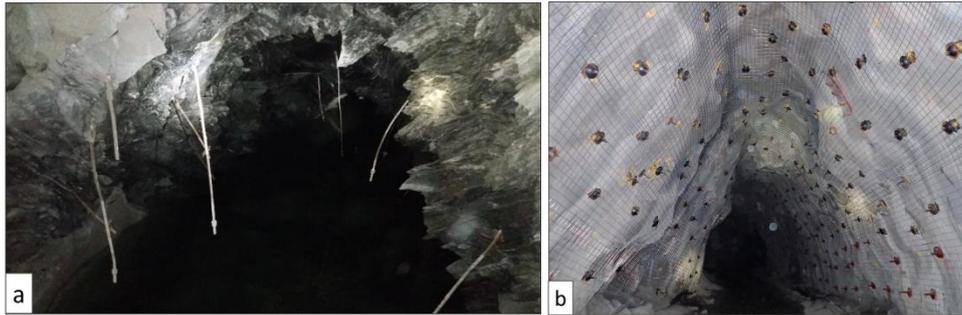
Figure 10. Adjusted support system applied in the Serrotinho ramp. (a) Damaged support system previously the rehabilitation. (b) Rehabilitated gallery with the new support system

Understanding the interactions between the various support and reinforcement elements was a critical step in formulating a new design capable of guaranteeing the operability of the underground excavations. This new design has a higher support capacity and can cope with larger displacements. The performance of the adjusted system is illustrated in Figure 10.
