Advanced techniques for the monitoring of pillar and excavation behaviour at a deep level massive mine

P.G. Andrews¹, L. Rwodzi², J. Ekkerd², and N Ratshitaka²

¹Gold Fields, Australia

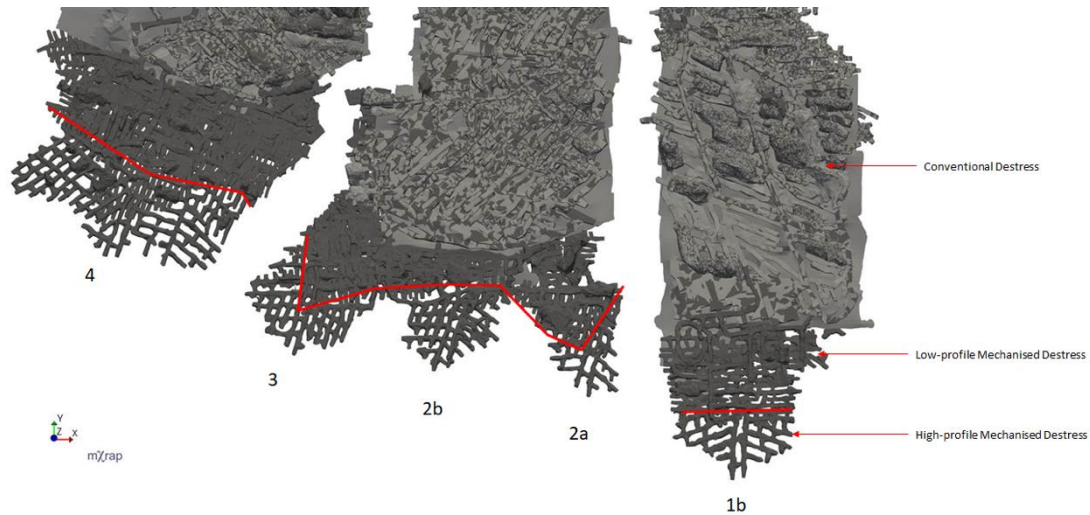
Figure 1. Various mining cuts and phases of mining at South Deep. Corridor 2B started off with 4.5 m wide by 10 m long pillars which were subsequently increased to 6 m wide by 10 m long pillars and then most recently 8 m wide x 20 m long pillars

The mine is divided into six corridors with a maximum span of 180 m. Each corridor is separated by a 60 m regional pillar (See Figure 1 and Figure 2). Where reef targets are thinner, between 5 m and 15 m, drifting and benching is applied.

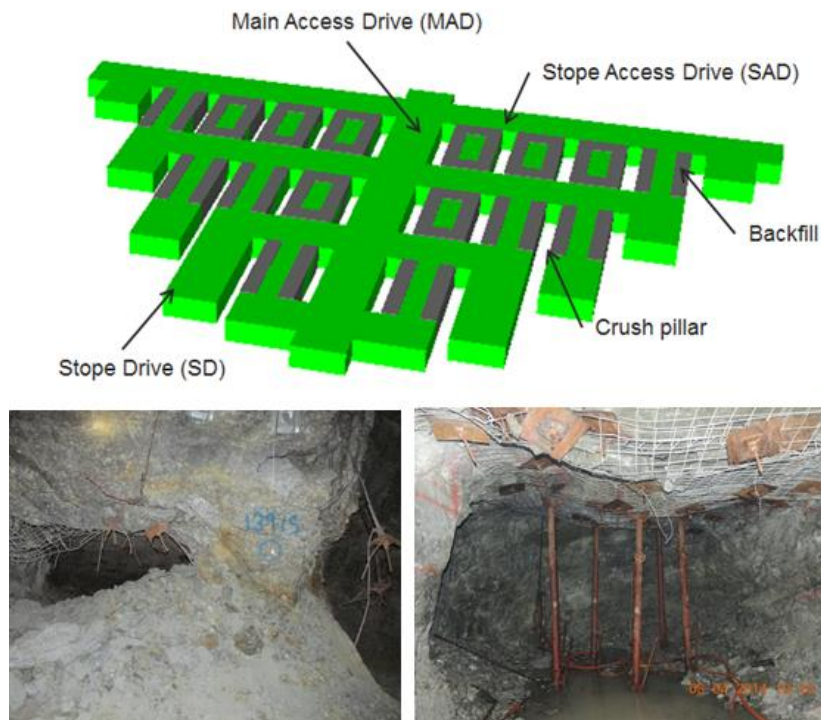
Figure 3. Low profile stoping layout, pillar and support conditions

Initial layouts consisted of 10 m long x 1.5 m wide x 2.2 m high crush pillars, Watson et al (2014). This method is known as low profile stoping (LPS). The initially reduced extraction ratio and lower backfill demands resulted in improved productivity. As mining extended, the behaviour of the crush pillars was characterised by extensive fracturing and failure (See Figure 3). Consequently, in late 2013, the

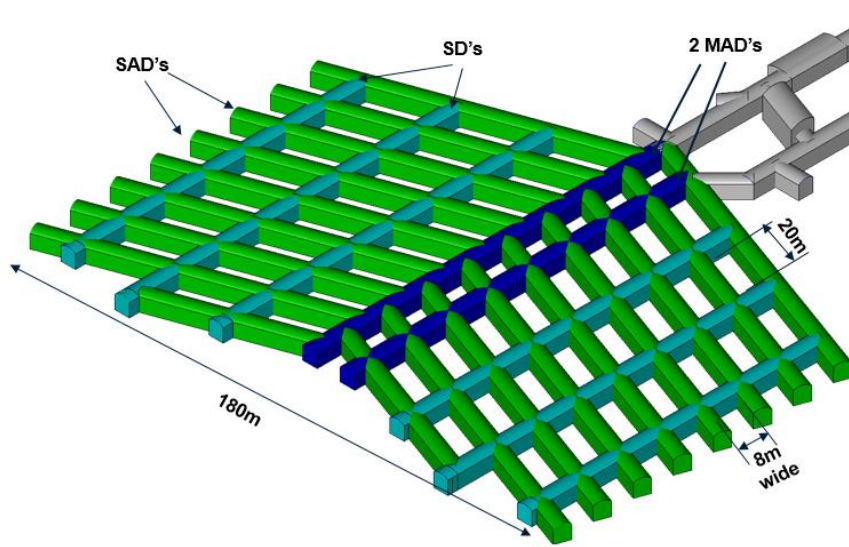
Figure 4. HPS layout with the 8 m wide x 20 m long rib pillars

The cut yield pillar design (8 m wide by 20 m long (See Figure 4), is based on the work of Lilley (2016) and the following was noted during the study:

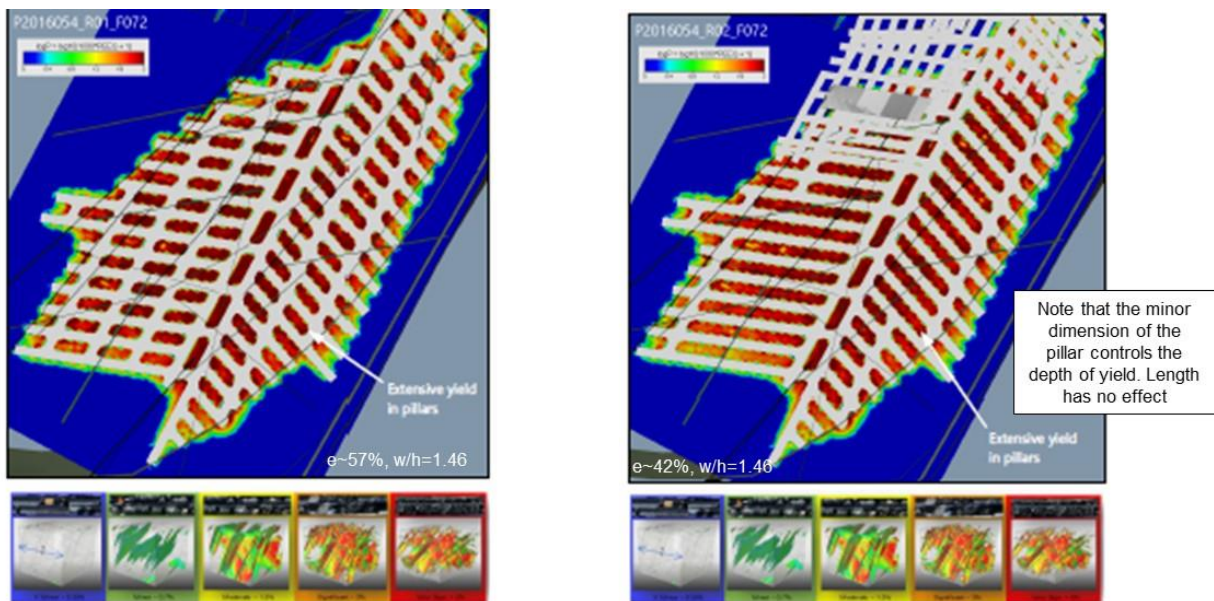
Figure 5. Lilley (2016) used the non-linear inelastic package finite element package ABAQUS to evaluate the performance of various high-profile mining pillar sizes. Rockmass damage is depicted for the 8 m long x 20 m wide pillars is on the left and for 8 m wide by various length pillars on the right

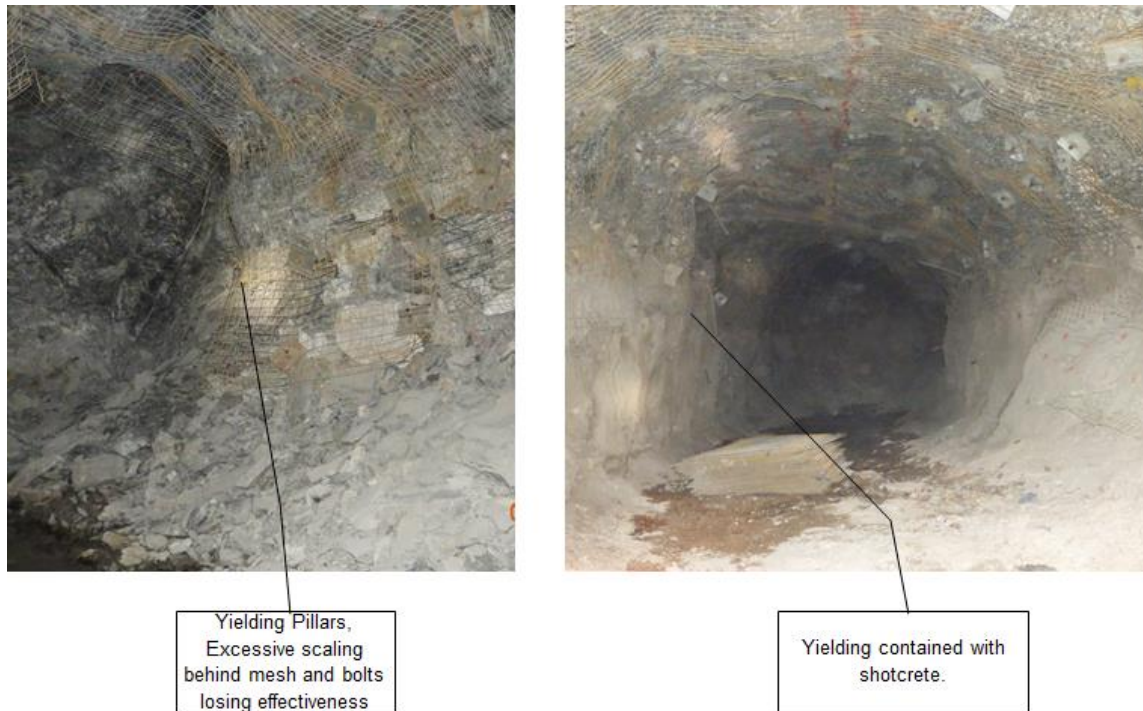
Figure 6. 8 m wide x 20 m long pillars pillar yielding and spalling behind the mesh

From underground observations, it was clear that the new 8 m wide x 20 m long pillars were extensively spalling and potentially yielding as modelled by Lilley (2016); however, no onsite calibration was done to confirm the amount and depth of damage in the pillars and the predicted closure in the mining cuts (See Figure 6). There was ongoing uncertainty as to what pillar size was the appropriate size to achieve controlled yielding without undergoing too much deformation or storing too much energy that could potentially lead to bursting (See Figure 7).

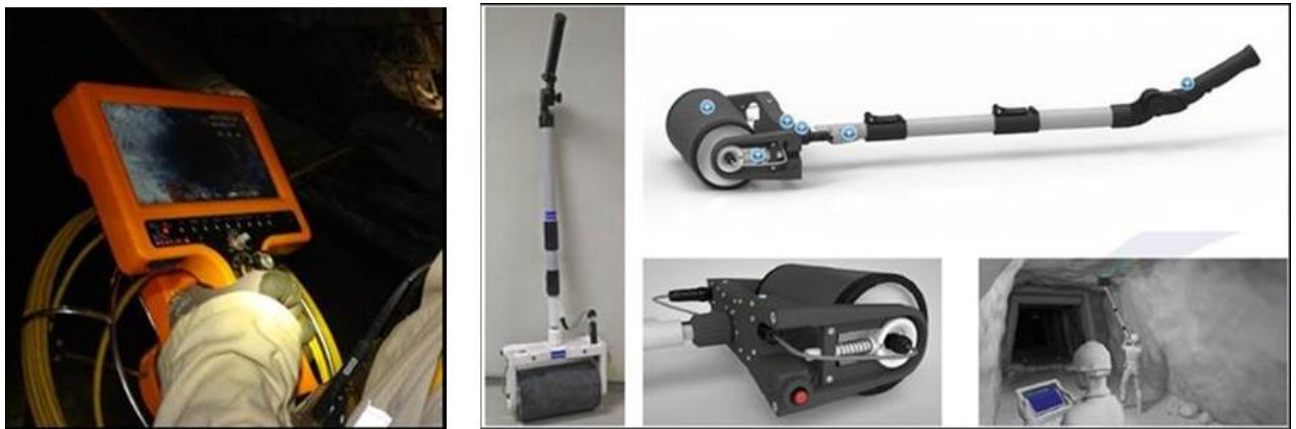
Figure 8. Rock vision borehole camera (left) and sub-surface profiler for GPR assessments (right).

At the South Deep Mine, the Rock Vision borehole camera (See Figure 8), was used by Sengani and Andrews (2017) to successfully determine the extent of fracturing of 6 m wide x 10 m long x 5.5 m high in-stope yield pillars as well as assessing the effectiveness of face preconditioning.

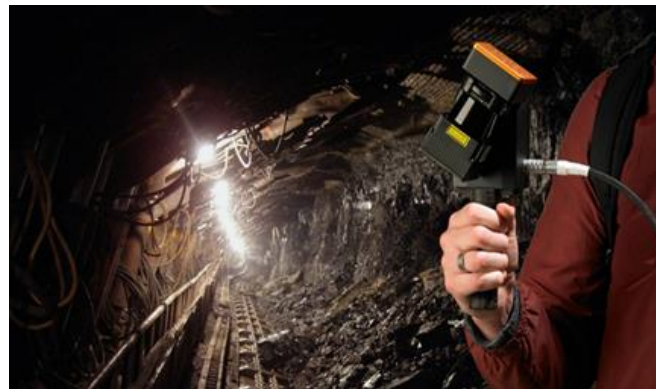
Figure 9. GeoSLAM Zeb-Revo handheld scanner (Image from GeoSLAM Brochure)

South Deep Mine purchased the Zeb-Revo 3D laser scanner (See Figure 9) in 2018 to conduct convergence monitoring of its destress cuts. This scanner is a handheld unit which captures cloud points at a rate of 43 200 points per second at 30 mm to 300 mm absolute accuracy (according to the original equipment manufacturer (OEM)).

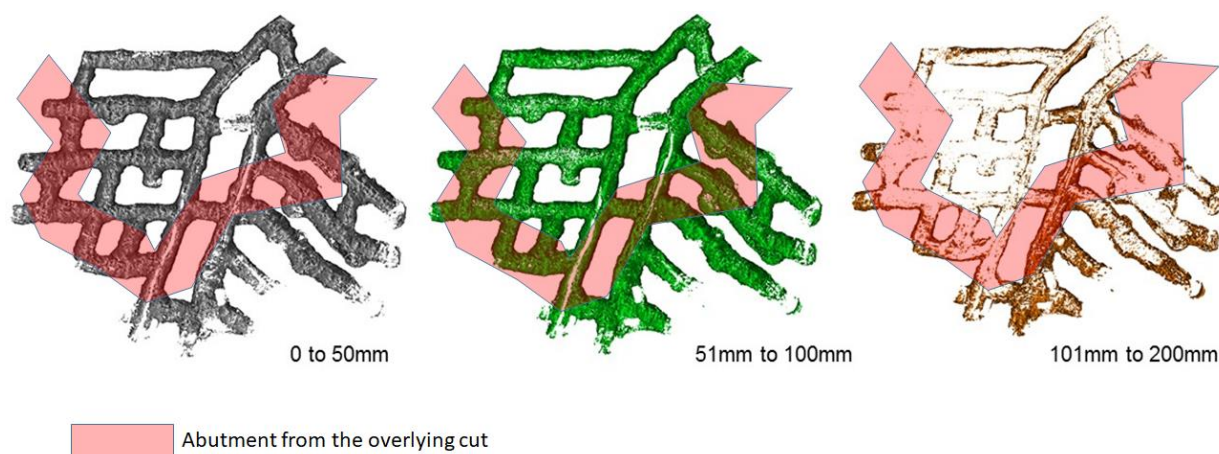
Figure 12. June 2018 vs December 2018 displacement 100 2BW Cut 3

Figure 12 shows the net cloud density for areas which had undergone displacement from 0 mm to 50 mm, from 51 mm to 100 mm and from 101 mm to 200 mm (from left to right respectively). The convergence scanning data indicates that the whole cut had undergone at least 100 mm of deformation with up to 200 mm of deformation observed in the excavations directly below the overlying cut's abutment zone.

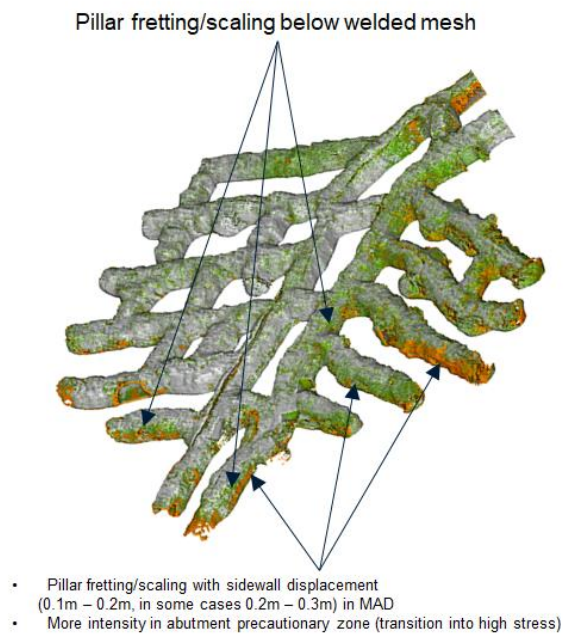
Figure 13. 3D isometric view showing high deformation below the grade line

Historic ground support standards were installed to the gradeline and did not cater or manage to inhibit pillar scaling. From the laser scanning data, a significant amount of spalling below the gradeline can be observed. This is consistent with scaling of the yielding pillars observed underground where the ground support is not installed to the footwall. The bottom 1m is not supported and therefore permits escape of scaled material. Figure 13 shows the perspective view of excavation displacement in 100 2BW Cut 3.

Laser scanning data was found to match underground observations and indicated that extensive spalling took place below the support level. Based on these results, it was determined that the pillars require support to the footwall to ensure their long-term integrity. Historically, ground support was installed across the backs and down the sidewalls to the gradeline (~1.0 m to 1.5 m above floor level). This did not prevent pillar spalling. From the laser scanning data, a significant amount of spalling below the gradeline was observed (See Figure 13). This measure depth of spalling is consistent with underground observations below the gradeline. The bottom 1 m was not confined and therefore permitted escape of fractured material. Figure 13 shows the perspective view of excavation displacement in 100 2BW Cut 3.

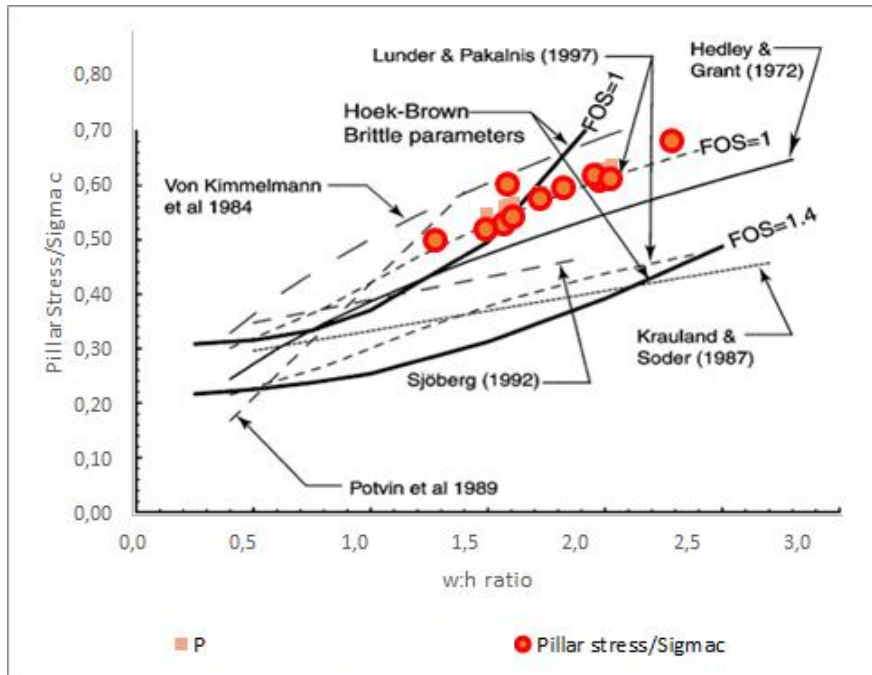
Figure 14. Pillar w:h ratio vs pillar stress/UCS.

To compare pillar stability at South Deep to other pillar classification schemes, the width to height ratios of several 8 m wide x 20 m long x 5.5 m high pillars were plotted against pillar stress (calculated from numerical modelling) divided by Sigma c (UCS of intact rock) as shown in Figure 15, Martin and Maybe (2000). The data fits into width to height ratio (w:h ratio) range of between 1.3 to 2.5 with the concentration range falling between 1.6 and 2.1.

Based on Figure 14, the South Deep data falls at the upper limit of Class 4 and lower limit of Class 5 in the pillar stability classification which shows optimal yielding and fracturing through the pillars. This finding is consistent with the findings from the numerical modelling and underground investigations; borehole camera, GPR and convergence investigations.
