# Anisotropic rock mass behaviour in large deformation ground at CSA mine

G.B. Sharrock<sup>1</sup> and B. Chapula<sup>2</sup>

This paper summarises key findings from a 39-month study at CSA Mine on factors controlling anisotropic ground behaviour in sub-level open stope (SLOS) access tunnels at depths of 1500 m – 1700 m. The aim was to understand factors controlling high displacement ground behaviour through numerical and empirical back analysis at 45 damage sites over a 39-month period. It was found that excavation orientation, rock mass matrix and foliation strength, and stress path are key parameters influencing tunnel damage and convergence at CSA Mine. Tunnels driven parallel to foliation (i.e., along strike), experienced much higher levels of damage than those driven perpendicular to foliation. Drives at intermediate angles experience varying levels of damage, depending on rock mass strength and stress. The stress path induced by mining was found to significantly affect both the initiation and progression of damage in both tunnels and raises.

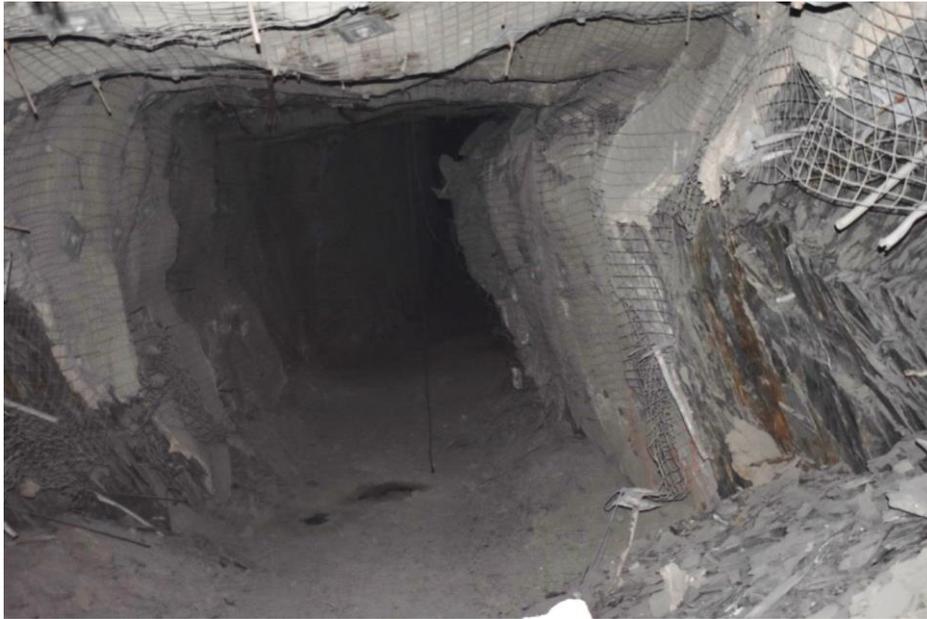
*Figure 6 - Significant deformation (Level 3-4 damage) along the 8670 ore drive at CSA mine*

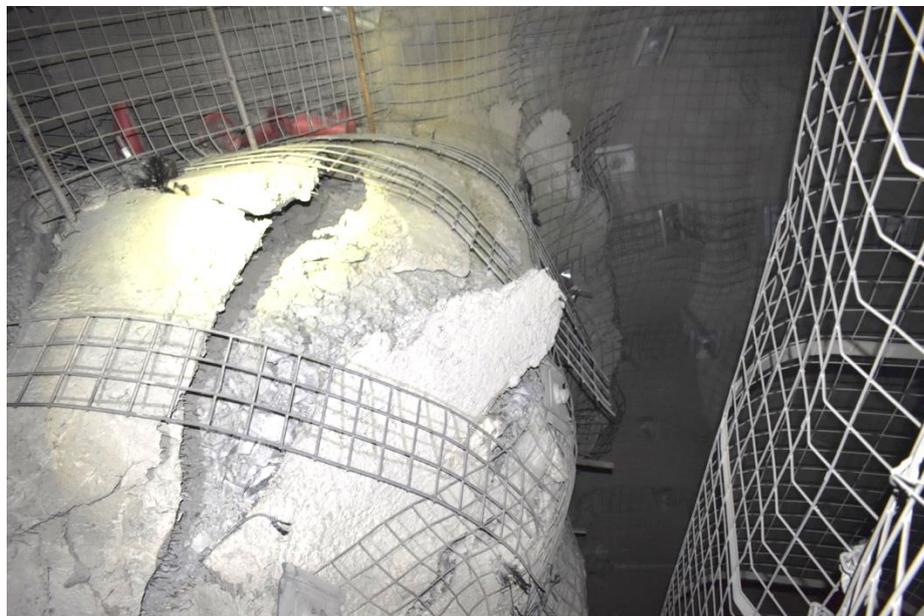
Figure 8. Significant deformation (Level 3-4 damage) on the eastern side of the 8700 – 8670 FAR at CSA mine

approaches, shear stress around the excavation rotates and increases, inducing shear and tensile failure in bedding in the excavation sidewalls and corners (See Figure 7a). Stress rotation (See Figure 7a) in particular is thought play a key role in the extension of the zone of damage in tunnel sidewalls, as evidenced by the cessation of deformation after the mining front has past (at least in moderate to poor rock masses). After the mining front has passed, deformations are locked in, and shear stress reduces significantly. Deformation typically ceases if the excavations are adequately supported. In badly damaged ground destressing can accompany increased support loads. Similar deformation responses to stress and strength occur in ventilation raises located in the footwall, which are typically supported heavily with bolts and reinforced Fibercrete (FRS) (Figure 8). Fibre-reinforced shotcrete (FRS)
