An overview of the slope monitoring program at the Serra Sul Iron Ore Project, S11D, northern Brazil

MF Souza *Vale S.A., Brazil*

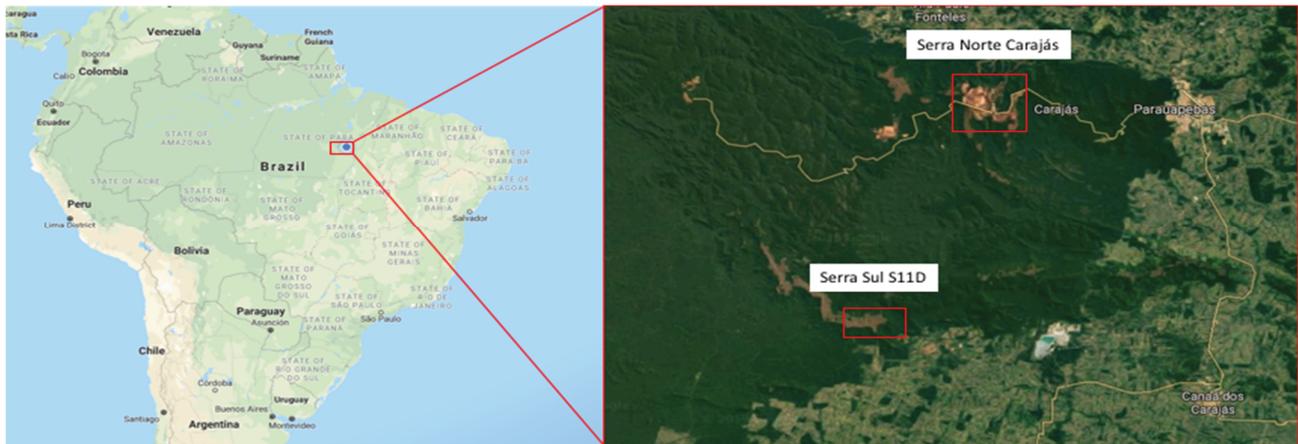
Figure 1 Geographic location of the Serra Sul Iron Ore Project, S11D

The Serra Sul Iron Ore Project (Serra Sul) is located in the north of Brazil, in the state of Pará (Figure 1). Mining was initiated in 2017 at the S11 orebody, block D. According to Vale S.A. (2013, 2019), the mineral potential of the S11 orebody is 10 billion metric tonnes of iron ore, and block D alone has proven and probable reserves of 4.28 billion metric tonnes.

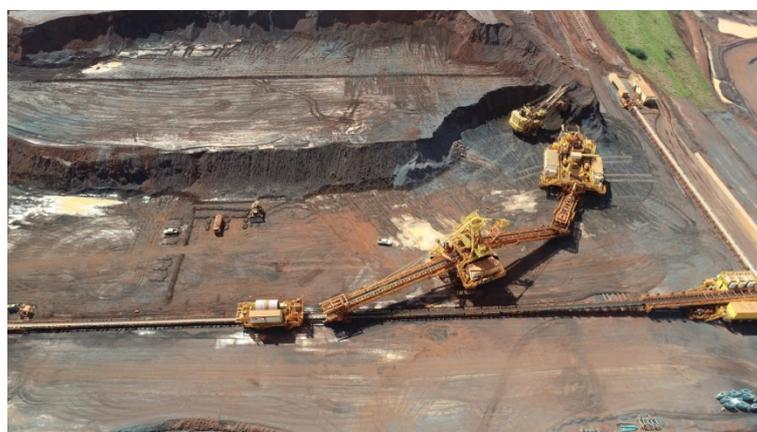
Figure 2 Standard system setup: excavator, mobile crusher, bridge conveyor and bench conveyor belt

There are currently four mining faces in Serra Sul. The active mining faces are called systems, as each of them has its own excavator connected to a mobile crusher, a bridge conveyor and a bench conveyor belt (Figure 2).

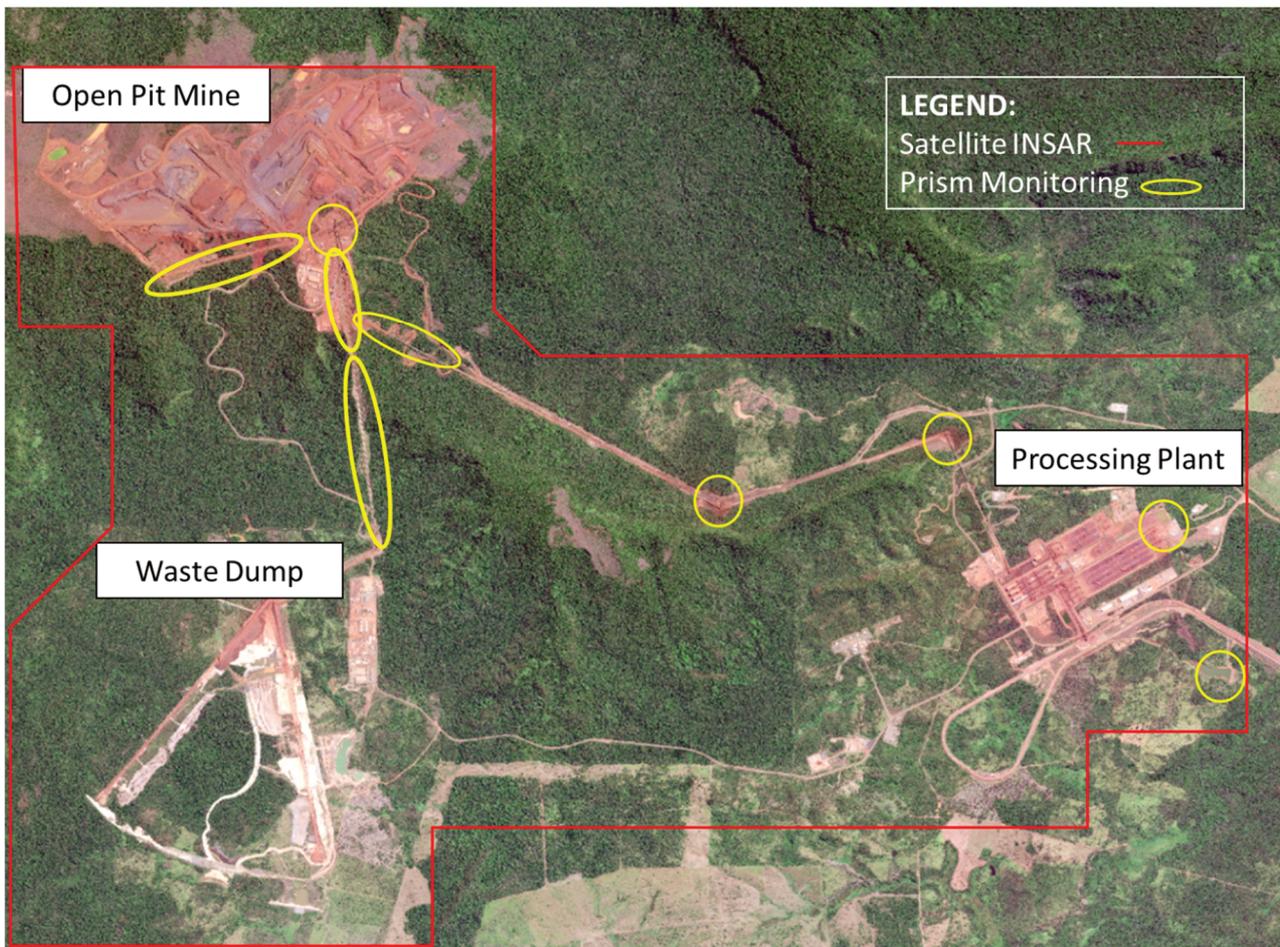
Figure 3 Locations of the principal sectors of Serra Sul: the open pit mine, the waste dump and the processing plant, together with the indicated areas that are covered by InSAR and prism monitoring. Highlighted in red is the satellite monitoring coverage boundary and in yellow circles is the survey monitoring area

The three methods are complementary. InSAR has a broader coverage of the Serra Sul Complex, while prism monitoring is focussed on specific locations of geotechnical interest, and visual inspections are scheduled and conducted at multiple pre-defined areas of the complex. Figure 3 shows the locations of the principal sectors of Serra Sul—the open pit mine, the waste dump and the processing plant—together with the indicated areas that are covered by InSAR and prism monitoring.

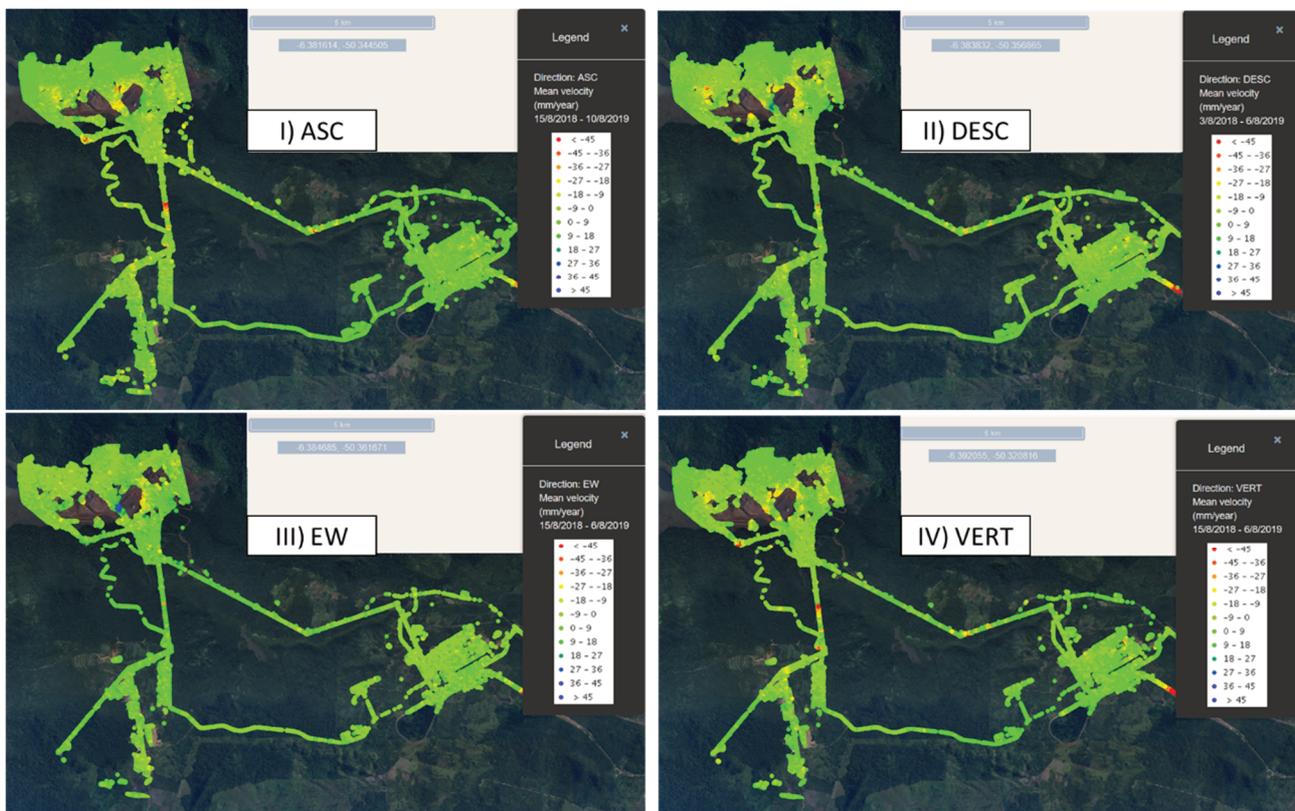
Measurements for the ascending LOS (I), descending LOS (II), positive values indicate movement towards the satellite LOS. For the E–W measurement (III), positive values indicate movement towards the east direction. For the vertical measurement (IV), positive values indicate uplift movement.

Figure 4 Velocity maps, ascending and descending orbit, vertical and E–W. The maps indicate PS mean velocities relative to one year (15 August 2018 to 10 August 2019)

According to Constantini et al. (2016), vertical and E–W PS information are available if both ascending and descending geometries are available, as the ascending and descending SAR acquisition LOSs lie on a plane practically perpendicular to the north–south direction. Due to this, the SAR satellite is almost insensitive to movements in the N–S direction, while it is sensitive to E–W and vertical movements. The calculation of the E–W and vertical components of movement are obtained by simple geometrical relations of the ascending and descending vectors. Figure 4 shows the four maps, indicating the mean PS velocities, approximately relative to one year.

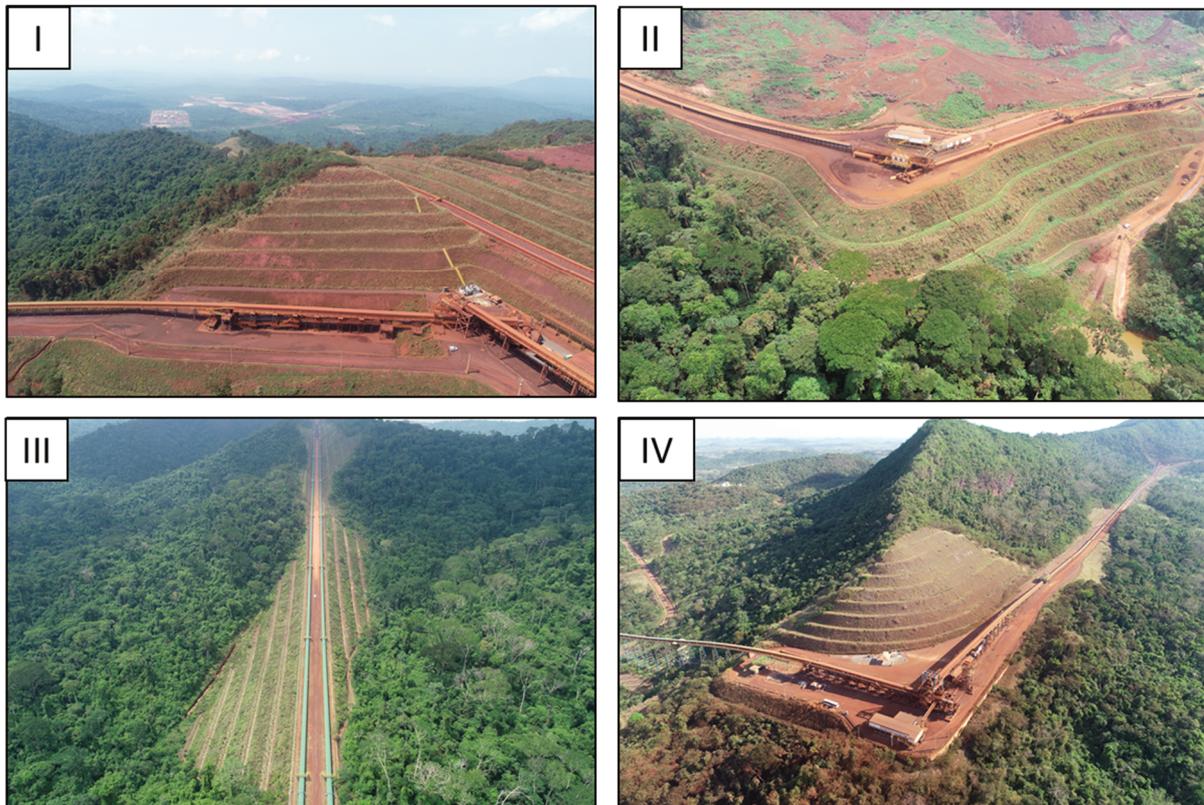
Figure 5 Aerial view of four cut-and-fill slopes that are monitored by field instrumentation at Serra Sul. From I to IV: CT-2, Corredor Oeste, Overland and CT-7

Figure 5 shows some of the cut-and-fill slopes along the conveyor belts that are monitored by field instrumentation at Serra Sul.

A detailed investigation of one of the monitored areas is presented in this paper. Transfer house 07, also known as CT-7, is near one of the highest slopes situated along conveyor belts at the site (Figure 5 IV). The geotechnical team monitors both the behaviour of the slope and the embankment where the conveyor belts are located. The InSAR data produces the velocity maps of the CT-7, relative to the acquisition period of 15 August 2018 to 10 August 2019 (Figure 6).

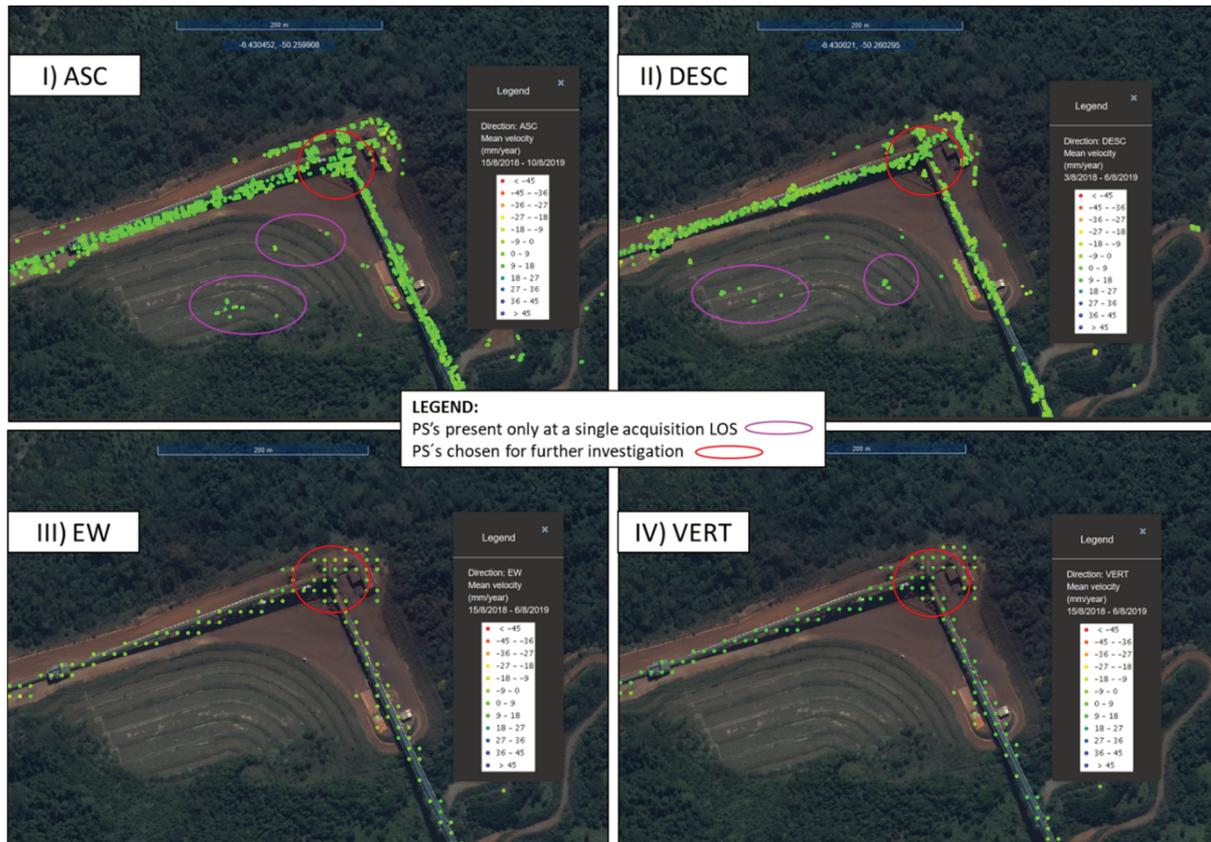
Figure 6 Velocity maps illustrating both I) ascending and II) descending orbit, III) E–W and IV) vertical of the CT-7 area (15 August 2018 to 10 August 2019)

Some persistent scatter points are present only at a single acquisition LOS (refer to the purple circles at Figure 6). It is noticeable that the higher density of PSs are displayed at the ascending and descending maps compared to the vertical and E–W maps. As mentioned in Section 2.1, the calculation of the E–W and vertical components of movement are obtained by simple geometrical relations of the ascending and descending vectors. If a PS is present at only one acquisition LOS, it would not be possible to calculate vertical and E–W vectors. That said, it is paramount to evaluate the four velocity maps, as well as the temporal displacement evolution of the PSs, to have a full understanding of the deformation.

It can be observed that most PSs are placed on top of infrastructure rather than at the slope itself. This comes down to the limitation of this method, which is due to temporal and geometrical decorrelation, and atmospheric inhomogeneities. This is discussed by Ferretti et al. (2001):

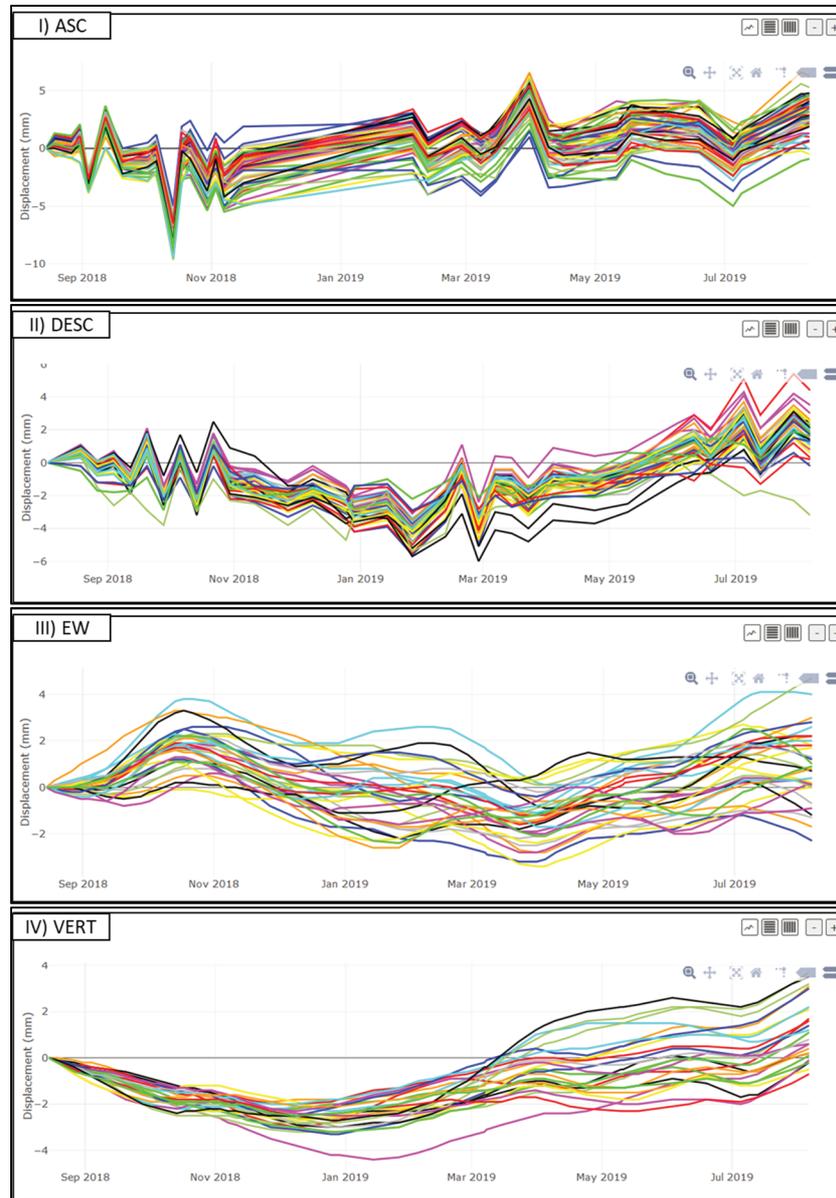
See Figure 7 for measurements for the ascending LOS (I) and descending LOS (II); positive values indicate movement towards the satellite LOS. For the E–W measurement (III), positive values indicate movement towards the east direction. For the vertical measurement (IV), positive values indicate uplift movement.

Figure 7 Cumulative PSs displacement plots: I) ascending and II) descending orbit, III) E–W and IV) vertical of the CT-7 area (15 August 2018 to 10 August 2019). The data displayed is relative to the circled areas in red in Figure 6

The CT-7 area has not shown significant movement over the past three years through satellite-based InSAR. The cumulative displacement time series of the previously circled PSs in red are shown in Figure 7. The four cumulative displacement plots indicate relative stability of the area. Most of the displacement measurements vary in the -5 to +5 mm range, which is within the accuracy of the method (Constantini et al. 2011).

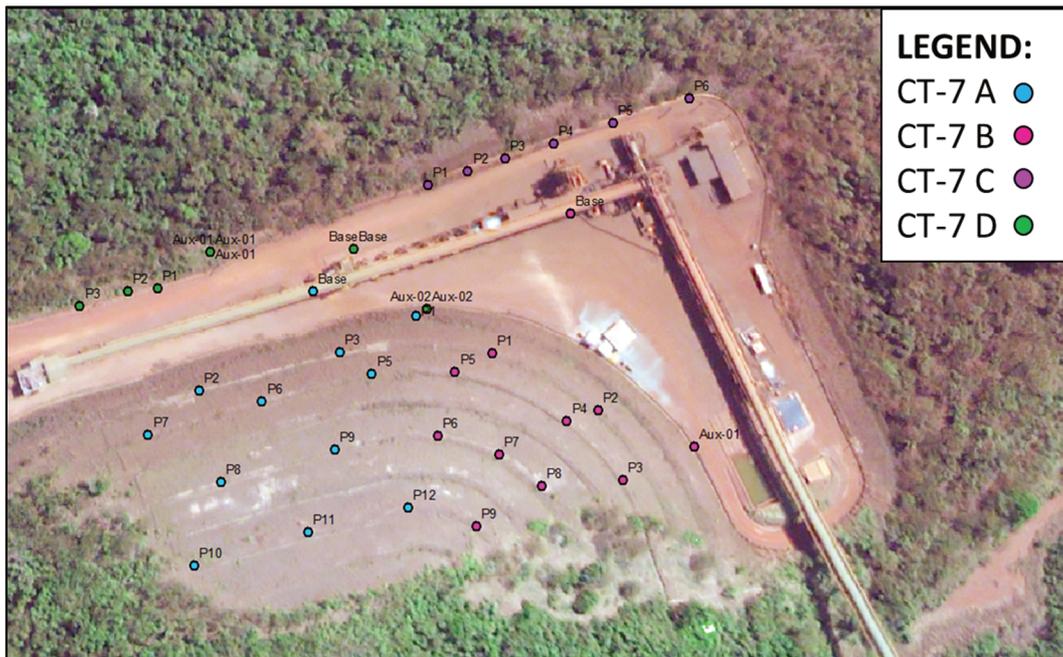
Figure 8 Top view of transfer house CT-7 and the slopes near the conveyor belts. There are four prism monitoring field projects. Each prism project is indicated as the assigned colour. Prisms are called P1, P2, P3, etc., and reference beacons are Aux-01, Aux-02, etc.

At this location, there are currently four prism monitoring field projects, aiming to cover the full extent of the target: an excavated slope and a soil embankment below the conveyor belts. The location of each instrument is shown in Figure 8. Each prism project is indicated as an assigned colour. CT-7 A and B cover the slopes parallel to the conveyor belts, while CT-7 C and D cover the fill embankment on the lower level.

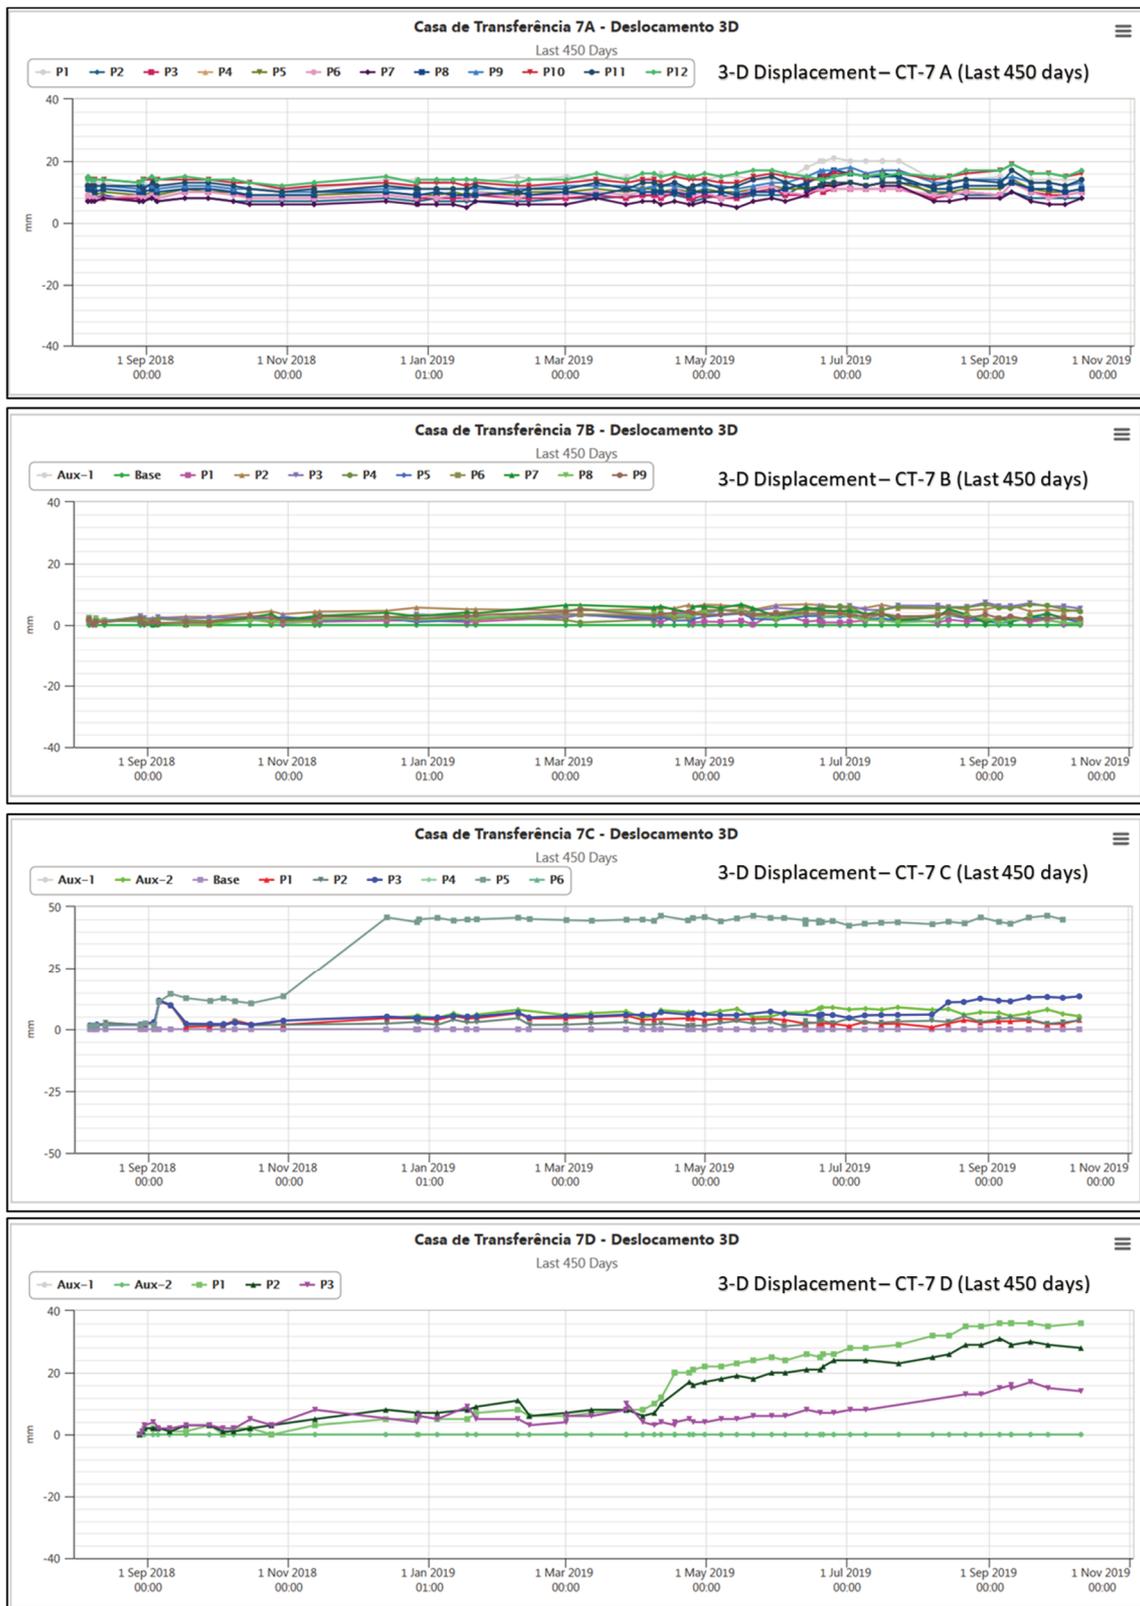
Figure 9 The plots indicate the tri-dimensional cumulative displacement of the prism targets, respective to each surveying project for the last 450 days, starting in August 2018. Positive and negative values are relative to the direction of the displacement vector. The slope behaviour is relatively stable, as observed at the CT-7 A and B plots. However, CT-7 C and D pointed out targets that had significant displacements

The prism monitoring data is shown in Figure 9. Each plot presents the tri-dimensional displacement of the prism targets of each field project. Positive and negative values are relative to the direction of the displacement vector. Prism data is presented for the last 450 days, starting in August 2018, analogous to the InSAR starting acquisition time. Notice that the prism data time frame is 25% longer compared to the InSAR data, as the satellite images have to be processed and data is never up to date.

The slope behaviour is relatively stable, as observed at the CT-7 A and B graphs. However, CT-7 C and D illustrate a number of targets that had significant displacements. In this case, a visual inspection was necessary to investigate the causes of movement and evaluate the risk profile in terms of likelihood and consequence for personnel and/or equipment.

In the case of prism P5 of CT-7 C, it was concluded that the movement might have happened due to equipment interference; a road grader could have pushed the instrument while levelling the ground surface. There were no other signs of natural movement at this prism point.

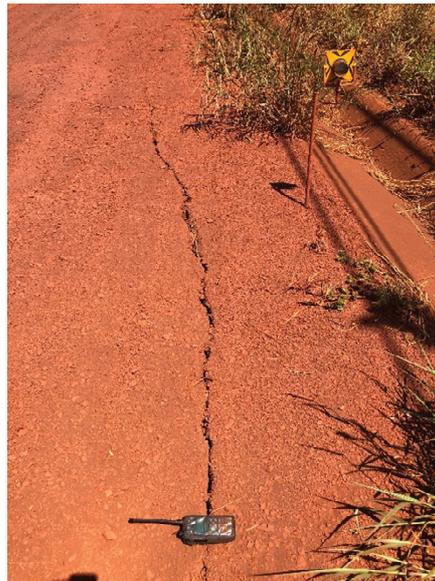
Figure 10 Cracking at the transfer house 7 area (CT-7), parallel to the soil embankment crest

Prisms P1, P2 and P3 of CT-7 D are located parallel to the crest of the embankment. After the indication of movement through survey monitoring, the geotechnical team identified tension cracking parallel to the embankment crest (Figure 10). The anomaly initiated during the rainy season (April 2018). It is believed that cracking developed by the lack of compaction of the embankment near the edge (as for safety reasons, compaction equipment might not approach the edges of embankments). It was recommended to seal the crack to avoid surface water percolation and further development of movement by saturation and erosion. Movement has stabilised since the end of the rainy season. Unfortunately, due to temporal decorrelation, InSAR data was not available at the area where cracking developed, which made it impossible to compare survey monitoring to the interferometric method.
