Management of geotechnical hazards through embracing technology and innovative thinking

KT Mandisodza *Evolution Mining Ltd, Australia*

Abstract

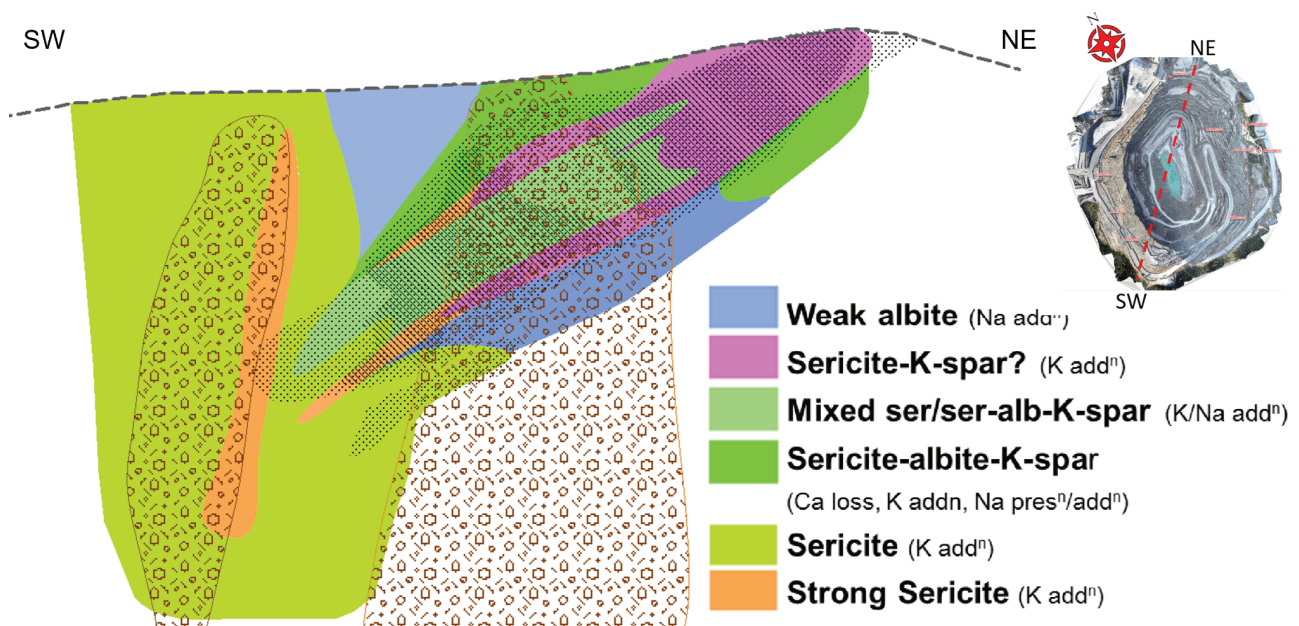
Figure 6 Short wavelength infrared (SWIR) alteration from Mt Rawdon. The initial prograde propylitic alteration characterised by albite and K-feldspar (plus epidote associated with dome-emplacement overprinted by retrograde sericite which dominates near the western dome) (adopted from Corbett 2019)

Hydrothermal alteration is apparent as early prograde propylitic alteration characterised by chlorite-epidote-pyrite (Duckworth 2014) and later retrograde sericite (illite)-carbonate-chlorite-pyrite overprint (Howard 2015). The well-developed sericite near the western dacite dome may be associated with dome emplacement (Corbett 2019). This well-developed sericitic alteration on the western dacite is thought to be the main factor contributing to rock mass behaviour differences and response relative to the eastern dacite unit following excavation. The west wall's characteristic alteration profile compounded by the complex and persistent structural joint sets, particularly the low-angled structural joint set, has played a major role in the ground challenges that have been experienced on the west wall. Figure 6 shows the alteration profile for Mt Rawdon.

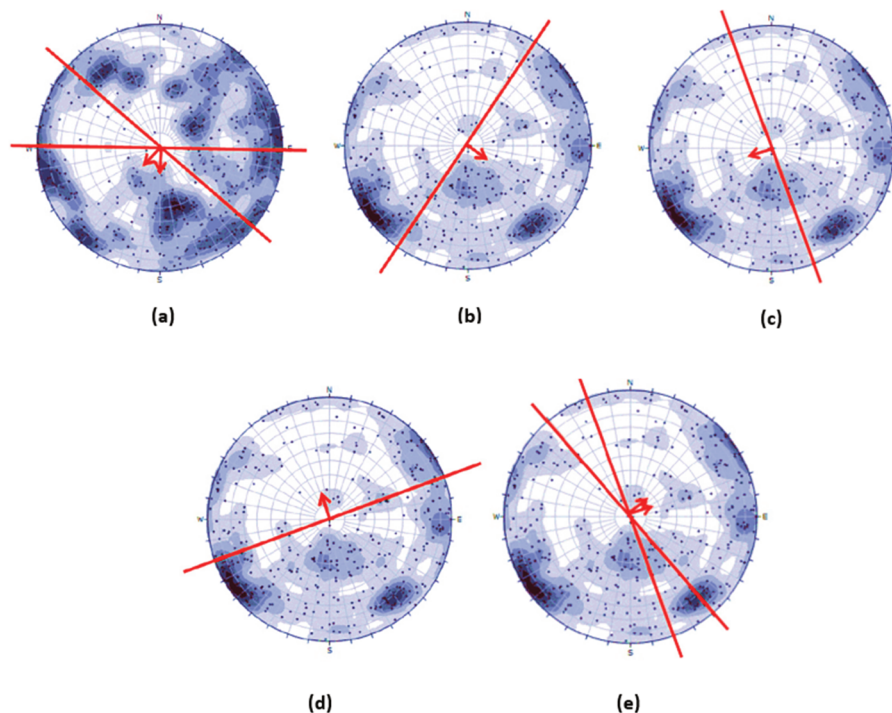
Figure 8 Mt Rawdon geotechnical stereographic plots showing structural orientation and pit wall orientation (red lines) for different slope faces. (a) North wall; (b) Northwest wall; (c) East wall; (d) South wall; and (e) West wall (after Jele & Sullivan 2016)

Ground control challenges are mainly a result of the complex geology of the deposit, the geometry of the pit relative to the inherent structural networks and operational issues. Jele & Sullivan (2016) presented data for the Mt Rawdon open pit structural orientations and slope wall orientations in the stereographic projections shown in Figure 8. A brief description of the three slope failure events and the implemented solutions are provided in the following section.

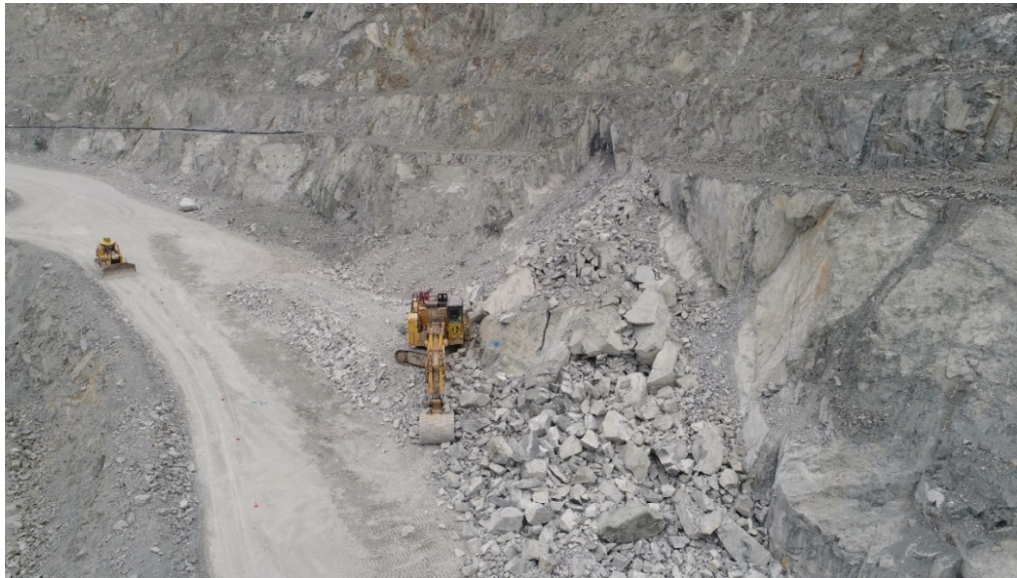
On 10 March, whilst mining a ground support pad that was constructed to access areas not easily reachable for an excavator, a planar failure of approximately 4,500 t occurred on the west wall. The material flow from the failure contacted the excavator and resulted in a significant incident being recorded (see Figure 9).

This failure was bounded by two primary joints with attitudes (dip/dip direction) of 60/120 and 75/020, respectively, and occurred along a dominant basal plane with an attitude of 35/070. This incident initiated the innovative change process for managing geotechnical hazards at MRO.

Figure 9 West wall planar failure, 10 March 2018

Considering the fall of ground risk potentially posed by the failure to mining of lower benches, and the extent of the basal plane on the west wall (attitude 35/070), an option to contain future failure material and shear-pinning of similar structures on the lower benches was proposed. Failure remediation involved placement of used haul truck tyres and rail steel acting as shear pins.

A total of 35 rail steels were installed over a 100 m lateral distance with holes drilled to various depths ranging from 16 to 5 m to the ramp grade leaving a 3.5 m protrusion. The embedded portion of the rail steel served to reinforce the batter, providing shear resistance across joints. Tyre diameters ranged between 3.6 to 3.2 m respectively were placed over the protruding rail steel to cover the 100 m lateral distance. The installation process involved fish plates to connect the rail steel, a crane to lift the rail lengths and placing them in 203 mm diameter hole sockets which were subsequently grouted. A tyre handler was used to lift the tyres and place them over the 3.5 m protruding rail steel to form a wall retainment structure (see Figure 10(a)).

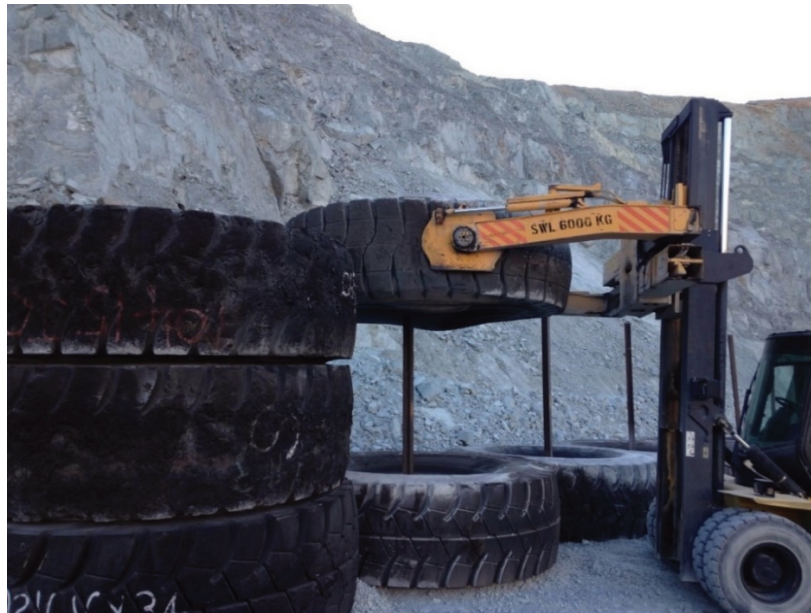
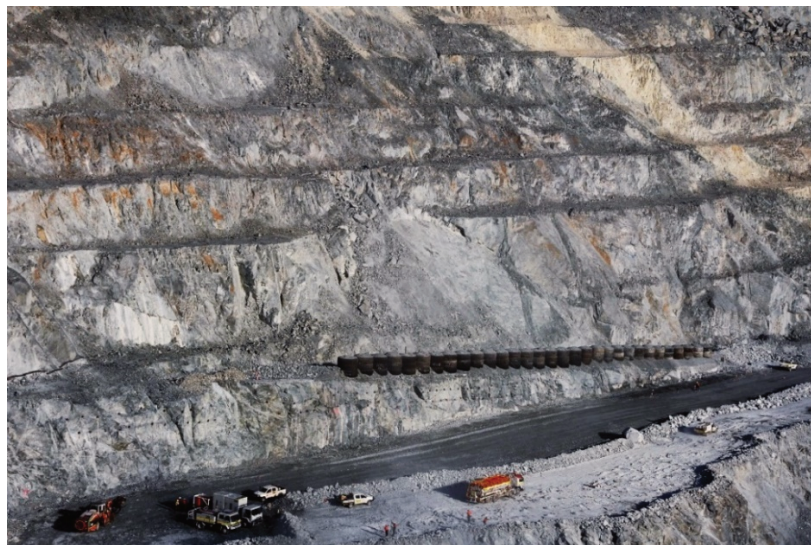
The tyre wall structure enabled the resumption of mining activities below the west wall failure without a change in the deliverable ounce-profile out of the reserve pit shell. The completed tyre wall structure is shown in Figure 10(b).

Figure 10 West wall (a) during and (b) after failure clean-up and construction of a tyre wall

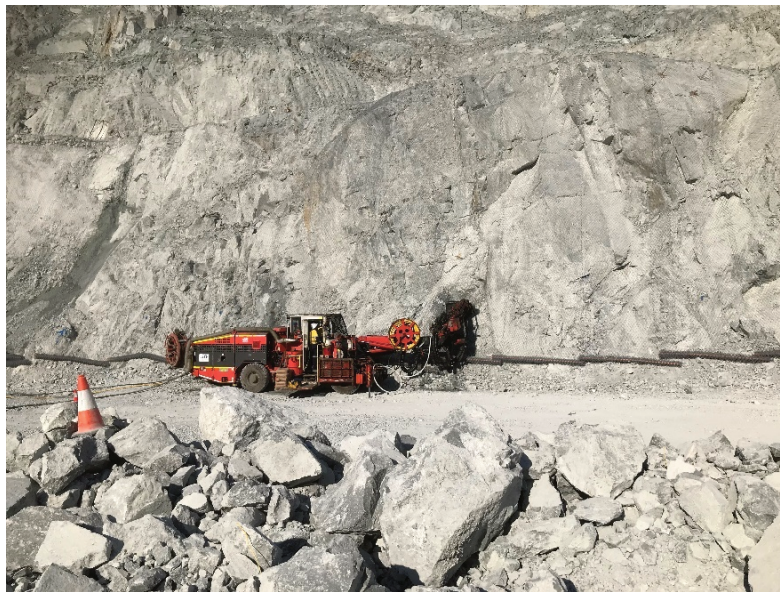
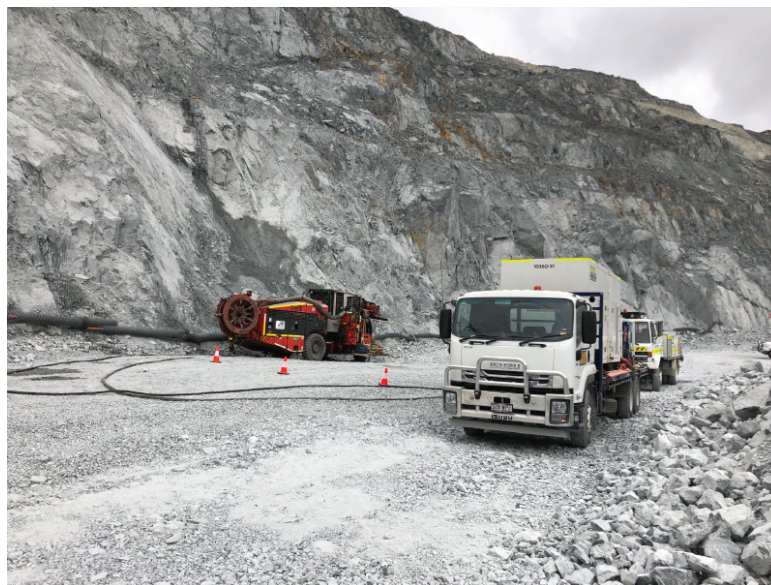
Figure 11 (a) Underground cabolter working in an open pit environment; and (b) Cabolter with a generator for power supply, compressor for air supply and water supply for flushing

Challenges encountered with the cable bolting solution through the use of an underground rig included water supply for drilling, compressed air and power supply in an open pit setup. According to DS421 model cabolter specifications (<https://www.rocktechnology.sandvik>), the cabolter requires water for flushing. The water

pump operates up to 100 l/min at a pressure rating between 10 to 15 bar and the air compressor operating at 7 bar. The electric system for the rig requires 50 to 60 Hz, with total installed power of 75 kW. To overcome these challenges, innovative solutions had to be implemented to realise the full potential of the cabolter in an open pit environment. Innovation came through equipment that was outsourced from different vendors to complement the cabolter. A 600 kilo-volt-ampere (kVA) 415/1100 transformer, a 350 kVA 415 V diesel generator and a 12 cubic metre per minute compressor for air supply, were leased by the mine site for the cabolter. The transformer and diesel generator were mounted on a truck and the compressor was a standalone unit. Water was supplied from an old fire truck, with a 3,000 L capacity tank. The water tank had to be topped-up in-between drilling cycles to ensure that a constant supply of water was maintained.

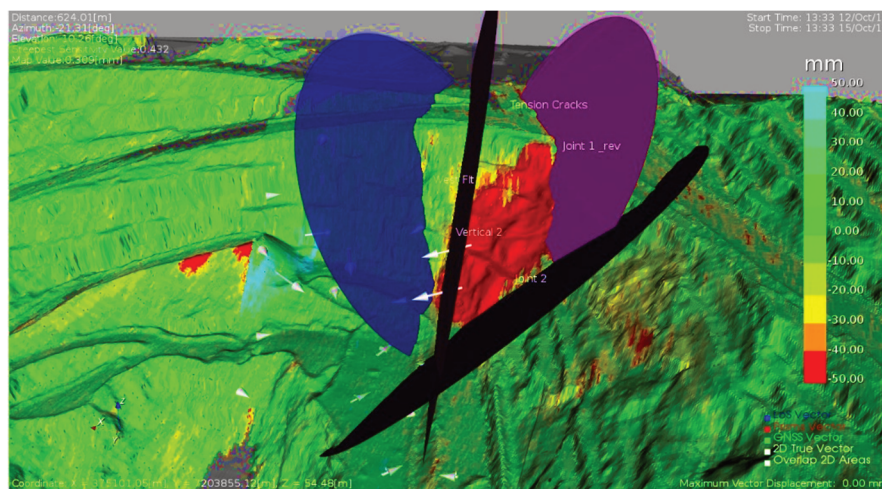
The instability was identified through the active slope radar monitoring. Total cumulative displacements within the unstable area ranged between 100 to 500 mm, with an average displacement of 150 mm within the moving mass. Tension cracks were also observed on the surface of the main pit access. Figure 12 shows the slope radar displacement map recorded during the event.

Figure 12 Radar map showing southwest wall total cumulative displacement from 12 to 15 October 2018

From 10 to 13 October 2018, a total cumulative rainfall of approximately 230 mm was received onsite, with rainfall intensity ranging between 50 to 100 mm/hr. The rainfall events induced an inter-ramp instability, bounded by two structures that formed a wedge. The total volume of the material contained within the wedge was calculated to be 400,000 m³ (approximately 1.1 Mt).

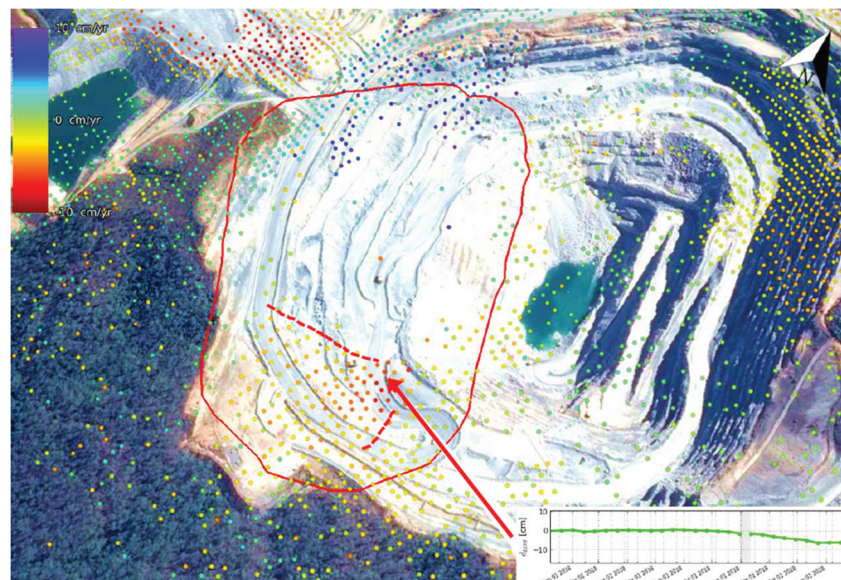
Subsequent to this event, a preliminary analysis of satellite radar data from interferometric synthetic aperture Radar (InSAR) indicated that small wall movements had occurred several months prior to the instability manifesting itself (shown in Figure 13).

Figure 13 Southwest wall InSAR monitoring – January to November 2018

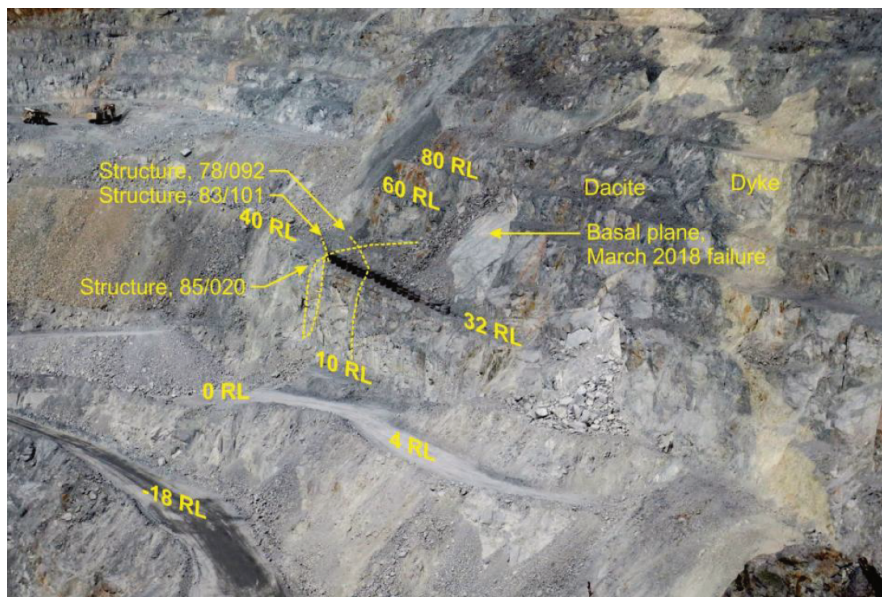
Figure 15 shows a view of the west wall looking across from the north wall. The basal plane appeared to have similar characteristics, though slightly steeper due to undulation, to the basal plane that had been exposed on the bench above. Considering the crest loss that had been experienced on the intermediate bench between the crest, where the tyre wall was constructed, and the toe of the 0 mRL position, it was critical to stabilise the failure and prevent a ‘domino-effect’. A slide analysis indicated that a 20 m high and 150 m long buttress was required to stabilise the potential instability and counteract the driving force.

Figure 15 View of the west wall looking from the north wall

March 2018, another batter-scale failure was recorded. Two ground-based radars started picking up trends on a block of rock that was controlled by two sub-vertical joint sets and a shallow dipping basal plane.

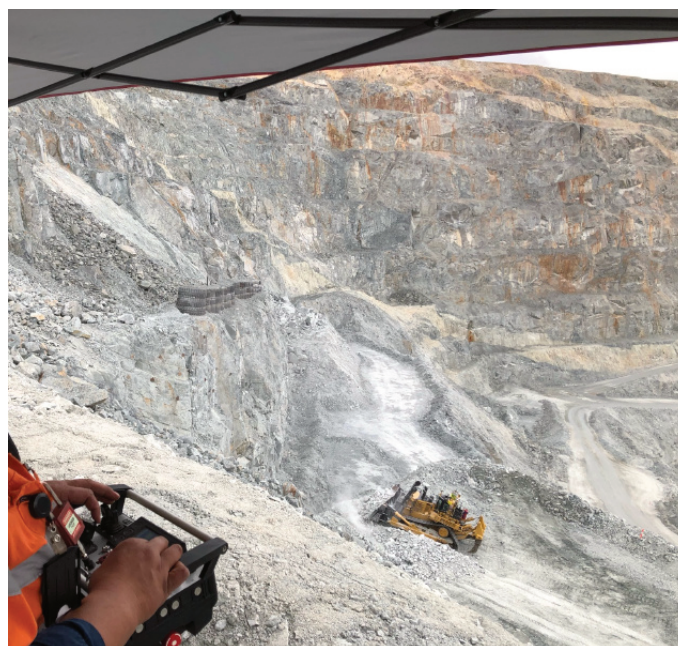
A remote dozer was hired to construct the stabilising buttress, which was a first for the site. The remote dozer’s ability to work in high hazardous areas provided a safer option to limit the exposure to mine personnel below the west wall instability. This action ensured that the mitigation measure (i.e. the buttress) was implemented safely. Figure 16 shows the remote dozer in operation during construction of the west wall buttress.

Figure 16 Remote dozer working on the west wall
