Monitoring of structurally controlled deformations at the Kanmantoo copper mine

BJ Hutchison *Hillgrove Resources Limited, Australia*

J Chambers *Maptek Pty Ltd, Australia*

Abstract

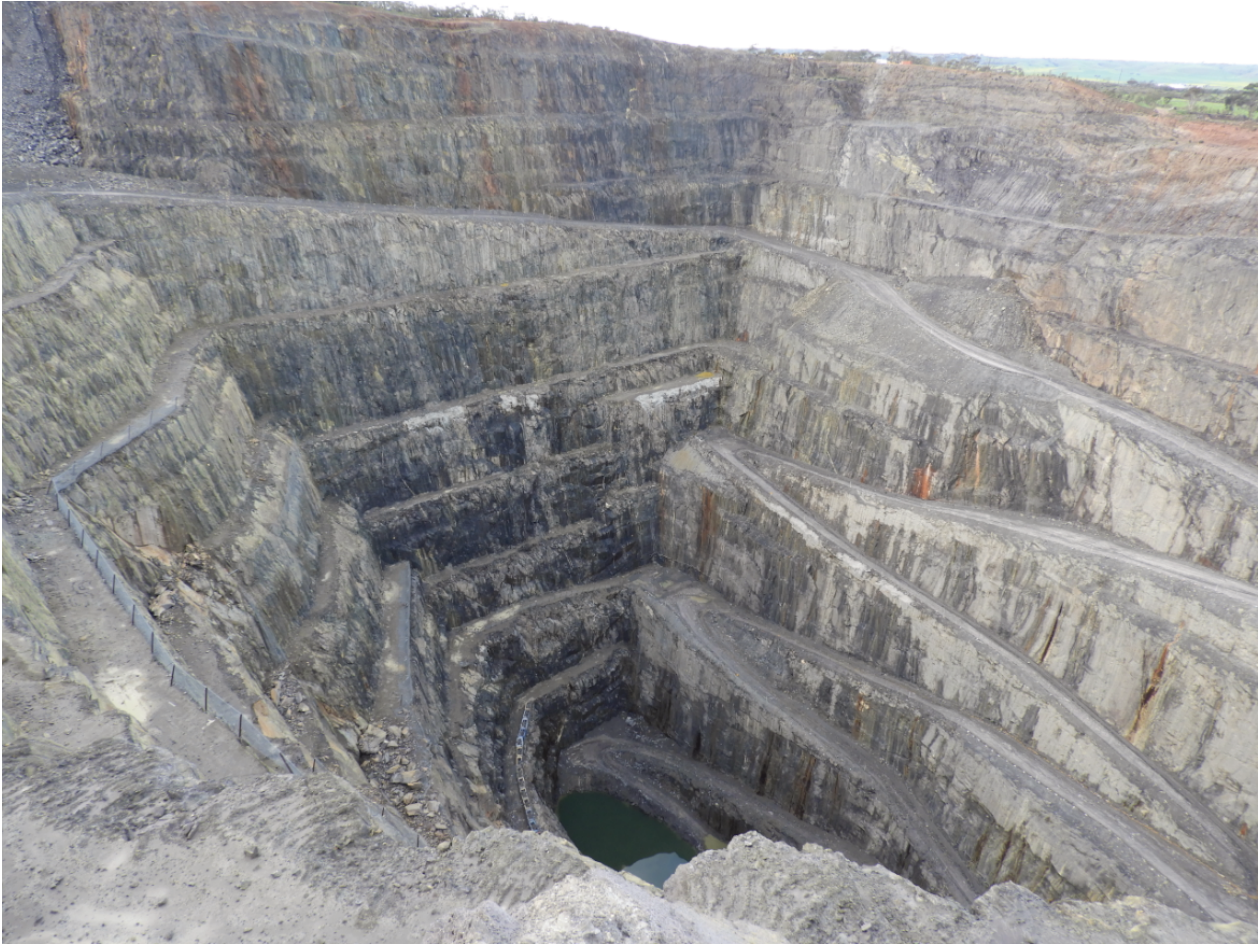
Figure 1 Giant pit (looking northeast)

The Kanmantoo Copper Mine in the Adelaide Hills of South Australia was mined with open cut methods by Hillgrove Resources Limited (HGO) from 2010–2019. The latest Giant Pit was a 360 m deep cutback, with aggressively steepened walls compared to the previous Kavanagh pit. For example, the 300 m high western wall inter-ramp slope angle (IRSA) was steepened from 45 to 57° (Figure 1). The justification for adopting this aggressive design on the western wall is discussed elsewhere (Hutchison et al. 2017, 2020). The northern wall, which cut across the predominant steeply dipping north-south striking structures, was also steepened to an IRSA of 68°.

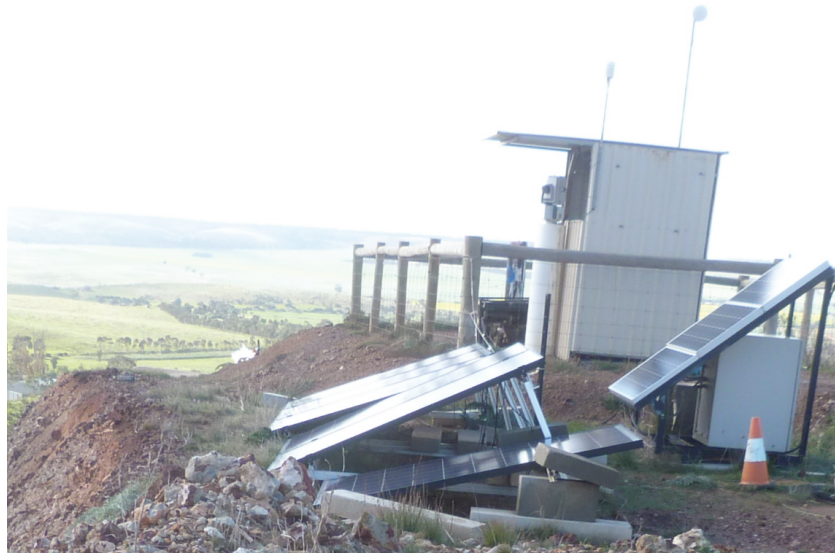
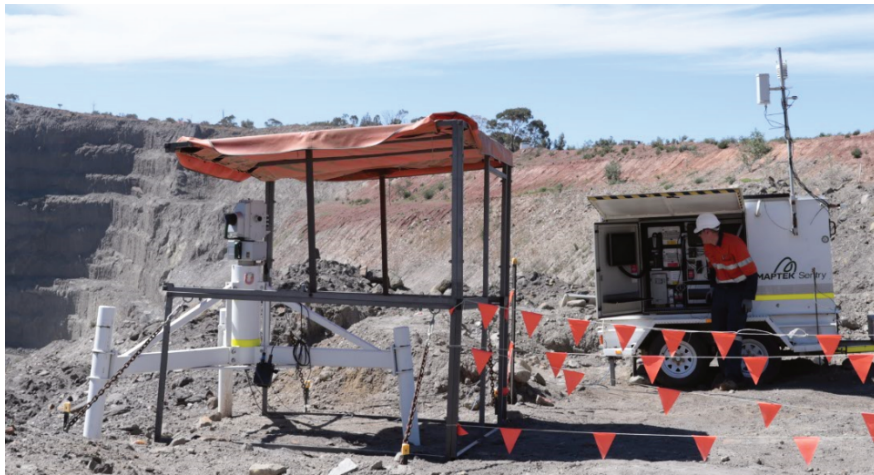
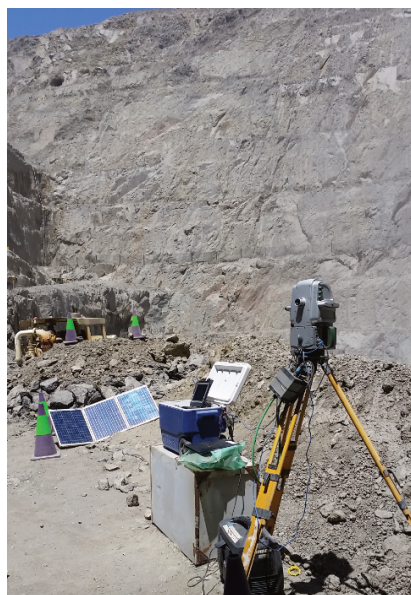
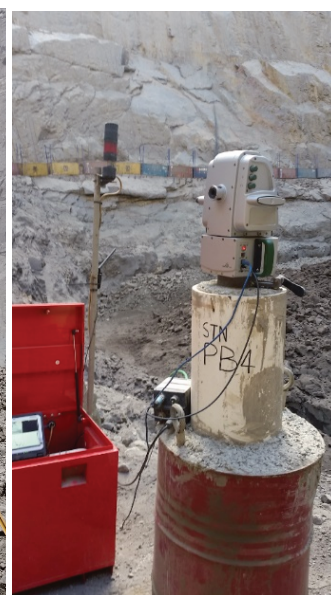
The Maptek Sentry system can operate in a variety of modes. At Kanmantoo, Hillgrove deployed long-term pillar mounted systems operating in a fixed, continuous monitoring mode (HMS, Figure 2a), a trailer-mounted deployable monitoring system mode (DMS, Figure 2b) and rapidly deployed tripod-mounted system modes (Patrol, Figures 2c and 2d).

Figure 2 Interim Sentry Patrol & XR3 in-pit setups

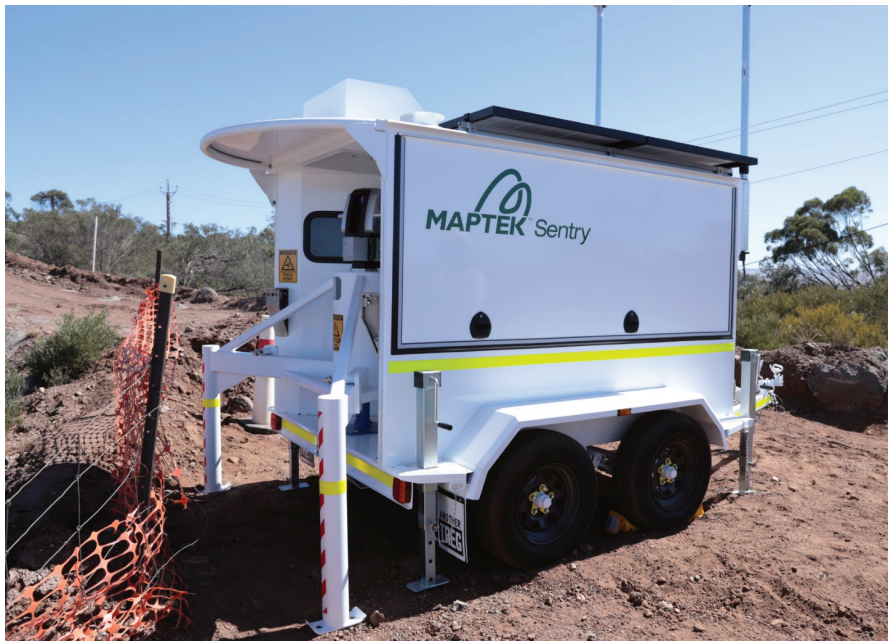
After the initial periodic monitoring from a tripod at Kanmantoo in 2014, Maptek developed a fully contained Maptek Sentry DMS system (Figure 3).

Figure 3 Maptek Sentry DMS

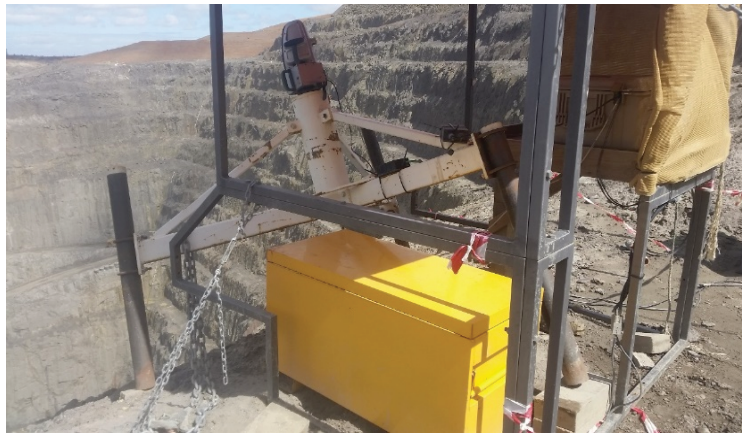
As pits deepen, it is often difficult for laser scanning to acquire data at the lower levels due to line-of-site issues with crests and underlying berms. At Kanmantoo, the scanner located on the west wall was elevated and tilted up (Figure 5) to allow the scanner to 'see' deeper into the pit. This scanner operated in this mode for over six months with no operational issues.

Figure 5 West wall scanner tilted to scan deep into the pit

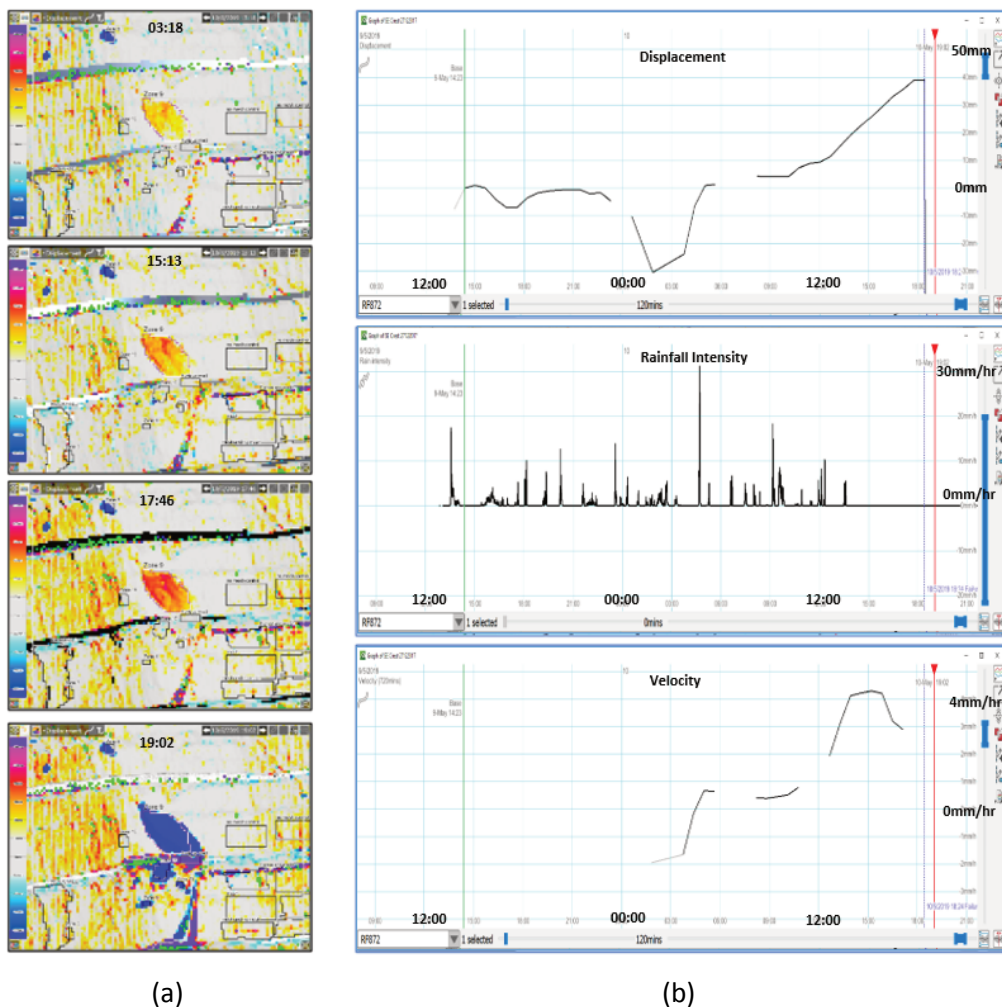
The Sentry DMS laser scanning system was successfully used to detect and monitor rockfall RF872 (Figure 6), which was a 2,464 t rockfall that occurred on 10 May 2019 during a period of heavy rain. The failure path of the fall can be seen in Figure 7 and further discussion on the consequences of the failure on underlying rockfall control structures can be found in Hutchison et al. (2020). Due to the rain, the pit had been closed for the previous 24 hours so no personnel were exposed to the rockfall risk. The effects of rainfall can be seen on the scan record (Figure 6) where the displacement values are interrupted due to lack of usable scan data.

Figure 6 RF872 Sentry monitoring record. (a) Heat maps; and (b) Plots

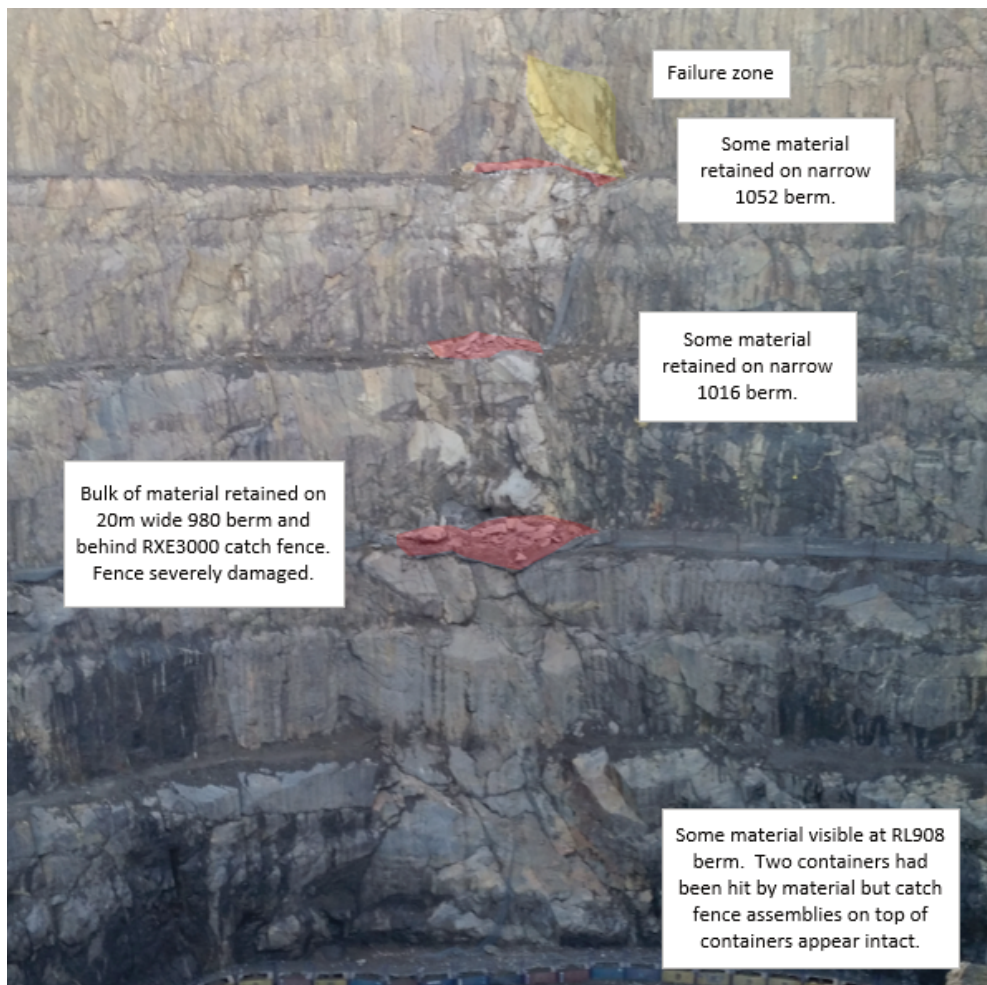
Figure 7 RF872 source and travel path

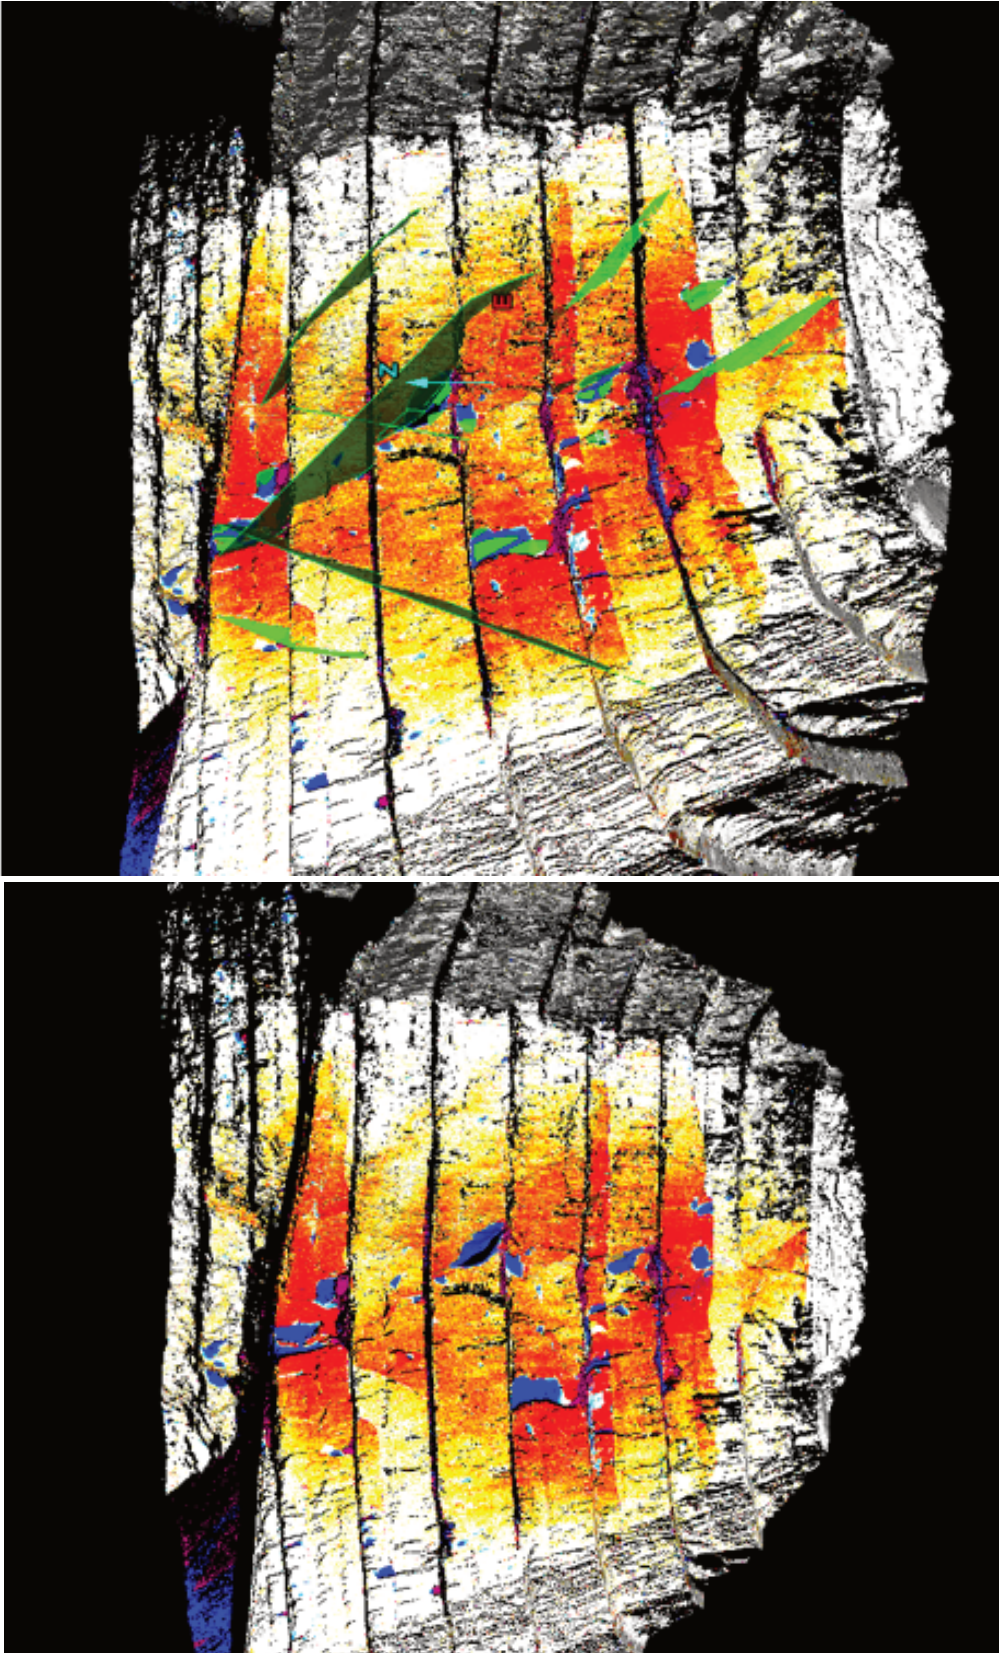
PointStudio had been used to remotely map the geological structure of the Giant Pit (Hutchison et al. 2018) but several through-going structures were not available in the time frame of the 2018 Flac3d modelling. When the final structural mapping is overlain on the dilation plot (Figure 9), one can see a direct correlation of distinct dilation movements to several of the major geological structures. These major structures are steeply inclined shear structures. In 2019, a third round of 3D stress modelling was undertaken which allowed these structures to be incorporated into the 2019 Flac3d model, as discussed by Lucas et al. (2020).

Figure 9 West wall Giant Pit structural mapping. (a) Dilation with no structures; and (b) Dilation with structures

PointStudio allows comparison of DTMs to look for rockfalls that may not have been picked up by the Sentry monitoring, not physically observed at the time, or which may have occurred when personnel had evacuated the pit during heavy rainfall events. The PointStudio plots of Figures 8 and 9 show the larger rockfalls and slips as dark blue areas. Smaller rockfalls from a monthly plot can be seen in Figure 10. The rockfall areas are noted in dark or light blue, while the accumulated debris can be seen as red areas on the berms. The arrows on the image show several examples. Just below the second berm from the bottom of the image, two areas moved with the adjacent rockfalls but did not fall into the pit and show up in red meaning movement towards the scanner. These types of analyses were fundamental in building up the Kanmantoo rockfall register, used to manage rockfall risk as described in Hutchison et al. (2015).

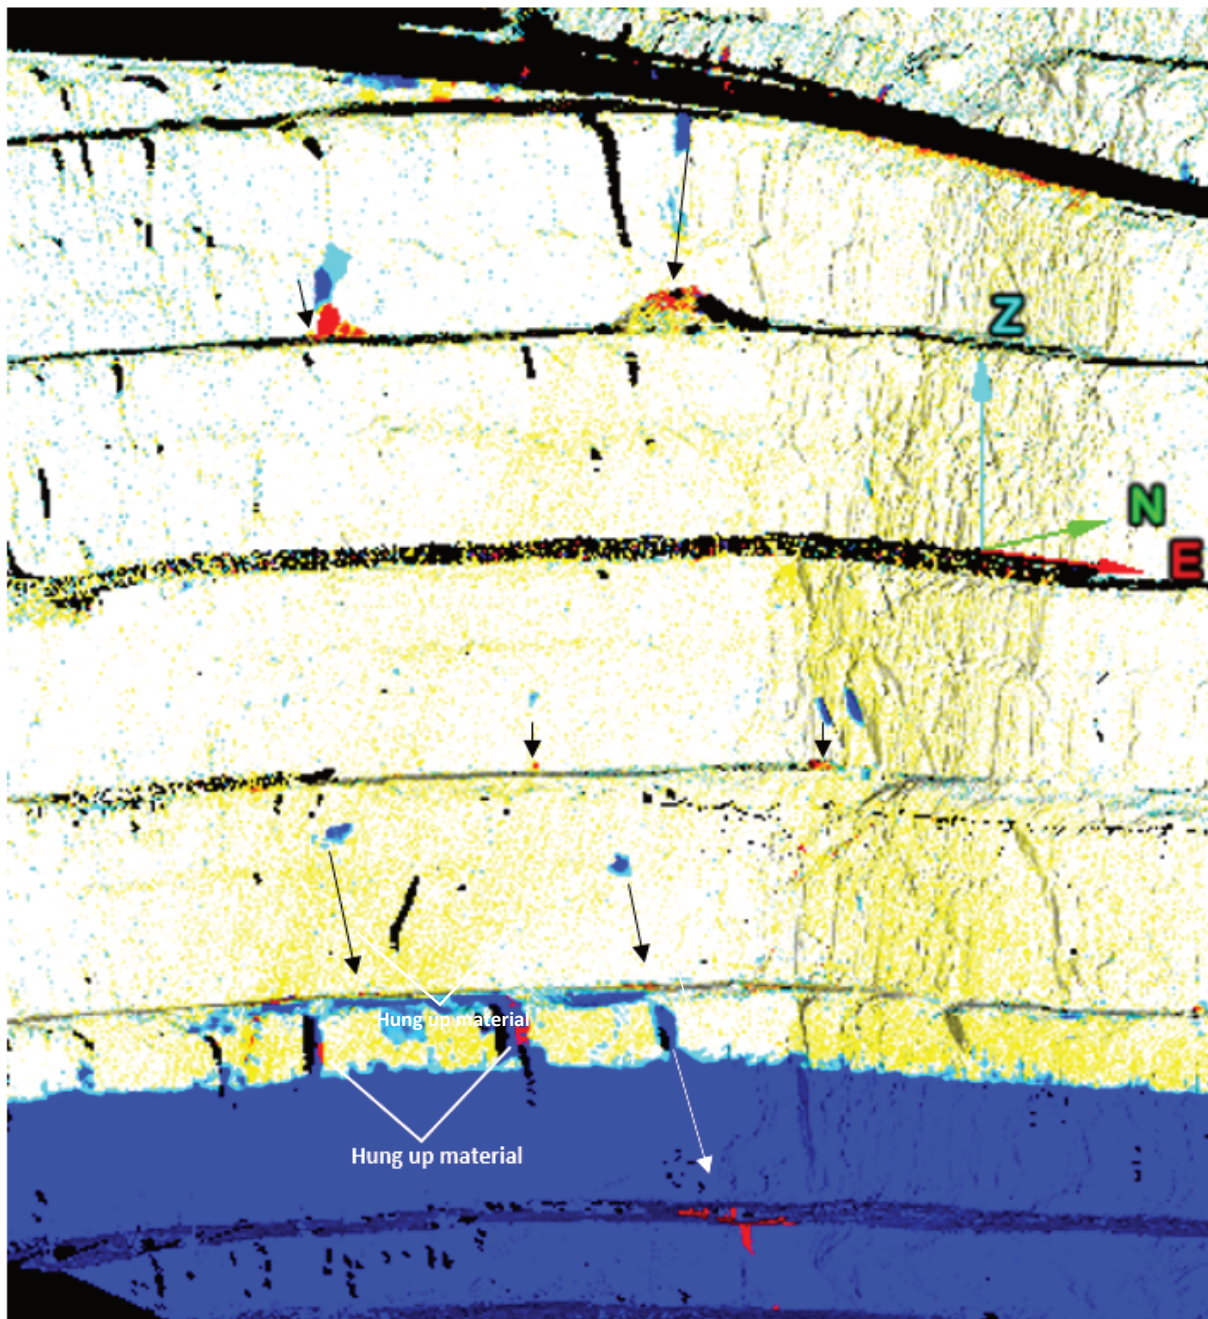
Figure 10 Small rockfalls identified from end of month analysis
