Monitoring applications for safe mining practices: case studies of sub-bench scale failures in hard rock and coal open cut mines

Keywords: *slope monitoring, sub-bench failures, working areas, geotechnical risk assessment plan, Hydra-X*

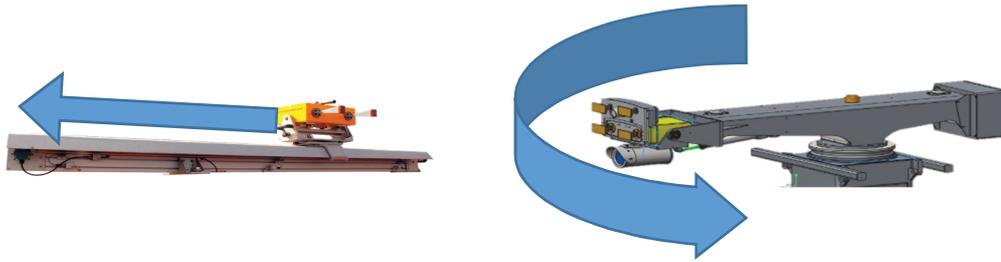
All interferometric radars available on the market, for the mining industry, use differences in the phase values of the backscattered electro-magnetic wave to calculate the displacement occurred between two consecutive measurements. In very simple terms, if a reflective target is stable, then the phase registered by the radar will be the same between two consecutive measurements. If a phase change is registered, then a movement of the target has occurred in between the two acquisitions. In 2009 IDS GeoRadar introduced the first interferometric radar based on SAR (Synthetic Aperture Radar) technology in the mining market (Farina et al. 2011). The radar sensor performs multiple acquisitions and for every acquisition receives the signal backscattered by the entire scenario. It performs this task by emitting continuous radio waves with a variable frequency (LFMCW, linear frequency modulated continuous wave radar) and comparing the received echo frequency with the transmitted wave: the difference between the two phases is proportional to the two-way flight time from the apparatus to the target and so to the distance between them. Range resolution, i.e. the ability to distinguish close targets along the line-of-sight of the radar, depends on the transmitted bandwidth while the cross-range resolution, i.e. the ability to distinguish close targets perpendicular to the line-of-sight of the radar, is obtained by means of the SAR technique (Cecchetti et al. 2017). The combination of range and cross-range resolution allows the creation of a bi-dimensional image, where each pixel is a measurement point providing real-time displacement information. The angular resolution was achieved initially exploiting the linear movement of the antennas along a two metres linear scanner now moved to a circular movement along a circumference being the two antennas installed at the edge of a rotating arm, as schematised in Figure 1. The longer is the circumference, the higher the angular resolution (Luo et al. 2014).

Figure 1 Linear synthetic aperture radar (SAR) versus ArcSAR

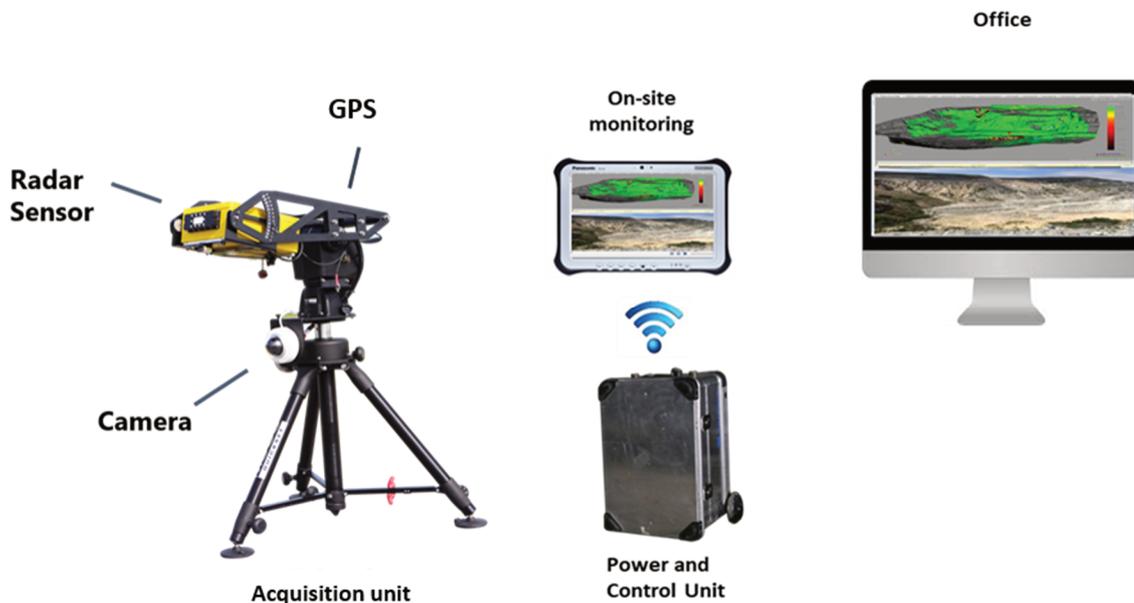
Differently from other IDS GeoRadar systems for slope monitoring in open pit mines (IBIS) (Escobar et al. 2013; Farina et al. 2011; Mononen et al. 2016; Ramsden et al. 2015), Hydra-X uses the motion of the radar antenna over a circular trajectory to provide finer angular resolution than conventional beam-scanning radars. Signal processing of the successive recorded radar echoes combines the recordings of multiple antenna positions. This process forms the synthetic antenna aperture and allows the radar to achieve a higher resolution than otherwise possible with a given physical real antenna. The circular trajectory used for obtaining the synthetic aperture (often denoted as ArcSAR) permits a more compact design of the radar and a wider-angle coverage with respect to the traditional linear SAR. It is capable of providing displacement measurement with an accuracy better than 0.1 mm, by combining a very high phase measurement accuracy (< 0.1 radians) to a short wavelength (4 mm) (Cecchetti et al. 2017). In the laboratory test, the displacement measure accuracy is about 0.002 mm (Cecchetti et al. 2018). The system can be divided into two main parts: the acquisition unit, and the power and control unit (Figure 2).

Figure 2 Hydra-X configuration

The acquisition unit consists of a pan/tilt module which rotates the radar sensor in order to perform the SAR acquisition, an optical camera that continuously provides visual feedback of the monitored area and a GPS, for automatic geocoding of radar data. The supply and control unit provides power to the acquisition unit, processes the radar data and provides the network interfaces to remotely control the system. The instrument can perform onsite processing in fact both acquisition software (Controller) and processing software (Guardian) run on an industrial computer integrated inside the supply and control unit. The real-time displacement/velocity heat maps can be visualised onsite on a rugged tablet in wireless connection, or remotely on a desktop PC. The system is designed to be transported by a single person and in transport mode, each box weighs less than 25 kg and all transport cases are equipped with off-road wheels. It is a remote sensing monitoring system that does not need any reflectors or instruments to be placed on the rock face and its maximum scan range is about 800 m from the point of installation.

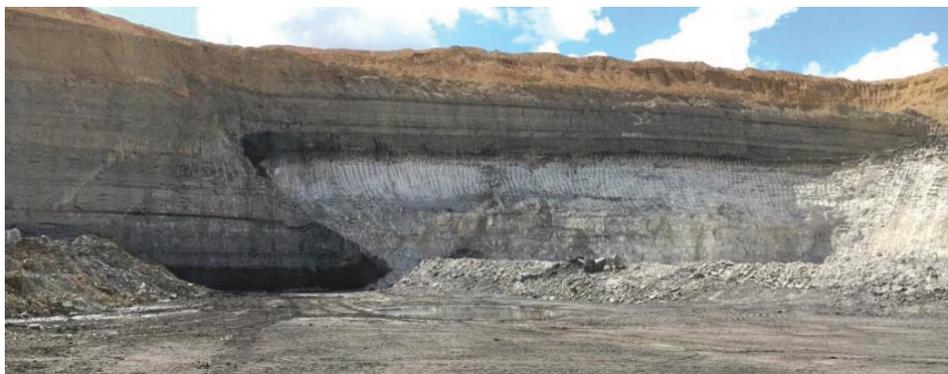
The Bowen Basin contains the largest coal reserves in Australia and is one of the largest deposits of bituminous coal in the world. The Bowen Basin is approximately 650 km long and 200 km wide and varies in depth to over 1,000 m. Due to the size of the deposit, most coal mines within the Bowen Basin target specific deposits. The mine shown in this case study targets the Rewan Group sedimentary system with the target coal seam being part of the Rangal Coal measures. These measures are late Permian in age at approximately 250 Ma. Coal from these deposits consists of hard coking, thermal and low volatile PCI coals. Interburden between the coal measures consists of interbedded coarse to fine grained sandstone, siltstone and carbonaceous shale. Major structural features of the region include the Isaac fault running through the east of the deposit plus minor associated thrust systems within the active mining area (Figure 3).

Figure 3 Typical faulting and stratigraphic sequence found in Bowen Basin open cut coal mine

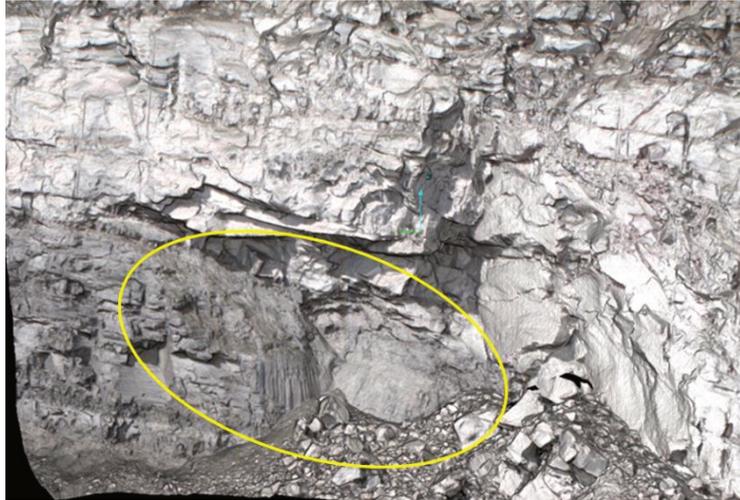
Due to the redistribution of the tectonic stresses within the deposit formation, associated listric structures have formed around the large-scale faulting. These structures are located mainly in the weaker carbonaceous mud/siltstone horizon underlying the competent sandstone unit. The rock mass shows a variation in intact rock strength ranging from 27–33 MPa, with the carbonaceous unit having a lower Geological Strength Index (GSI) value of 30 allowing for significantly weaker material than the more competent overlying sandstone unit with a GSI of 60–70. The relatively high intact rock strengths further highlight the failure mechanisms being observed across the mine site as being structurally driven, primarily from the carbonaceous shale horizon. The weak horizon appears to be approximately 5 to 10 m in thickness and lies directly above the basal coal seam within the mining lease. Once mining progressed through the thrust system, the listric surfaces became an issue to highwall stability and a risk to personnel and equipment working below. Due to

the uncertainty and variability in the orientation and location of these structure, their occurrence is generally not identified until the wall is exposed (Figure 4).

Figure 4 Listric structures circled in yellow

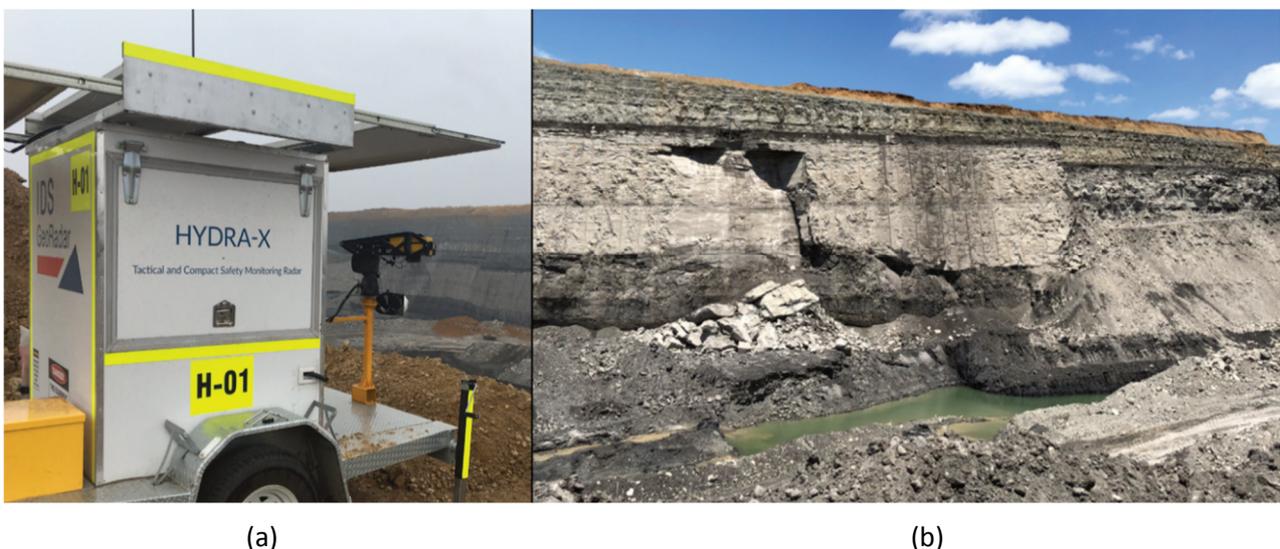
Following a series of large-scale highwall instabilities due to the listric structures sliding out and then undercutting the competent sandstone unit above, a targeted monitoring trial with Hydra-X was implemented. The system configuration used for the trial was a compact trailer mounted unit running off a combination of solar and batteries, designed to be deployed and packed-up quickly throughout the trail. This equipment was selected directly for its resolution (@100 m, 0.15 × 0.80 m). A section of exposed highwall was selected where a wedge failure had occurred. The failure happened on 13 January 2019 where a 3.000 bcm large sandstone wedge had fallen out of the wall, see Figure 5. It was assumed that the same failure mechanism had occurred where the underlying siltstone had failed post coaling, undercutting the competent sandstone unit. A continuous joint set was seen running through the sandstone unit providing one release plane for the wedge with the second plane either being a secondary joint set or breaking under tension.

Figure 5 (a) Trailer Hydra-X; (b) Initial highwall failure occurred in the south side of the mine on 13 January 2019

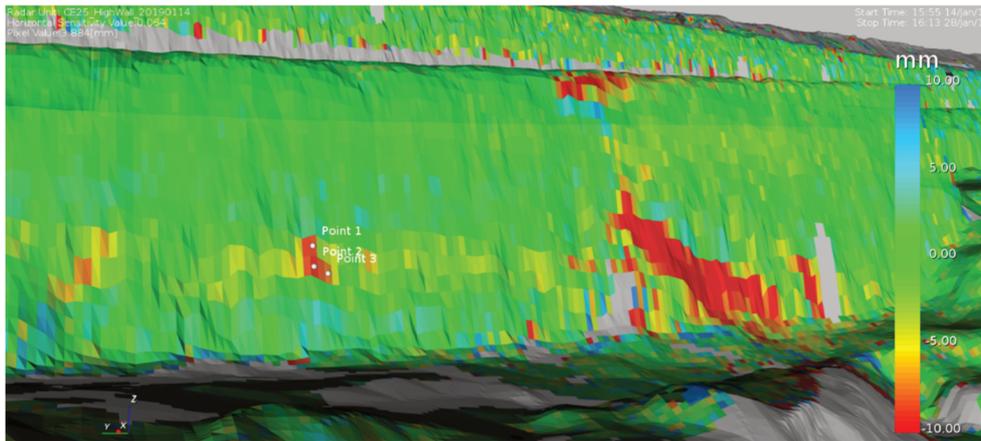
Deformation plots of each area confirm what we thought was occurring with the highwall, that is, relaxation and movement within the lower siltstone unit. This movement occurs gradually once the highwall face is exposed and eventually leads to failure and undercutting of the competent sandstone unit above. Movement was also detected within the siltstone band North of the active failure area, as small discrete blocks/listric surfaces dropped out as the wall further deteriorated (see Figures 7 and 8).

Figure 7 Additional movement in the carbonaceous mud band north of the main monitoring area and displacement average result for points selected on deteriorating siltstone band

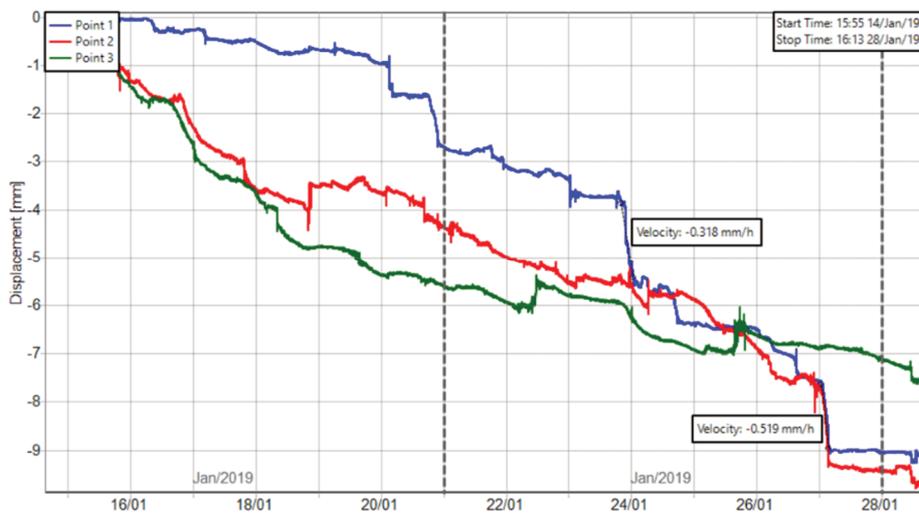
Figure 8 Displacement time series of the three points

This confirmed to site that the failure mechanism for its recent highwall issues initiates in the siltstone and that sub-millimetre movement is detected prior to failure within the sandstone unit. Just after the trial was completed, complete bench failure of the highwall occurred as seen in Figure 9. Where the underlying siltstone failed, undercutting the sandstone unit and due to the continuous discontinuity, caused a large wedge (approximately 30 m in height and 7.500 bcms) to drop out.

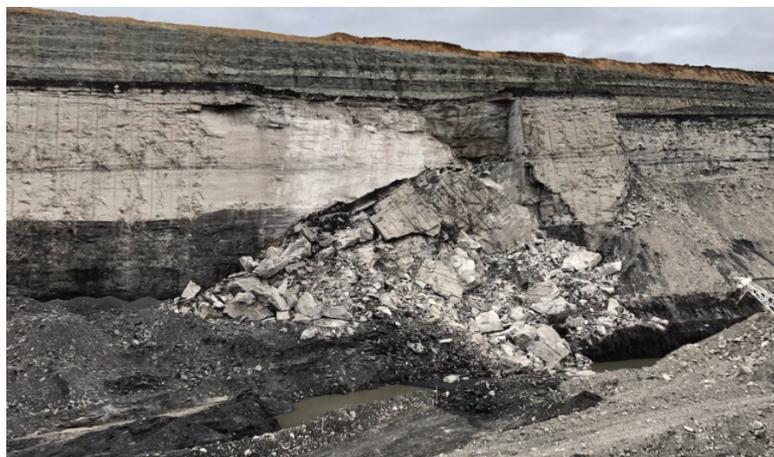
Figure 9 Post-failure of the highwall after the trial was completed

Finally, as a result of the trial in the Bowen Basin and thanks to the information gathered by the equipment, site was able to confirm the correct failure mechanism that was occurring on the highwalls after crossing the large thrust system. It was clear that the underlying siltstone unit begins to relax/dilate as it is exposed in the face allowing the listric surfaces to mobilise. Due to the random nature of the listric surfaces, site has now implemented design changes to minimise the impact on the highwall. They include reducing the wall angle from 70° to 65° and the incorporation of a catch bench into the wall design to reduce the height of the sandstone unit sitting above the weak siltstone unit below.

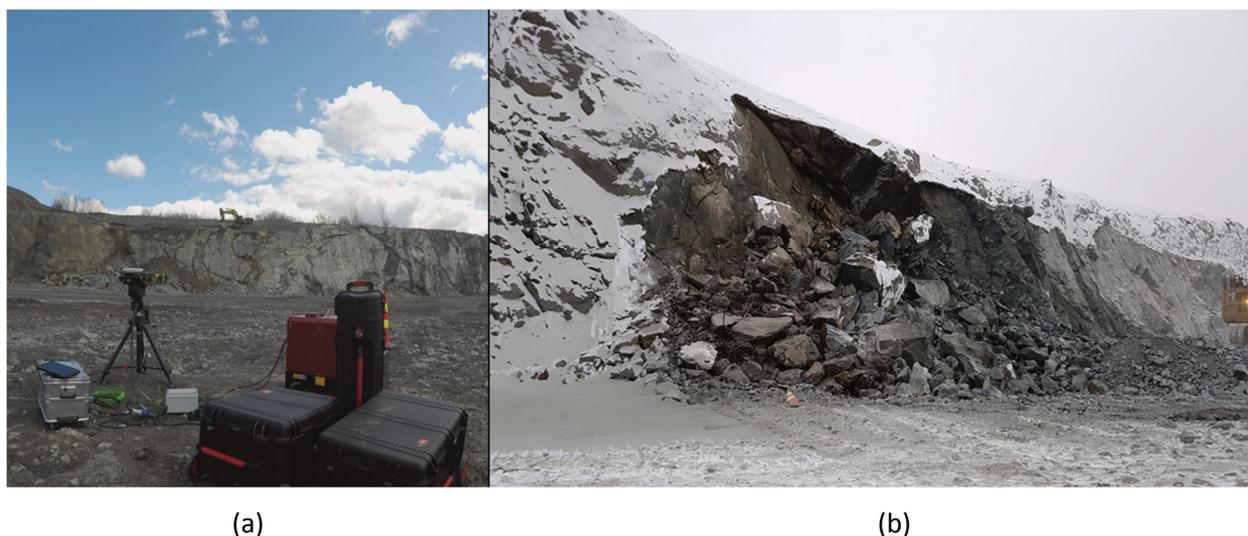
Yara Suomi Oy operates two open pits in the Siilinjärvi area in Eastern Finland, the mine life is foreseen to stretch up to 2035 and it is currently the only apatite mine in production in Europa. The main pit, called Särkijärvi, is 3,000 m long, 900 m wide and 250 m deep, while the satellite pit, Saarinen, is 800 m long, 400 m wide, 100 m deep and the height of the benches is between 28 and 30 m. The two pits belong to the same elongated orebody, it is 2.6 billion years old, which dimensions are 14.5 km long, 1,000 m wide and with a known depth of 800 m. While the surrounding rocks consist of granite, gneiss and diorite, the rocks of the complex are fenite, diabase and carbonatic rock. Fenite is an altered rim around the orebody, diabase occurs as crosscutting dykes and carbonatic rocks host the apatite ore. Most of the failures occur during spring and autumn when freezing and thawing cycles are at their strongest. If during winter season long continuous periods of freezing temperatures are reached, there are usually no instabilities. Blasting vibration, the high precipitation, the freezing/thawing cycles, a shear zone which runs parallel to the pit wall and the presence of fenite xenoliths inside the orebody, are the main contributing factors of failures. The largest failures are due to long, steeply dipping, continuous shear zones and the main failure mechanism is toppling. In some cases, shear zones are so heavily fractured that rotational failures might also occur. The different kinematics are also linked to the type of rock: fenite, diabase and diorite (waste rocks). These are more brittle and tend to cause wedge and plane failures. Diabase and diorite veins have often three sets of joints that create wedges of different sizes (1–1,000 m³). The carbonatic rocks on the other hand, are more plastic, and generate more toppling failures. The Särkijärvi pit has been active since 1979 and, even though it has been working for over 30 years, in 2007 the production rates increased significantly, and rock mechanics and mine safety started to become a concern. Yara's mine staff decided to purchase four radar systems to start critical safety monitoring of the pit walls. In December 2018 the mine had a bench scale failure on the northeast part of Särkijärvi. The size of the block was 15 m tall × 11 m wide × 10 m thick and it was left on the wall with tension fractures clearly visible. This was obviously seen as a risk that had to be removed and for this reason the equipment was implemented in spring 2019 to monitor the area (see Figure 10). The Hydra-X was powered with a diesel generator and the touchpad controlling the radar was granted remote access with a 3G router and a SIM card.

Figure 10 (a) Hydra-X installation in spring 2019; and (b) Initial plane failure that occurred in December 2018

The unit was located approximately 100 m from the 20 m bench, monitoring an area of around 2,580 m². The installation was set up in the spring because the mine staff decided to wait until all snow had melted in order to see and map the structures clearly. It was decided to use it to monitor the loose rock block that was left unstable after bench scale slope failure happened next to it. Monitoring was carried out because a dozer was excavating the overburden on top of the unstable block. The continuous monitoring undertaken on the

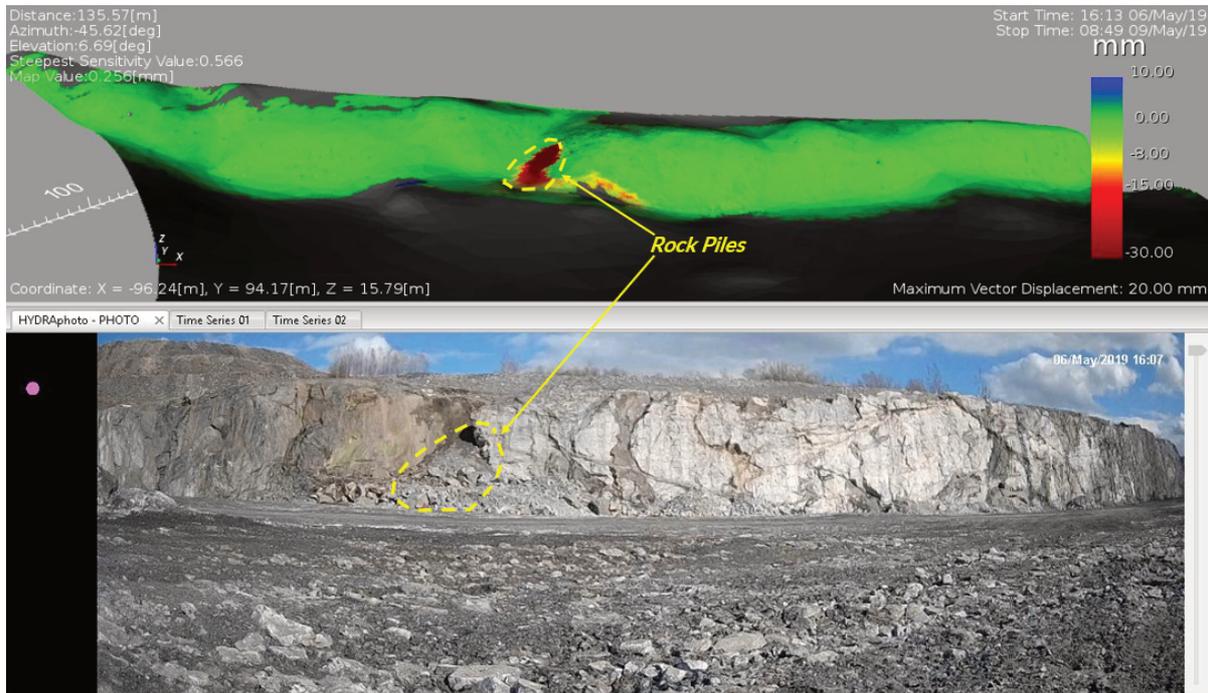
area gave the crew the possibility to understand that there were no displacements on the pit wall while the loose debris piles were in constant movement. A period of three days was defined to show the behaviour of the working area (Figure 11).

Figure 11 Hydra-X data showed displacement in loose rock piles

Basin coal mine). In the case study of Yara, thanks to the continuous monitoring of the area below the bench, the clearing of the debris could be carried out safely. The dozer could work in a safe way knowing that the material was stable, and the data processing onsite with alarms allowed the operator to get alarms in case of movement. The continuous monitoring undertaken in Kevitsa gave to the geotech the tranquillity to know that operators onsite could be alarmed in case of any displacements due to loose rocks laid on the berms or unstable areas of the benches above the main ramp, where trucks were passing on the main line, or the remote excavator, working on the +90 bench.

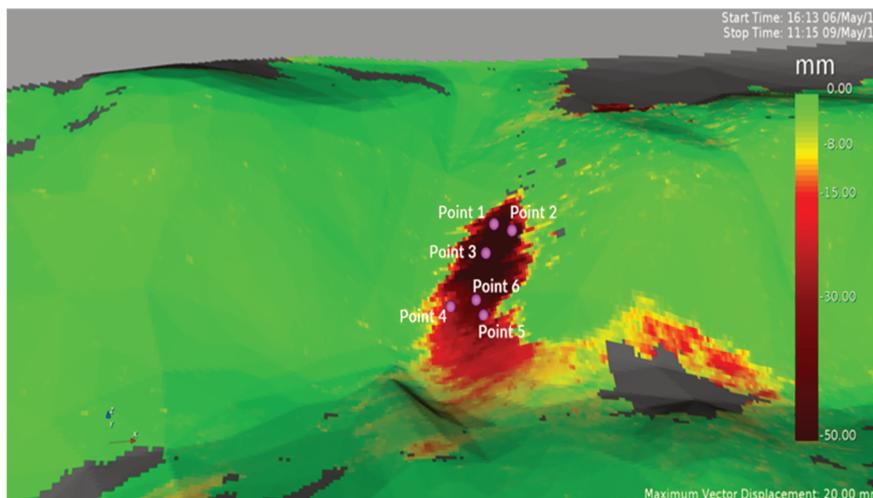
To define the constant movement inside the loose debris piles, six points have been analysed (points 1, 2, 3, 4, 5 and 6), which location and time series are shown in Figure 12.

Figure 12 Location of the points analysed

Points located in the upper part of the moving area (points 1, 2 and 3) show a cumulative displacement around 60 mm, while points located at the bottom (4, 5 and 6) register a value between 40 and 25 mm in three days. An acceleration event is visible on 8 May around 12 pm and the displacement time series of the entire moving area has been analysed in order to obtain the general deformation trend of the rock piles (Figure 13) that encompassed by an area of 45 m².

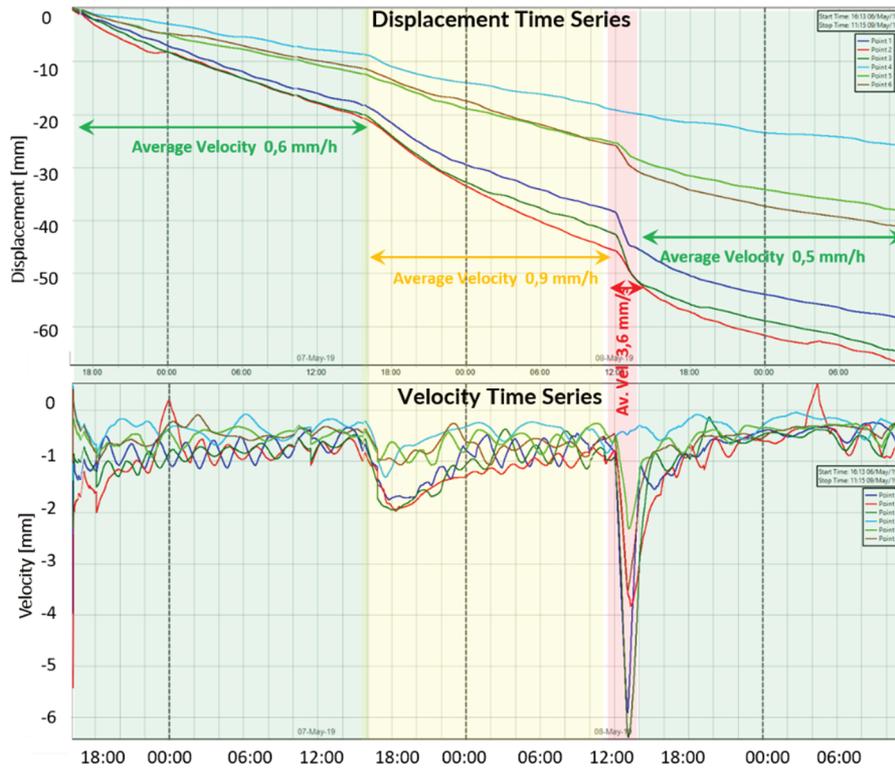
Figure 13 Displacement and velocity time series of points 1, 2, 3, 4, 5 and 6

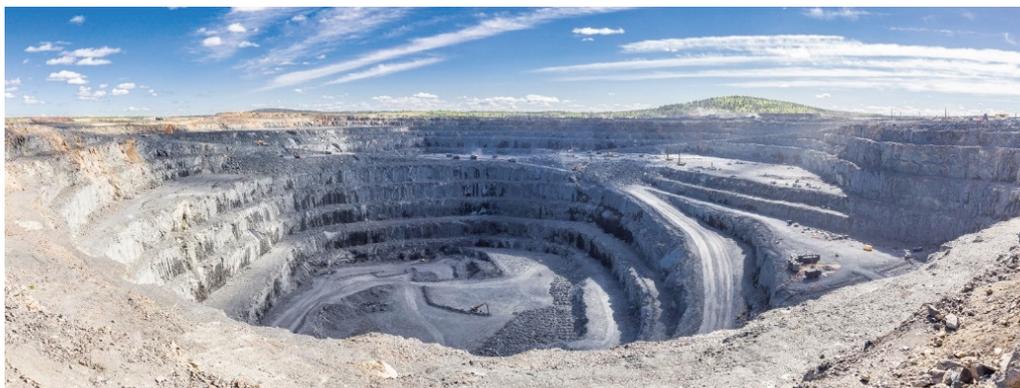
Figure 14 Overview Kevitsa mine

Kevitsa, a mine of New Boliden, is located in the north of Finland, in Lapland, closed to Sodankylä. The deposit was discovered in 1987 while the production started in 2012. It is composed by a round pit producing nickel-PGE, copper and gold where the diameter is about 1,000 m and 220 m deep (Figure 14).

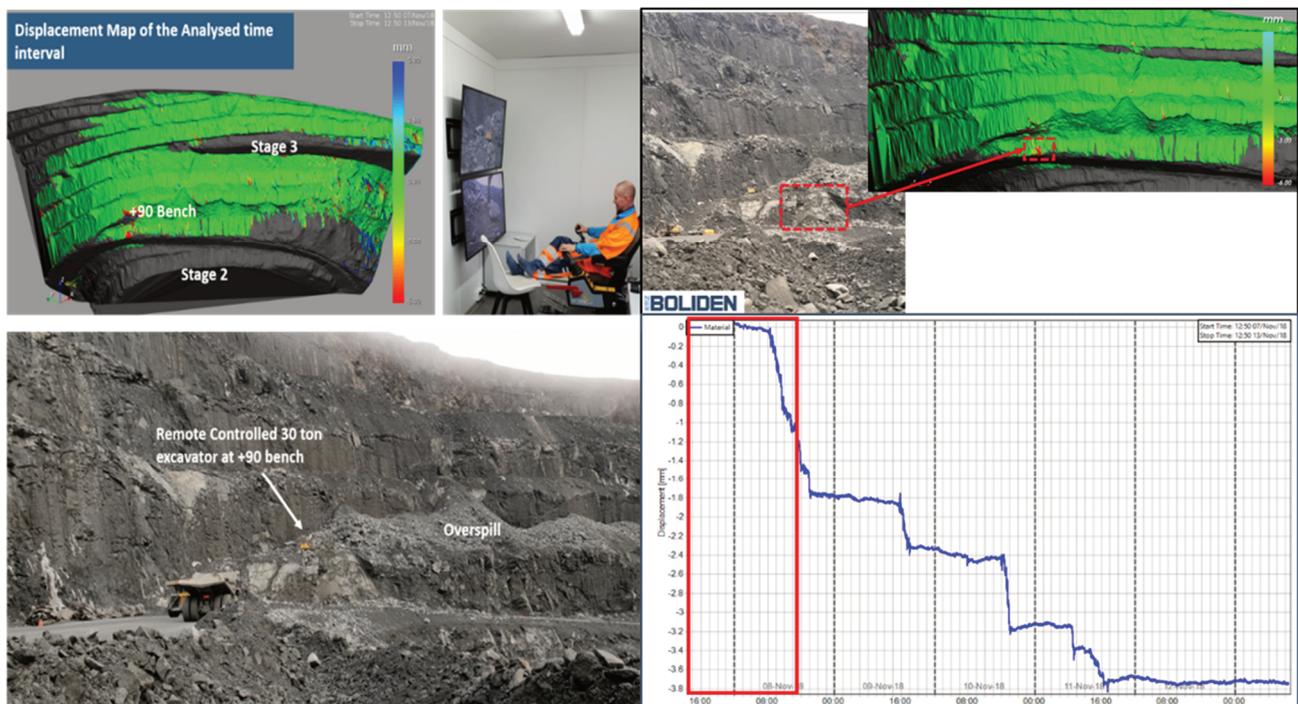
In November 2018 Kevitsa decided to monitor a specific area of the mine, the east wall, with an instrument that could measure, identify and alarm if a little displacement may happen. A remote excavator was working on a specific wider bench, named +90 bench, because all the safety benches were full of blasted material from the upper stage 3 cut back. The aim was to create wider catchment bench, about 25 m. Furthermore, the safe benches where the excavator was working were above the main and only ramp to stage 2 cut back, where only single line truck access was implemented due to rockfall risk. This ramp was actively used from the operation to arrive to the other active area at the bottom of the pit. The excavator was controlled from a control cabin inside a container localised at 100 m from it. The mine staff decided to install the Hydra-X close to the container to have the complete overview of the area and to monitor the sector above the excavator. The cameras positioned on the excavator were useful for operation and positioning, but not good enough to monitor above the excavator. Figure 15 shows the main ramp, the excavator on the +90 working bench, the remote controlled excavator and the radar data.

Figure 15 Displacement map; monitored area; excavator control room and displacement time series. The area within the red rectangle is analysed in detail in the following section

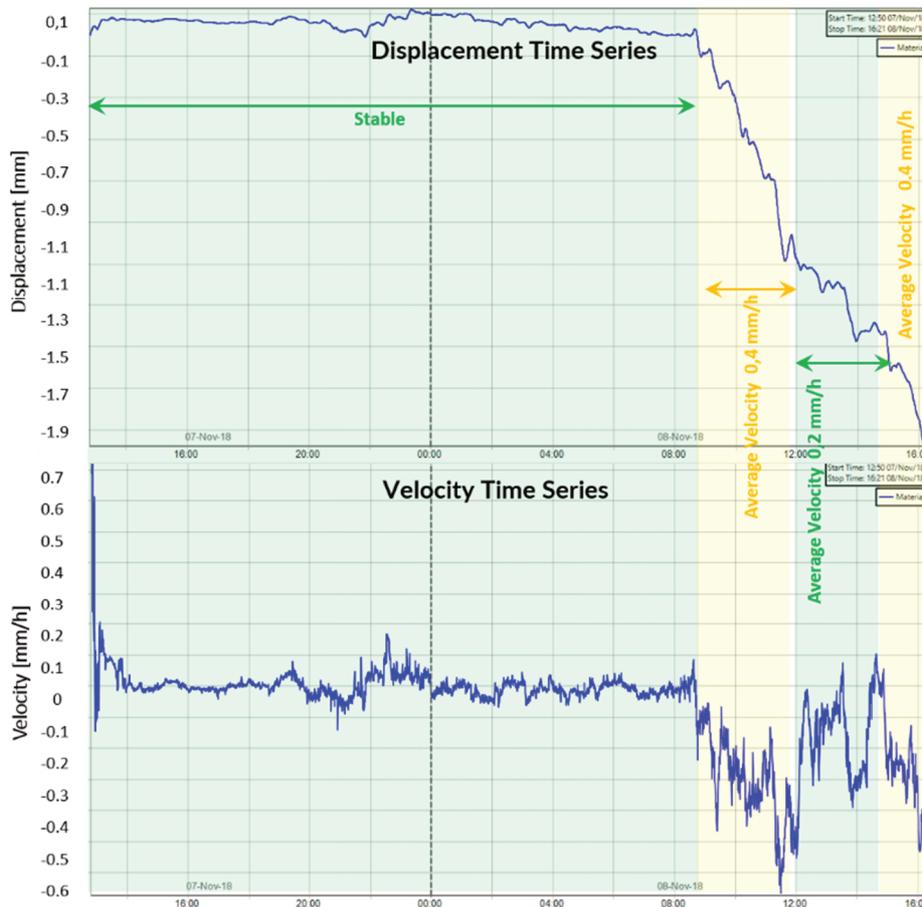
The equipment was located approximately 250 m from the 24 m bench, monitoring an area of around 4,500 m². The installation was set up in the autumn because the mine staff wanted to clean the +90 bench before winter. It was decided to use Hydra-X to monitor the benches above and also the loose rock block that may fell during the cleaning work of the excavator, down to the main ramp. A detailed analysis has been performed on the first day of data. The displacement time series shows 2 mm of cumulative displacement (Figure 16).

Figure 16 Displacement and velocity time series

A detailed analysis has been performed on the first day of data. The displacement time series shows 2 mm of cumulative displacement. The time series has been divided in different sector according to the deformation rate measured by the radar. Green sectors show a lower velocity average value compared to the yellow sector. The overall cumulative displacement considering six days of data is around 3.8 mm, due to the mobilisation of material by the excavator. Hydra-X was able to monitor continuously the area above the excavator with a focus on the loose material on the east wall benches, guaranteeing the possibility for trucks and other machineries to use the main ramp in a safe and controlled environment. In the six days showed in this analysis, it was possible to notice a displacement of 3.8 mm due to the mobilisation of material by the excavator. Hydra-X was able to monitor continuously the area above the excavator and mainly, the loose material on the east wall benches guaranteeing the possibility for trucks and other machinery to use the main ramp in a safe and controlled environment.
