Mechanical and physical properties of chalk and impacts on mining operations and slope designs

P Ebeling *Holcim Technology Ltd, Switzerland*

A Iwanoff *BGW Geotechnik GmbH, Germany*

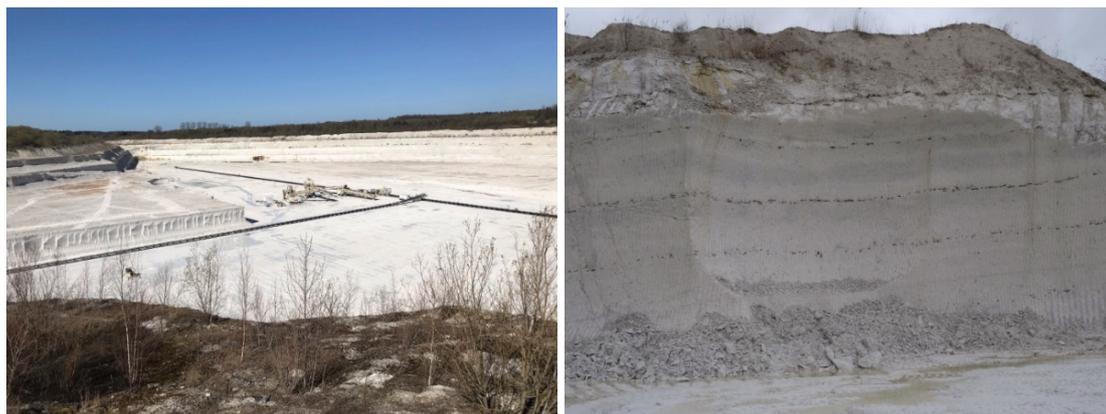
Figure 1 (a) View on the chalk quarry Neue Heidestrasse west of Lägerdorf; (b) The dark flint layers within this deposit

The chalk deposit around Lägerdorf in northern Germany is also Cretaceous material (Figure 1a). While the topography is relatively flat terrain, the underlying deposit is situated on top of a salt dome which lifted the entire chalk formation to the surface and exposed material from the Coniacian to the Maastrichtian stages (Iwanoff 1994). The culmination point is just under the town of Lägerdorf and, due to the uplift the deposit, is dipping in the active mining areas west of Lägerdorf at $5\text{--}7^\circ$ towards the northwest, while east of Lägerdorf the formations are dipping $5\text{--}7^\circ$ towards the southeast.

With regard to geological structures, faults are observed but the displacement is in the range of a few metres and not relevant for the mining operation. While the bedding planes can be followed over tens of metres in the faces, jointing is intense but of low persistence. Several bedding-parallel flint layers (or chert or silex) can be observed and are used as marker horizons (Figure 1b). The flint is usually fist-sized but can have sizes of up to 30 cm. The chalk itself is chemically rather homogenous but the upper 20–40 m are visibly more weathered and are mechanically weaker than the lower layers. This is probably a weathering effect of the regional groundwater flows over time.

Chalk often has significant flint layers. In the case of Lägerdorf, these are clearly visible and continuous but do not impact on the slope design. However, the selected mining and process equipment must be able to deal with such very hard layers within a soft chalk matrix.

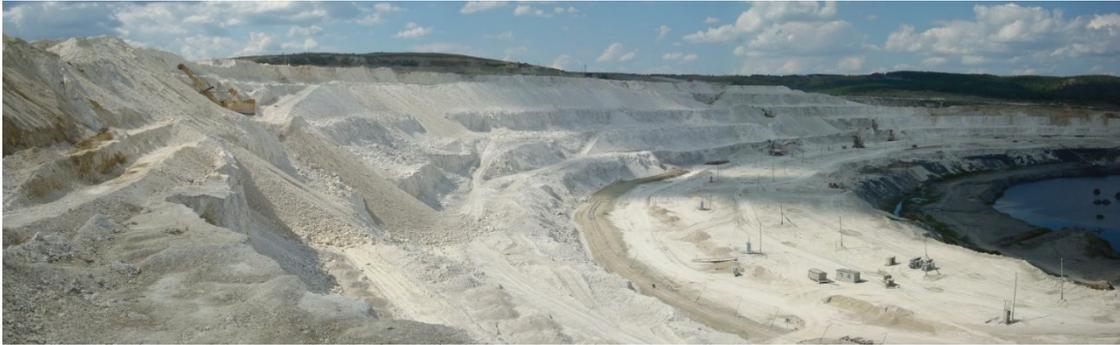
Figure 2 Overview of the Volsk mining operation

The deposit is located about 650 m north of the Volga River in the Saratov region (Figure 2). The Cretaceous deposit consists of clays of Albanian stage, overlain by chalks of Touronian to Maastrichtian stage and diatomite overburden. All materials are being extracted. The natural groundwater level is within the underlying clays and above the level of the Volga river.

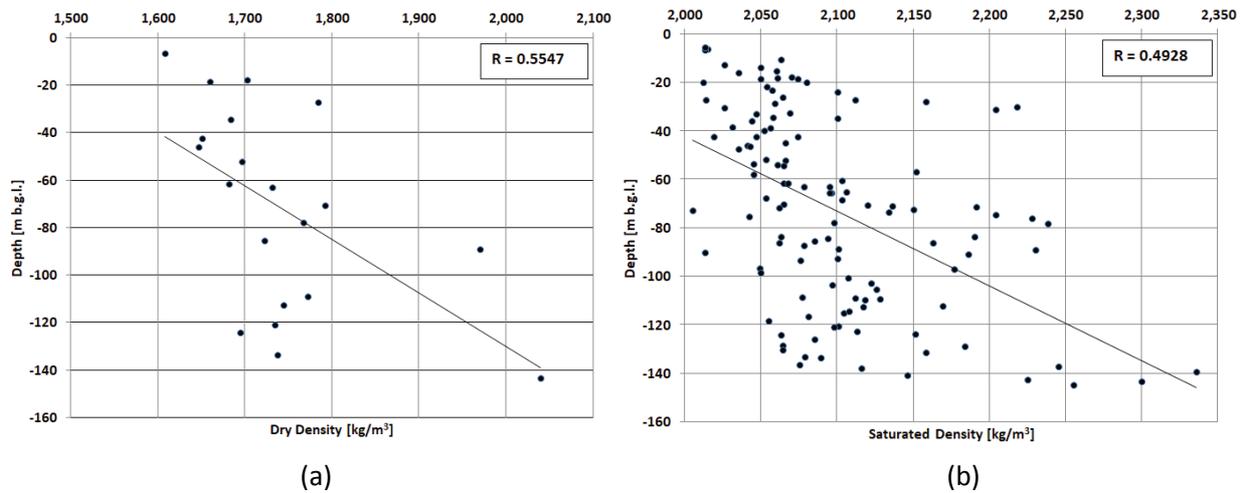
Figure 3 Increase of (a) dry density and (b) saturated density with increasing depth at Obourg

Although all three deposits are of similar geological age, the variations of the material properties are significant. The greatest number of tests were carried out in 2019 on the Obourg materials. Descamps et al. (2019) carried out a very high number of tests along three drill holes with a total length of 375 m (100 saturated densities, 20 dry densities, 200 unconfined compressive strength tests (UCS), half with Young’s modulus determination, and 45 Brazilian tensile strength tests (BTS)). They concluded that saturated as well as dry density increases with depth, likely due to a reduction of porosity (Figure 3). Also, the UCS increases with increased depth, while the tensile strength does not seem to follow such a trend (Figure 4). However, all linear correlations presented in Figures 3 and 4 are not very robust with low correlation coefficients between 0.39 and 0.55. It has to be noted that although there are a large number of tests results, especially for the UCS, these originate from only three drill holes, and minor local variations may have an influence on the test results.

While at Obourg there is an increase in densities with greater depth and a decrease of the porosity, the same could not be observed at Lägerdorf.

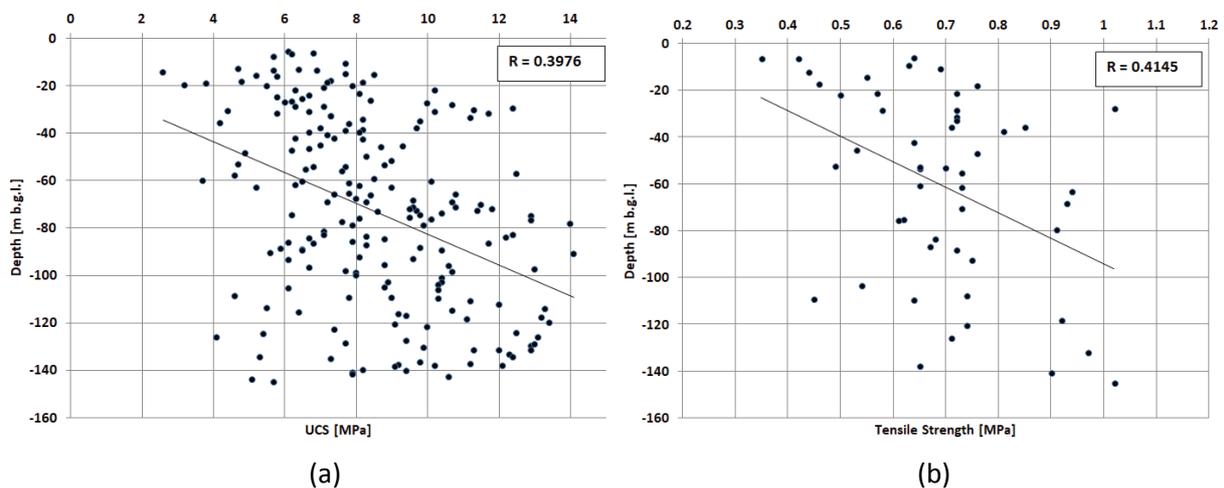
Figure 4 (a) The unconfined compressive strength (UCS) and (b) the tensile strength at Obourg do not follow an obvious pattern

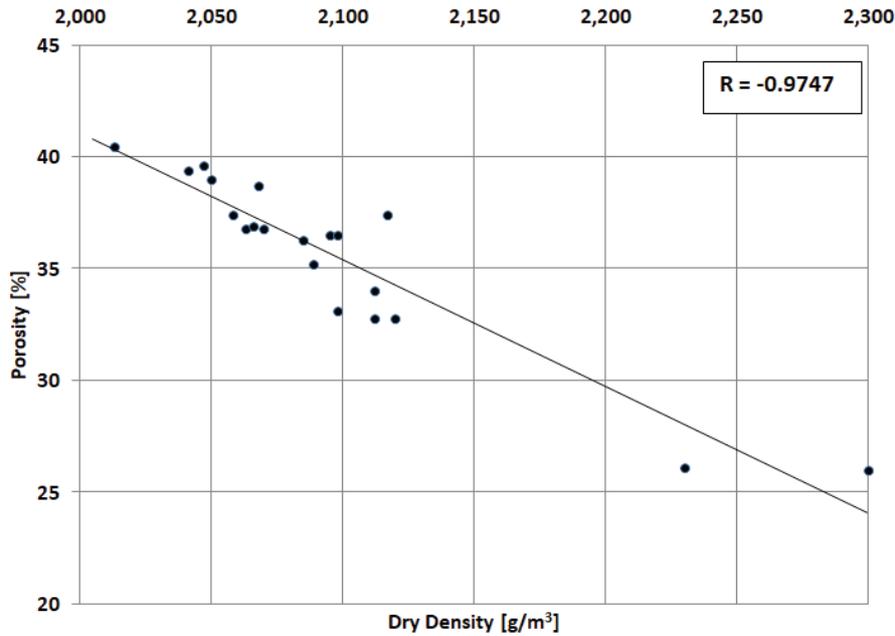
There is a good correlation between the porosity and the dry density (Figure 5). Since there is also an increase of the densities at deeper levels, the increase in density and decrease in porosity is likely a result of consolidation at higher overlying stresses.

Figure 5 Correlations between the porosity and the dry density at Obourg

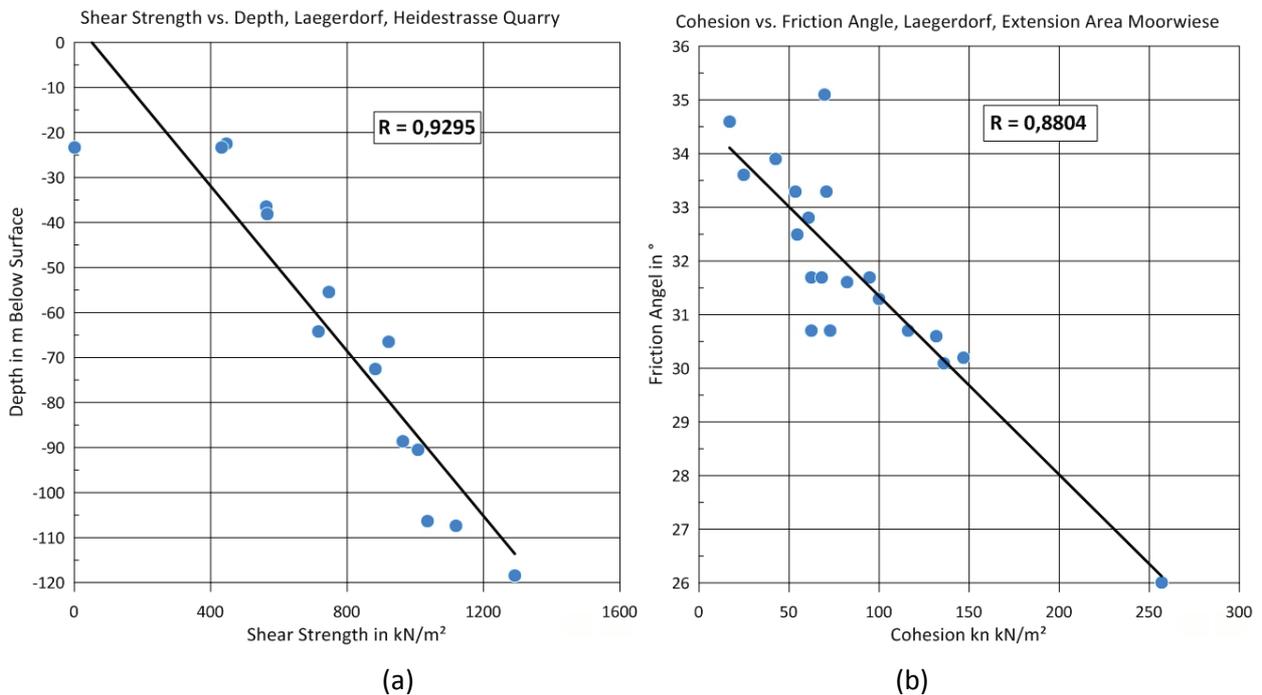
At Lägerdorf, the increased shear strength could be correlated with increasing depth for the western pits Heidestrasse (Figure 6a). Also, a correlation between cohesion and angle of friction was observed in the eastern deposit Moorwiese (Figure 6b). Both correlations are highly significant, as the correlation coefficients (R) show. However, no correlations of angle of friction, cohesion, porosity or permeability could be determined with increasing depth (Figure 7), which is proven by the low correlation coefficients.

Figure 6 Good correlations of (a) shear strength versus increasing depth as well as (b) angle of friction versus cohesion at Lägerdorf

At Lägerdorf there was a correlation between increasing cohesion and friction angle and increasing depth. Such a correlation could not be established for Obourg due to lack of available tests.

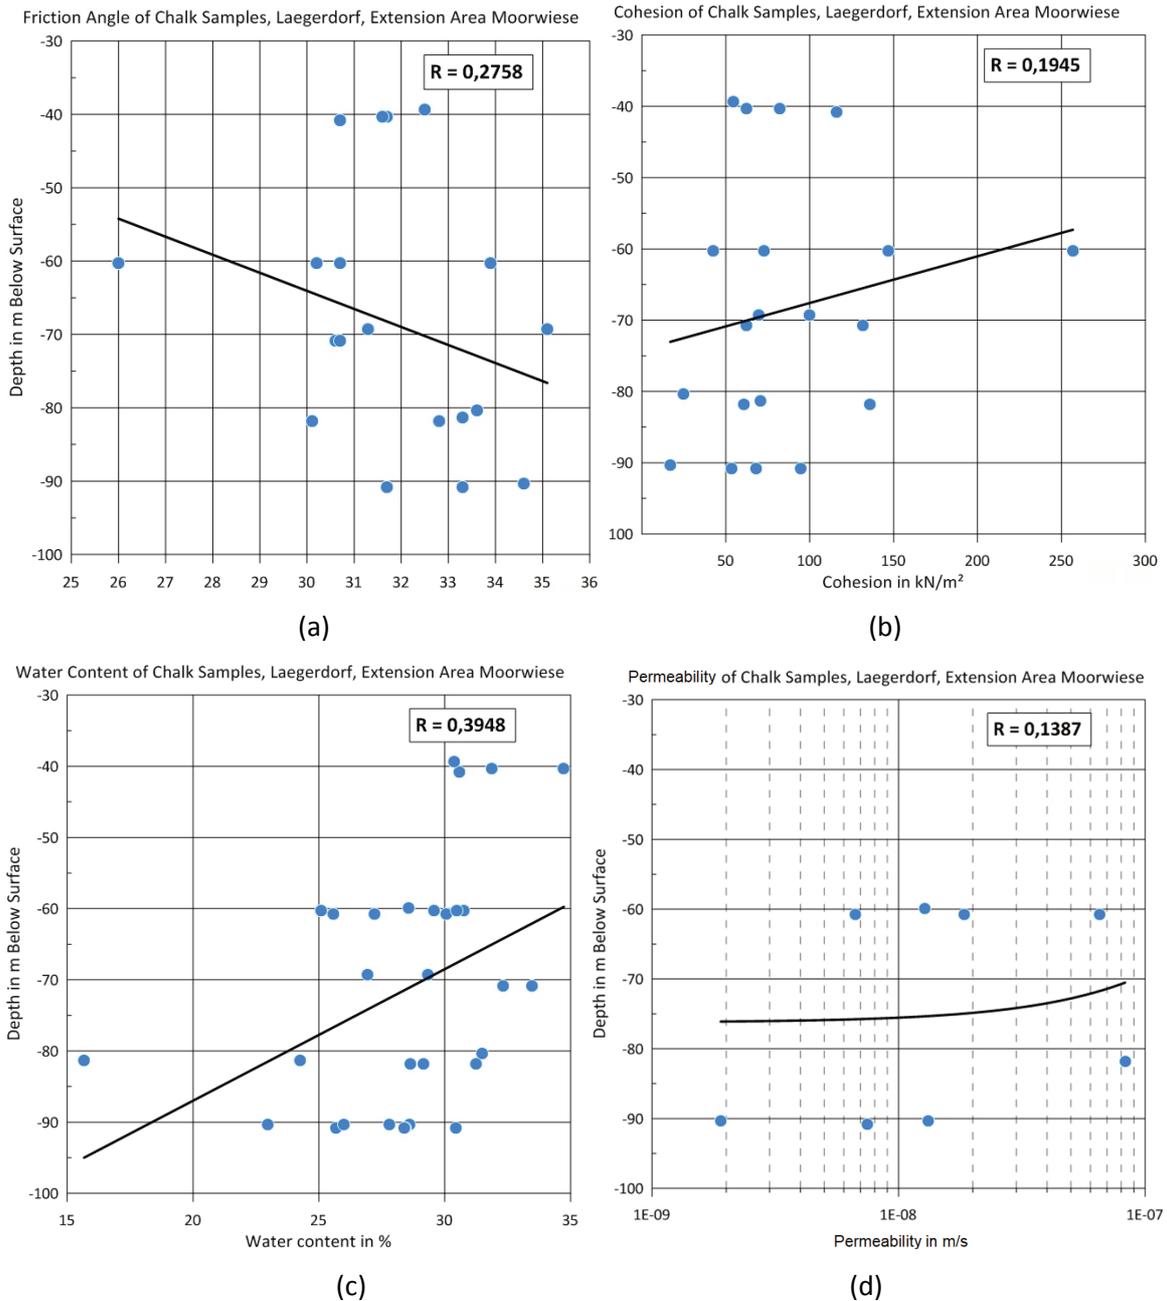
Figure 7 No correlations of (a) angle of friction; (b) cohesion; (c) water content; or (d) permeability with increasing depth at the Moorwiesen pit at Lägerdorf

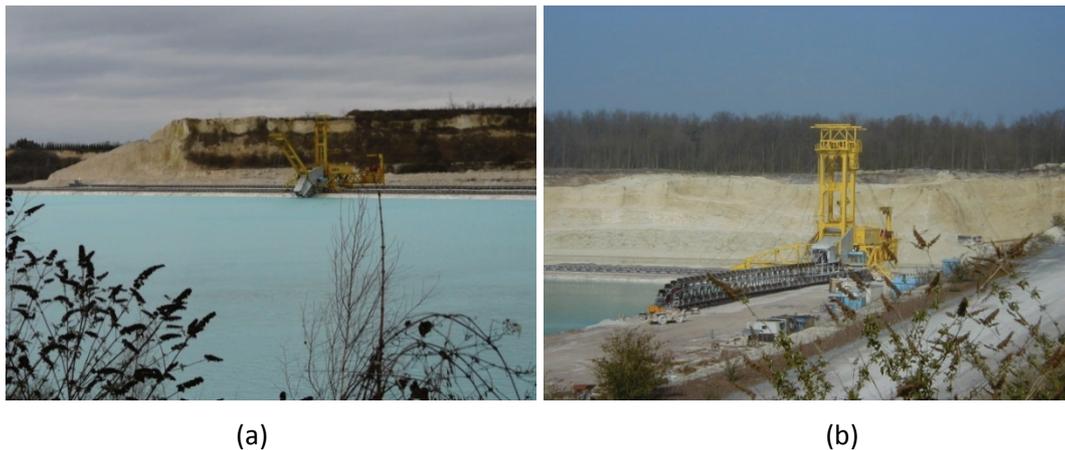
The deposit at Obourg is close to a major public canal which presents a major shipping lane. The operators decided not to drain the pit and work in dry conditions, but to extract the majority of the material below groundwater level by means of a dredging operation with a bucket chain excavator (Figure 8). The excavator can reach down to a maximum of 50 m below ground and extract the chalk at an even overall slope angle of 46°. The minor part of the deposit above the groundwater level is mined directly by backhoe excavators. No slope failures were reported, however, since most of the slope is submerged, slope failures would not be obvious. Today the slope design is not geotechnically optimised for maximum chalk recovery but is merely a result of the mining method and constraints. Tshibangu et al. (2019) assessed the possibility to steepen the slope angle and to optimise the chalk recovery and determined that overall slope angles of 65–70° are possible.

Figure 8 (a) The submerged dredging operation at Obourg; (b) Exposed bucket chain excavator on land for maintenance purposes

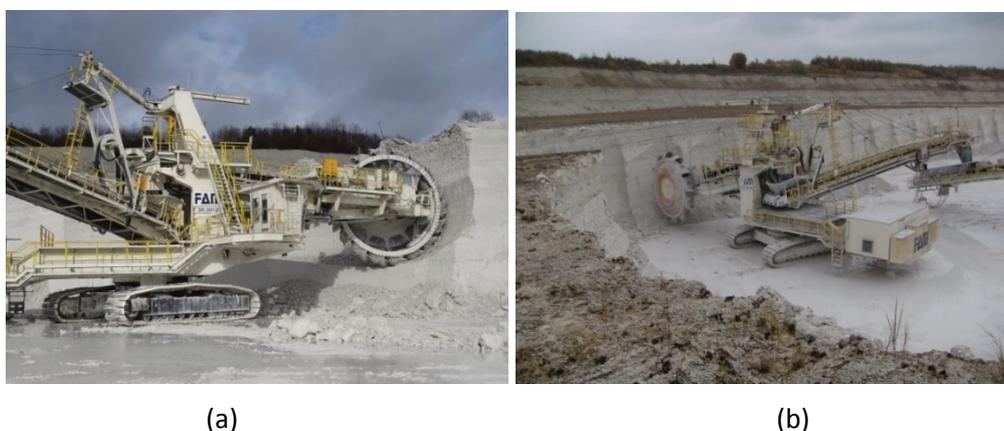
The final slope design for the current mining area Neue Heidestrasse foresees eight benches in chalk of 11 m height each, resulting in an overall final slope height of 88 m and an overall slope angle of 60°. The extraction equipment is a bucket-wheel excavator (BWE) (Figure 9).

Figure 9 The mining operation at Lägerdorf with (a) a bucket wheel excavator up close and (b) from the distance, showing the limitation of the mining method not to separate the inclined dark flint layers

The dip of the formation is gentle and favorable for the mining and slope directions. Wedge formation is locally possible. The persistence of the jointing is too low to be relevant, but unfavourable intersection of bedding and faulting can form locally unstable blocks. However, due to the weak rock mass properties, the principle identified failure mode is by exceeding the material rock mass shear strength. Being a 'weak rock', the slope design process followed the process of defining the overall slope angle first (60°) and fitting the benches into this overall slope angle. In the weathering zone on top of the deposit, the slope angles are reduced to 45° in the lower half and less than 25° in the upper half as well as in the overburden. The bench height and the bench face angle is a result of the dimensions and cutting action of the BWE's cutting wheel and not of the bench material properties or geological structures.

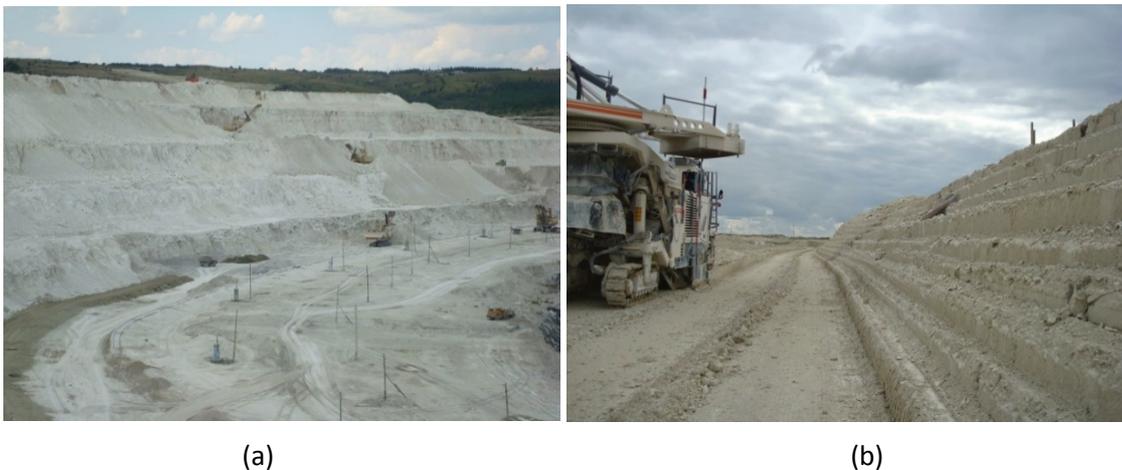
At Volsk, the operation is mining in dry conditions and the full final slope height of 85 m of chalk is exposed. Until recently, this deposit was mined by conventional drilling and blasting of 13 m benches and during the dry summer months also complemented with a surface miner (Figure 10). Since 2019, drilling and blasting has been limited to only a hard layer at the lower contact to the underlying clay, and the rest is mined directly by backhoe excavators.

Figure 10 The dry mining operation with (a) electric face shovels and (b) surface miner at Volsk

The relatively low final overall slope angle of only 20° is a result of the operation's permit and the large bench widths required for the electric face shovels. Similar to Obourg, the material properties would allow for steeper slopes and greater material recovery.
