Steep wall mining: engineered structures used in the management of rockfall hazards at Kanmantoo copper mine

Abstract

This paper describes the various methods utilised to manage a range of rockfall hazards experienced at the mine including the use of shear pins, drape mesh, attenuator fences, low- and high-energy rock catch fences and mesh/cable strapping.

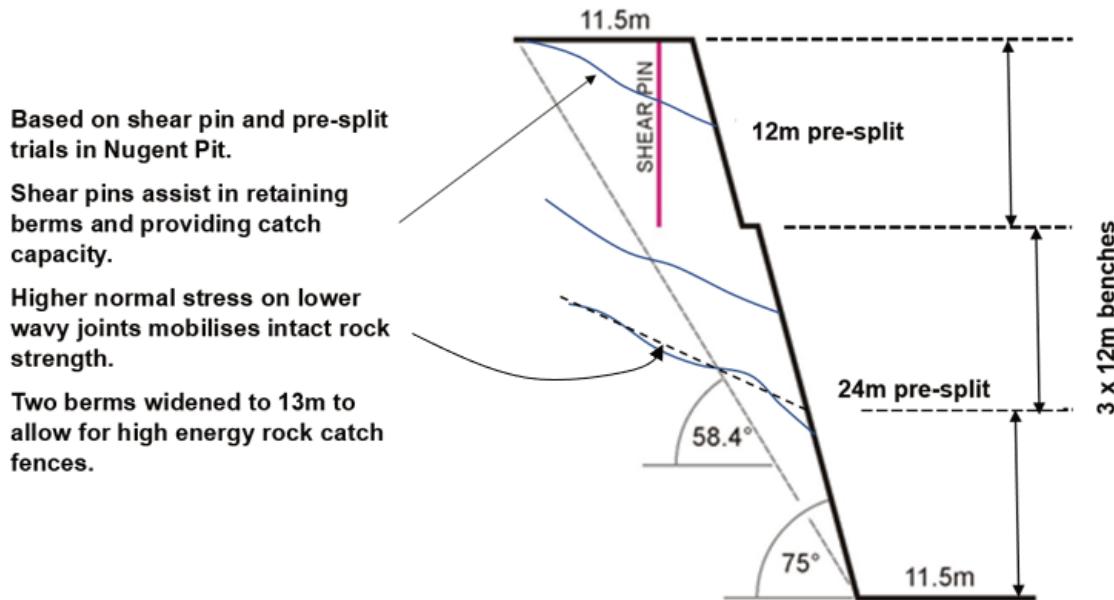
Figure 1 West wall slope configuration

The details behind the assessment and adoption of the steep wall design of the Giant Pit cutback are described in Hutchison et al. (2017). The adopted slope configuration can be seen in Figure 1. The first line of defence against rockfall is the maintenance of adequate berm widths to provide catch capacity. HGO had compiled an extensive rockfall database (Hutchison et al. 2015) that showed that 97% of rockfalls came to rest within 10 m of the toe of the batter on the working floor. The vast majority of these rockfalls were less than 500 kg. Based on the runout data, the berm width was set at 11.5 m to allow some crest loss. More importantly, it was well known that extensive crest loss occurred on the west wall of the previous cutbacks due to the existence of 35–45° easterly dipping joints (J1 joints). Based on experiences from the Savage River and Koolan Island open pit mines, the lead author instigated trials of shear pinning, in similar rock conditions in the adjacent Nugent Pit. Following those successful trials in preventing large planar and wedge failures and the reduction in crest loss, shear pinning of all western berms was adopted. This was subsequently extended

Another feature of the steep wall design was the adoption of 36 m high batters. Such batters would allow any rockfall from high up on the batter to gain significant levels of kinetic energy, especially if a rock was not contained on and overflew a catch berm. To mitigate against such circumstances, three berms spaced about 108 m vertically apart (RL 1190, RL 1082 and RL 908) were widened to 13 m to accommodate high-energy rock catch fences.

The resultant design—with the three widened berms for the fences and a subsequent flattening of the lower 36 m batter to 60°—increased the west wall inter slope angle from 45 to 57°, over a height of 300 m.

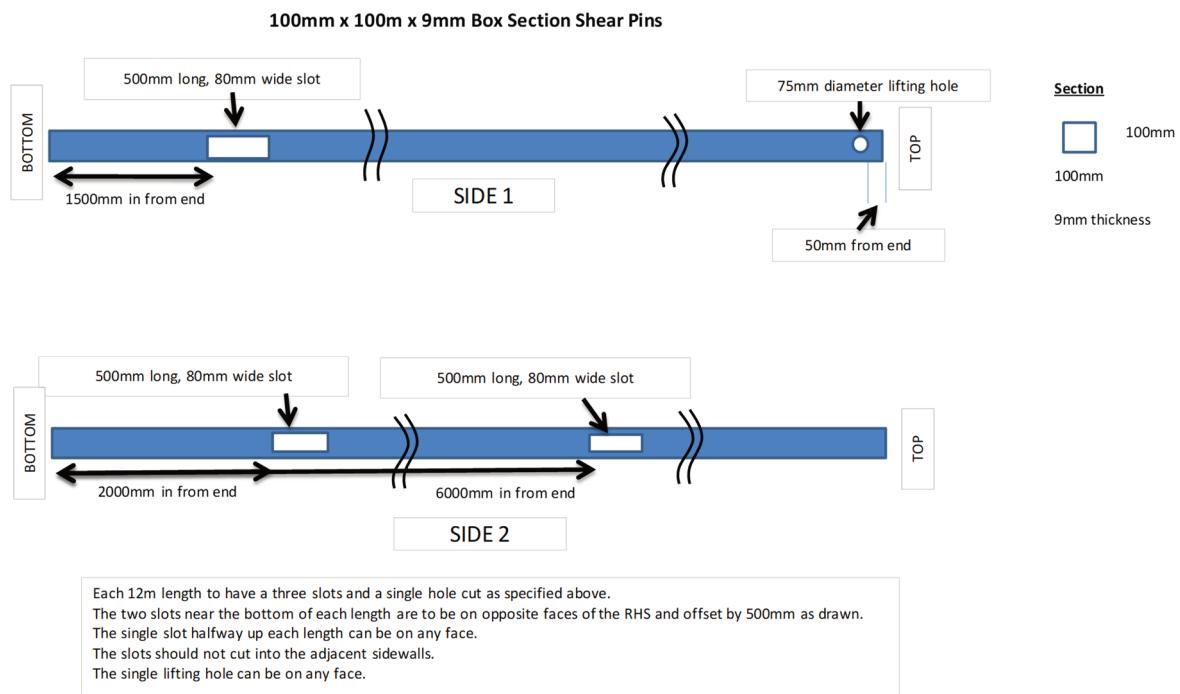
Figure 2 Shear pin details

The lead author's previous experience in shear pinning utilised used railway line as the pin. This required a 300–350 mm diameter drillhole to allow concrete to be poured around the pin. At Kanmantoo, the maximum diameter hole that could be drilled by the available Atlas Copco L8 rigs was 210 mm. The shear pin material adopted was 12 m long, 100 mm × 100 mm × 9 mm rectangular section grade 350/450 steel. The steel pins were lowered into the drill holes by crane. The pins had two 0.5 m long slots cut on opposite sides 1 m up from the base of the pin and then a third slot was placed 6 m up from the base, refer to Figure 2. The pins were grouted in place using a 32 MPa 75% sand – 25% cement grout mix delivered to site by agitator trucks. The grout mix was directed down the centre of the pin. As it emerged from the bottom slots any water in the base was displaced up the drillhole. The middle slot was required when there were significant amounts of groundwater.

The shear pins were typically drilled 1.5–1.7 m apart and 1.5 m behind the design crest. Theoretically, the pins were only required to be 2 m apart to provide stability against planar failures along the J1 joints. The pins were initially trialled at the 2 m spacing but in practice, the closer spacing was required due to the blockiness of the rock mass.

Shear pin installations along ramp crests required the initial ramp shot to be widened enough to allow for pre-splitting and a trim shot. Once the widened ramp shot was cleaned off, the shear pins were then drilled and installed from ramp grade. Typically, a minimum of 24 hours was allowed for the grout to set before taking the pre-split shot in front of the pins.

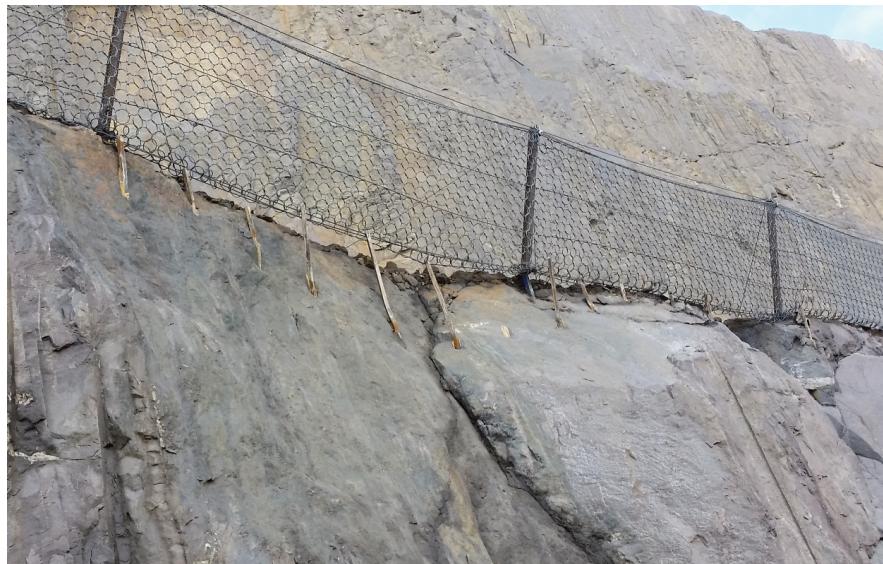
Figure 3 Geobrugg RXE 3000 A barrier

Two relatively long 3,000 kJ rock catch fences were installed on the RL 1180 and RL 1008 levels (293 m and 500 m respectively). The fences were designed to capture multiple hits of 20 t blocks originating 36 m higher

up. The upper fence (Figure 3) was designed with the Rocco mesh on the downhill side of posts. Following the blasting of the trim shots back to the design crest, the RL1180 fence was left with gaps between the base of the fence and the berm in several locations, as can be seen in Figure 3. In two locations, localised crest loss required additional bench mesh to be retro-fitted. In one area, the gap was quite extensive and could not be remediated so an additional 44 m long section of fence was then constructed on the underlying RL1052 berm.

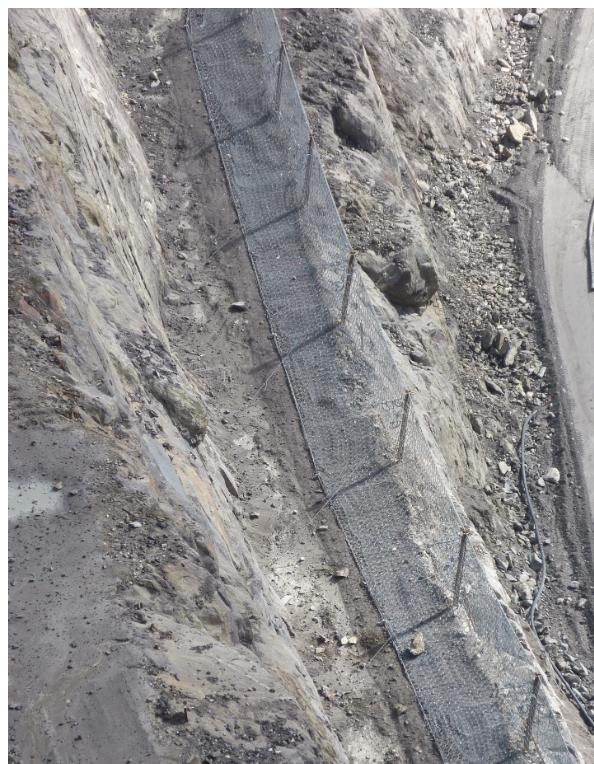
Figure 4 Geobrugg 3,000 kJ A modified barrier

Geobrugg was then asked to provide an alternative design that placed the mesh inside the posts and anchored about half the way back across the berm (Figure 4). This design was adopted for the RL 1008 berm installation. Although there were additional costs associated with improved design, these were offset by not requiring any remedial works, as is discussed later in the paper.

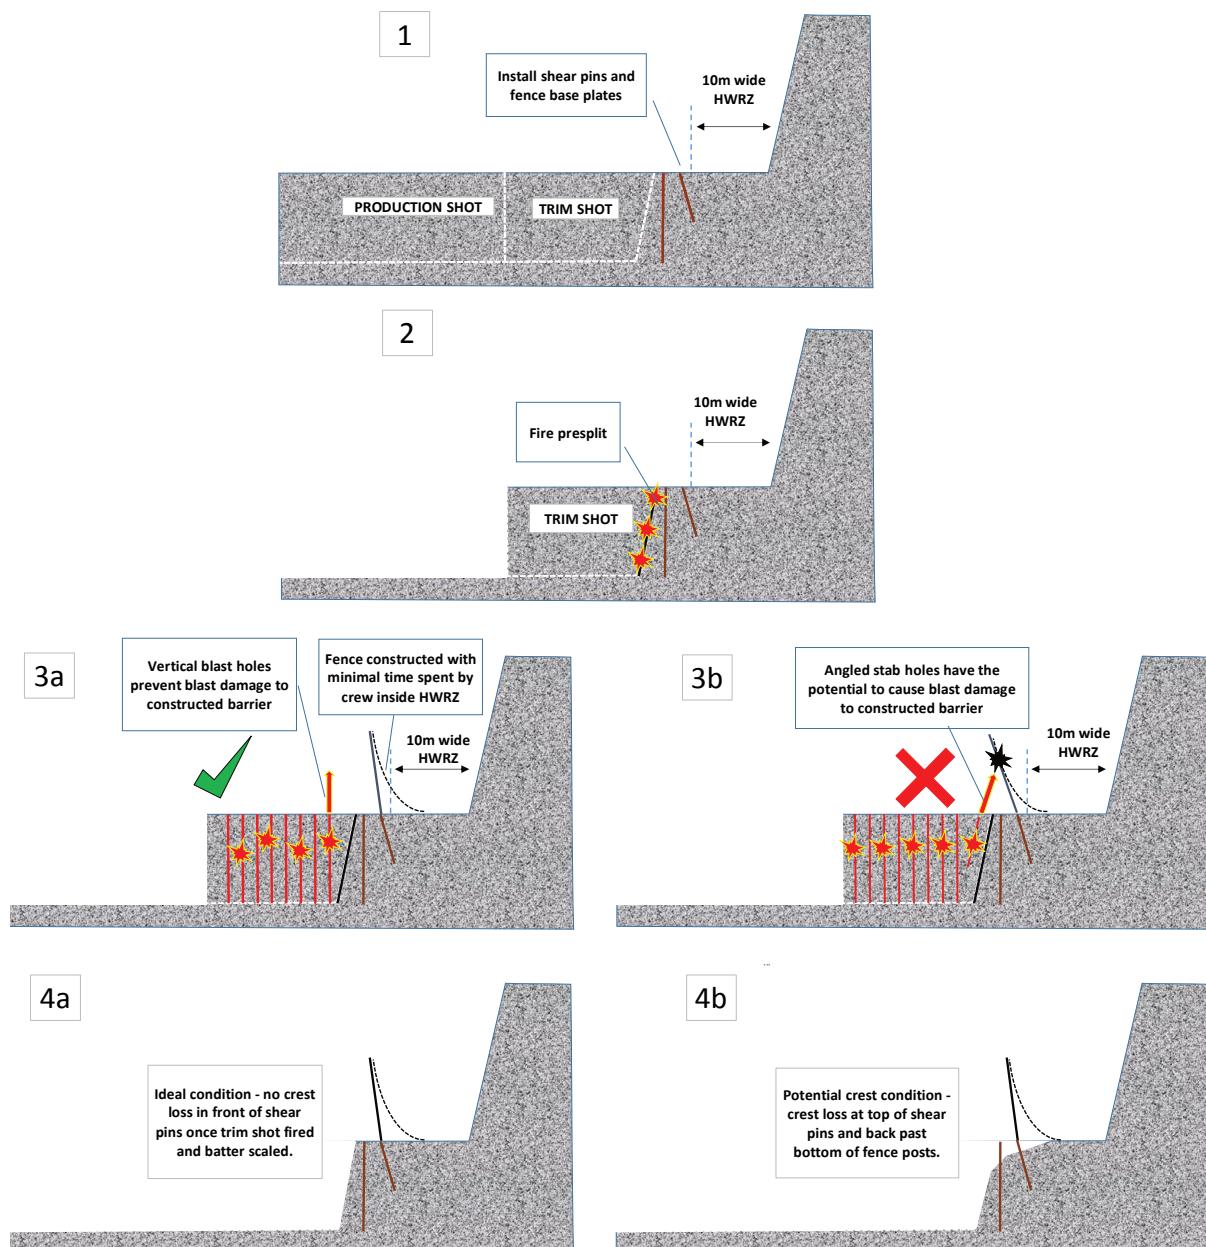
Figure 5 Rockfall barrier construction and mining sequences

This sequencing is summarised in Figure 5.

- Upon reaching the fence berm, all scaling and washing of the batter was to be completed and the floor for 30 m out from the toe was to be fully dozed and graded. This provided a clean working platform and the space for a subsequent trim shot in front of the fence.

- The mining production crews were then free to continue mining the main production shots in the centre of the pit.
- The shear pins, the fence post holes and the fence anchor holes were remotely drilled.

- The shear pins and fence posts were installed by a crane, located outside the restricted zone.
- Agitator trucks were used to grout the pins and posts by travelling along 12 m off the wall and grouting via an extended chute.

- After grouting the pins, a row of pre-split holes was drilled along the crest line and then fired 24 hours after the pin grouting had been completed.

- The fencing contractor was then mobilised and grouting of the anchors occurred. In this instance, the back anchors were quickly placed in the holes near the toe of the slope. A long poly grout line was placed into the anchor hole allowing grout mixing and pumping to occur from outside the 10 m restricted zone.

- The fence posts, with the support ropes and pulleys attached, were then erected; with men looping the support cables back through the anchors and then tensioning the cables. This process placed the men close to the highwall for extended periods and was the period of highest risk.

- The upper longitudinal rope was placed and tensioned and the top of the posts securely clamped.
- Bundles of Rocco ring mesh were then lifted and the support cables placed through the upper Rocco rings and pulleys; followed by a repeat with the lower cables. For the revised design, the fencing contractor was again required to work inside the restricted zone to attach the lower row of Rocco rings to the back-anchor cables.

- The Rocco ring panels were then pulled out like curtains and the panels were shackled together, always working in front of the mesh.
- The last stage of construction was to place secondary mesh from the top support rope down behind the Rocco mesh and to then clipped them together. Most of this work was carried out from elevated work platforms or from the ground outside of the mesh.

- Following the completion of the fencing, the production crews would then drill and fire the trim shot back to the pre-split.
- Production excavation of the trim shot was followed by careful mechanical scaling to ensure the shear pins and fence were not damaged. Most of this work was carried out on day shift under the direction of the geotechnical department.

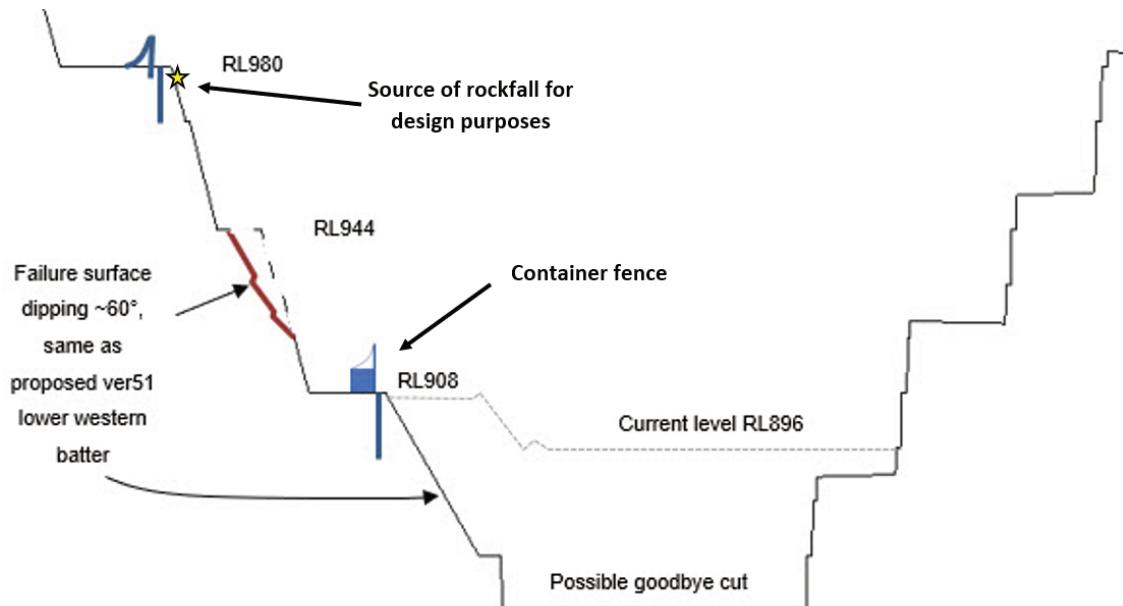
Figure 6 Container fence and rockfall simulation cross-section

Mining One carried out a rockfall assessment using RocFall software to determine the optimal width of the berm and location of the container fence. The RocFall assessment assumed that tabular shaped blocks of rock of various weights would originate from just below the RL 980 level. Rockfalls above that level were assumed to be retained by the high-energy rock catch fence on the RL 980 berm. There was no effective berm to retain rockfalls at the RL 944 over most of the affected area, due to a major rockfall. This meant that the design rockfall height needed to be 72 m, as shown in Figure 6.

As the Giant Pit approached the lower levels of the cutback, the size and frequency of rockfalls on the west wall increased, with several falls in the several hundred tonne range. The reasons for the increased size was thought to be related to a steeper 60–70° joint set, referred to as J4 joints, and the gradual dilation of the wall that had been standing for almost two years. The mine plan had the pit reaching its final depth of 360 m before the autumn rains in 2019. To counteract these rockfalls, the mine design over the lower 60 m was altered to flatten the batter slopes to 60° and to leave a wider berm at the RL 908 level. Not being able to quickly order and construct a Geobrugg high-energy fence within the short time frame available, an alternative container-based fence was designed between the site staff, Mining One and Geobrugg, refer to Figure 6.

RocFall simulations were calibrated to HGO's comprehensive rockfall database, by adjusting parameters that control the interaction of falling rocks with the batter face and benches. Rocscience RocFall software provides a comprehensive table of suggested parameters. It was found that parameters that were much lower than those suggested by Rocscience needed to be used to produce realistic simulations. Parameters for the rock batter and bench surface are provided in Table 1. Rock parameters are summarised in Table 2. The shape and initial rotation of -60° were chosen to simulate tabular blocks sliding on J4 joints.

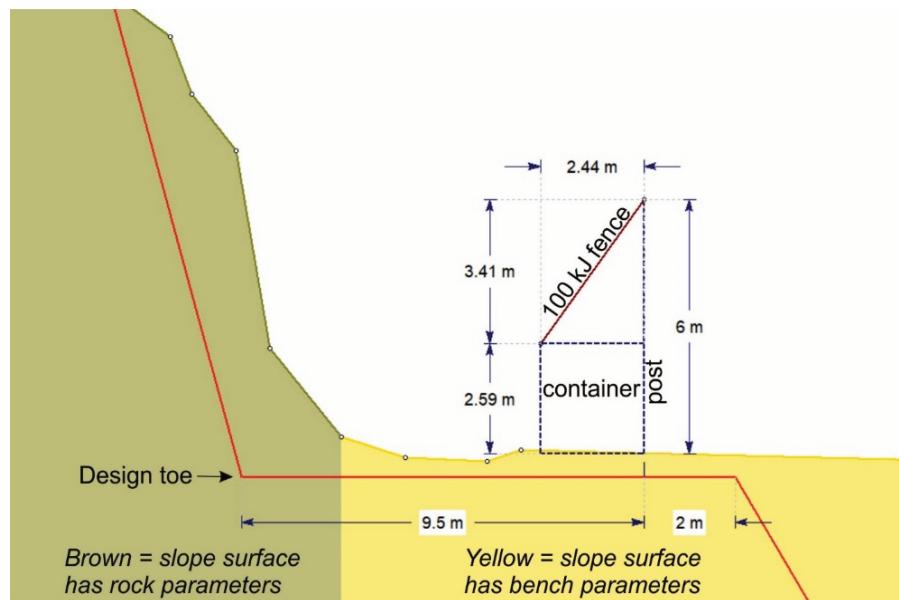
Figure 7 Arrangement of container fence relative to original design and as-mined slope

Figure 7 shows the representation of the container fence in RocFall. The two shades of slope materials represent rock/surface interaction parameters for rock surfaces, and floors or benches.

The container fence was represented in RocFall as a series of 'collectors', which are virtual boundaries that count the number of rocks falling through them. Collectors were used for the fence on the container, to record the number of rocks striking the fence and their energies of impact. Collectors were also extended above the fence, to record the number of rocks that cleared the fence. For this assessment, the containers themselves were assumed to be impenetrable.

The distance of 9.5 m shown in Figure 7, from the original design toe to the outer edge of the container fence, was the average distance that containers could be placed on the original design. In the analysis, this distance was then varied to determine the optimum location for the container. In the highest risk area, where the RL944 berm was lost, the outer edge of the containers to achieve the best effective results was determined to be a distance of 16 m from the toe. To allow for the shear pins and some crest loss, the revised crest line was placed a further 2 m off the container. The mine design was then altered to allow for the new container fence and to flatten the lower batters to 60°. The reduced batter angle of 60° below the berm was adopted to reduce the risks of failures along J4 or J1 structures undermining the containers.

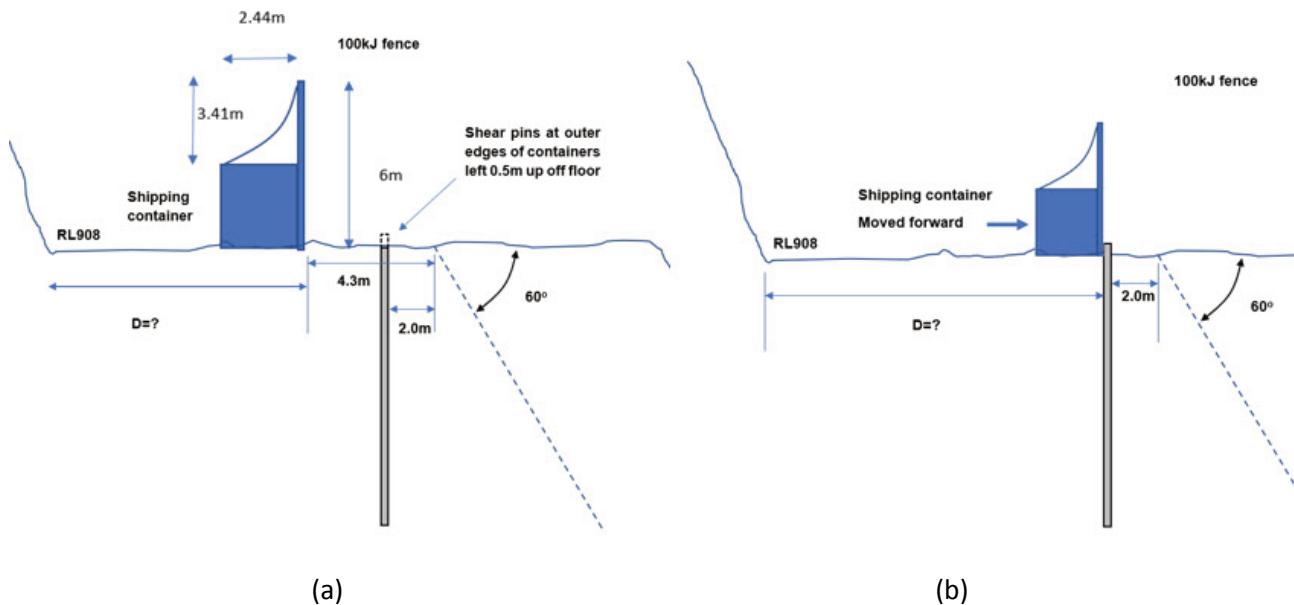
Figure 8 Container barrier concept

Figure 8 shows the concept of staging the container fence and its position on the berm. The containers were placed in an initial position (Figure 8a) to provide a safer working area to install the shear pins and to drill, load and fire the pre-splits. At that point in time, the containers were not filled with sand, nor were they shackled together.

Once the shear pins and pre-splits were completed, the containers were manoeuvred further out to the shear pin line (Figure 8b) to increase the catch capacity. Once in their final location, the units were filled with sand then the units shackled together. The trim shot was then drilled, loaded and fired.

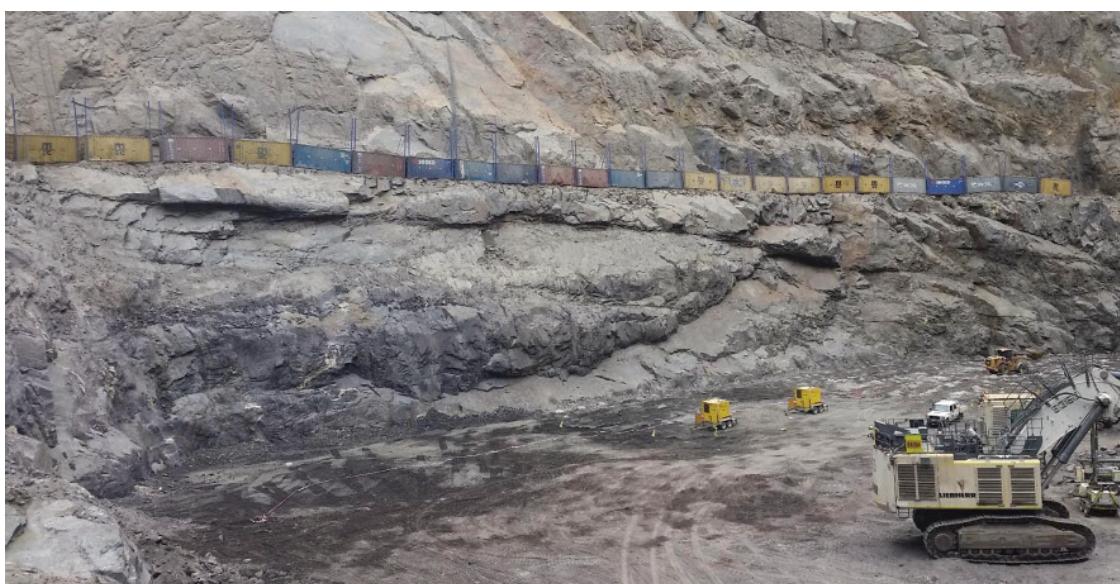
Figure 9 Completed container fence after excavating the batter below

The materials for the container fence were procured and fully installed within three weeks of deciding to build the fence. Figure 9 shows the completed container fence after the batter below it was excavated. The J1 joints are evident and are effectively retained by the shear pins with the 60° batter design also reducing the likelihood of undercutting by J4 joints.

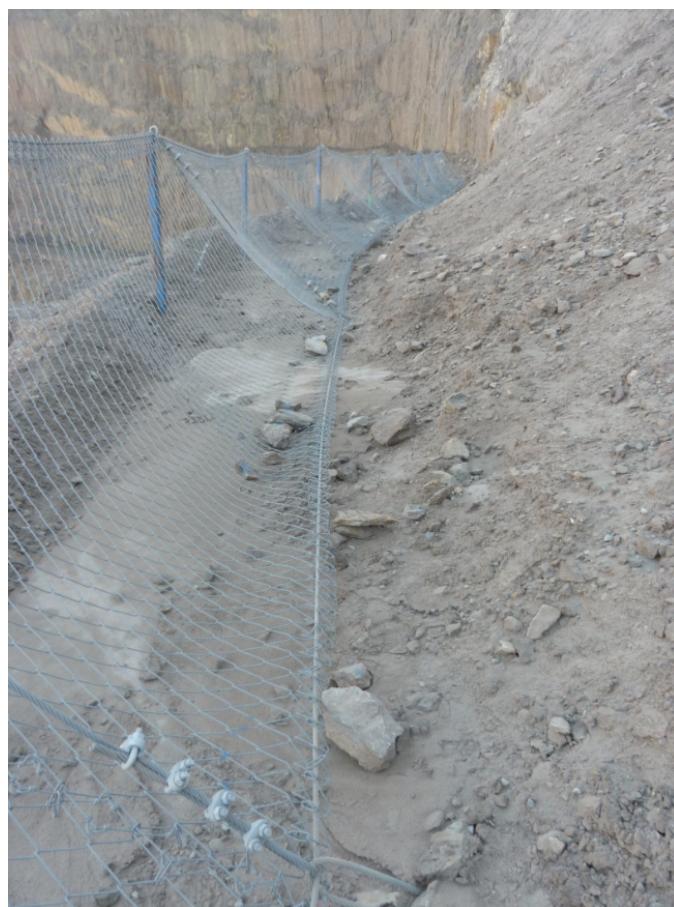
Figure 10 East wall T35 fence

Two Geobrugg T35 (35 kJ) type low energy rock catch fences were installed around the pit to control low energy rockfalls. In the case of the fence shown in Figure 10, the slope above the fence was a rill slope with mainly flaggy slabs of rock sliding down the slope. Occasionally, more rounded relatively lightweight rocks rolled down the slope and into the fence as can be seen in the photo. This fence was directly above the main haul road.

Examples of the smaller rocks retained by the T50 low energy fence can be seen in Figure 10; while a 5 t rock was restrained by the 3,000 kJ fence in Figure 16.

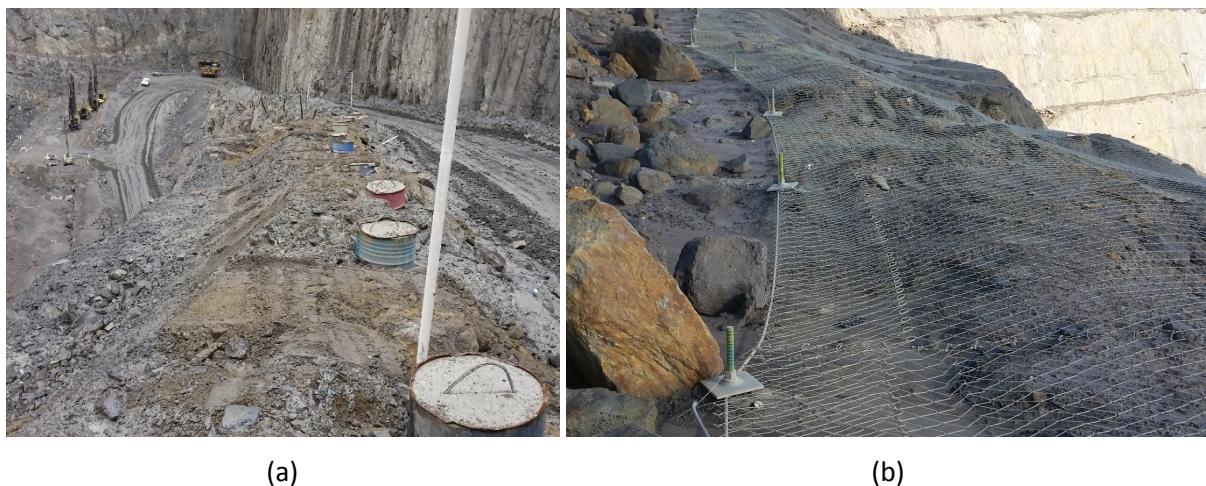
Figure 11 Drape mesh anchoring systems

Two methods of anchoring were used (Figure 11). Along the pit crests, 2 m long 25 mm GIWI® bars were grouted into the ground to anchor the upper supporting cable. Along the lower east wall ramp areas, windrows of loose rock were left as safety windrows preventing trucks from driving off the edge of the ramp. In such conditions, rock materials from the windrows often loosened and had the potential to fall down the underlying vertical rock batters. Where meshing of these areas was required, concrete-filled, 200 litre drums were placed into the safety windrows and the upper cable was shackled to wire rope loops set into the concrete.

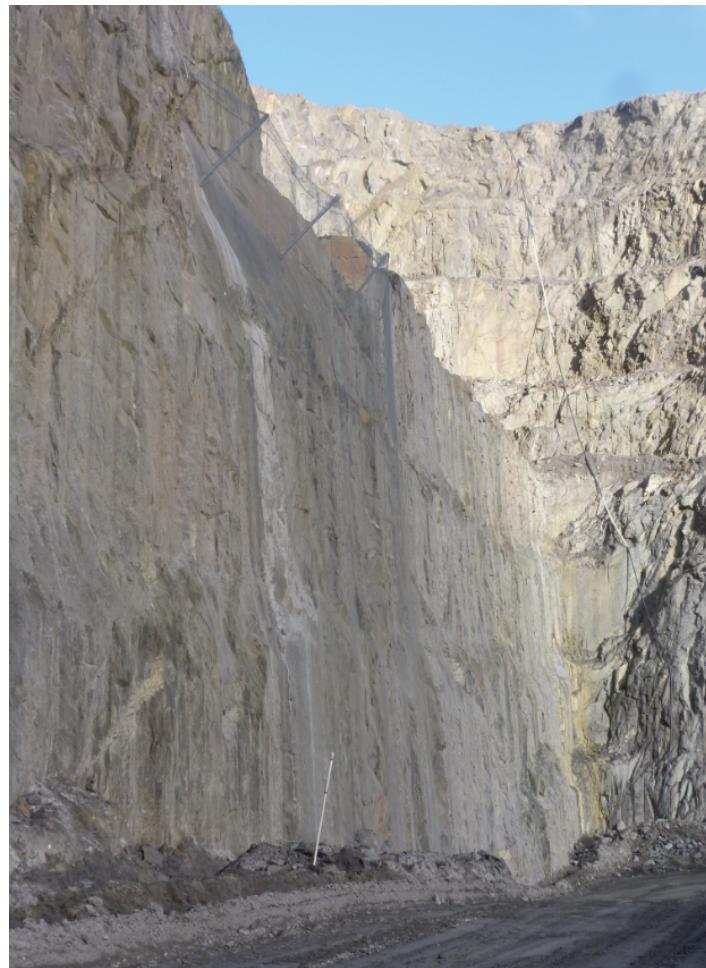
Figure 12 Attenuator fence

Several attenuator fences were installed where extensive berm losses occurred. These attenuators are designed to ‘capture’ blocks of rock falling from the batters above the lost berms and to then ‘control’ those blocks, as the rockfalls down behind the lower mesh. The upper mesh is typically designed for larger impact loading. The attenuator shown in Figure 12 was designed to control 2.4 t blocks falling from up to 36 m above the fence. The energies calculated from RocFall simulations were typically in the range of 500–660 kJ, with outliers of up to 800–900 kJ. The upper mesh designed to take the initial impact of the fall was Tecco 65/4 mesh, while the lower control zone was comprised of Minax 80/3 mesh.

Prior to installing the attenuator, the batters above were thoroughly scaled over two days to remove as much loose material as possible. The work on this fence then took an additional eight days with the rope specialist working 10-hour day shifts. Trucking continued on night shifts and for most of the day shifts as an offramp was constructed just above the work area. The ramp directly below the work area was then windrowed off allowing protection to the crews and crane that took up the full width of the lower ramp.

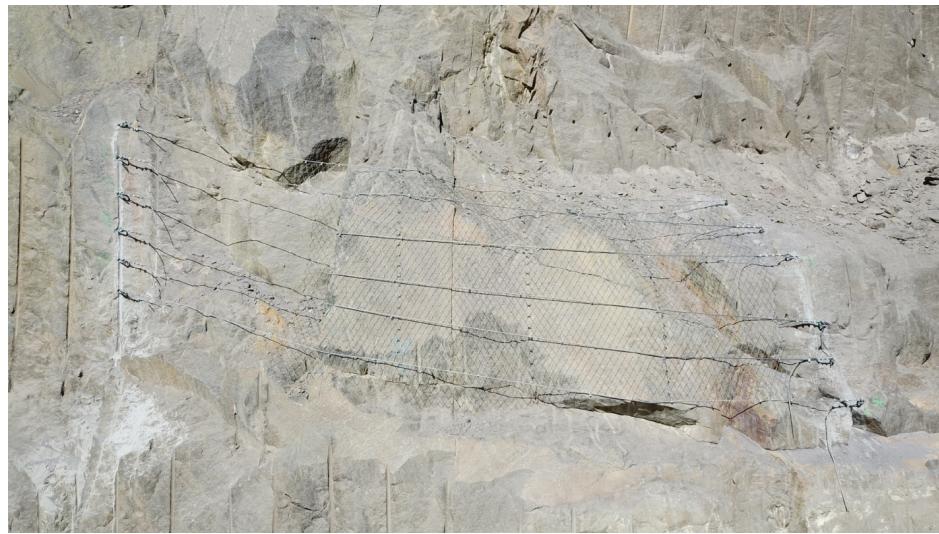
Figure 13 Cable strap/mesh installation

Where large potentially unstable blocks were identified and could be reached by cranes, cable strapping was employed to prevent such blocks from working loose and cascading down the slope. One such block is shown in Figure 13. This block was directly above the attenuator fence of Figure 12. During the initial scaling process, before the construction of the attenuator, the block had been noted but it appeared to be stable. Several months later during routine batter inspections (using binoculars), small cracks were identified around the block. A drone was flown over the area and then a rope specialist rappelled down to inspect the area and confirmed the recent movement. In such cases, the block would normally have been scaled or air bagged off the slope. In this case, the attenuator fence was directly below the block. Due to the size of the block, the attenuator would likely have been badly damaged or possibly destroyed if the block was scaled off the batter. Upon confirming the movement, a cable strapping/mesh reinforcement system was designed by Geobrugg, which also mitigated the need to work directly below the potentially unstable block. The system was installed by drilling anchors from a crane basket on either side of the block, with Spider mesh then hung off the upper cable and draped down over the block. Additional cables were then strung over the mesh and tension across the block as can be seen in Figure 13.

Most of this work was carried out from the dog box lowered by the crane placed on the upper crest over three days. As the crane was out of the way and the attenuator was in place to control any small blocks that may have become dislodged, trucking continued directly below as the works were undertaken.

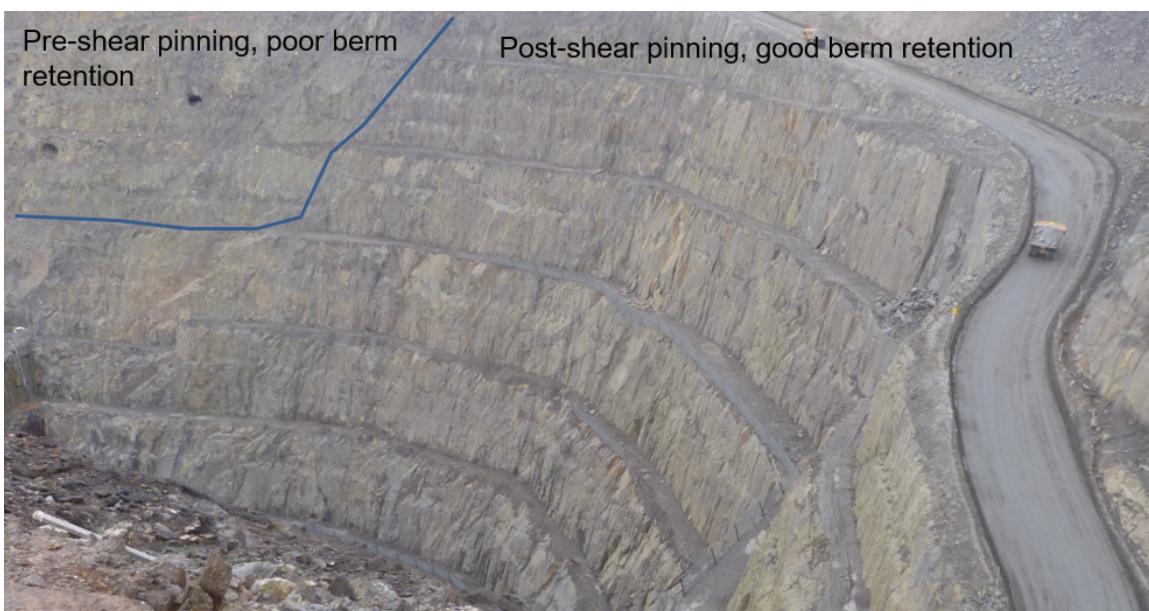
Figure 14 Southern and western walls of Giant Pit

The effectiveness of the shear pinning can be seen in Figure 14. The left-hand side of the photo was a previous remnant wall from the Spitfire Pit, where no shear pins had been utilised. Very few portions of those berms were retained. In contrast, the centre and right-hand side of the photo, where shear pins were installed showed greatly improved berm retention. This was not always the case. A 160 m long attenuator fence was required on the RL 1154 level of the northwest wall after a trim shot was initiated and sequentially fired in the wrong direction. This resulted in gases entering a long continuous discontinuity and lifting the complete berm off the underlying discontinuity.

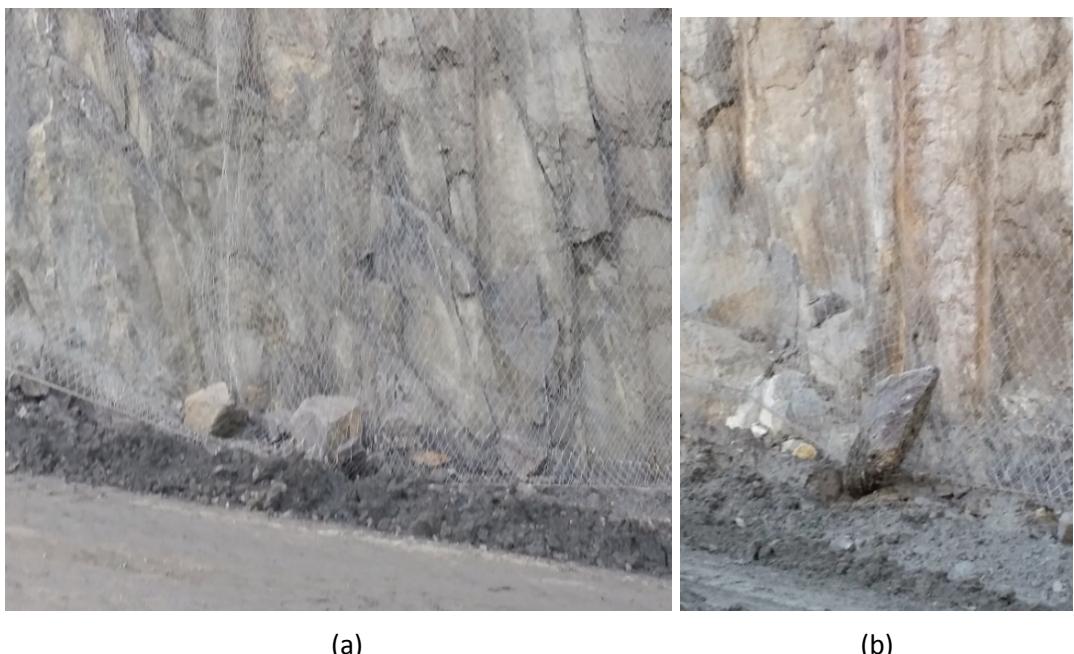
Figure 15 Drape mesh rockfall control

Examples of rocks controlled by the drape mesh can be seen in Figure 15.

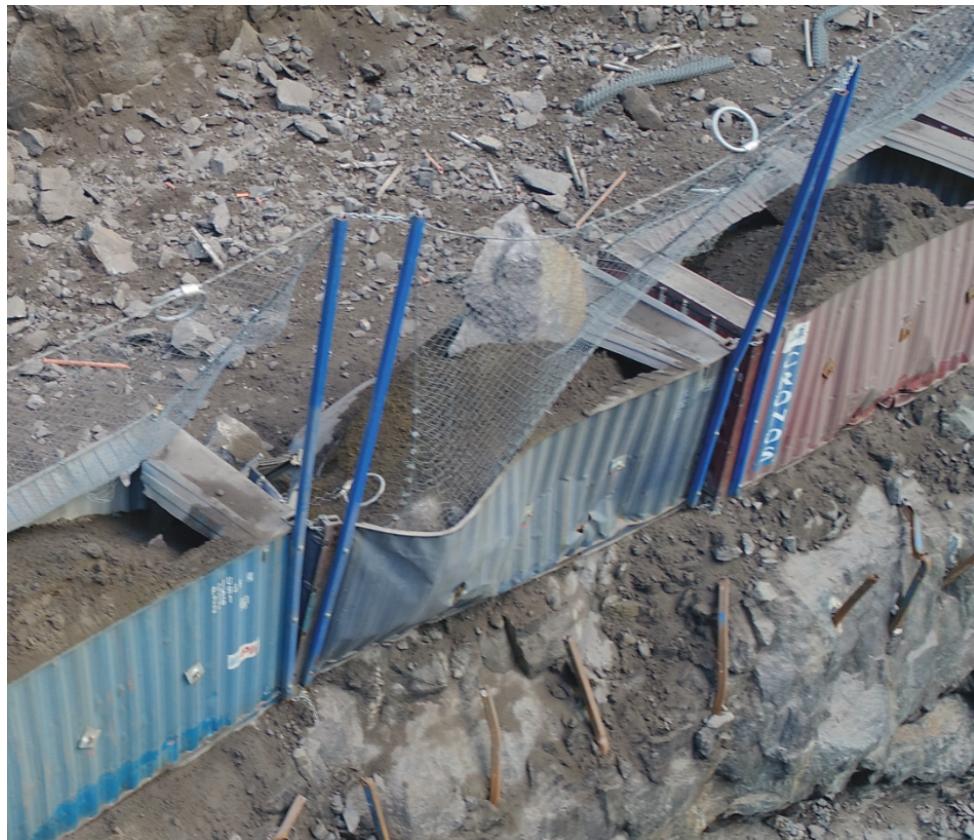
Figure 17 Container fence effectiveness

The container fence also proved to be very effective, as can be seen in Figure 17, where two major sized blocks from rockfall RF872 are lodged in one container. For a further discussion of the detection of this rockfall, refer to Hutchison & Chambers (2020).

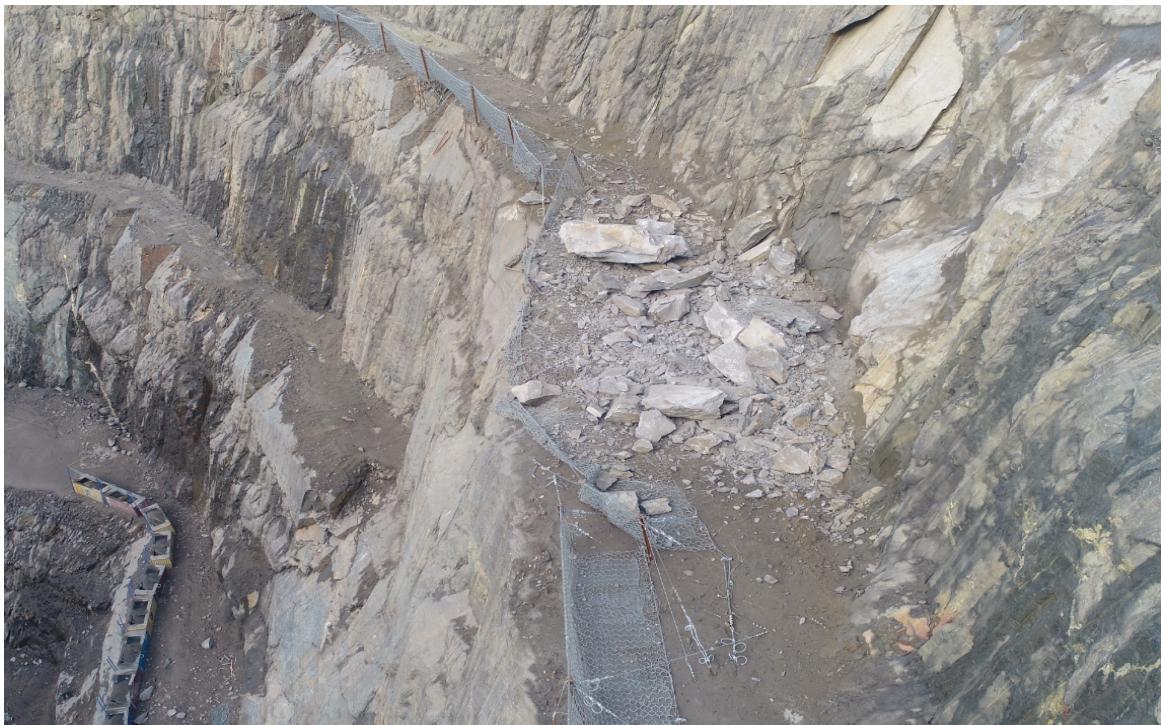
Figure 18 Rockfall 872

In the case of rockfall RF872, the RL988 berm and rock catch fence retained the majority of the 2,464 t rockfall, but as can be seen in Figure 18 the rock catch fence was effectively destroyed. Three large blocks made their way down to the RL908 berm and container fence. One block initially hit the berm and careened into the side of the container, without displacing it. The other two blocks landed in/on another container, as shown in Figure 17. A few small blocks of rock (<100 kg each) flew over the container fence and came to rest amongst parked up equipment on the pit floor.

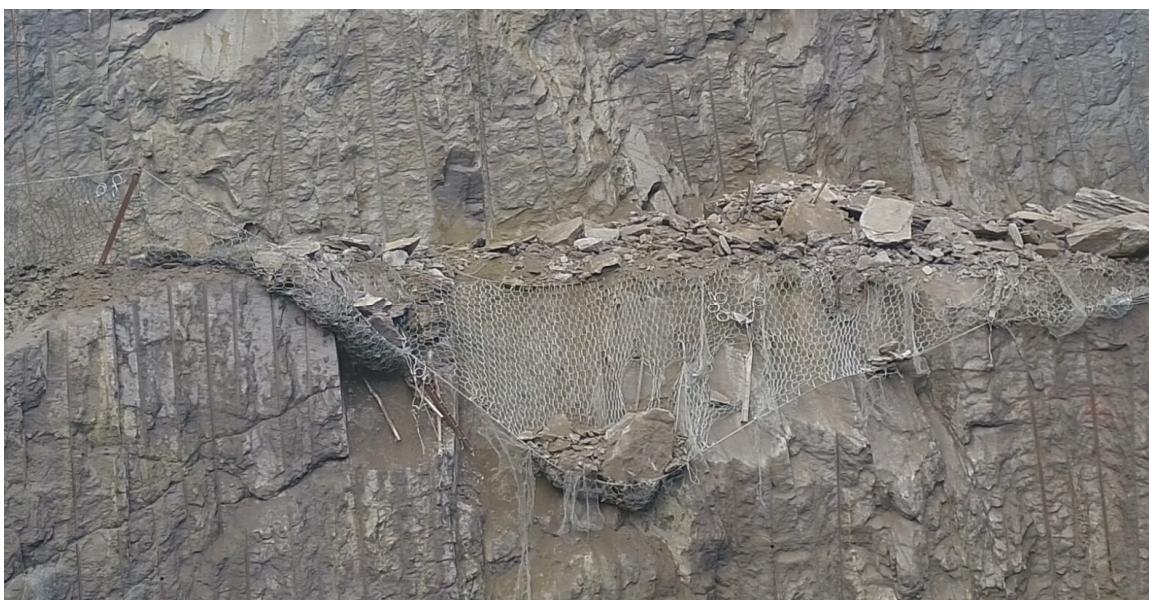
Figure 19 Rockfall RF879 – destruction of RL988 rock catch fence

Rockfall RF 879 was comprised of 1,250 t of rock material. The fall was instigated by heavy rainfall and occurred from 100 m above the RL908 berm. The source was a shear pinned crest that had initially been supported by shear pins 20 months before the failure. The RL988 fence under this rockfall was also destroyed (Figure 19), as was the container fence (Figure 20) which was hit by several large blocks up to 16 t. In this case, several larger blocks, in the order of up to 5 t, reached the floor.

Although the two high-energy fences were ‘destroyed’, they and the berms, were effective in controlling over 98% of the rockslide material, with only four large blocks reaching the pit floor. Due to the rain and the known increased rockfall risks, all production had ceased and the pit had been abandoned on the days before the two rockslides, so no one was put at risk.
