Slope performance monitoring and management of a pit wall experiencing large-scale deformations near Kalgoorlie, Western Australia

JW Watton *PSM, Australia*

MJ Fowler *PSM, Australia*

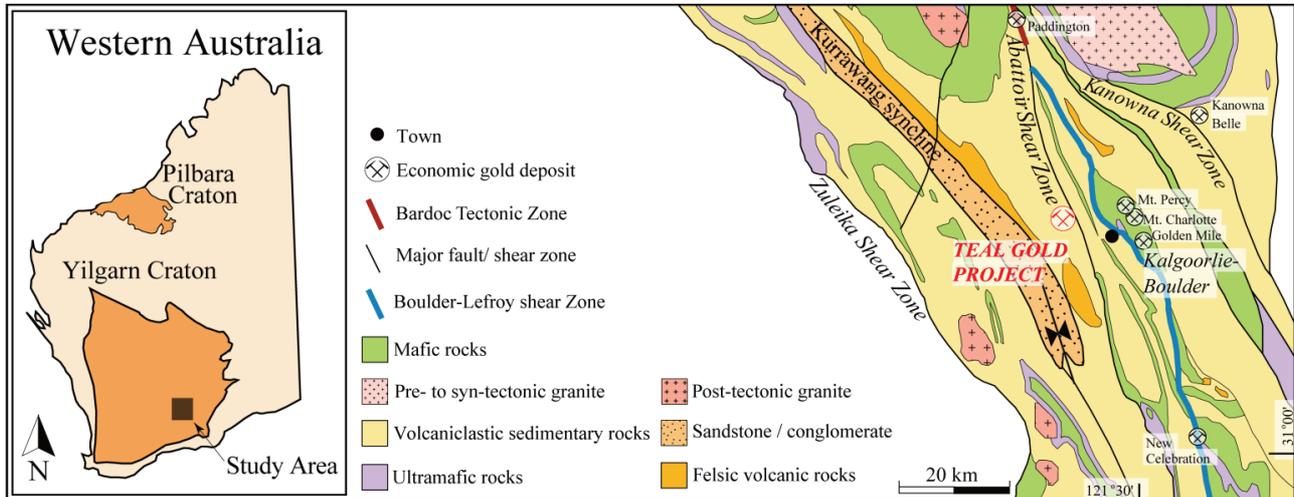
Figure 1 Locality and regional geology map (after Morey et al. 2007)

The Teal Gold Project is a small-scale open pit gold mine located 11 km northwest of Kalgoorlie, within the Goldfields Region of Western Australia as shown in Figure 1. The open pit was mined for approximately 18 months, up to early 2018. The open pit is approximately 500 m long × 150 m wide and was mined to a final depth of approximately 50 m.

The Teal Gold Project is located 700 m west of the north-northwest trending Abattoir Shear Zone as shown in Figure 1. Locally, the geology consists of transported sediments overlying caprock and a weathered, foliated sequence of felsic tuffs, porphyries and intermediate volcanics. The volcanic sequence is

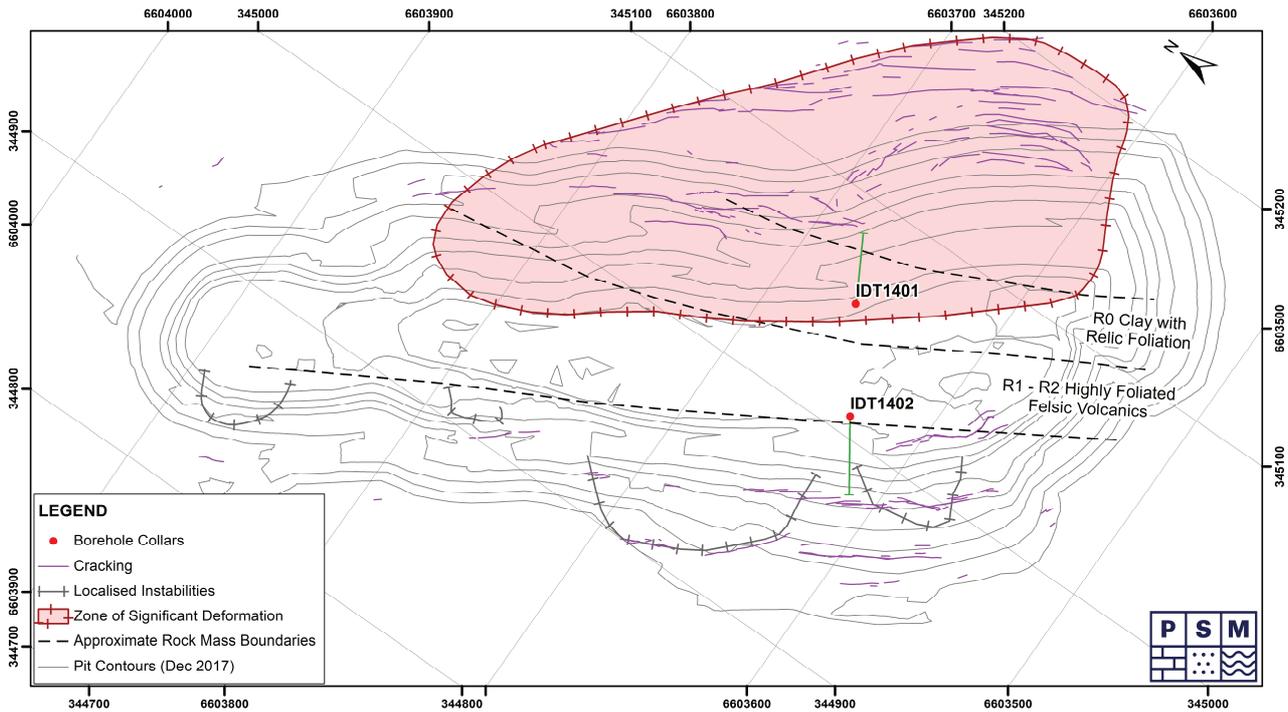
The geotechnical site investigation comprised two geotechnical boreholes with a total length of 145 m. The HQ3 diameter boreholes were inclined at 60° and drilled into the east and west walls, near the southern end of the proposed final pit as shown in Figure 2. Figure 2 presents an engineering geological plan of the Teal Gold Project, including:

- Borehole traces.
- Final pit contours.
- Tension cracks.
- Reported instabilities.

Figure 2 Teal Gold Project site plan, showing instabilities and observed tension cracks

Significant slope instability was observed during mining. Approximately 75% of the eastern pit wall and 30% of the western pit wall deformed during mining as shown in Figure 2. Figures 4 and 5 show examples of slope instability along the western and eastern pit walls, respectively.

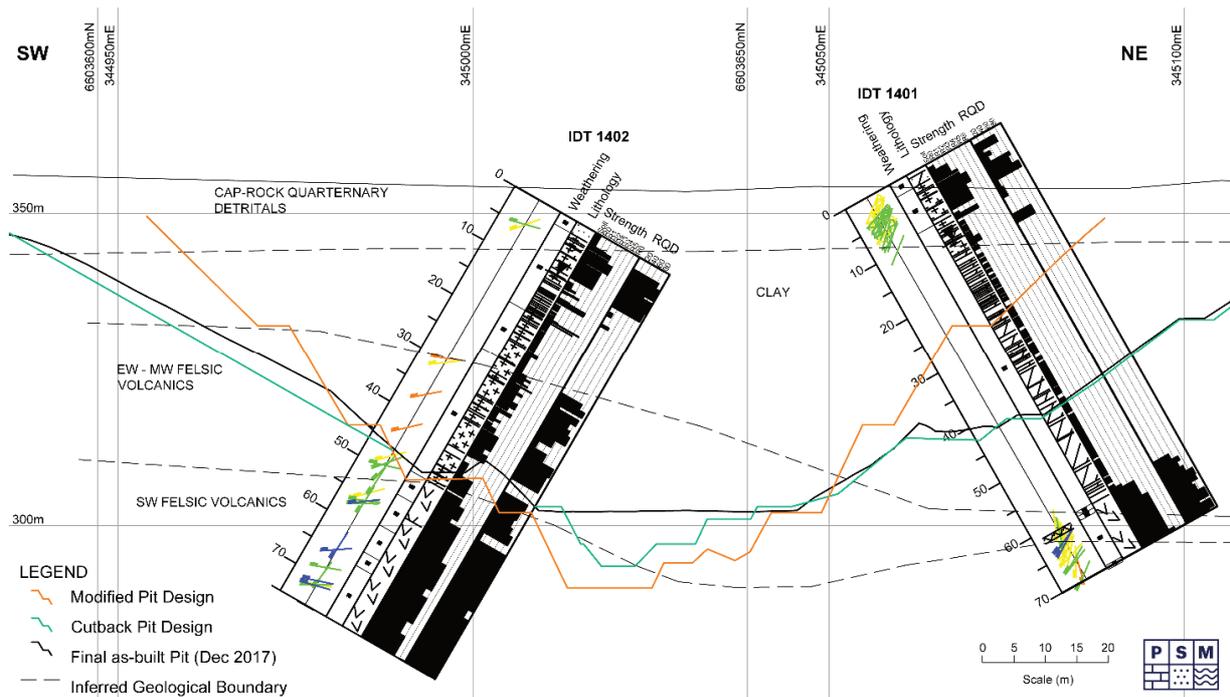
The geotechnical model was developed based on a combination of the resources model and the geotechnical drilling. Three geotechnical rock mass domains were defined as described in Table 1 and as shown on the interpretive geotechnical cross-section presented in Figure 3. The groundwater table was initially estimated to be approximately 40 m below the ground surface, based on limited observations from nearby boreholes. However, permeability in the clay was interpreted to be relatively low, and any natural drainage from the slope was expected to be limited.

Figure 3 Interpretive cross-section of the Teal Gold Project, showing the deep clay weathering profile

These design modifications combined with the encountered geotechnical conditions resulted in an increased geotechnical risk for the operation. The modified pit design is shown in Figure 3 and a discussion of the increased risk is presented in Section 7.

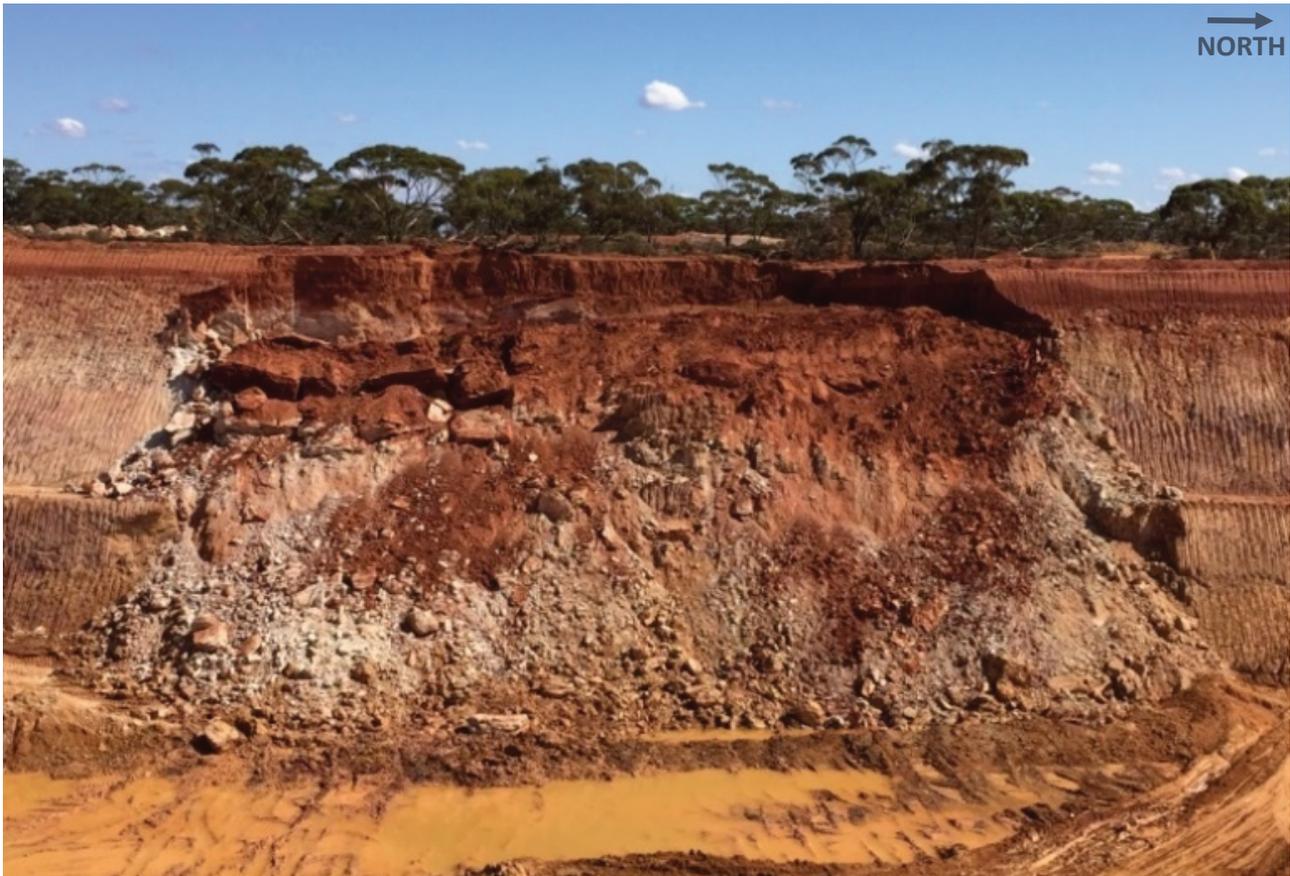
Figure 4 Observed instability along the western pit wall. Instability is 20 m in height

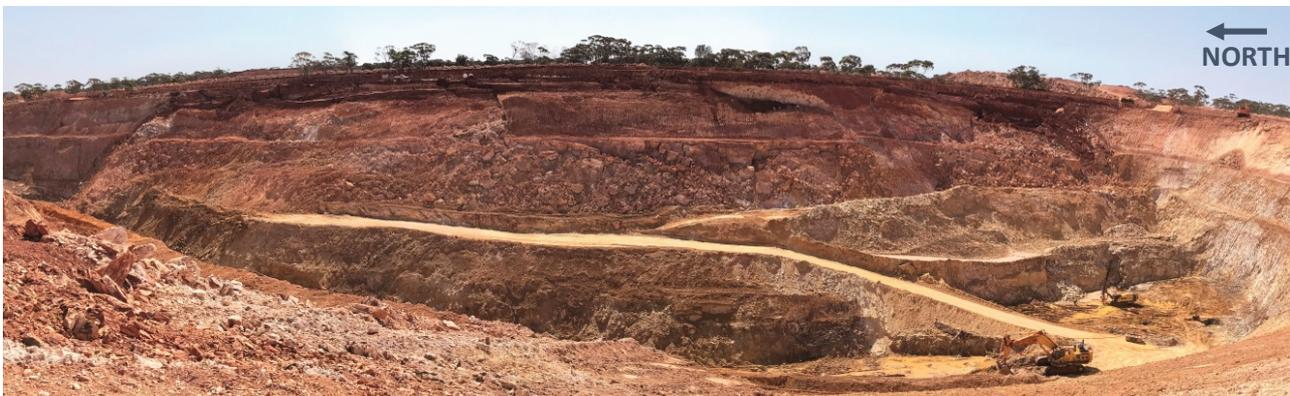
Figure 5 Eastern pit wall before slope unloading, showing the large-scale instability and strategic buttressing material (midground). Pit wall is 40 m in height

Slope monitoring initially consisted of geotechnical inspections and prism monitoring. As the eastern pit wall buttressing material shown in Figure 5 was excavated, slope deformation rates increased significantly, reaching peak deformation rates of greater than 10 mm/hr. An example of slope displacements from the slope stability radar monitoring as shown in Figure 6.

Remedial slope modifications primarily comprised strategic toe buttressing of the eastern pit wall to reduce rates of deformation and sterilisation of ore, followed by unloading the pit crest using a cutback as shown in Figures 5 and 8.

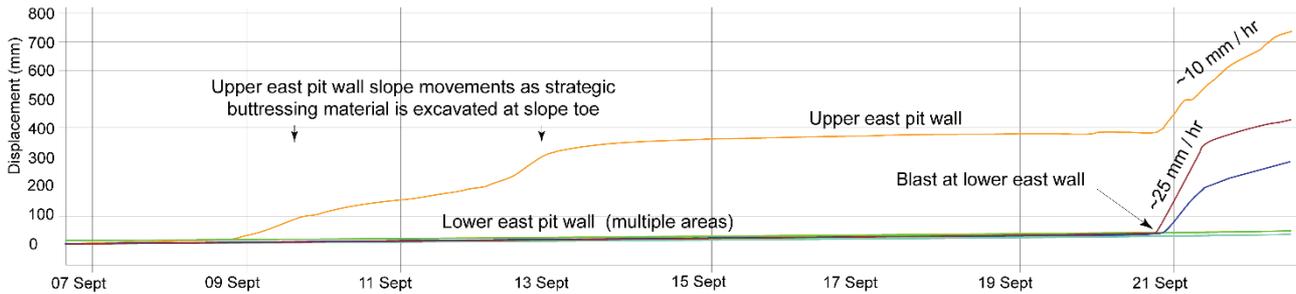
Figure 6 Slope stability radar displacement plot

The TARP utilised both rainfall and displacement triggers. Displacement trigger levels were automated and based on back-analysis of initial radar monitoring, including the time taken for displacement rates to return to prior levels following a blast or failure. The displacement trigger levels are summarised in Table 3. The TARP also established exclusion zones for personnel and equipment most at risk (i.e. people on foot, light vehicles and stationary ancillary equipment such as pumps).

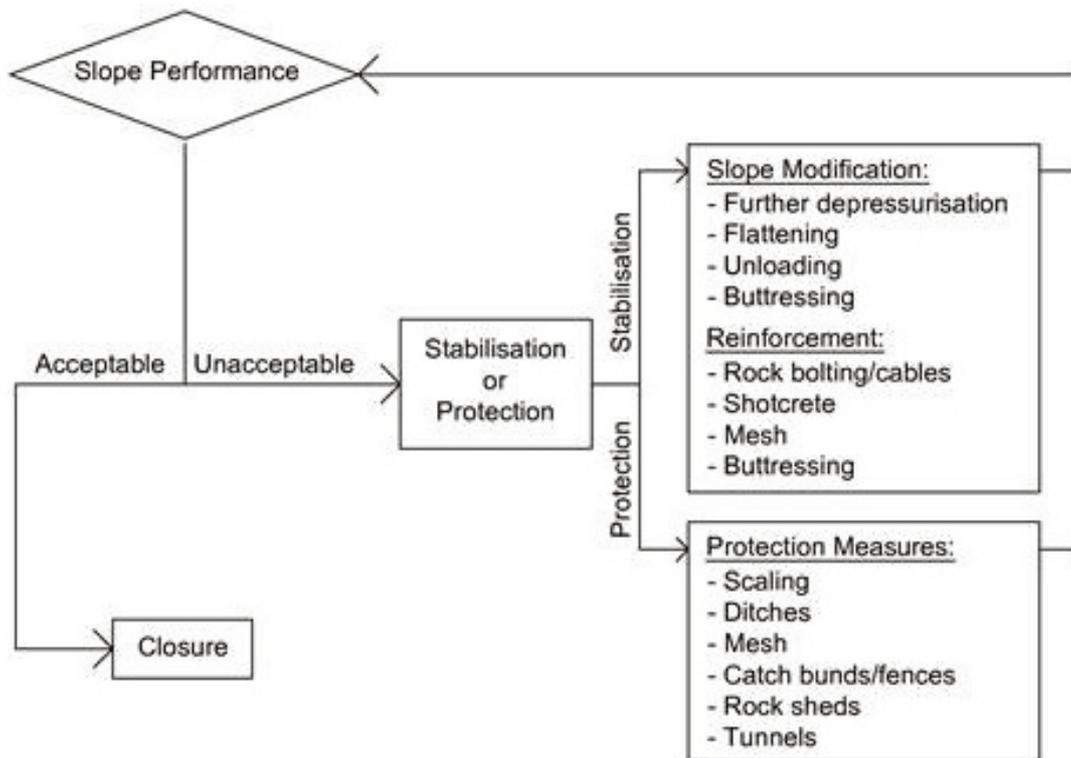
Numerous remedial measures are available for the geotechnical management of unstable pit slopes. The 'slope performance toolbox' (Fowler 2016) is shown in Figure 7 and presents a flow chart of available remediation measures. Typical slope remediation measures comprise:

- Slope stabilisation:
 - Controlling groundwater through slope depressurisation and dewatering, and surface water through effective drainage and surface water management.
 - Decreasing the instability driving force through slope modifications such as crest unloading or a cutback that flattens the upper slope.
 - Increasing the instability resisting force through slope modifications such as toe buttressing, a step-in or flattening of the lower slope.
- Slope reinforcement such as rockbolts or cables, shotcrete and mesh.
- Slope protection such as wall scaling, mesh, ditches, bunds and catch fences.

Figure 7 Slope performance toolbox (Fowler 2016)

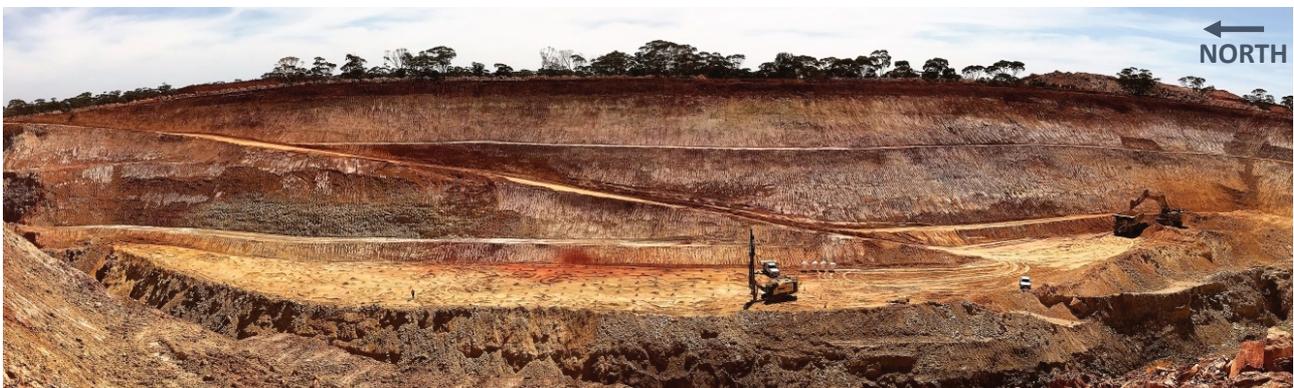
Figure 8 Eastern pit wall after slope unloading and approaching the completion of mining. Pit wall is 40 m in height

To minimise the loss of ore, cutbacks were preferred to a step-in of the design. Limit equilibrium analyses were conducted to assess the unloading requirements and the area was monitored post remediation to evaluate the slope performance and thus confirm the analysis results.

The cutback along the eastern pit wall also included a second ramp access to the pit, reducing the risk of complete loss of access to the open pit and decreasing the overall slope angle for the eastern pit wall.

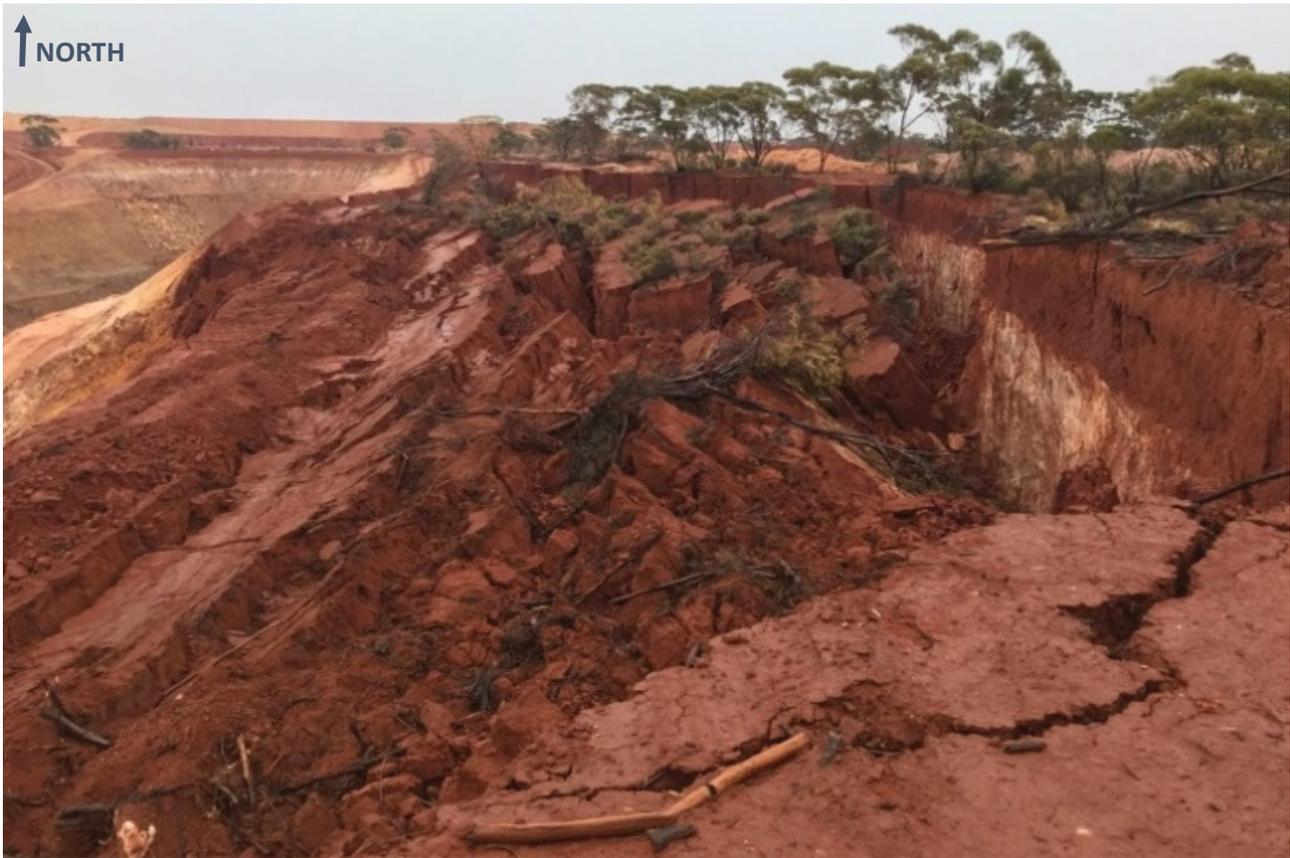
Deformation of the eastern pit wall continued at manageable rates until the completion of mining, with total displacements of over 10 m and cracking observed up to 90 m behind the crest of the eastern pit wall as shown in Figures 9 and 10.

Figure 9 Head-scarp of the eastern pit wall instability at the completion of mining

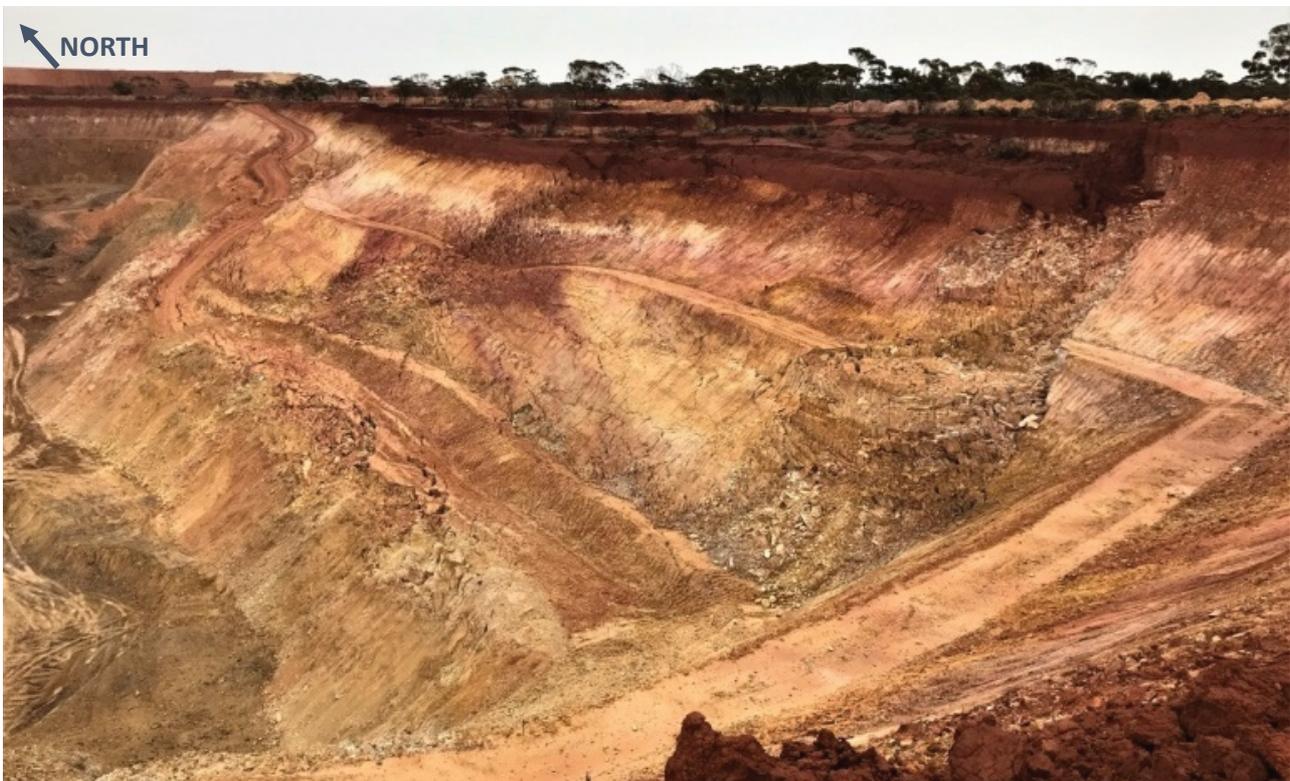
Figure 10 Eastern pit wall instability at the completion of mining. Note the dislocation of benches and deformation of the haul road
