Numerical back-analysis of highwall instability in an open pit: a case study

JM Kabuya *École Polytechnique de Montréal, Canada*

J Carvalho *Golder, Canada*

Abstract

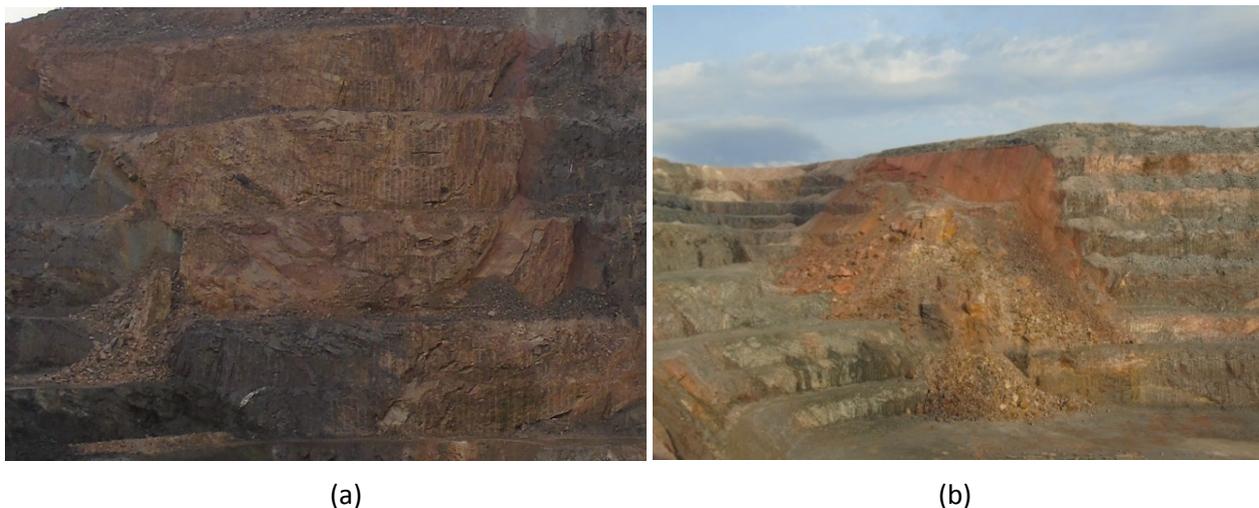
Figure 1 Southeast highwall: (a) Pre-failure (2018-07-02); (b) Post-Failure (2018-07-05)

In this paper, we carry out a numerical modelling study to back-analyse a highwall instability event which occurred in an open pit in Canada. The unstable highwall was over 125 m high and 200 m wide. The overall slope angle was 44°. This highwall's failure provided the opportunity to develop an understanding of the mechanisms and key sensitivities involved with failure of this magnitude. The instability in the open pit studied was identified in 2017 in the southeast highwall, consisting predominantly of a mass of foliated quartzite (QR) bounded by contacts with a more competent iron formation (IF) exposed on the pit wall. Photographs (such as Figure 1) show that a series of single to double bench scale wedge failures had developed on or near these QR-IF contacts prior to the main failure event, indicative of the low strength and unfavourable orientation of these structures (QR foliation and QR-IF contacts) relative to the pit wall. Kabuya & Henriquez (2017) completed a review of the instability in late 2017 and issued a memorandum summarising their findings, in which recommendations were made for engineering controls to limit the impact of a potential highwall failure. These controls included increased slope monitoring which incorporated movement trigger warnings and conducting a slope stability assessment prior to continuation of mining beneath the toe of the failure. In July 2018, the initial instability progressed into a multi-bench failure containing an estimated 3,000,000 t of rock, becoming one of the most significant instability events to have occurred at the mine site (see Figure 1b for post-failure photograph).

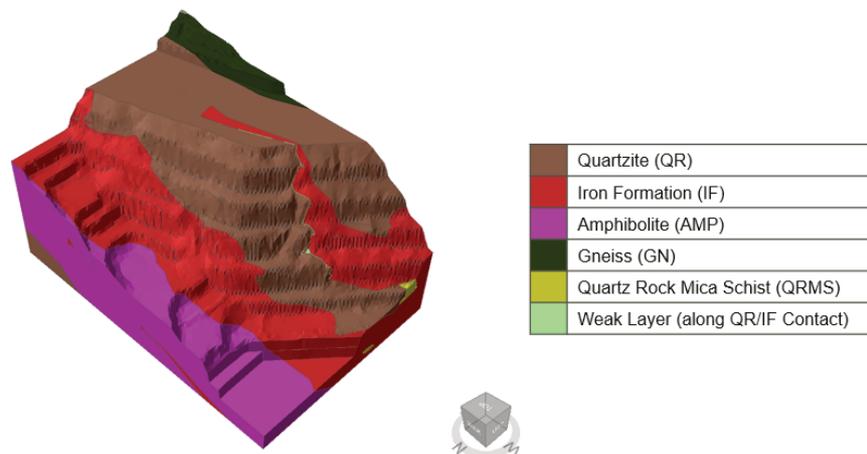
Figure 2 Geometrical model including the geological model

The geometrical model including the geological model used in the initial iteration of the base case model was depicted in Figure 2. The first model simulated isotropic rock mass strengths according to Section 3.3, without incorporation of directional weakness along the predominant orientations of discontinuities. The contact between QR and IF which appears to have formed a significant portion of the upper failure surface was assigned QR foliation strength parameters assuming 5% rock bridging (cohesion = 283 kPa, friction angle = 35.9°), making it weaker than the surrounding rock. Dry groundwater conditions were assumed. The results of the isotropic rock mass model indicated that the slope was stable (minimum FoS = 6.5), suggesting that the estimated rock mass strengths alone do not effectively simulate the directional weakness which can control stability when persistent discontinuities are aligned with a direction of potential sliding. Nonetheless, the geometry of the lowest FoS slip surface did match well with the observed extents of the failure as detected by the mine's GroundProbe slope monitoring radar, as shown in Figure 7a (compare to GroundProbe screenshot in Figure 6). Much of the western boundary, as well as the back-sliding plane and the lower east boundary of the minimum FoS surface, were constrained by QR/IF contacts, as expected. The critical surface extended to the 615 m bench elevation, breaking through IF at the toe, closely matching the interpreted extents of movement detected by the GroundProbe radar immediately prior to the failure (refer to the GroundProbe screenshot in Figure 6). Note that the model results presented in Figure 7a solely depict the extent of the main highwall failure event that took place on 5 July 2018. This scenario excludes the smaller failure that preceded the main event, which took place along the eastern boundary on 4 July 2018 as detected by the GroundProbe SSR.

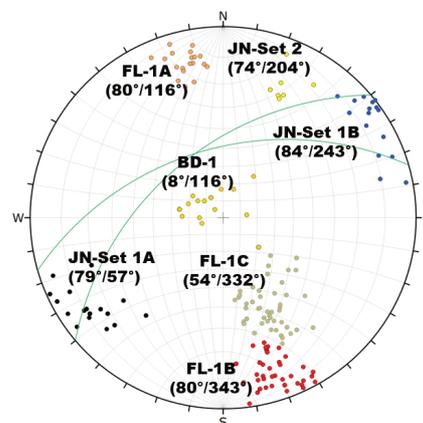
Figure 3 Structural interpretations of the southeast region of the open pit (Kabuya & Henriquez 2017)

Kabuya & Henriquez (2017) provided more specific commentary on the structural interpretation of the immediate area of highwall instability. The structural data were collected from photogrammetry mapping of the unstable highwall. Figure 3 presents a stereonet representative of the discontinuity sets and orientations. Discontinuities along foliation in the region of the failure are typically moderately to steeply dipping with strike near-parallel to northwest-facing pit wall (FL-1B, FL-1C, and FL-1A). Cross joints oriented orthogonally to the foliation are also present (JN Set 1A/1B, BD-1). Photos in Kabuya & Henriquez (2017) indicate that the dip of the foliation may flatten and become progressively shallower with increasing pit depth in the immediate area of the failure, which was investigated further in model calibration.

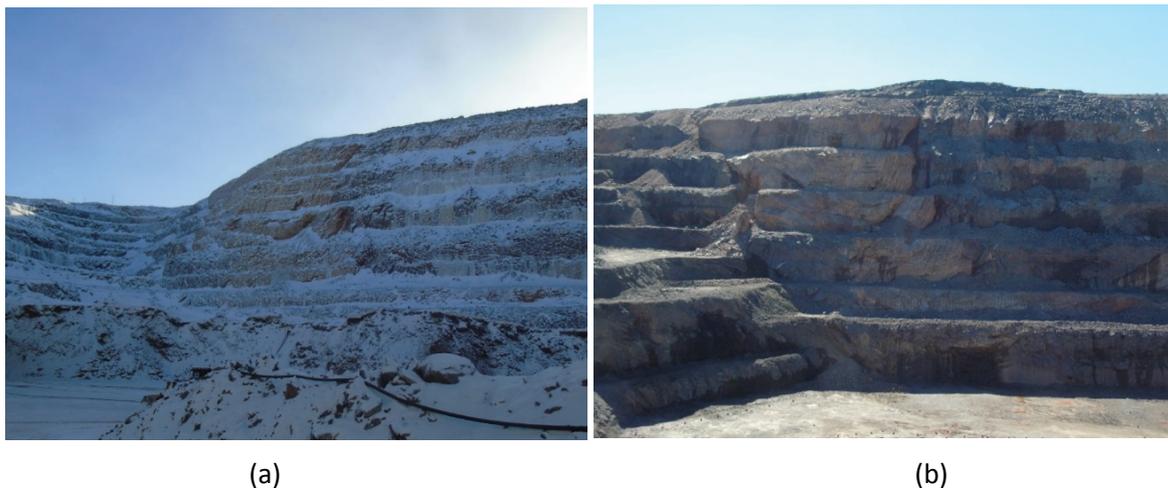
Figure 4 (a) Ice formation due to groundwater drainage surrounding the failure mass; (b) Post-thaw conditions of the slope surrounding the failure mass

conditions based on observed drainage on the slope surface is highly uncertain, the lack of drainage through the failure mass may be interpreted as a result of the groundwater flow encountering conductive features around the perimeter of the failure. While this suggests that much of the failure mass itself may be dry, pore pressure along bounding features and near the toe of the failure may still have contributed to the instability. An additional photo presented in Figure 4b, taken on 1 July 2018, shows the post-thaw conditions of the slope. Dark colouration on the rock mass suggests the presence of groundwater surrounding the failure mass extending to the crest of the slope while the failure mass itself is mostly dry, consistent with the interpretation of Figure 4a.

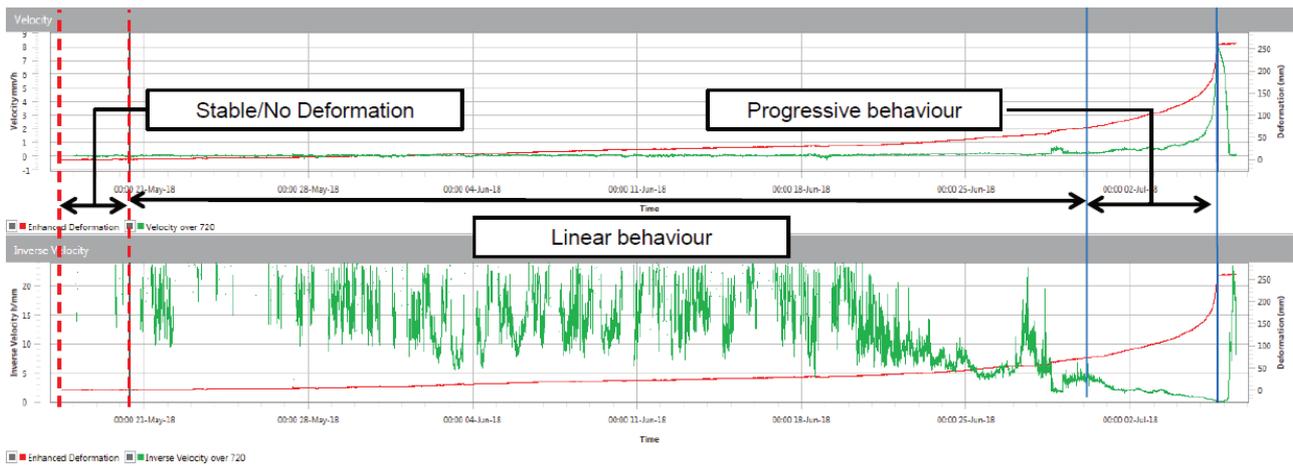
Figure 5 Sequence of highwall behaviour (GroundProbe 2018)

Following the identification of the instability risk in the open pit but prior to the highwall failure event, slope movement monitoring was established in the area of concern using a GroundProbe SSR (slope stability radar) unit. The purpose of the radar was to track the movement of the slope and to provide warning of any acceleration which could indicate imminent failure. For the purposes of this back-analysis study, the data collected by the radar system and summarised in GroundProbe (2018) were reviewed for potential insight into the progression, extents, and mechanism of the failure. According to the summary by GroundProbe, the SSR system detected a period of zero deformation between 17 and 20 May, followed by linear, stable creeping behaviour in the region of concern between 20 May and 30 June 2018. GroundProbe's back-analysis concluded that 30 June marked the onset of progressive failure, which continued until the eventual multi-bench failure at 16:40 on 5 July 2018 (Figure 5). Trends were analysed for pixel (63,16) which exhibited the highest deformation and velocity magnitudes. The pixel (63,16) size is 4.20 x 4.13 m. Accumulated deformation reached 253 mm prior to the failure, velocity increased from ± 0.25 mm/h to ± 8 mm/h, and inverse velocity decreased from ± 4.0 h/mm up to ± 0.125 h/mm (GroundProbe 2018). Figure 6 shows the slope movement data collected by the radar system just prior to the main failure event on 5 July.

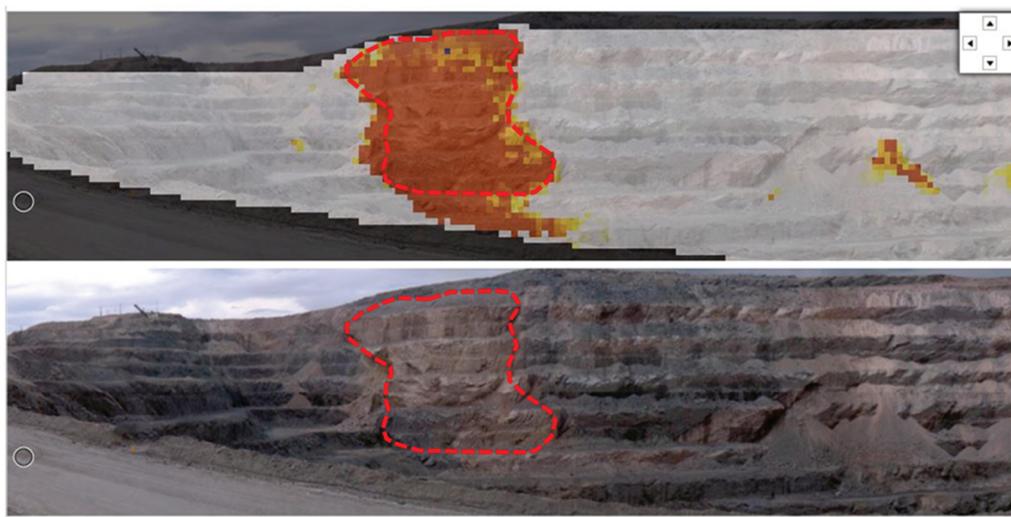
Figure 6 Slope movement area detected by GroundProbe radar prior to the 5 July main failure event

The precise toe ‘breakout’ elevation of the failure is unknown, as it remains covered by the broken rock which has run out from the failure. Based on the GroundProbe data, movement was detected prior to failure extending below the 600 m elevation bench which features a wide step-out. Photos and scans taken post-failure suggest that this bench did not fail. The movement detected by the GroundProbe may have been related to other interference (talus ravelling) or misalignment. Based on available data, it is expected that the toe of the failure did not extend below 615 m elevation, though the area remains buried in the failure run out.

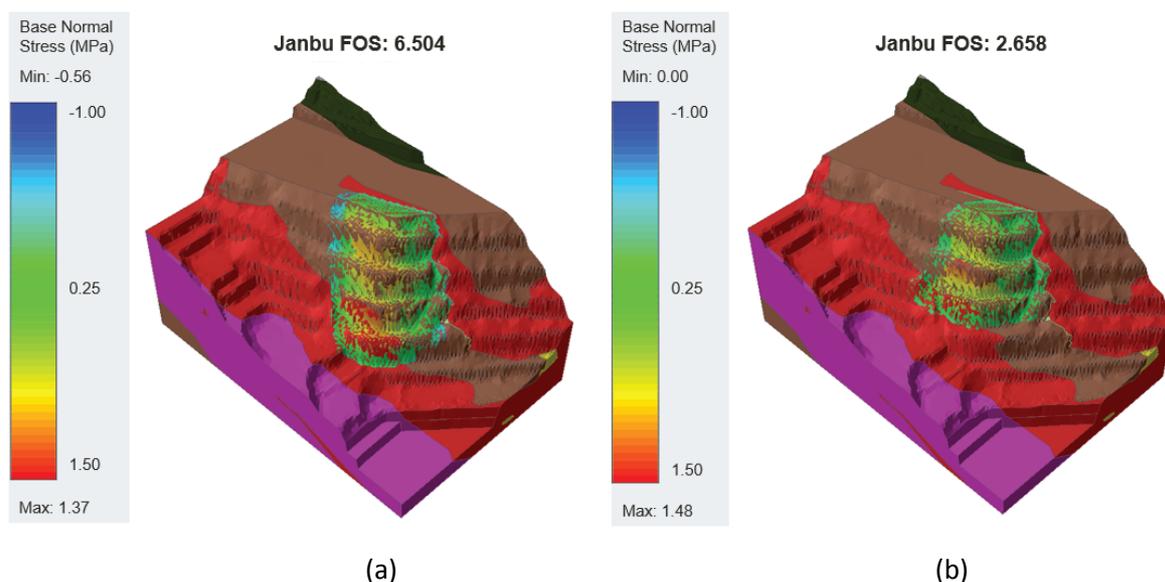
Figure 7 Critical slip surface: (a) V1 model; (b) V2 model

With the aim of reducing the slope FoS and to better represent the directionally-dependent strength of the jointed rock mass, anisotropic strength windows representative of the average orientation of Foliation 1B and 1C (67°/338°), and joint sets JN-1A (79°/57°) and JN-1B (84°/243°) were added to all rock units in the model, which resulted in a reduced slope FoS of 4.8. When anisotropic strengths representative of JN-2 (74°/204°) and BD-1 (8°/116°) were also added, FoS was further reduced to approximately 2.7 (Figure 7b).

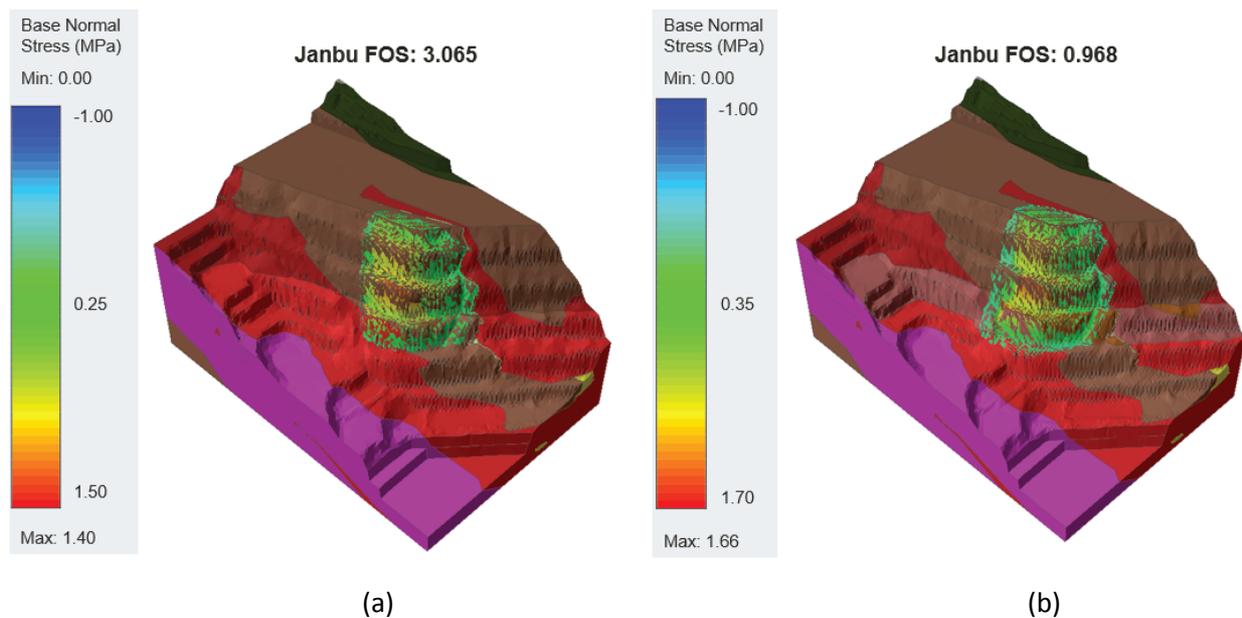
Figure 8 Critical slip surface: (a) V3 model; (b) Calibrated SLIDE3 model

The above parameters and assumptions produced a model with a minimum slope FoS of 0.97 for a failure surface which slides along the weakened QR-IF contact, exiting the slope at a minimum toe elevation of approximately 642 m, exploiting the weakened BD-1 joint set at the toe. Figure 8b shows an image of this failure surface. The same model, run without the influence of groundwater, indicated a slope FoS of 1.3. Equivalent models run using the 2015 and 2017 pit topography surfaces produced FoS values of 8.2 and 1.2 under wet conditions (as described above), respectively. This indicates that the pit wall was nominally stable at these earlier pit floor elevations, as expected.

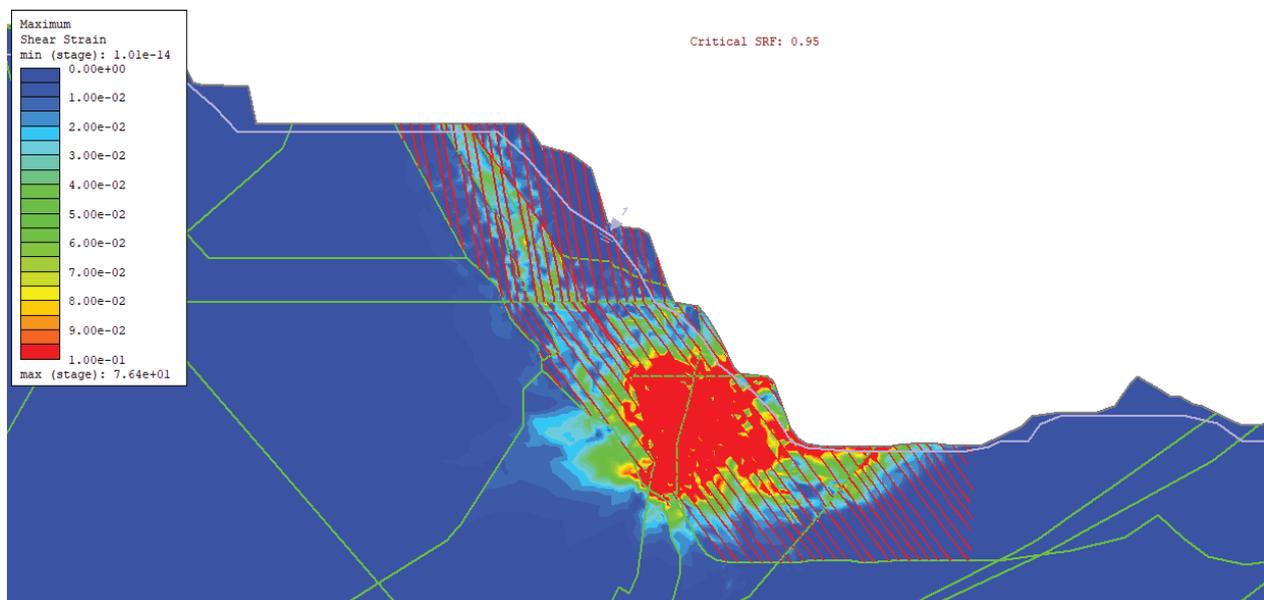
Figure 9 Critical strength reduction factor for RS2 case 10 final model (maximum shear strain)

Figure 9 depicts the critical SRF state of the RS2 case 10 final model showing contours of maximum shear strain. The contact between QR and IF forms a significant portion of the upper failure surface and the sub-horizontal BD-1 joint set forms the lower portion of the failure surface. Figure 10 depicts the critical SRF state of the RS2 case 10 final model showing contours of total displacement.

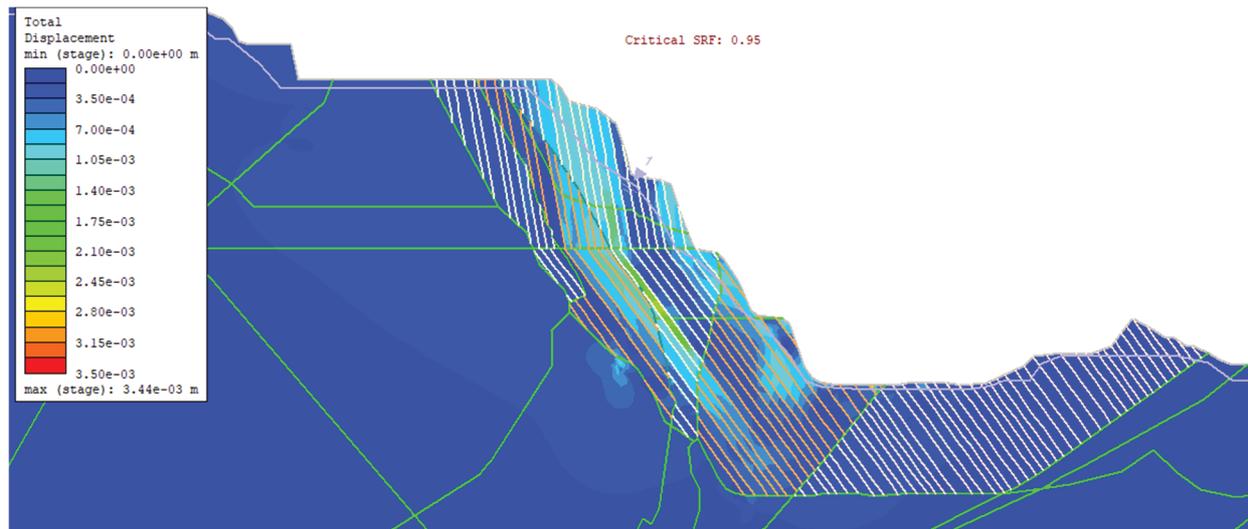
Figure 10 Critical strength reduction factor for RS2 case 10 final model (total displacement)
