Scaling the heights: the background and development of a novel remote highwall scaling machine for use at the Savage River Mine

MS Anderson *Grange Resources Ltd, Australia*

C Johnson *Jayben Group, Australia*

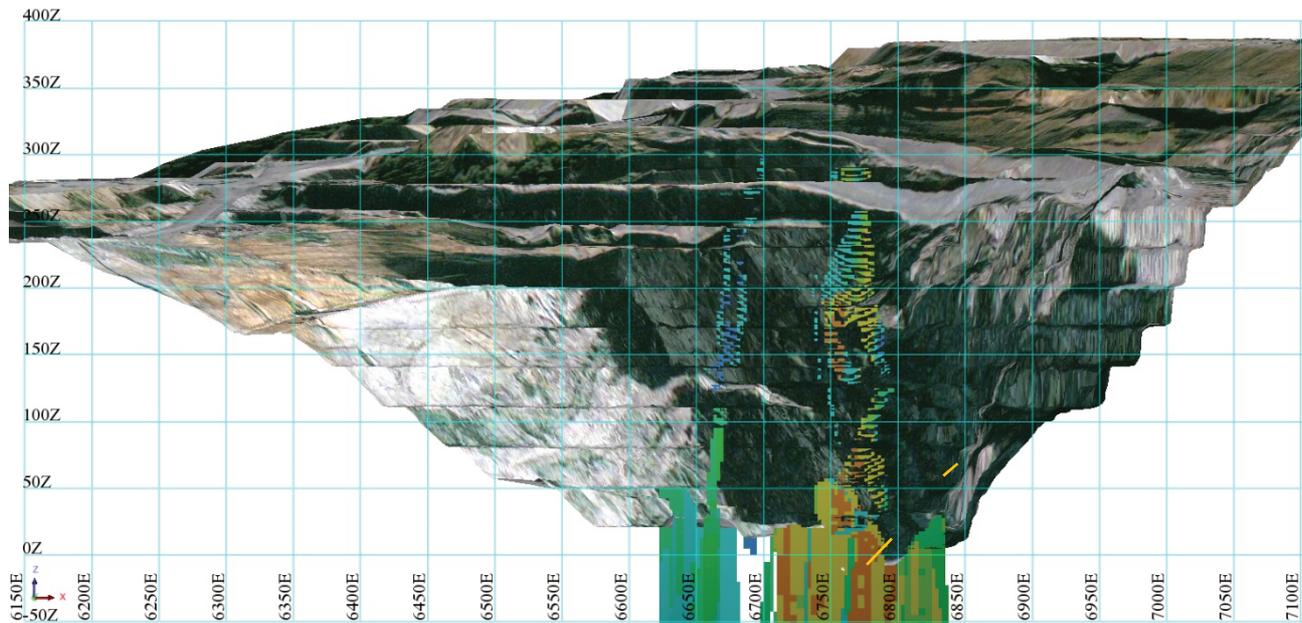
Figure 1 Typical cross-section of North Pit 9700N

Through the life of the operation there have been no less than six pits along the 6 km strike length of the orebody and numerous large-scale wall failures. By far the largest of these pits is the North pit. It is currently 1,900 m long, 1,000 m wide and 400 m deep. The pit is characterised by a high-grade massive magnetite orebody in a weak schistose host and bounded to the east by a steeply dipping fault with much stronger calcite-chlorite schist (amphibolite) to the east. This results in an oval shaped pit with inter-ramp slope angles (IRA) approaching 36° on the western side of the pit and 63° to the east.

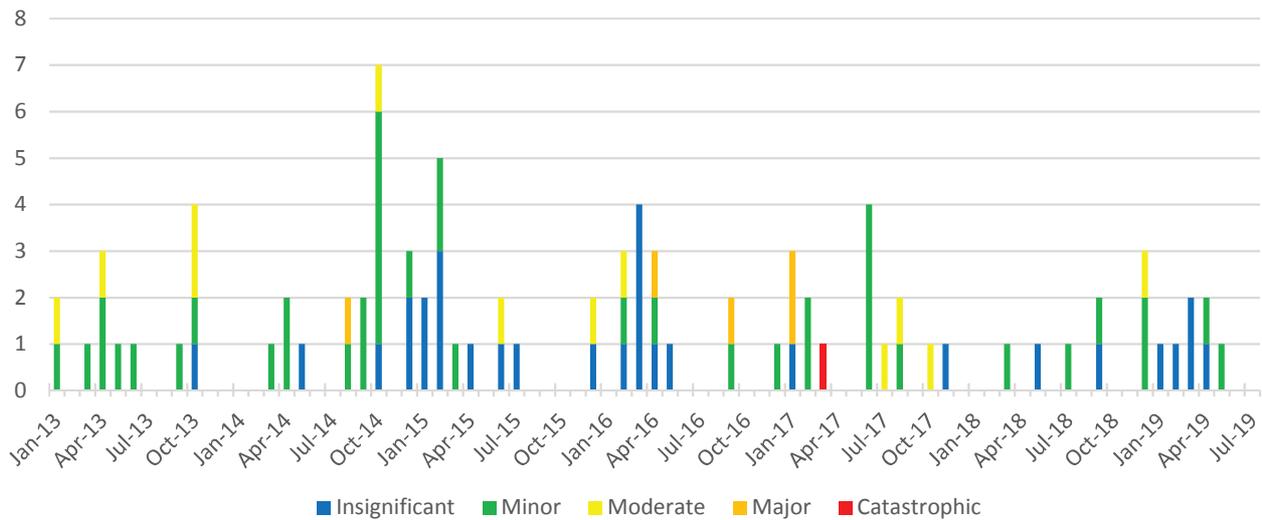
Figure 2 Rockfall frequency for height greater than one bench (30 m)

Since 2006 the site has been collecting data on all rockfalls across the site as reported by personnel or detected through radar monitoring and laser scanning of walls in the active pits. All these events are recorded in the 'Rockfall Register' along with other related data such as rainfall, relationship to blasting, size, runout distance and whether or not the movement was predicted in advance by the slope stability radar systems. Figure 2 shows the number of rockfalls occurring on the east wall that were too small or rapid to be predicted by slope stability radar and Figure 3 shows the runout distance of those rockfalls. Both graphs are categorised by rockfall potential consequence from insignificant (small rockfall entirely retained on the first berm) through to catastrophic (the potential for a fatality). The data also identifies high risk times for rockfall like immediately after blasting and during rainfall events. This correlation has allowed administrative controls to be developed to further reduce risk by closing high risk areas of the pit completely during these times.

Immediately following the scaling that was completed on the east wall, the incidence of rockfalls in this area was dramatically reduced, as can be seen in Figure 2. The runout distance of rockfalls occurring with no radar warning also decreased. This demonstrated that scaling of problematic pit highwalls was an effective solution to reduce rockfall risk, however the risk to personnel involved in this process was too great.

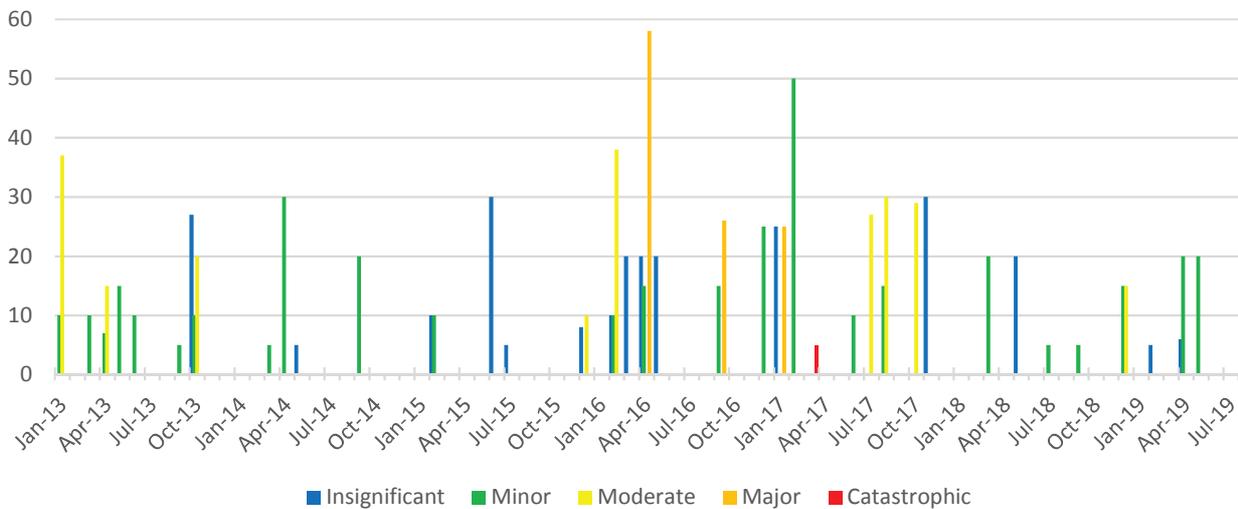
Figure 3 Rockfall runout distance (m) for height greater than 30 m

During 2016, a trend emerged of increasing frequency and runout distance of un-detected rocks. These were mostly small scats or clusters up to 100 kg that were coming to rest outside the exclusion zone and posing a risk to personnel. It was determined that the seed location for these rocks was around 260 m Reduced Level (RL, height above sea level), about 90 m above the working bench. This height coupled with areas of low catch capacity across multiple berms led to rocks gaining horizontal momentum and projecting further into the working area than had previously been experienced.

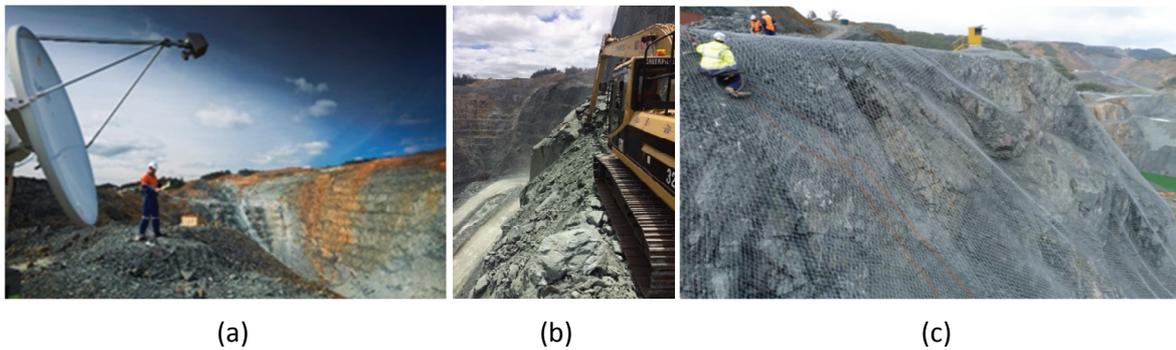
Figure 4 Photos of North Pit: (a) Radar monitoring; (b) Long reach excavator clearing berms; (c) Drape mesh installation

The two main causes of poor catch capacity in this section of wall were identified as crest loss through the intersection of the ski-jump joint set and the remaining rill slopes from previous rockfalls. A 30 t long reach excavator was trialled to access along the berms from the south in an attempt to reach areas where small rockfalls had over time filled the berms to the point that no effective catch capacity remained (Figure 4b). While this met with some limited success, there were many areas that could not safely be accessed using conventional equipment of this type.

Despite the addition of a geotechnical berm at the 170 RL where the width was increased from 12 m to 20 m, and the installation of a section of 30 m high drape mesh as used with great success previously (Hutchison et al. 2013) to reduce the incidence of rockfall from the 260 RL crest (Figure 4c), isolated rockfalls continued. Following a further incident in January and 2D modelling (Figure 5a and 5b), the haul road below this section of wall was closed and a specialist rope access team engaged to manually scale the batters between 260 m RL and 170 m RL using pry bars and air-bags. This removed the loose rocks and wedges identified and sought to re-establish the catch capacity on the 230 m and 200 m RL berms. It was anticipated using 2D rockfall modelling (Figure 5c) that following the success of this program, a 5 m, high energy rock catch fence could be installed on the 170 m RL berm, providing protection to the haul ramp and enabling it to be re-opened.

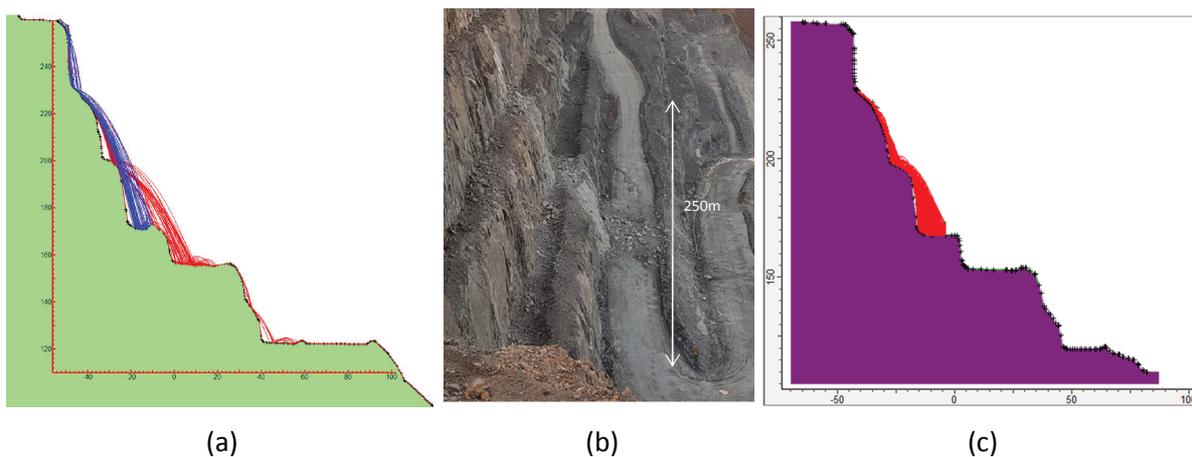
Figure 5 Analysis of January 2017 rockfall that led to the closure of the 170–140 RL ramp: (a) RocScience RocFall analysis of East Wall without rock catch fence; (b) Photograph of January 2017 failure looking south through the modelled section; (c) RocScience RocFall analysis of East Wall with rock catch fence

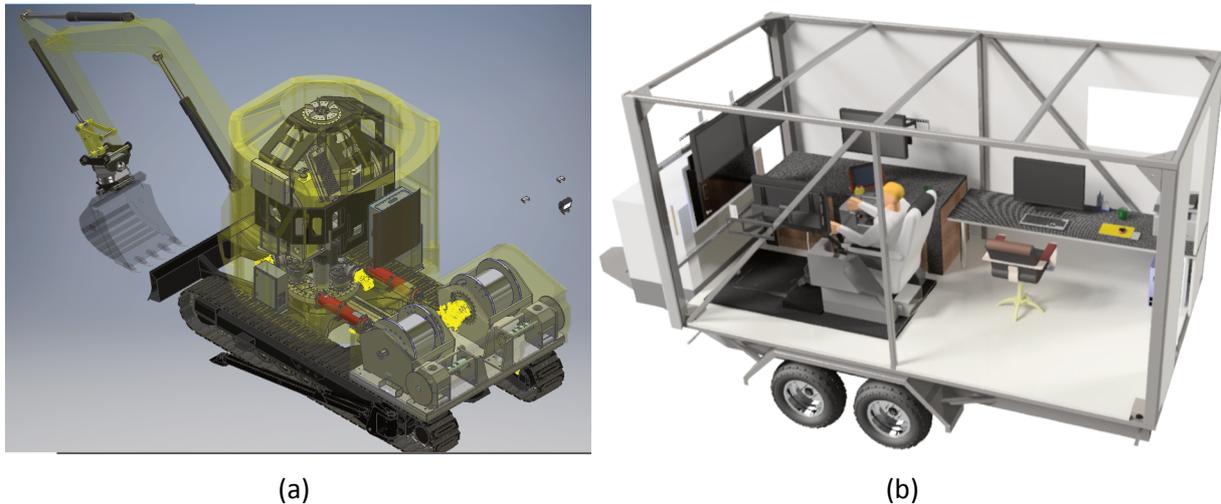
Figure 6 (a) Schematic of remote scaling machine; and (b) Schematic of operator station

The prototype (Figure 6a) is based on a Caterpillar 308 E2CR excavator that has been heavily modified to allow it to operate both horizontally and at any angle through to fully vertical. The operator cabin has been removed and the track frame lengthened to provide a mounting point for twin hi-torque winches. Each winch and cable are independently capable of supporting and retrieving the 18 t machine in the event of a failure of the other winch. The power module is protected by a modified counterweight when operating vertically and by toughened composite panels elsewhere to reduce mass. A 360° tilt rotator hitch allows for precise positioning of the tools for scaling and improved breakout force geometry. Initially the machine will be supported using grouted rock anchors with a specialised braking system to reduce the shock loading forces during a fall or emergency event.

The machine operator is provided with a range of aids, including an array of cameras, overload protection for the hydraulic and electrical systems, and an advanced 3D camera system that dynamically provides depth perception and 3D mapping in real time. This data is also recoded to the operator station (Figure 6b) to allow site geotechnicians to review the point cloud and images generated by the 3D camera system on each deployment independently to highlight areas for further attention.

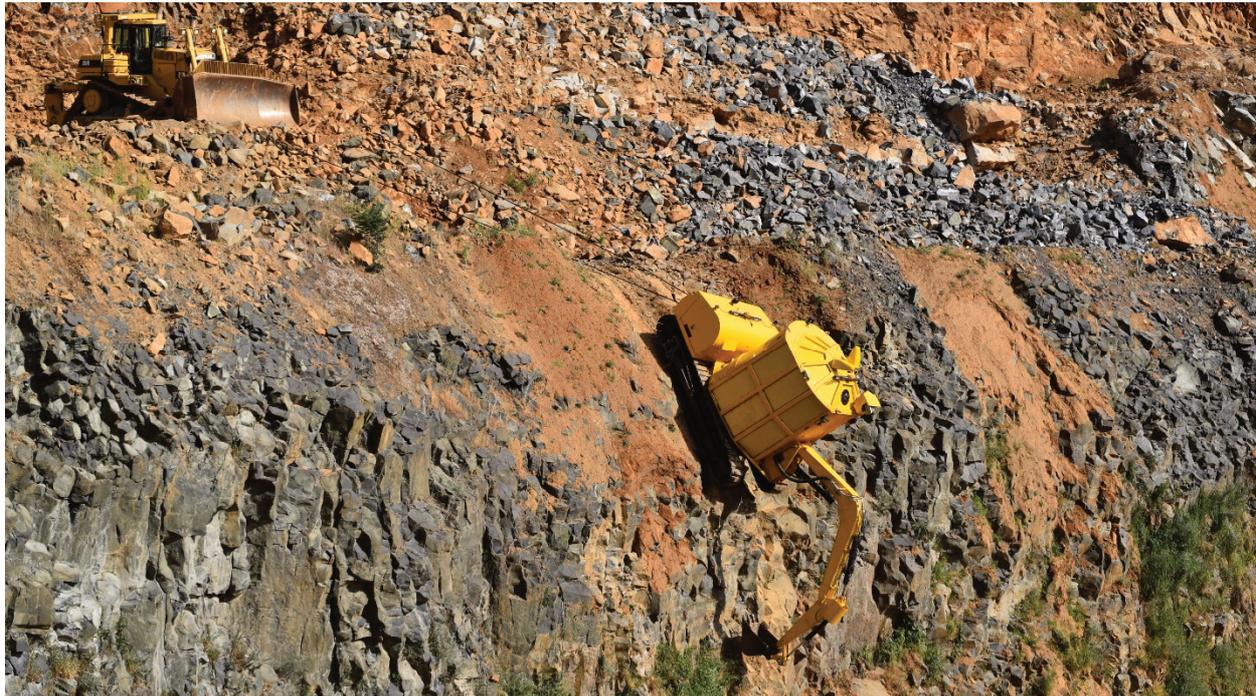
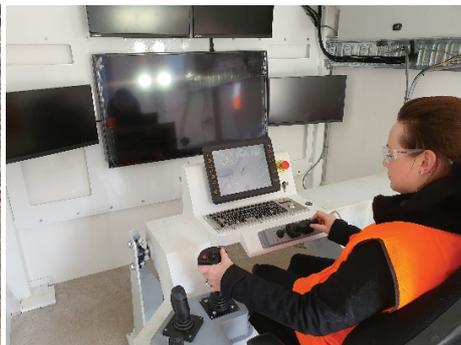
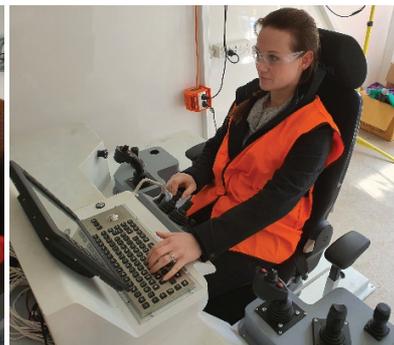
Figure 7 (a) and (b) Remote highwall scaling machine in operation; (c) and (d) Operator station

During December 2019 initial field testing was completed at a nearby quarry. The scaling machine was anchored with a Caterpillar D9 dozer (Figure 7a) and successfully transitioned over the crest and down the near vertical batter face (Figure 7b) and returned to the starting position using the maintenance remote kit. The machine was far more stable than expected and was able to quickly and effectively remove loose material from the batter face without any appreciable movement of the tracks on the wall. Winch performance was also impressive and provided plenty of torque to raise and lower the machine when working on the wall and to recover all of the way back to the bench.

The range of the remote operator station (Figures 7c and 7d) was tested to approximately 200 m but interference and signal strength proved to be a problem. As such the remainder of the test was done using the hand held maintenance remote system. The wireless remote system will be reviewed and improved prior to the next round of testing.
