Recovery of blue water ramp access affected by rockfall

Abstract

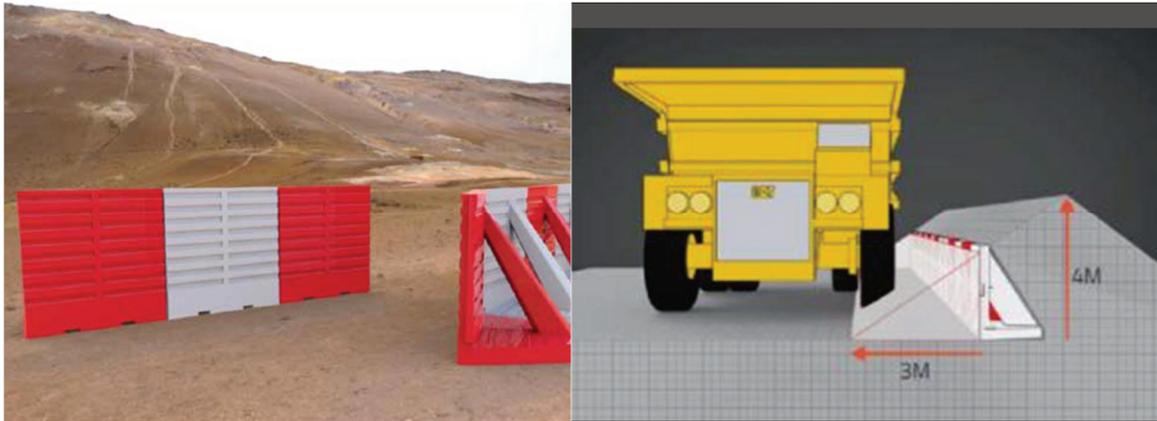
- Edge protector barriers: These are barriers that are built of reinforced polypropylene and their approximate weight is 700 kg. They are 2 m high, 2 m wide and 2 m long, and they are built with buttresses and have been used for this purpose at mines abroad (Figure 11).

Figure 11 Edge protector barriers

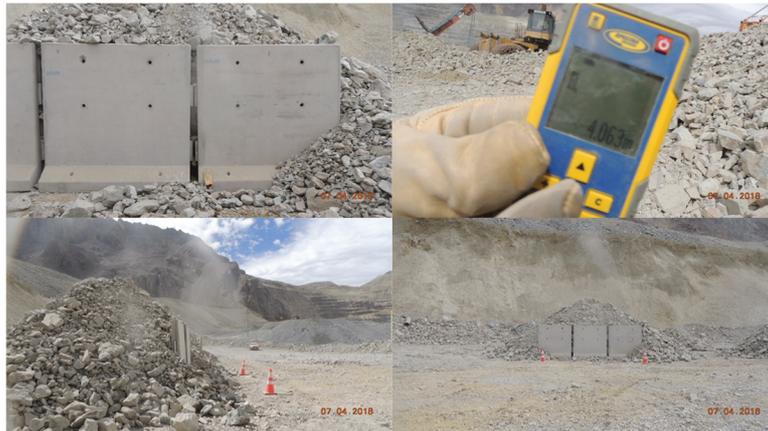
- Static test, when the material reaches 4 m at the central part: No changes, complies (Figure 13).

Figure 13 Static test – okay

Tests developed in situ were successful for the static and dynamic case, whereby no failure or cracks on the wall or its base were noted. Furthermore, no deformations or signs of overturning on the wall-berm were noted. Based on the aforementioned, it is concluded that the barriers may be used with a 4 m wall behind them. It must be noted that the aforementioned has been carried out to verify that, in the event of an overload of a berm due to material in the pit (hole), it will not have any stability related issues. Resistance to rockfall has not been considered since such energy will be absorbed by the granular material behind the wall.

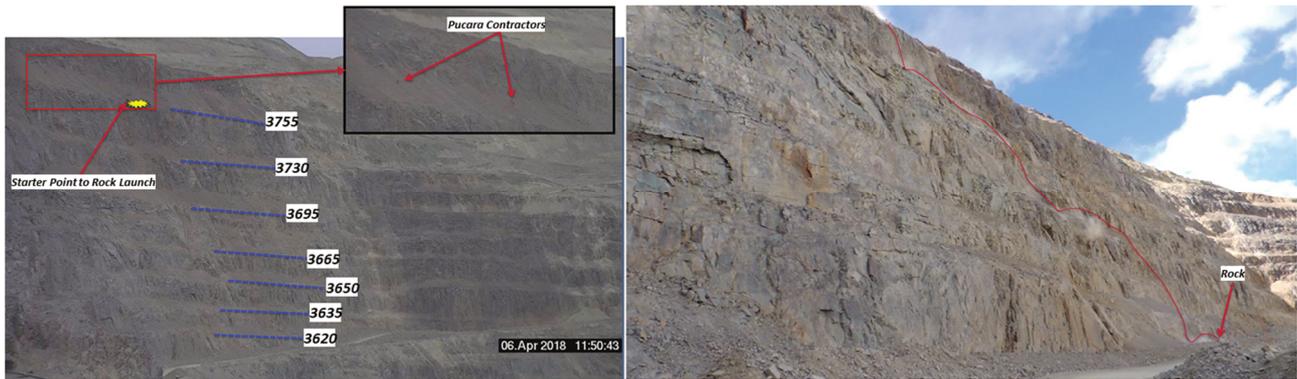
Figure 17 Rockfall back-analysis zone

In order to perform the back-analysis, it was requested that personnel specialised in vertical work drop rocks from the medium–high part of the slope in order to see their behaviour and path (Figure 17). This was carried out several times with small to medium sized rocks. The fall of rocks was registered and analyses were carried out through the RocFall software to calibrate coefficients of restitution of fill material, in order for them to better represent that which was observed in the field. Only fill material will be calibrated, since it represents a major proportion at the slope as most of it is overloaded. Rock type material coefficients will remain conservatively as shown in Table 1. The height of rockfall is approximately 150 m and there is a 2.5 m high berm at the ramp. After the tests, it was noted that a low percentage of rocks was able to pass over the berm of the sector. The results of the base case are shown in Figure 18 and calibration is shown in Figure 19.

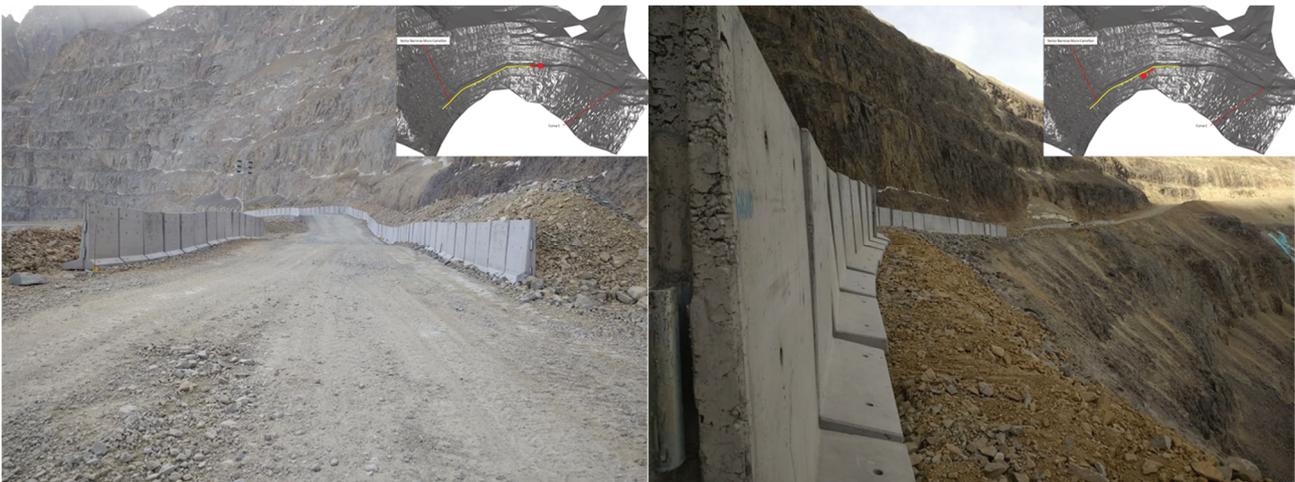
Figure 22 Blue water road access recovery

Once the re-analysis was finalised, tasks to resume transit through blue water were initiated. For this purpose, New Jersey barriers were installed on both sides of the access ramp, while creating the requested operational width. Thus, safe transit to access the phase is resumed, as shown in Figures 22 and 23.
