Between a rock and a hard place

PJ Lombard *GHD Pty Ltd, Australia*

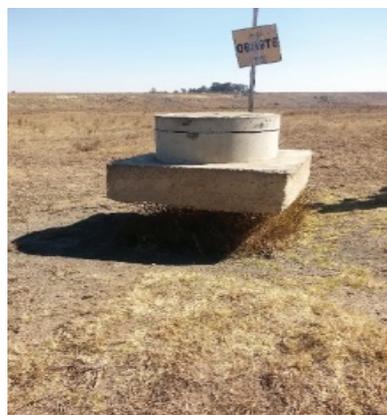
Figure 1 Borehole structure: evidence of void fill material settlement over time. -500 mm over a five-year period

Void closures using draglines and dozers facilitates the concurrent rehabilitation process in terms of timelines, however the spoil material settlement takes place over time and this creates challenges for designers in terms of the inflow and outflow levels of structures to facilitate the expedient removal of surface water from the footprint of the mine (Figure 1).

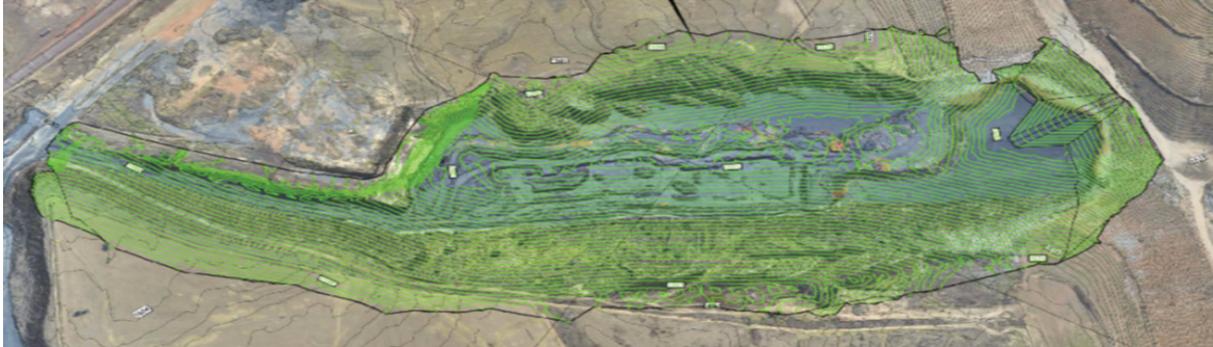
Figure 2 Final void closure design (courtesy Jones & Wagener Services)

The cost effectiveness of a closure project will be severely affected by poor designs and specifically steep slope designs that would challenge the practical implementation of the rehabilitation process as well as the sustainability thereof. “Quality water models and surface rehabilitation structure designs will optimise closure options” (Botha et al. 2018). Figure 2 is an example of a final design integrating the final void into the existing completed rehabilitation.

- Included are the berms leading up to the structures for a distance of 20 m from the edge of the structures irrespective of the slope of the berm drains. This includes vegetation of a 20 m wide strip along the berm centreline as indicated in Figure 2.

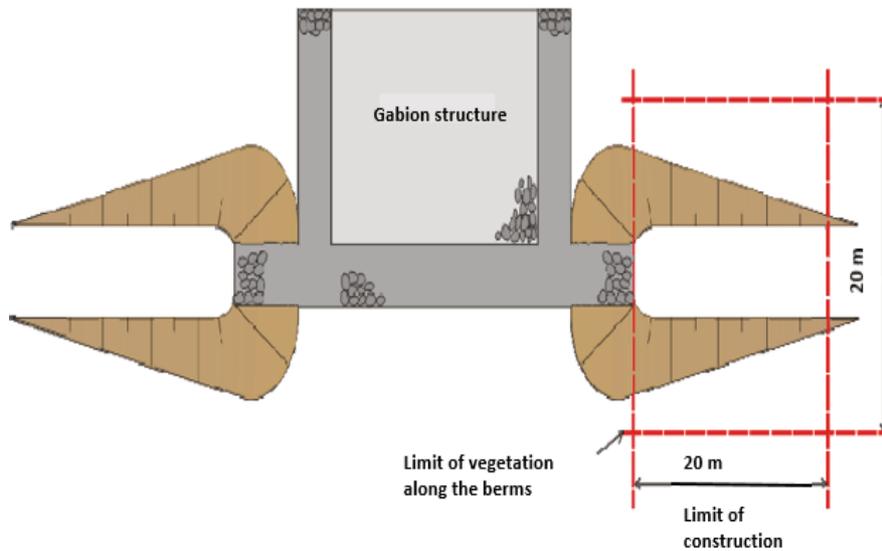
Figure 3 Limit of construction and vegetation criteria at gabion structures (courtesy Jones & Wagener Services)

- This includes vegetation of a 40 m wide strip along the berm centreline as indicated in Figures 3 and 4 indicating the extent of the vegetation in the flow channel of the structures. Included is making good of surfaces and vegetation of all areas previously vegetated and damaged by the construction works under this contract. Included is berm rectification for access roads constructed by the contractor under this contract.

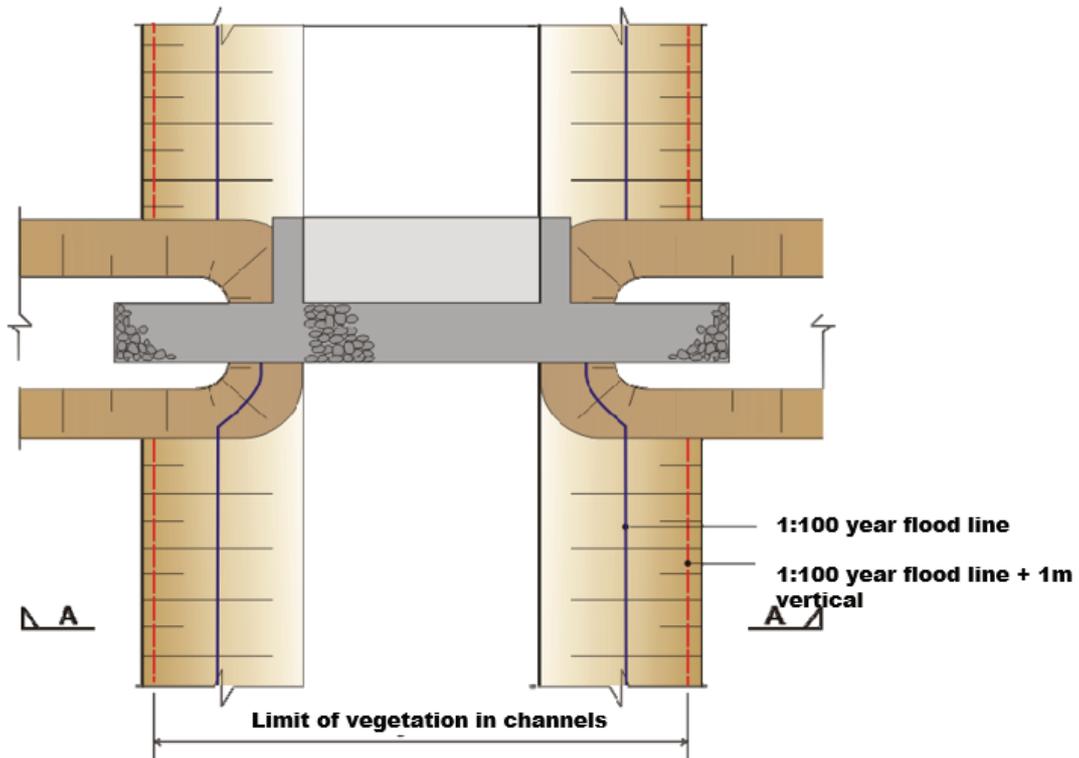
Figure 4 Limit of vegetation in the channels through the gabion structures (courtesy Jones & Wagener Services)

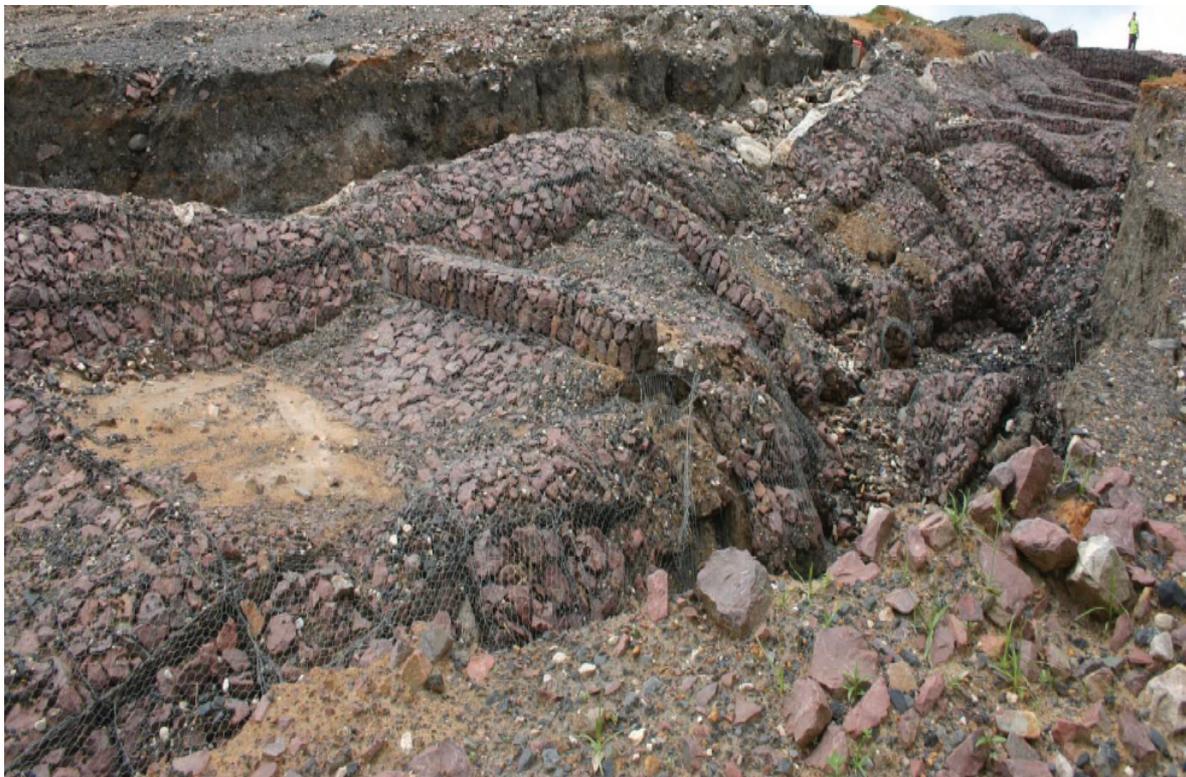
Figure 7 Failed structure after rain event of 90 mm in 30 minutes

The construction phase of large projects can stretch over months and sometimes even a year or more, and during this time rain events will highlight design inadequacies as well as poor construction sequencing of which the results can be seen in Figure 7. Significant failures will challenge the design and construction teams' relationship onsite.

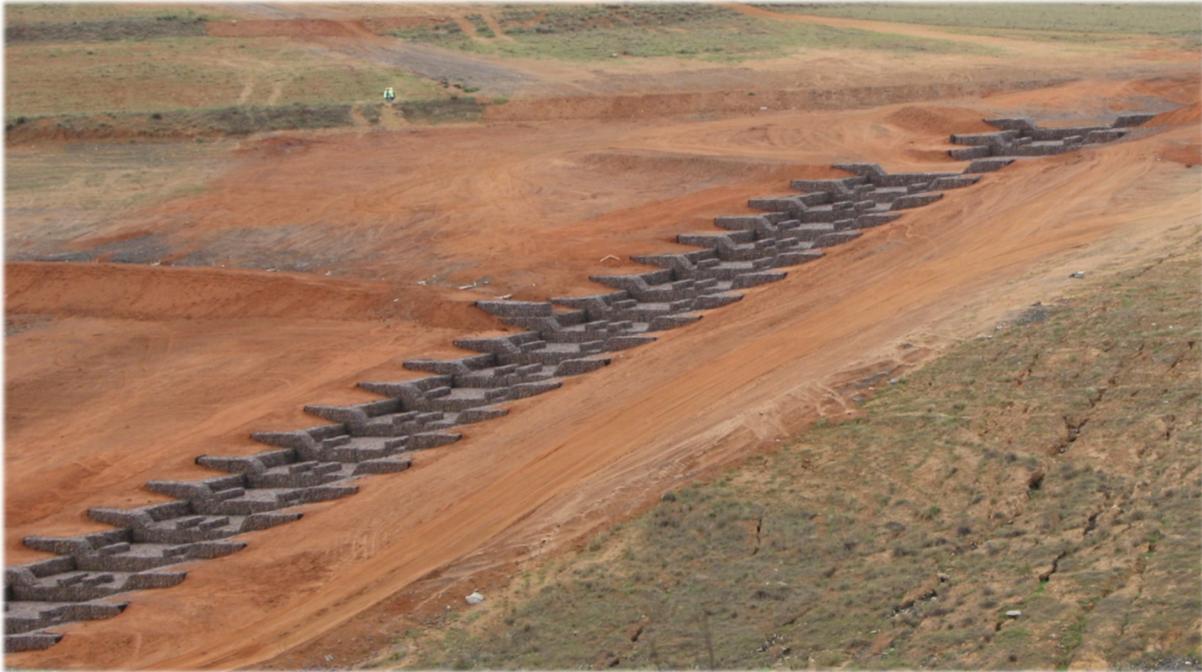
Figure 8 Re-design and re-constructed chute after failure of initial structure in Figure 9

The remediation process of significant failures are very time consuming and costly while re-introducing unnecessary risks to construction teams. The redesigned and constructed structure is shown in Figure 8. Additional energy dissipating baskets in the flow channel can be seen in Figure 8. These baskets were not in the initial structure, as shown in Figure 9.

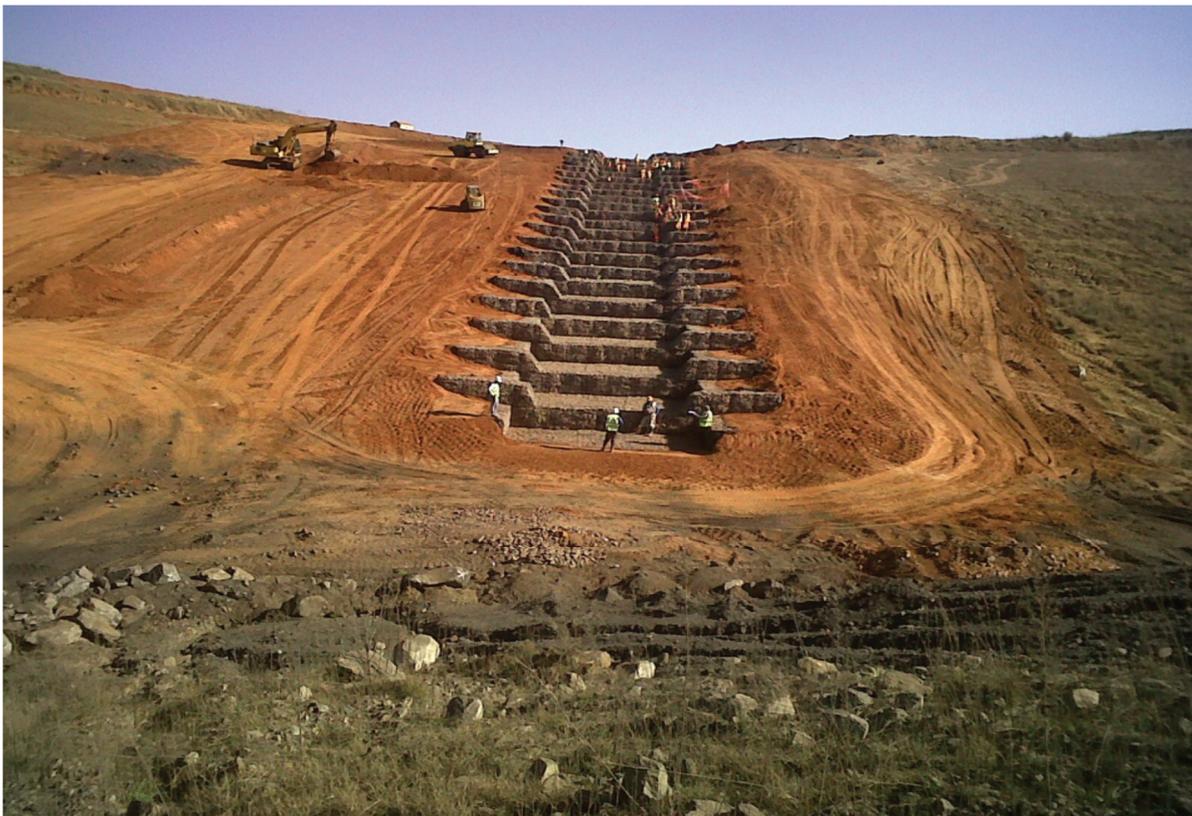
Figure 9 Completed chute structure before rain event of 90 mm in 30 minutes

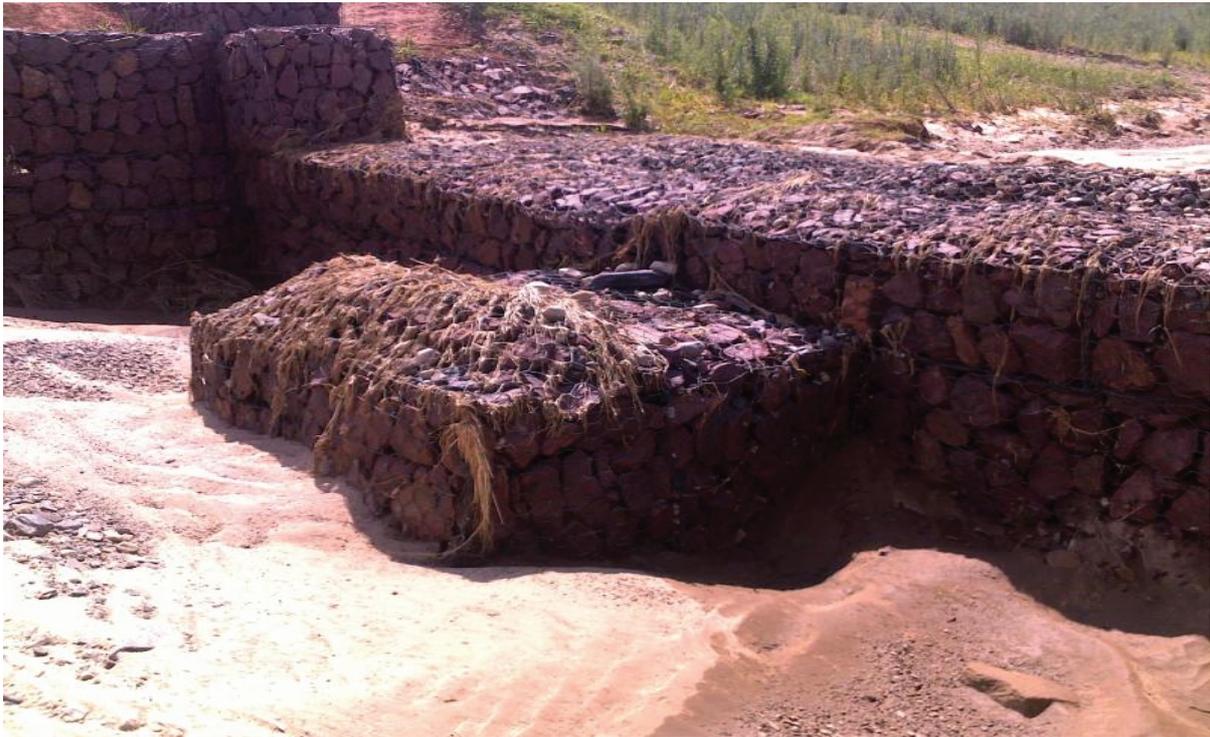
Figure 10 Displaced rocks-deforming structure

Design calculations of velocities in the inflow channels are critical, and in a number of cases, the volume of water coming down the structures is so great that the rocks inside the baskets are displaced. This can be seen in Figures 10 and 11, showing the gabion structures are unable to absorb the water energy, and more energy

dissipation is required to prevent damage to the baskets. If the energy is not dissipated, then the baskets may tear and be destroyed in time.

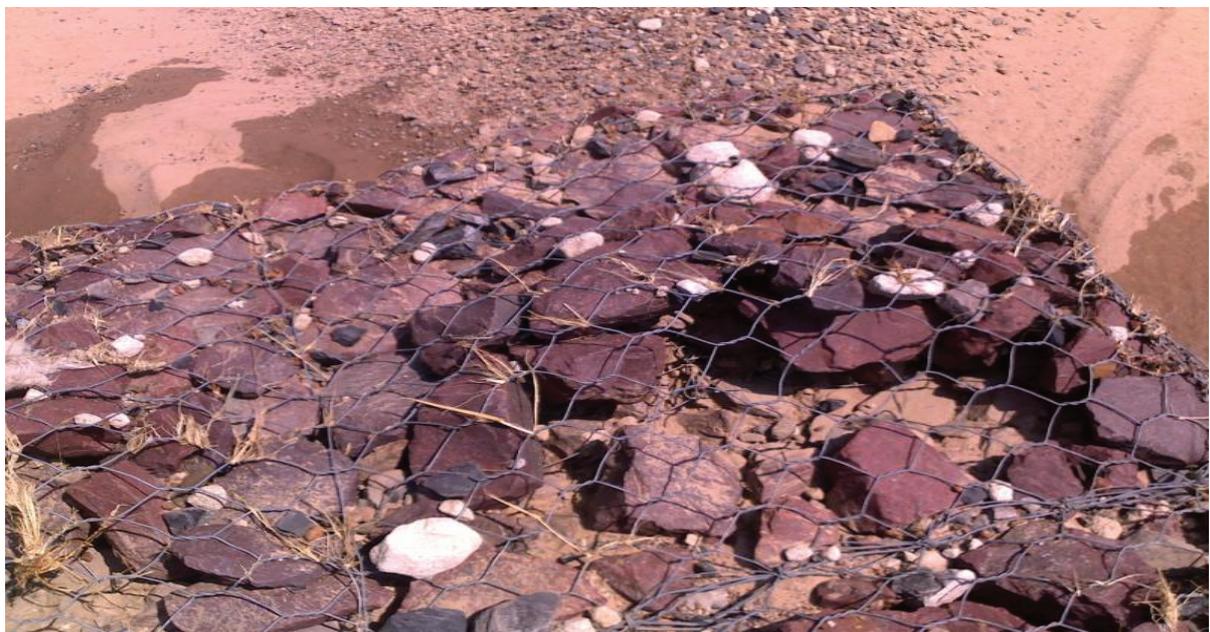
Figure 11 Rocks displaced in gabion basket

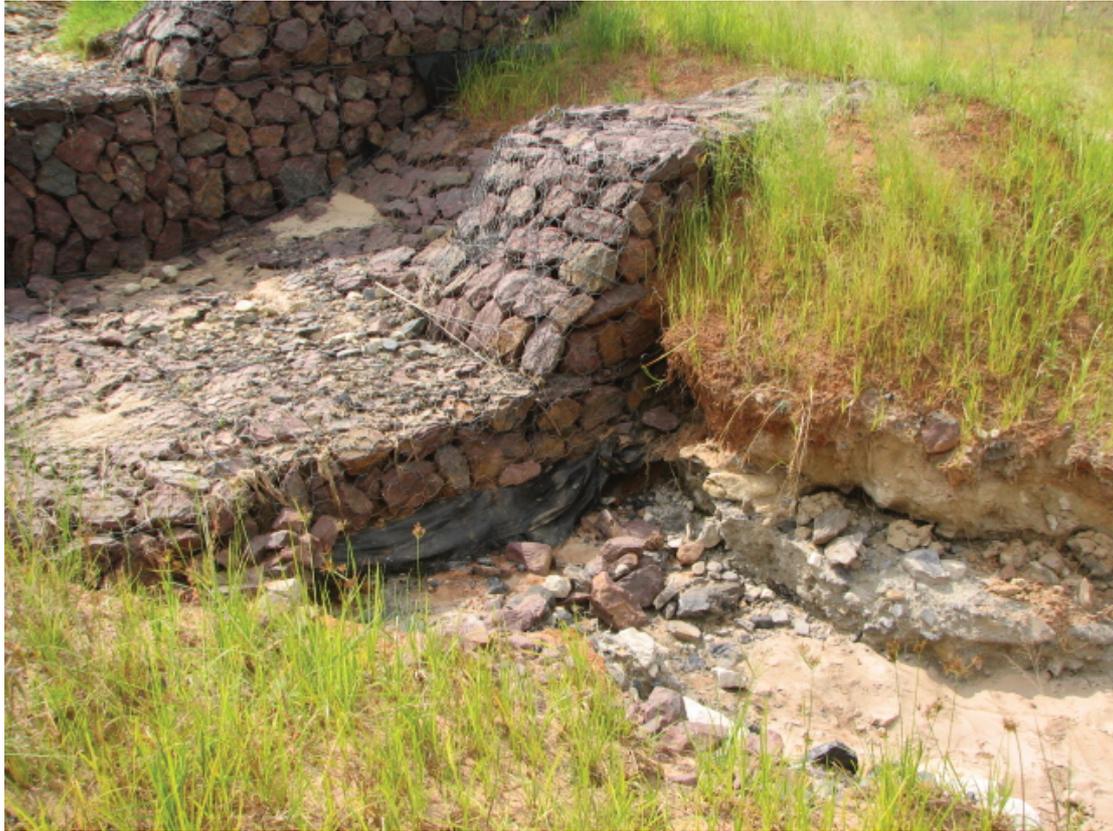
Figure 12 Size of structure inadequate (N1 1st Inlet photo IMG_0002 as per Table 2)

Some structures are stopped too early as shown in Figures 12 and 13. The energy in the water is not yet dissipated and it causes high erosion at the end of the structure. Typically, if the end of the structure had a longer section of reno mattress, erosion may have been prevented.

- Excessive erosion downstream of the structure, due to high energy dissipation of the water at the bottom of the drop, and possible failure of structure due to undermining effect of water concentrated flow paths.
- Therefore, higher velocities where the last structure is not low enough to join up with final water flow channel in the ‘riverbed’. Examples are shown in Figures 12 and 13.

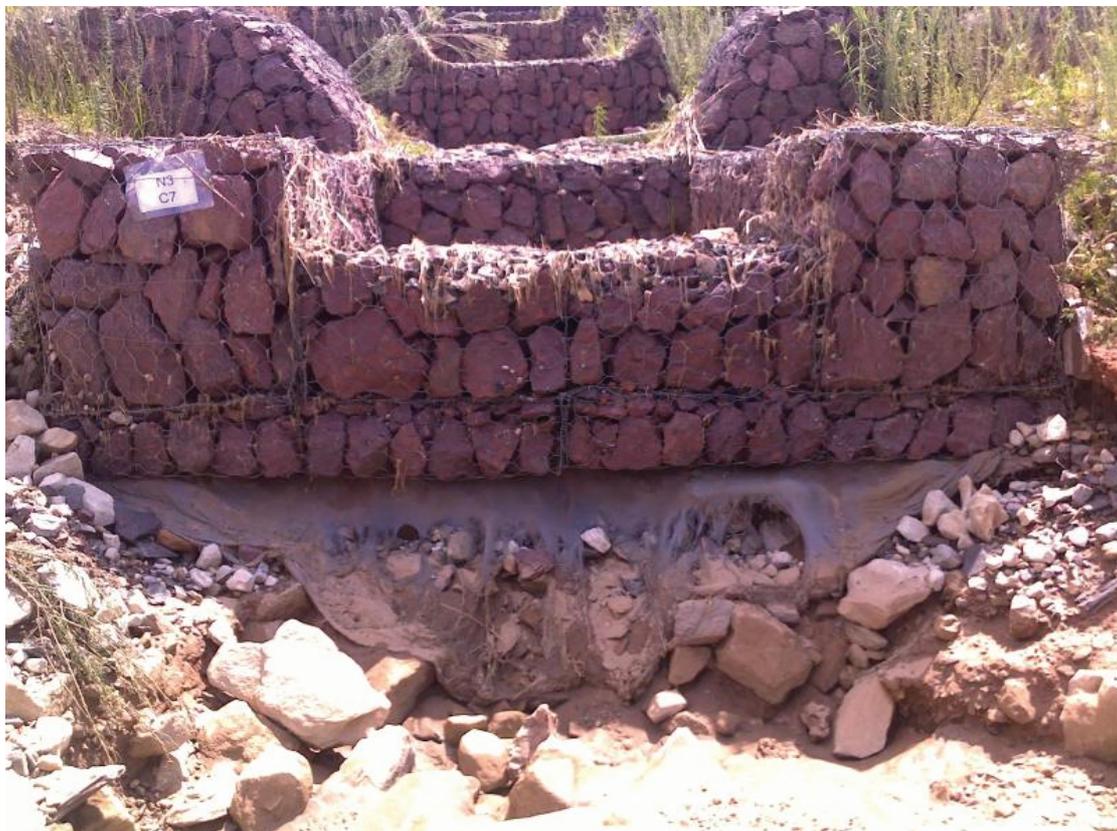
Figure 13 Size of structure (N3 C07 photo 002 as per Table 2)
