# Elimination of structure controlled highwall failures at an open cut coal mine

J Li *BHP, Australia*

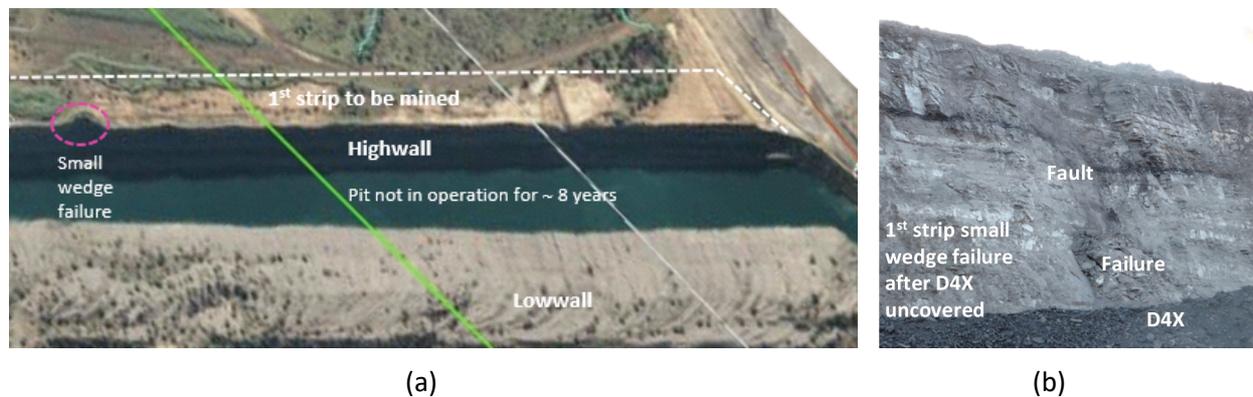
A small fault controlled planar failure was observed after the D4X seam was uncovered (Figure 3b). Visual monitoring was implemented by open cut examiners and geotechnical engineers, the safety and operational risk was managed by keeping a 10 m standoff from highwall. The D4X coal was mined to design and the D05 overburden was drilled and blasted as planned.

Figure 3 (a) Pit status prior to the first strip mining after abandoned for around 10 years; and (b) A small highwall instability above D4X

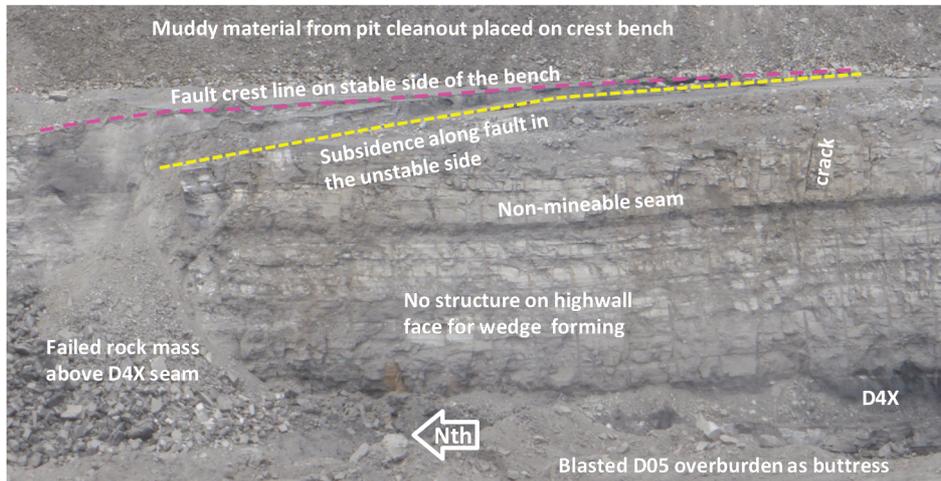
Significant highwall slumping and subsidence along the same fault occurred during D05 overburden blasting (Figure 4). The photo was taken from the low wall around 300 m away from the highwall, as access on the crest bench had been blocked by the mud waste material from the pit cleanout in previous strip. Observations of the face and crest bench later (Figure 5) found that:

The unstable area was approximately 100 m in length along highwall crest and up to 25 m wide behind the highwall crest, with a total unstable volume of around 5,000 m<sup>3</sup>. The safety and operational risks would be very high if the failure were not managed and controlled.

Figure 4 Highwall slumping and subsidence along the fault caused by D05 overburden firing

The risks were that the rock blocks were too big to be handled by dragline and unsafe and time-consuming for a dragline to scale the area to stable. Geotechnical recommendations were to blast the unstable ground first (called trim blasting), and followed by dragline removal and scaling. As the blasted D05 overburden acted as a buttress and stopped the unstable ground further moving, drilling within the concerned area proceeded with an 8 to 10 m standoff from crest, and drilling on day shift only (Figure 5b). A 3 m high bund around 150 m long was installed on the bench below, on top of the blasted D05 overburden, at a minimum 20 m from D4X highwall toe.
