Reopening and closure of a block cave

H Paetzold Palabora Mining Company (Ltd), South Africa

Abstract

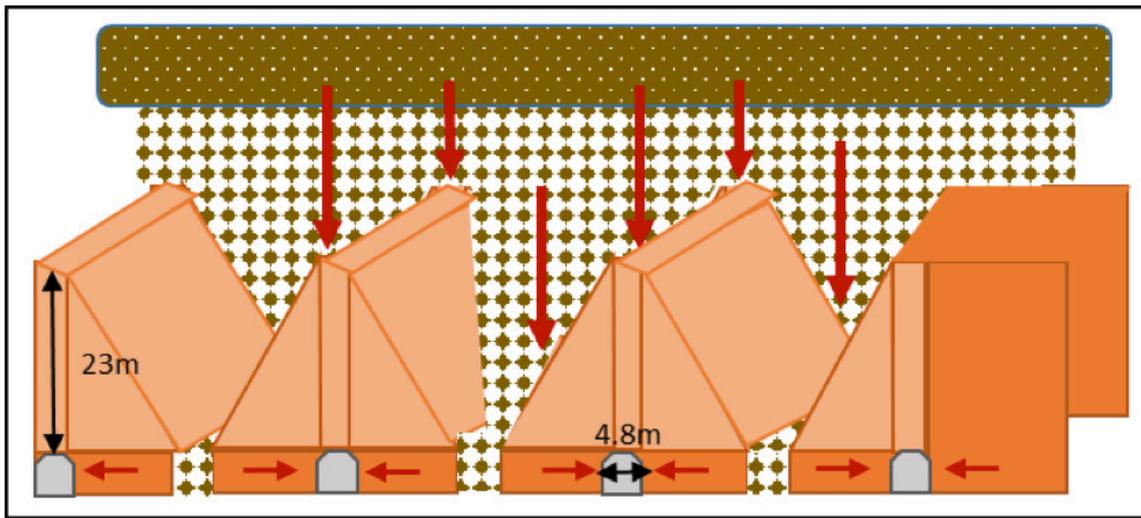
Figure 2 Block cave footprint with vertical and horizontal stresses

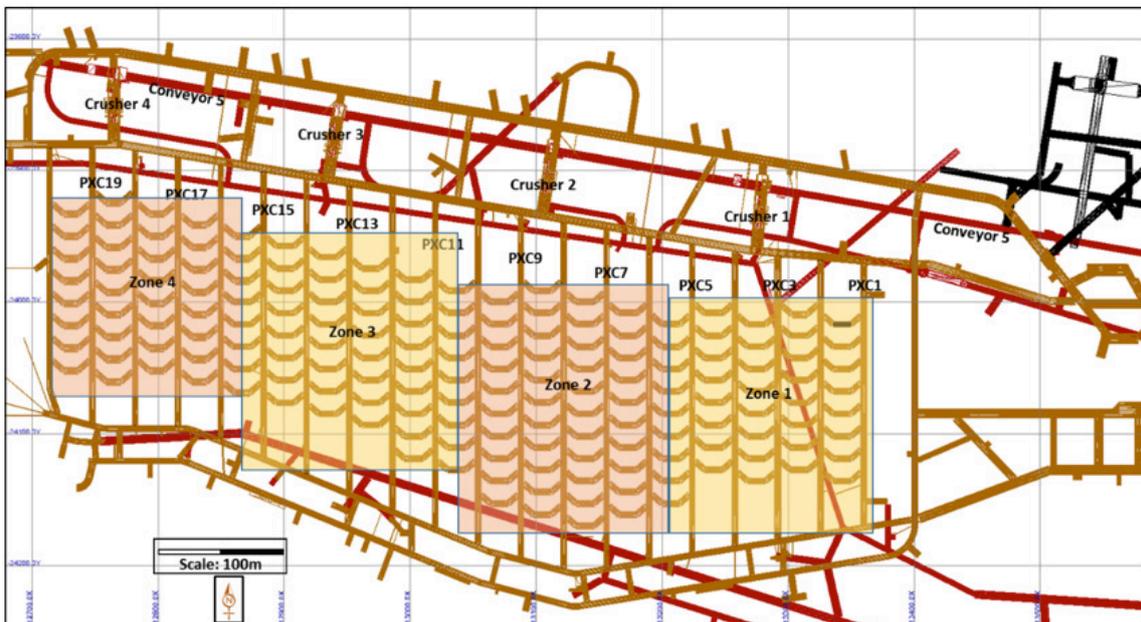
Figure 3 PMC – Lift I production level

Loading of drawpoint material from the cave commenced on the 16th of May 2019 in Sector 1. Crusher 1 with sacrificial (conveyor) 1 feeding the crushed rock onto conveyor 5 was already recommissioned by this stage. The loading from Sector 2 commenced in late May, also utilising crusher 1, followed by Sector 3 in June and finally Sector 4 on the 6th of July 2019. The recommissioning of crushers three and four coincided with the loading of their respective sectors, sectors 3 and 4 refer to Figure 3 for a plan view of the Lift I production area.

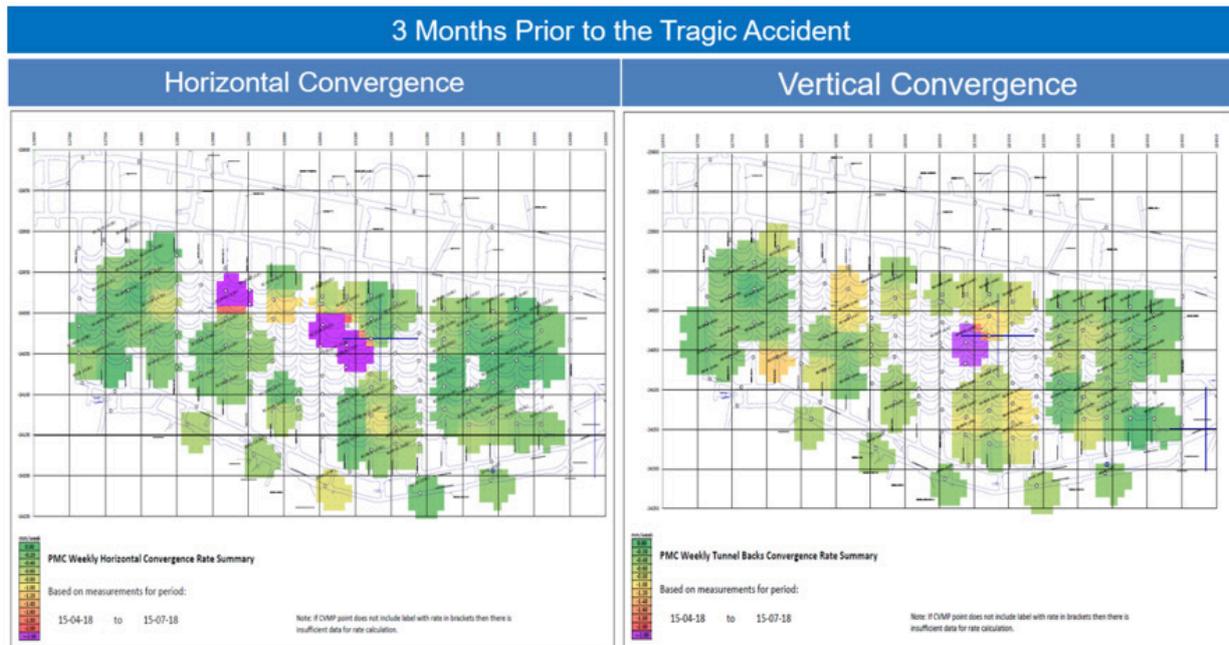
Figure 4 Convergence, 3 months prior to incident

- Uniform convergence across the Lift I footprint of less than 1mm, with the exception of crosscuts 9, 10, 12 and 13, where localised high convergence readings were recorded. Take note that crosscut 11 collapsed in 2004, with no access for monitoring currently (Ngidi & Boshoff 2007). Figures 4, 5 and 6 illustrate the vertical and horizontal deformations experienced over 3, 6 and 12 months prior to the incident. The purple colour indicates high convergence areas and the green colour indicates low or no convergence.

From Figures 4, 5 and 6 it can be seen that the centre of the cave experienced the greatest strain prior to the incident and constant rehabilitation work took place in these crosscuts to maintain stability and access for production from the drawpoints. The rest of the cave footprint is stable and remained stable even after the period of production inactivity, refer to Figures 4 - 7. The data for the horizontal convergence monitoring after the incident is incomplete due to the fact that some of the monitoring stations were damaged in the centre part of the footprint due to the stockpiling of Lift II material, refer to Figure 7. Damage mapping and geotechnical inspections indicated that horizontal convergence did indeed occur in the central area, in conjunction with the vertical convergence.

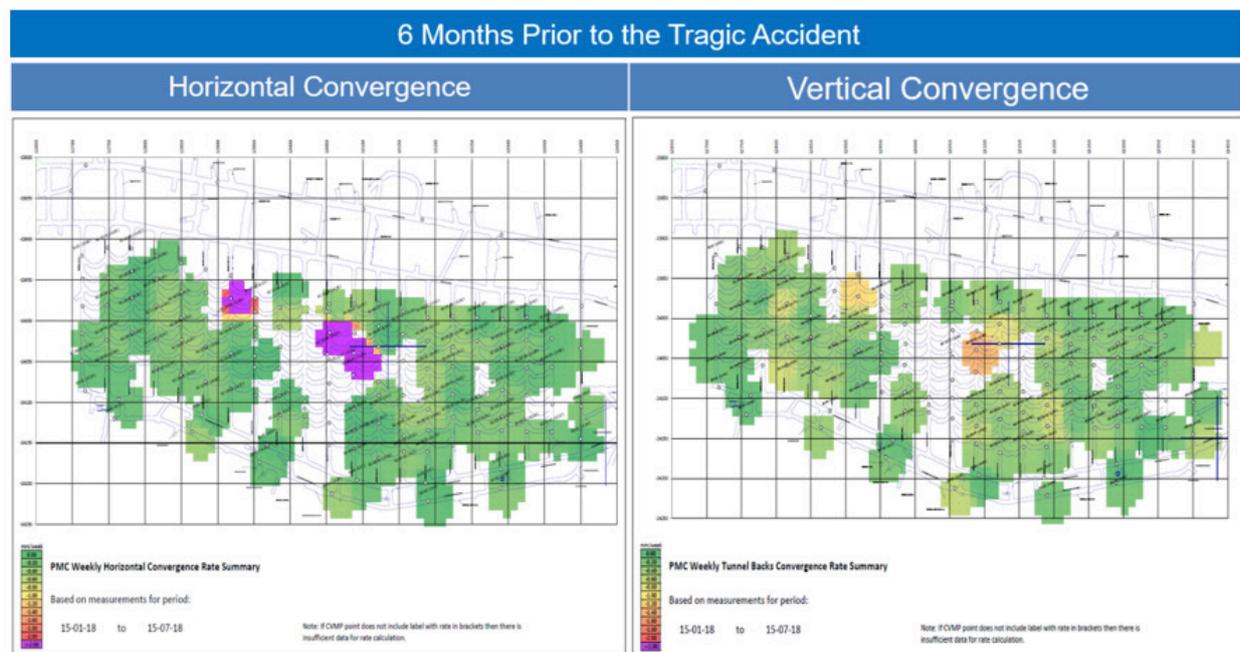
Figure 5 Convergence, 6 months prior to incident

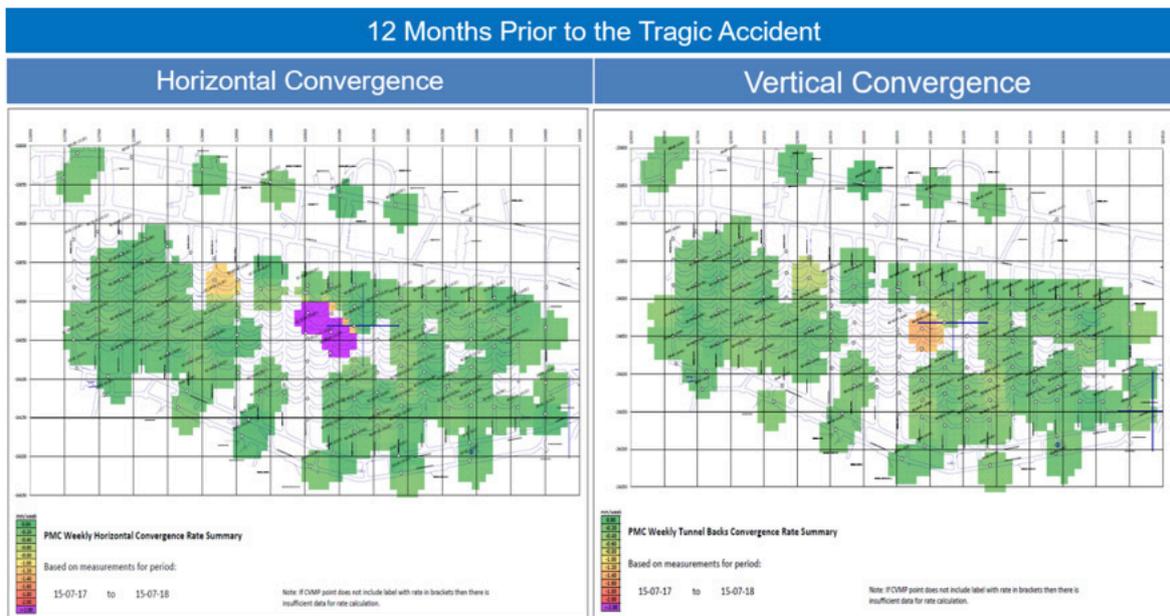
Figure 6 Convergence, 12 months prior to incident

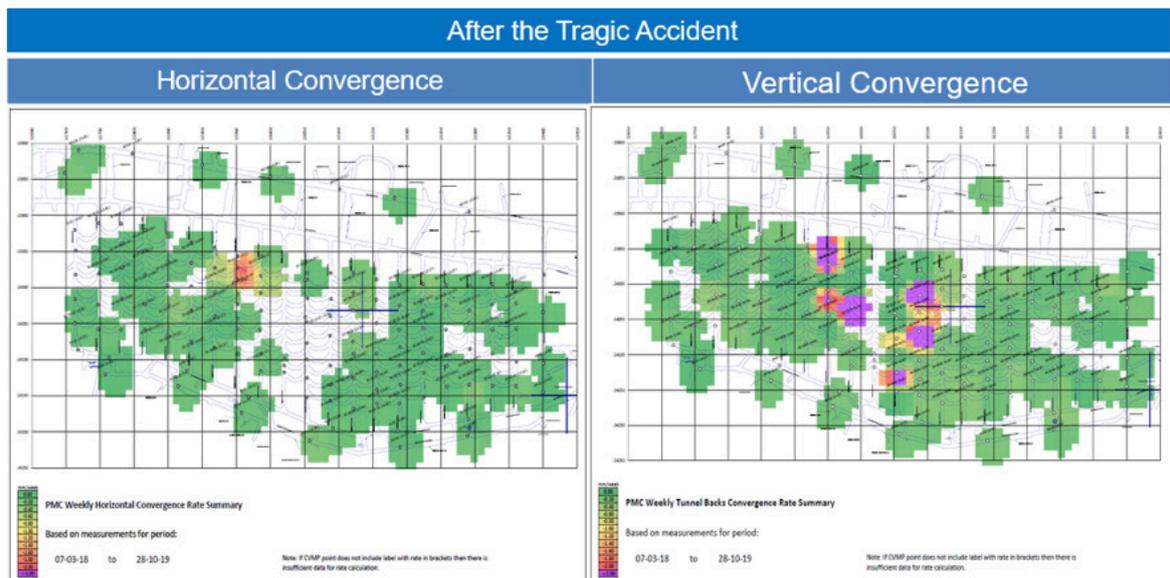
Figure 7 Convergence, after the incident

- Damage mapping and geotechnical inspections conducted prior to the accident indicated that the Lift I cave footprint was generally stable, with the exception of crosscuts 9, 10, 12 and 13, where localised stress induced failures were evident.
- Palabora’s Lift I experience has shown that small, continuous displacements are not problematic, rather it is the sudden increases in the trends (rate of convergence) that indicates stability issues. The Purple zones in the footprint represent areas with displacements in excess of 2.0 mm per week. Average closure rates of 2.5 mm – 6 mm / week were recorded within the crosscuts mentioned above. Although the convergence rates showed significant closure in these areas, no seismic related damage was reported. Figure 7 shows the convergence after the incident, once access to the footprint was obtained.

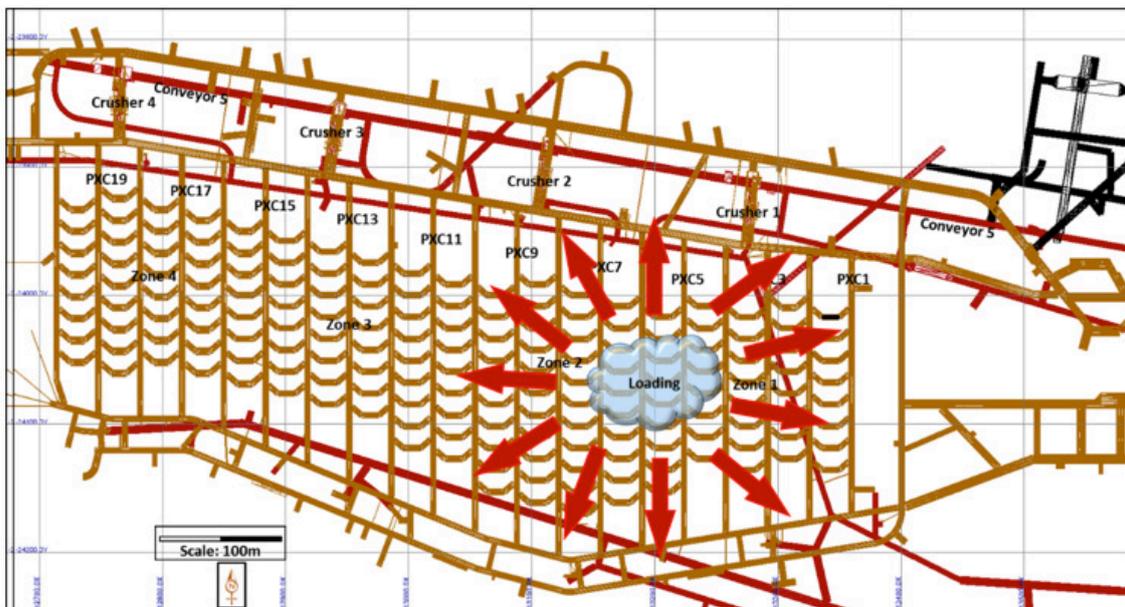
Figure 8 Stress dispersed in cave

During the planning of the cave restart, the focus was to ensure that the vertical stresses from the cave column, were equally distributed and that no point loads developed through erratic, unsystematic production draw. The plan was to start drawing from the centre of the footprint, outwards towards the perimeter. The thinking was that by drawing higher in the weaker, central area, the stresses would be forced to move toward the more stable perimeter areas and then onto the sidewalls of the cave, see Figure 8. However, this was not achieved for various operational reasons, namely;

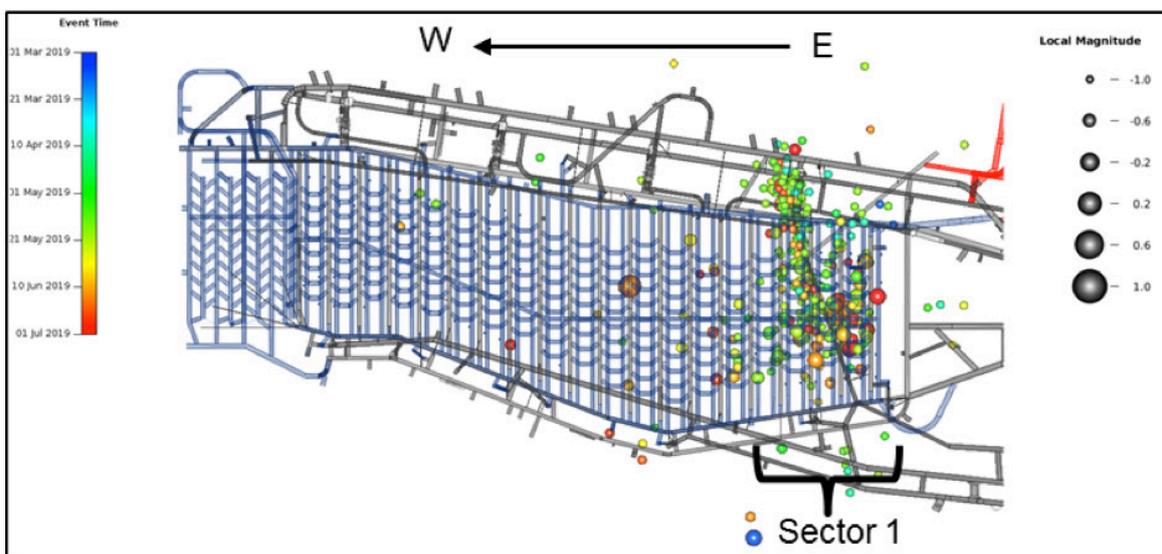
Figure 9 Lift I Seismic events during re-start, plan view (1st of March 2019 to 1st of July 2019)

During the re-start the seismic system only recorded low intensity seismic activity in sector 1 and 2. In Figure 9 and 10 the associated seismic events can be observed. During re-start, stress relief on the cave footprint occurred in the areas where the production loading commenced. In sector 1 the initial material movement in the cave resulted in observable stress concentrations and stress redistribution into the surrounding rock mass. The stress manifested as low intensity seismic events occurring in the rock mass surrounding the loading area, especially below the cave, refer to Figures 9 and 10. No deformation or damage was observed in sector 1 or at crusher 1 that could be related to the recorded seismic activity. As the production loading progressively moved to the west of the cave, the active production footprint area increased and stress concentrations, manifest through seismicity, were not observed in sectors 3 and 4 in the western areas, refer to Figures 9, 10, and 11. It should be noted that the higher concentration of seismic events in the east was most likely due to the higher incidence of dolerite dykes in the east and their absence in the west, thus the stiffer, more competent (~300 MPa) dolerite dykes (Basson et al. 2016), act as stress concentrators and stress conduits, relative to the “softer” carbonatite (~120 MPa), resulting in more seismicity. The Figures 9, 10 and 11 cover the period from the 1st of March to the 23rd of December 2019.

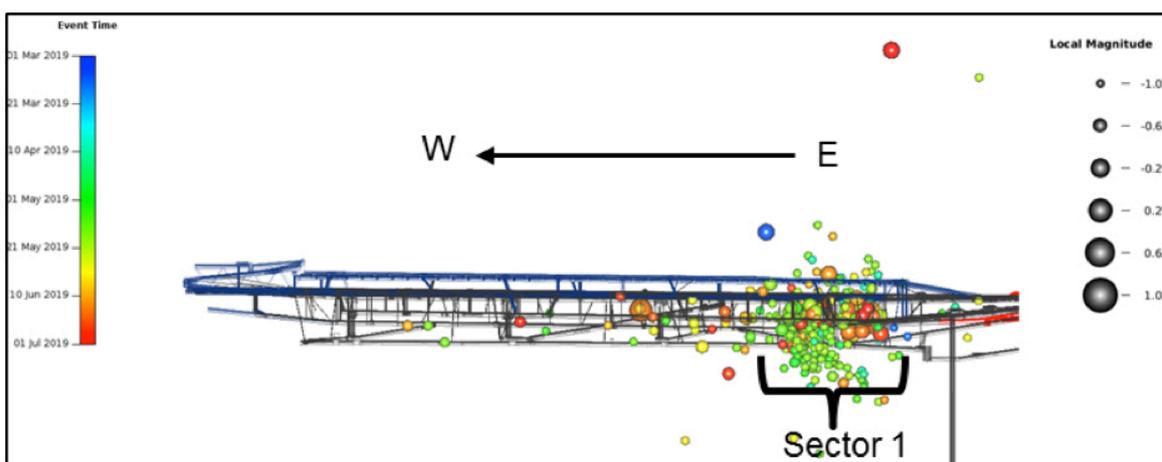
Figure 10 Lift I Seismic events during re-start section view (1st of March 2019 to 1st of July 2019)

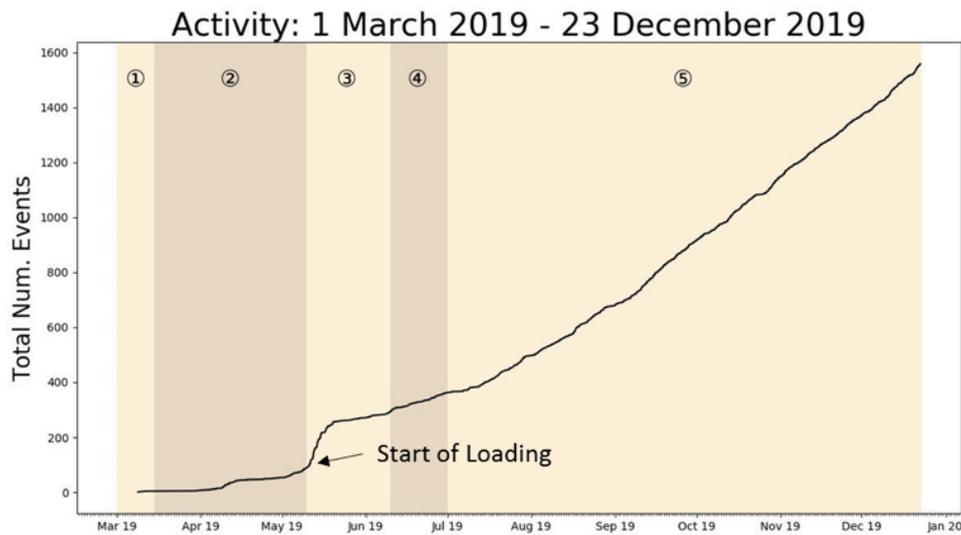
Figure 11 Cumulative seismic events over time on the Lift I level

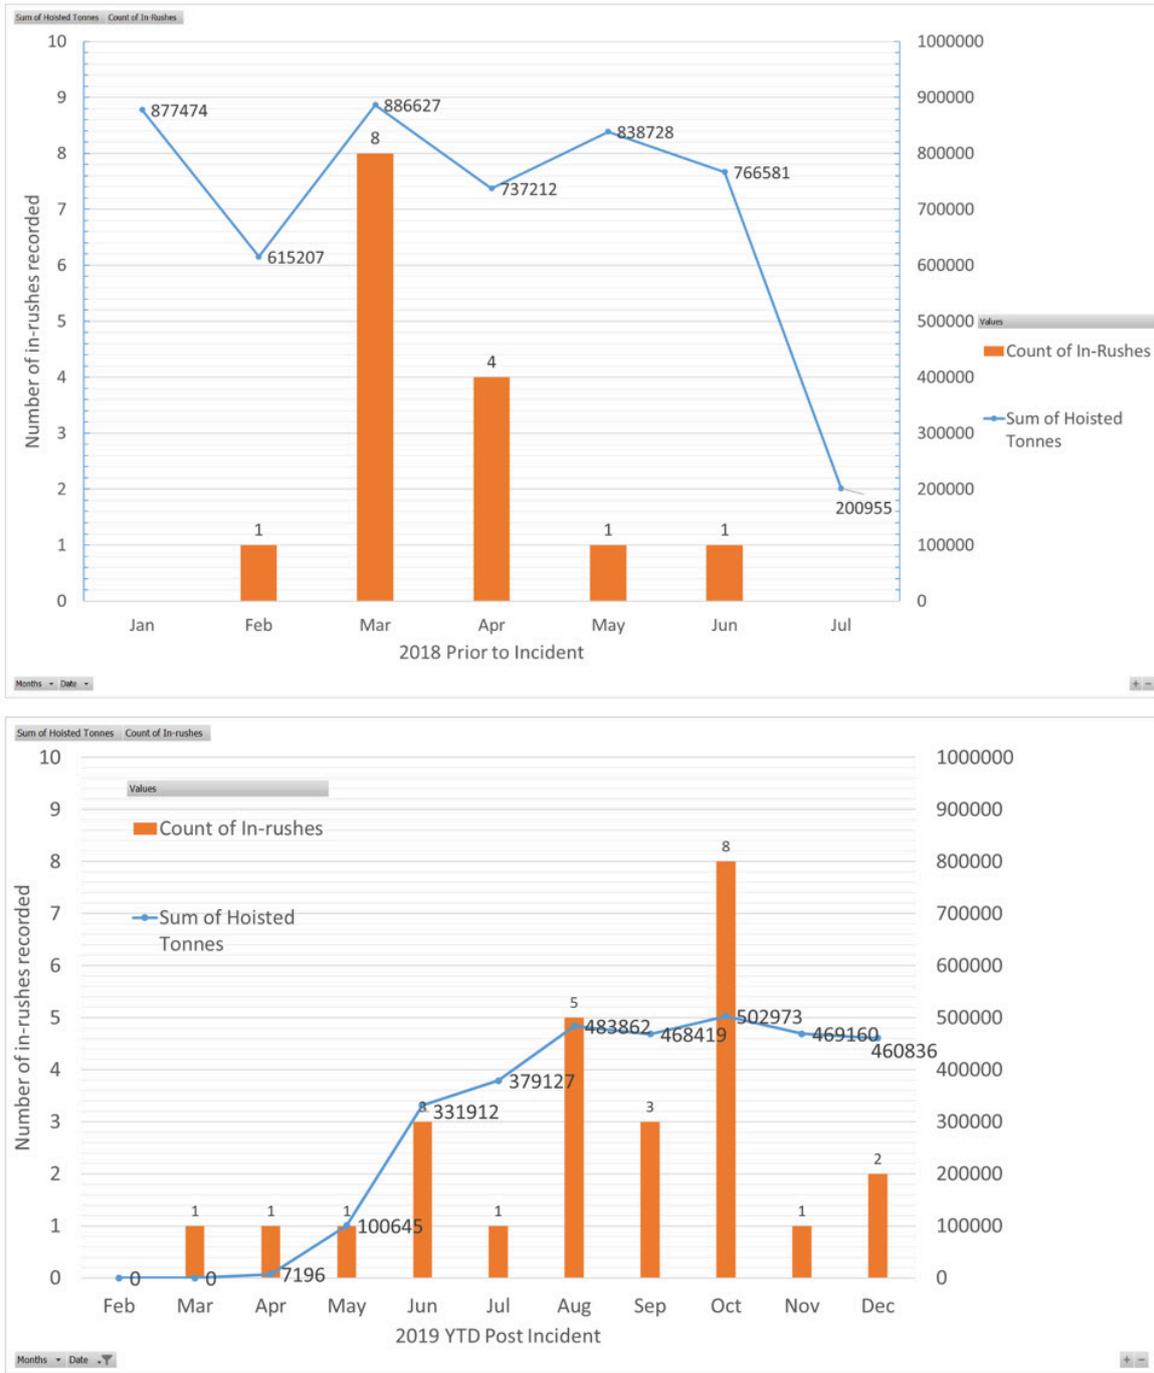
Figure 12 Count of in-rushes prior to the incident and after the start of loading relative to the tonnes

A noticeable increase in the incidence of (wet and dry) inrushes were recorded during the recommencement of production. The six months prior to the incident, the rate of inrushes was recorded at an average of one event per 552,935 tonnes, whilst for 9 months after the incident the average inrush rate increased to one event per 171,536 tonnes, refer to Figure 12 for the recorded inrushes prior and post incident. The increase of the inrushes could be due to the accumulation of water in the cave during the period of no activity, as well as some concentration of fine material that took place during the start-up of the cave with the low tonnes that were drawn. The limited available data on the conditions in the cave makes it difficult to conclude that there is a direct relationship between the increased in-rushes and the period of inactivity.

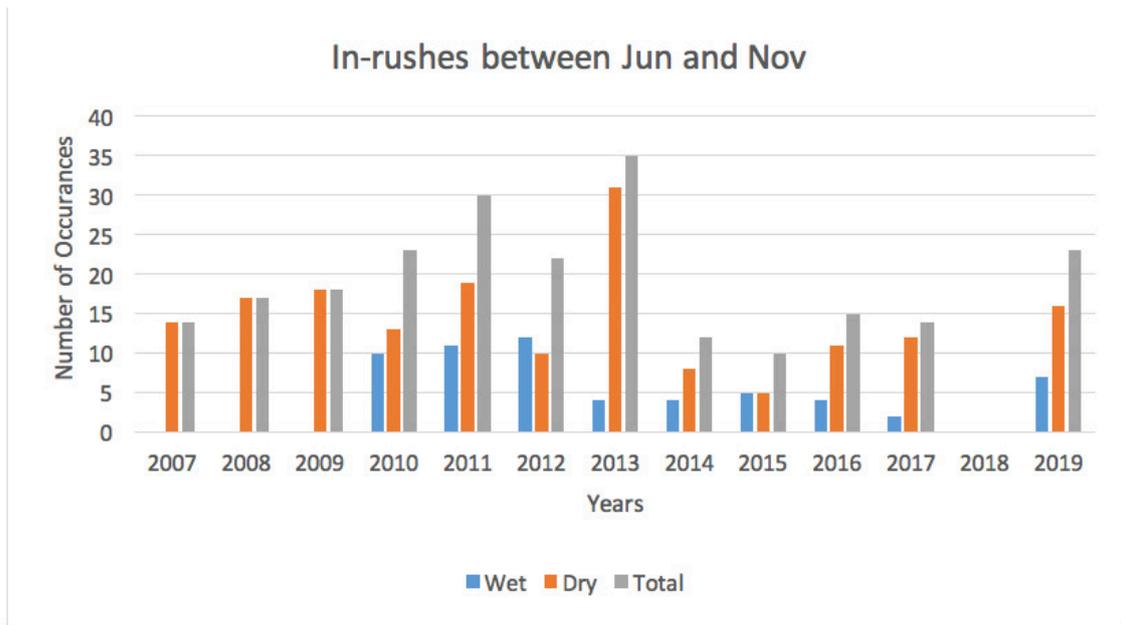
Figure 13 Count of in-rushes during June and November since 2007

When the occurrences of in-rush events are compared to the average of the previous four years an increase of 80% was recorded. When compared to 2017, an increase of 63% was recorded. The total number of inrush occurrences between June and November of each year since 2007 is depicted in Figure 13. The noticeable change in inrush occurrences from 2013 and 2014 relates to the introduction of PMC’s policy to close all high risk drawpoints prone to inrushes. Figures 14 and 15 shows the location of all inrush occurrences since 2007 as well as those drawpoints that that have been plugged and no longer accessible for production.

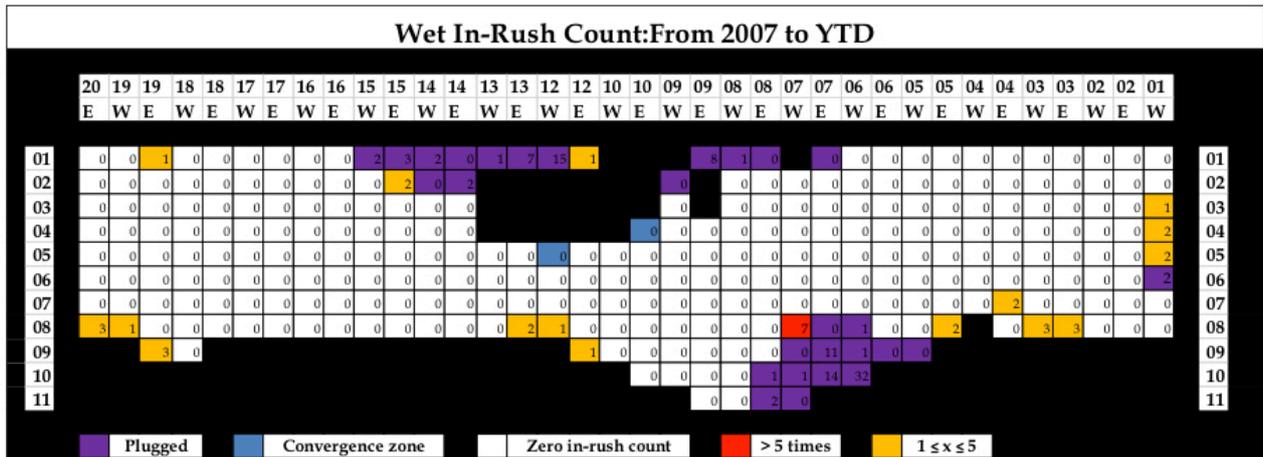
Figure 14 Count and location of wet in-rushes since 2007

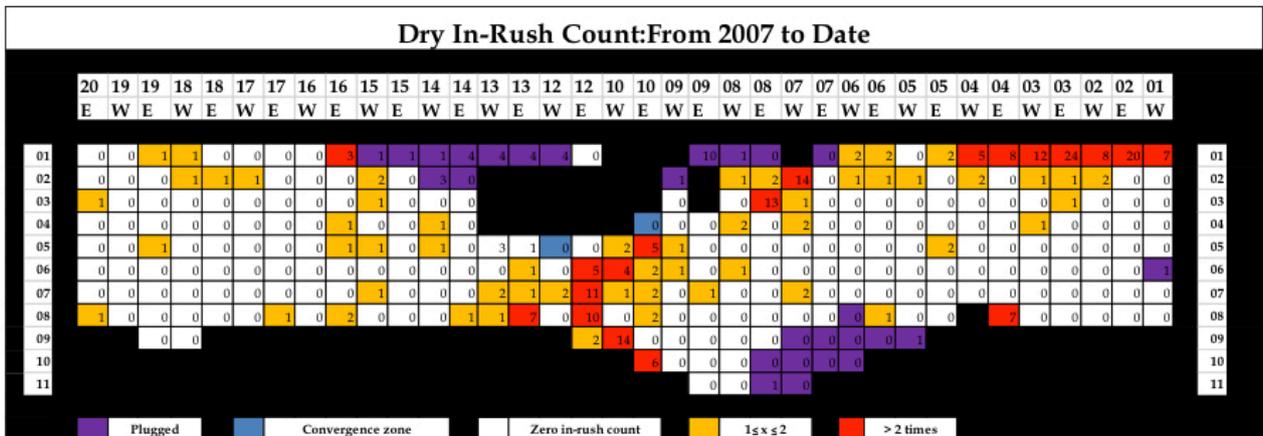
Figure 15 Count and location of dry in-rushes since 2007

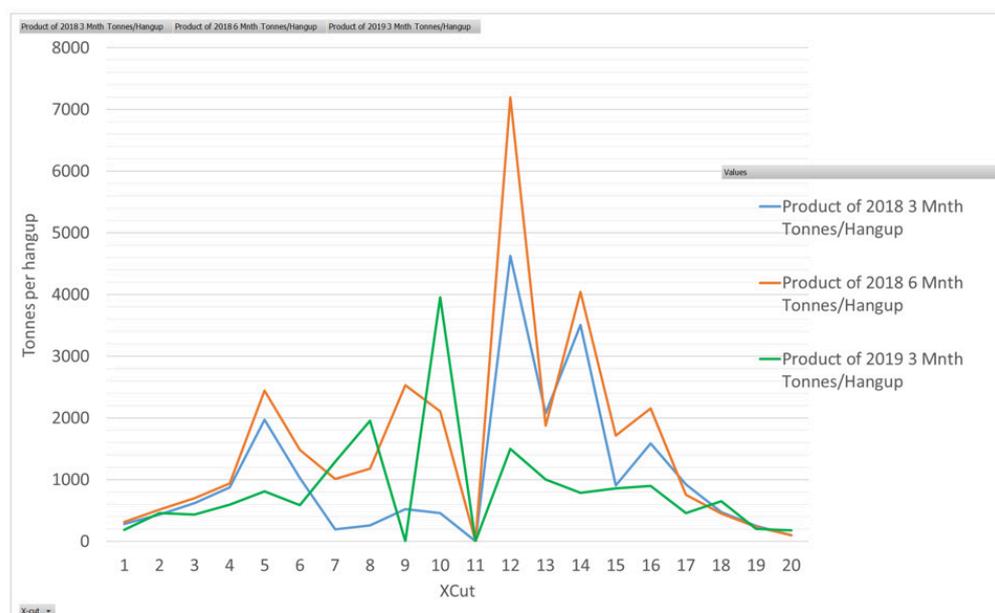
Figure 17 Typical hangups after the incident

Typical hangups experienced at PMC Lift I cave occur low in the drawbell and comprise of a number of boulders that have become wedged in the throat of the drawbell or in the drawpoint itself, as depicted in the photos in Figure 16.
