Novel techniques for rockfall management using remote equipment at Savage River Mine

Abstract

This paper describes the construction and remote installation of the rock fence and shear pins.

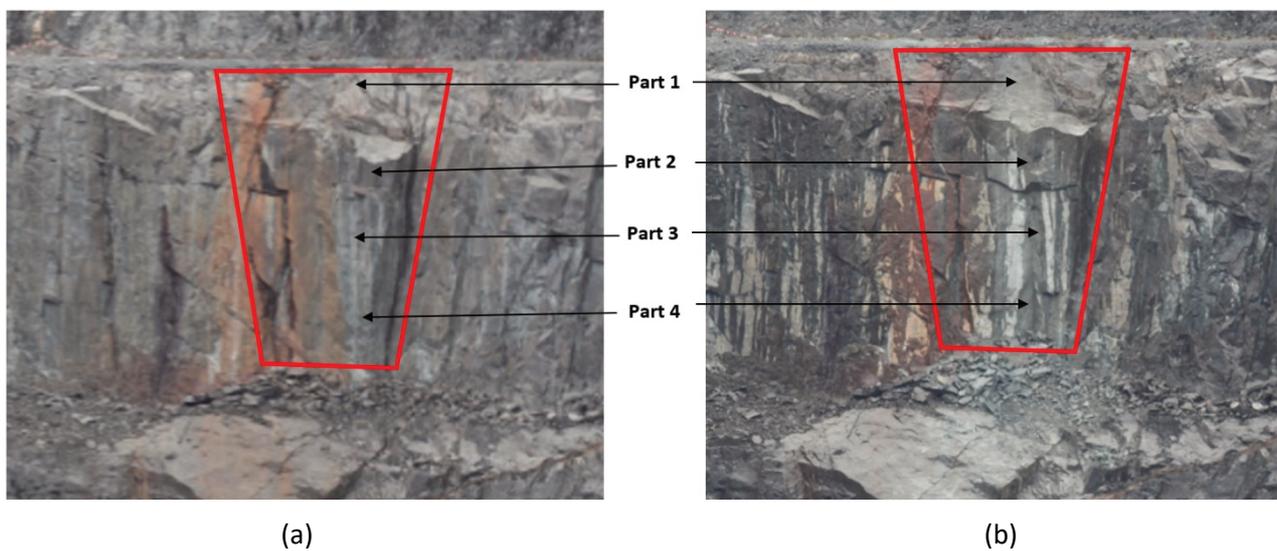
The rockfall event was interpreted to be a result of a complex series of failure mechanisms (Figure 2). An initial major planar failure occurred along a joint dipping 50° into the pit on the upper part of the batter below the 260 mRL crest (Part 1). After this initial detachment on the upper plane, a block from the crest of the plane dislodged (Part 2), leading to a toppling failure of the batter face along a steeply dipping foliation plane (Part 3) and subsequent blocks dislodging from the toe (Part 4). An image of pre- and post-failure batter faces have been included in Figure 2 with failure portions indicated.

Figure 2 (a) Pre- and (b) post-failure images of 260 mRL batter

The rock fall-out was further amplified by initial contact with the sub-horizontal joint plane below the detached blocks rather than a horizontal berm. This resulted in projection of the rocks, rather than containment by a berm, and thus caused greater scatter of rockfall material. Run-out was recorded down to the 50 mRL where drilling was being undertaken at the time. The incident was classed as a near-miss.

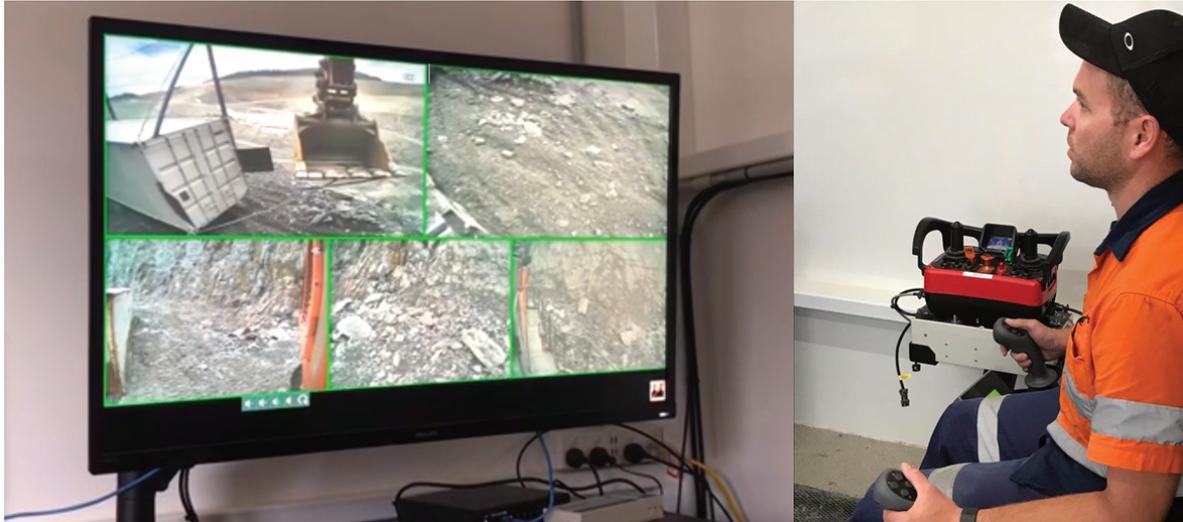
Figure 7 Operator installing shipping container rock fence using remote excavator

The 140 mRL shipping container fence required pre-fabrication and weighting (to limit movement upon impact) of the container fence module prior to it being moved into position using a remote operated excavator (Figure 7). Skids were welded to the base of each of the containers to assist in moving them into place. A DJI Phantom 4 drone was used for aerial live footage purposes to allow different angles for the operator to view the installation from. Figure 8 shows the fence positioned in its final location.

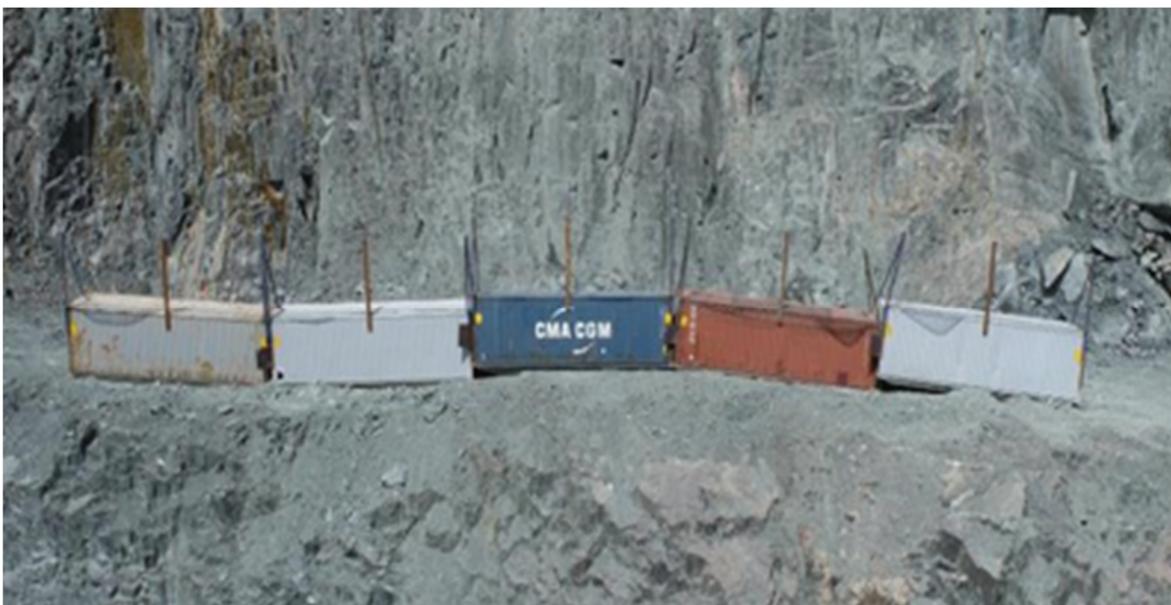
Figure 8 Shipping container fence installed using remote machinery on the 140 mRL berm

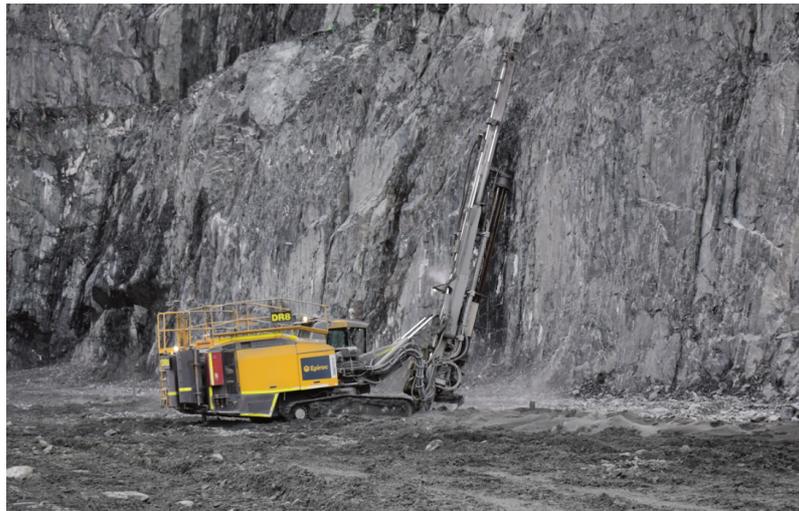
Figure 9 Remote drilling used for shear pin and production drilling

After installation of the shipping container fence on the 140 mRL berm, work on the 50 mRL could continue with controls developed during a risk assessment process. This included work being completed from behind mobile rock fences, the use of remote drilling (Figure 9), and loading of blastholes by use of a Grange Resources patented Merlo Roto 40.25 Remote Explosive Blasting Unit (Figure 10) (Hutchison & Widelski 2007). Figures 11, 12 and 13 give brief insight to the remote shear pin installation and grouting works.

The rock fence installation works were carried out under specific job hazard analysis (JHA) to quantify and manage the risks when working under the highwall in hazardous zones. Figure 9 shows the remote drilling and Figure 14 shows the mobile rock fences used to facilitate a safe working environment for the project.

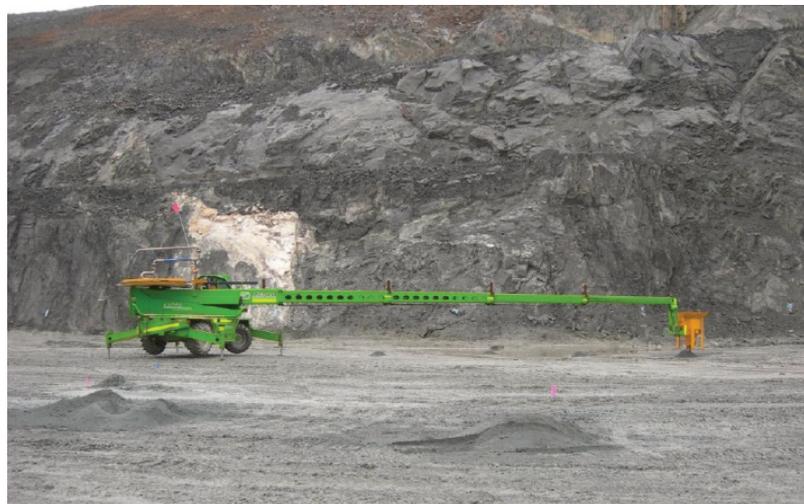
Figure 10 Grange Resource's patented Merlo Roto 40.25 Remote Explosive Blasting Unit

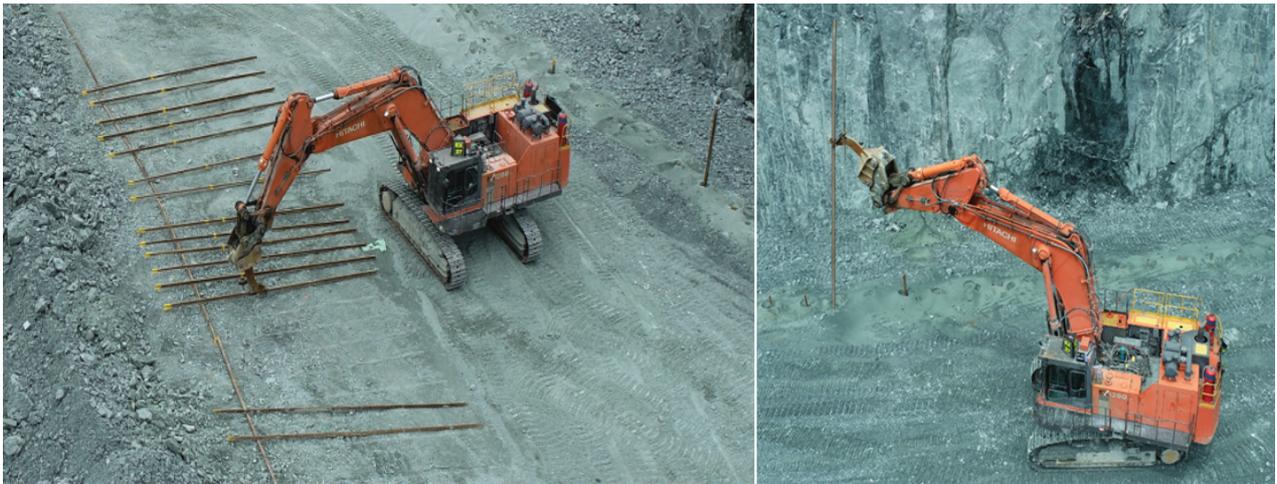
Figure 12 Remote excavator installing shear pins using in-house developed shear pin holding attachment

Where shear pins needed to be installed for the retention of wedge blocks on the crest, the same remote approach was used. Through use of a modified hook attached to the remote excavator's quick hitch (Figures 11 and 12), these pins could be installed from a safe location and grouted in place remotely using a remote-control concrete boom pump (Figure 13) limiting exposure to rockfall hazards. Again, a DJI Phantom 4 drone was used in aerial live footage as judging depth when installing the pins was difficult without a different angle of the shear pin installation.

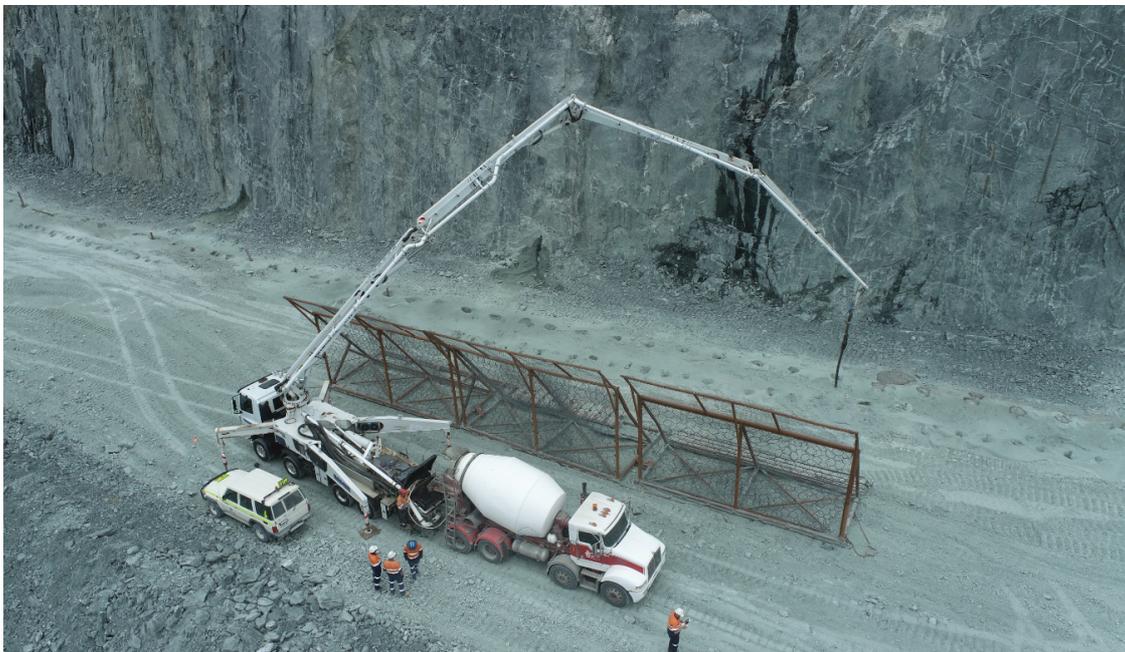
Figure 13 Concrete boom pump grouting shear pin holes

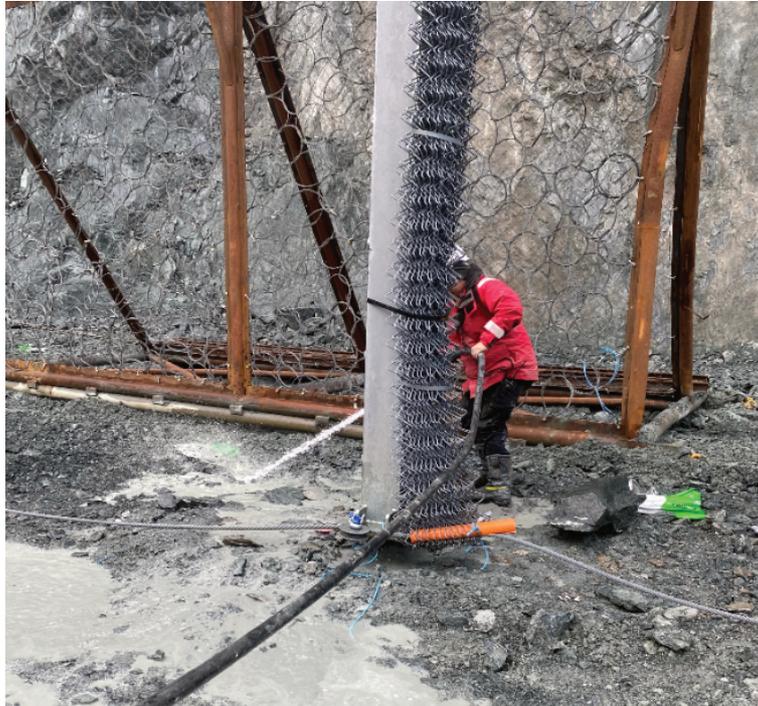
Figure 14 20 mRL rock fence installation completed behind mobile rock fences
