# Case study: open pit three-dimensional slope stability back-analysis for an anisotropic iron ore rock mass

*The challenges of representing geotechnical failure mechanisms in software is being gradually addressed as search algorithms and computing power advance, especially to deal with complex anisotropic rock masses in which failure mechanisms are commonly three-dimensional (3D). This paper presents a case study of an iron ore mine with highly anisotropic rock mass strength that has been back-analysed using 3D limit equilibrium analysis methods. In order to provide as realistic model inputs as possible, field characterisation data and the reconstruction of the failed surface were used, as well as the material properties available from laboratory tests or bibliographic references. A probabilistic approach was applied to the initial parameters, resulting in a series of stochastic simulations that provided scenarios for the failure moment, when the Factor of Safety achieved close to 1.0. Then, based on the knowledge of the local geological-geotechnical context and failure mechanisms, a range of values for the geomechanical parameters were achieved to enhance the constitutive model

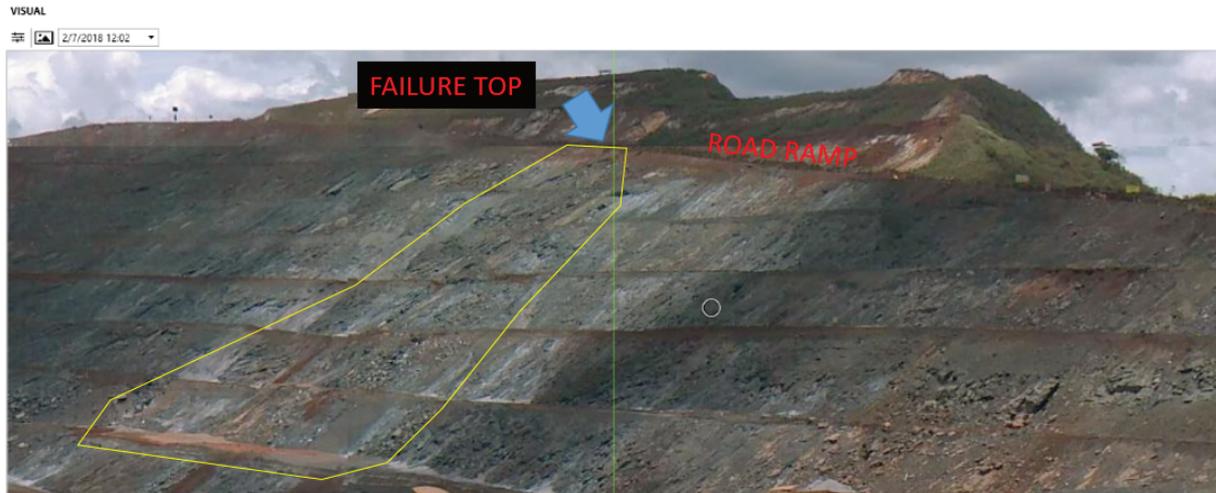
In 2018, a slope failure occurred in Serra do Sapo’s open pit during the rainy season, compromising six benches below the pit’s main access ramp. Figure 3 indicates the area where the failure event took place.

**Figure 3 Failure event in 2018**

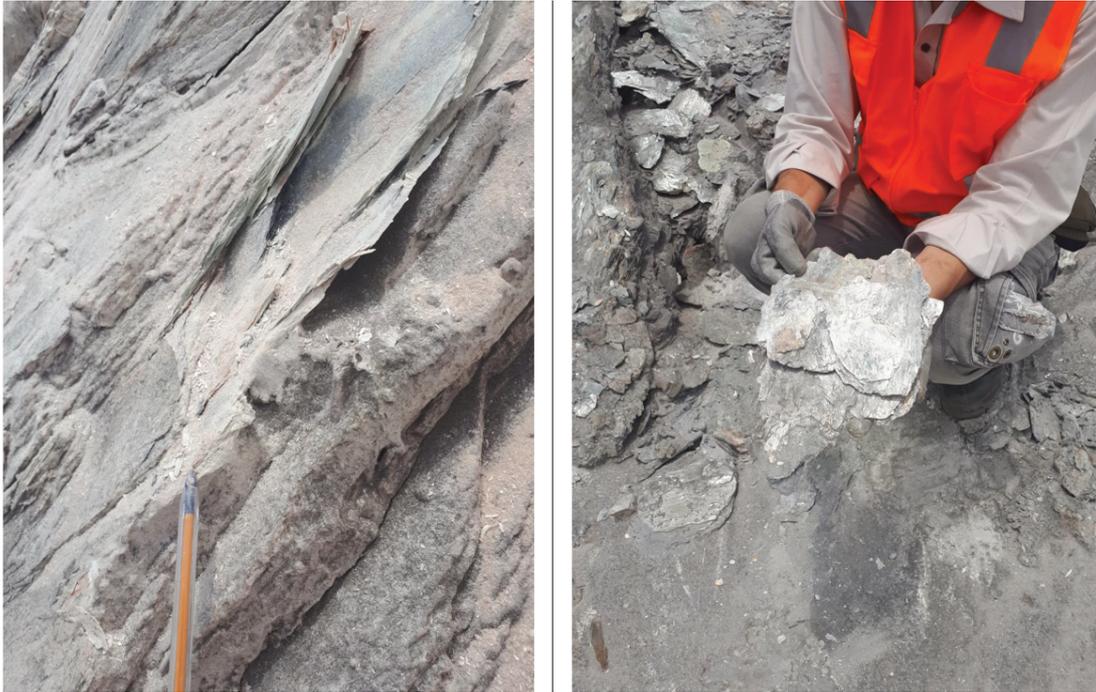
Initially, the failure mechanism and the strength criteria that better represent the constitutive model for the material involved in the event were verified. From mapping and borehole data, it was possible to identify that the 'phyllonite' conditioned the failure event due to its low strength parameters and low permeability coefficient. In general, phyllonite occurs in the contact between the itabirite and the footwall's quartzite, being this material (phyllonite) characterised by low thickness phyllite lenses with high persistence and low strength throughout the quartzite in the shear zone, as shown in Figure 6. Thus, it was decided to model this material as a surface/discontinuity once this approach better represents the failure. It was verified that one of the factors that lead to the failure event was the low thickness of the itabirite in the slope face, leaving the exposure of the phyllonite contact too close to the slope face.

**Figure 6** Examples of phyllonite in the field with low thickness phyllite lenses with high persistence and low strength throughout the quartzite in the shear zone

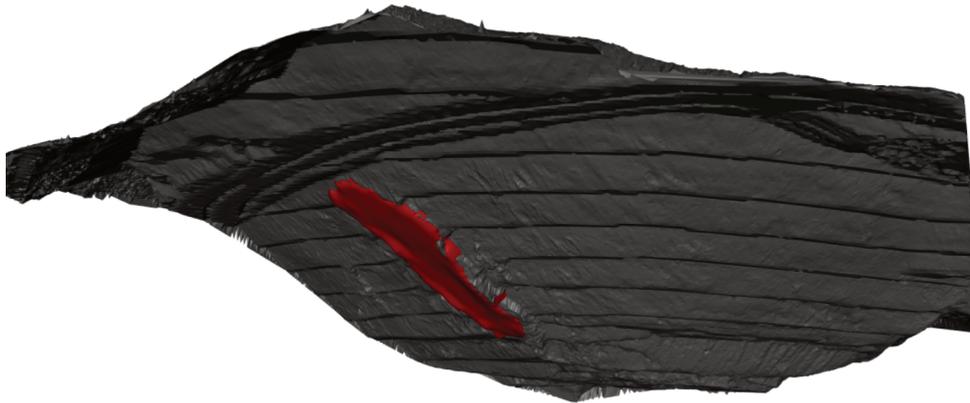
It was necessary to reconstruct the failure surface by an estimation based on the available data, such as the topography before and after the event, field data, geologic contacts, and radar displacement information. Figure 9 shows a reverse view of the failure surface modelled in 3D in relation to the slope in Serra do Sapo's open pit. It is important to highlight that this surface coincides with the phyllonite contact defined in the previous item of this paper as the conditioning material of the failure event.

**Figure 9 Reverse view of the estimated failure surface**
