Compaction faulting in thick mudstone: a slope stability case study of Prominent Hill open pit mine, South Australia

MJ Fowler *PSM, Australia*

DJ Goodchild *OZ Minerals Ltd, Australia*

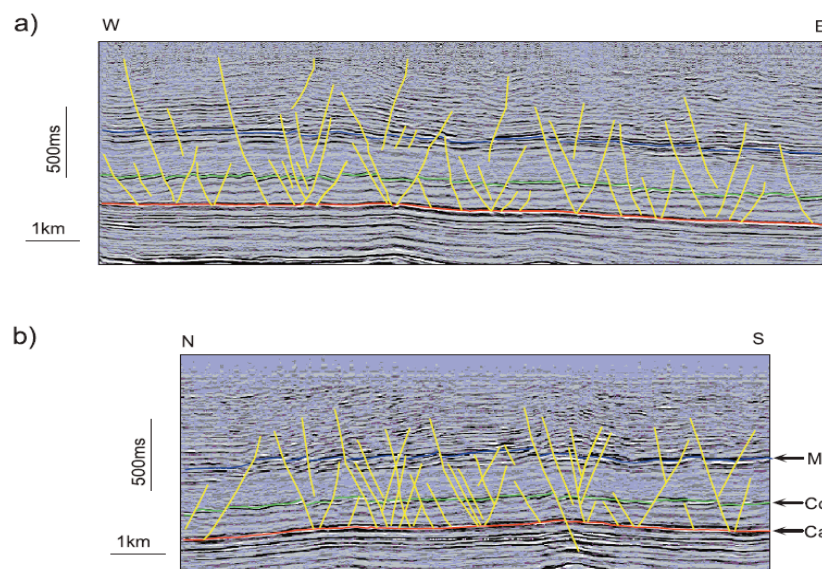
In sections, the faults are moderately steep and continuous through the Bulldog Shale and the overlying mud rocks, but do not penetrate the Cadna-owie Sands below as presented in Figure 4.

Figure 4 Cross-sections (a) and (b) through the Lake Hope seismic interpretations showing interpreted polygonal faults in yellow terminating (with the exception of one instance) at the red line which represents the Cadna-owie Sands (Ca) (after Watterson et al. 2000)

The results of the seismic survey are a good match with observations of exposures at the mine. One difference is that spacing of faults from the seismic survey is much wider (100–1,000 m) than that experienced onsite (~50 m). An explanation for this is that seismic profiling has difficulty identifying small displacement faults and there is an abundance of these in the outcrop.

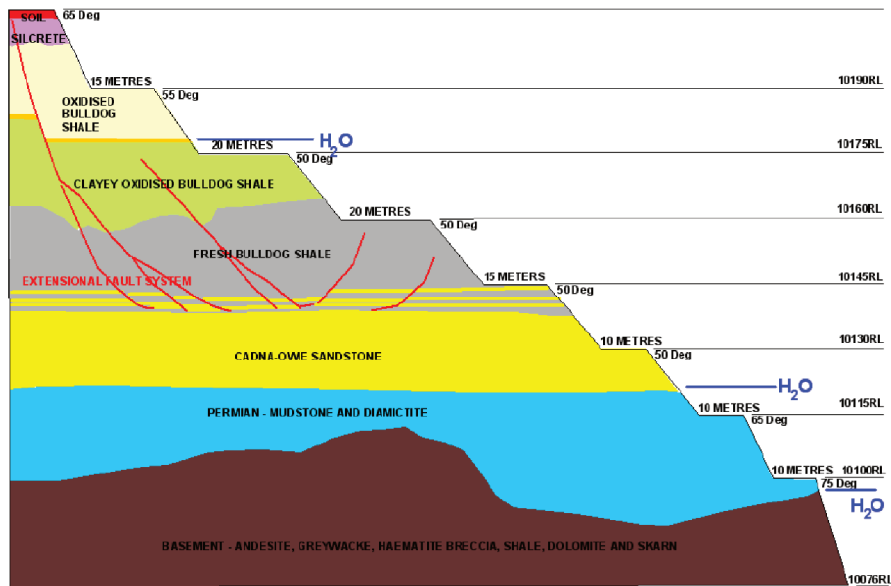
The engineering subdivision of the cover sequence materials is presented in cross-section in Figure 6 with an overview of excavated slopes shown in Figure 7. The subdivision of the cover sequence is based on stratigraphy as described previously in Section 2.2, and weathering. The Bulldog Shale is subdivided into silcrete, oxidised Bulldog Shale, clay oxidised Bulldog Shale, and fresh Bulldog Shale.

Figure 6 Cross-section through a typical mine slope showing the engineering subdivision of the sedimentary units. The red lines represent the polygonal faults which are the focus of the paper. The typical slope geometry is annotated on each bench. H₂O represents the locations of visible seepage on the pit face

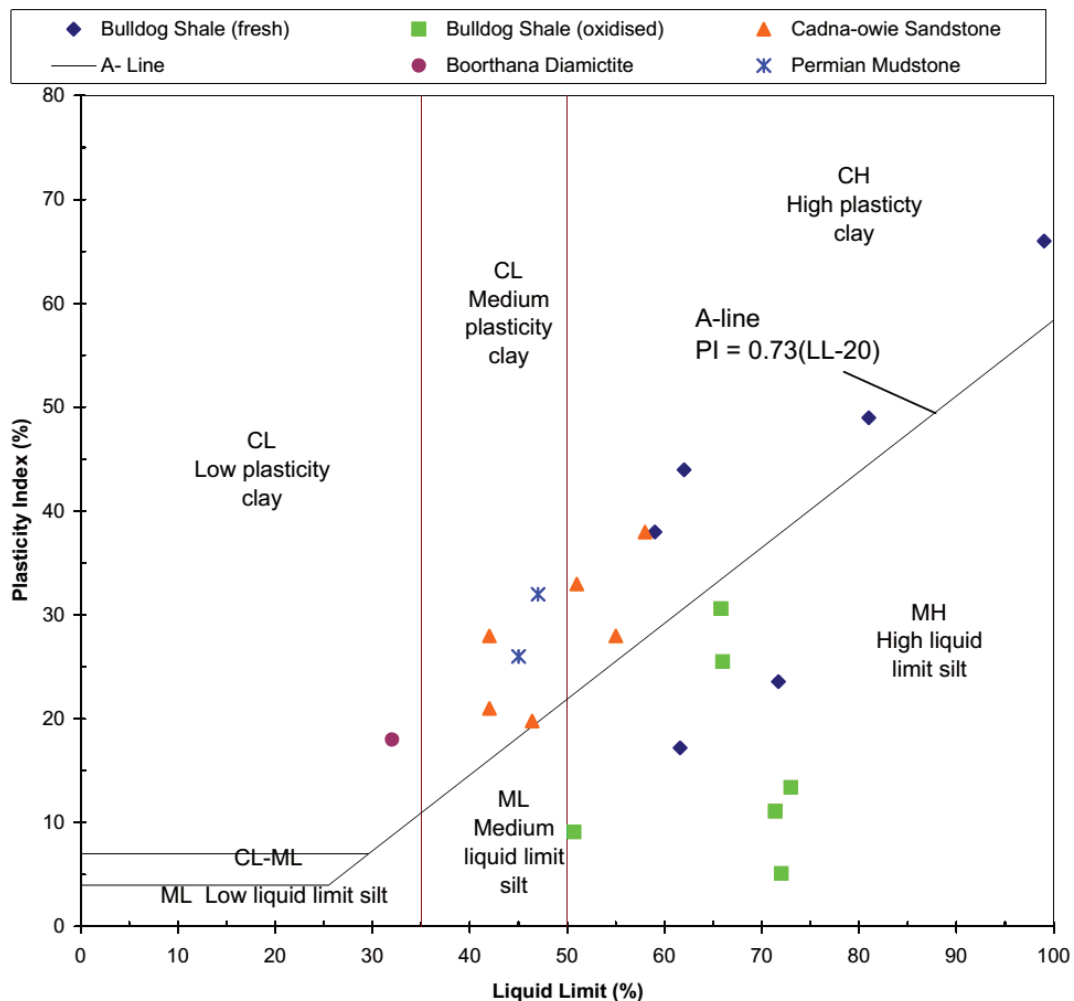
The results of Atterberg limits testing for cover sequence rocks are presented in Figure 8. The results indicate that:

- Remoulded oxidised Bulldog Shale behaves like high plasticity silt (MH).
- Remoulded fresh Bulldog Shale behaves like a high plasticity silt to clay (MH-CH).
- Remoulded plastic portions of the Cadna-owie Sands behave like medium to high plasticity clays (CI-CH).
- Permian sediments behave like medium to low plasticity clays (CI-CL).

Figure 8 Atterberg limits testing for cover sequence rocks

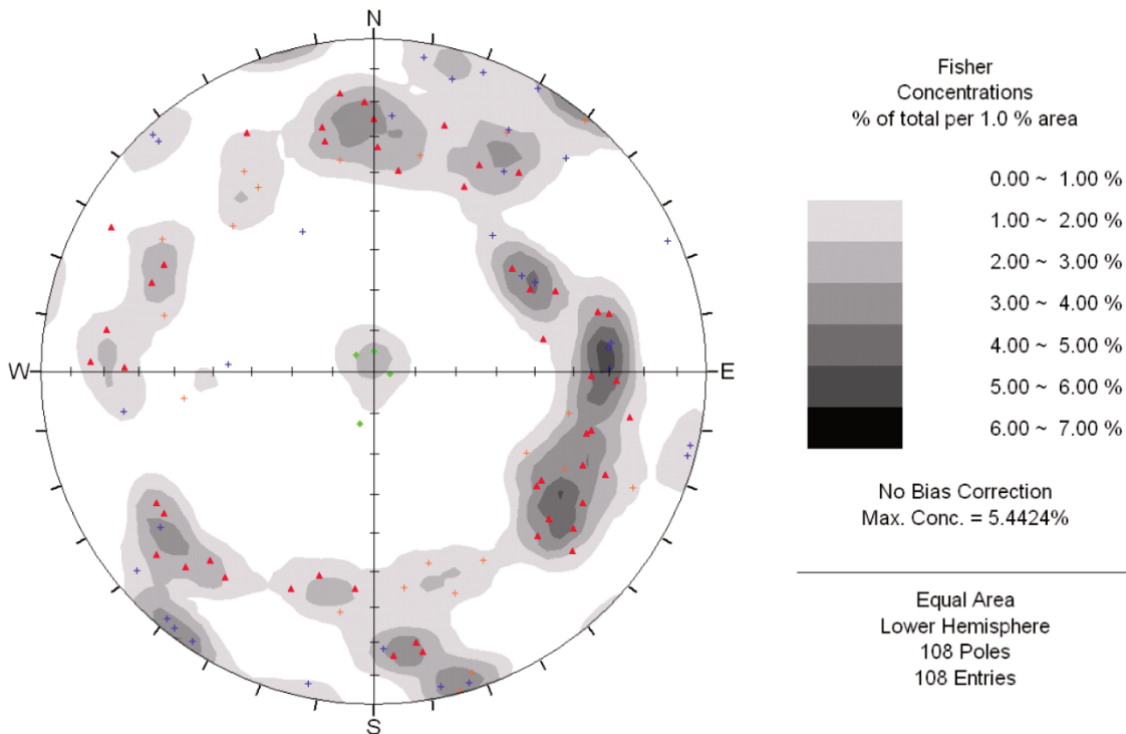
The orientation of discontinuities from mapping of pit exposures is summarised in Figure 12. The orientation of faults (red and orange symbols) dip at approximately 60° with a dispersed dip direction. This is consistent with both the theory and example of polygonal mapping from Lake Hope (Cartwright & Dewhurst 1998; Watterson et al. 2000). Notwithstanding this consistency, no direct observation of polygonal cells has been observed in exposures.

Figure 12 Stereographic projection of mapped discontinuities. Red and orange symbols represent faults, blue symbols represent joints, and green symbols represent bedding

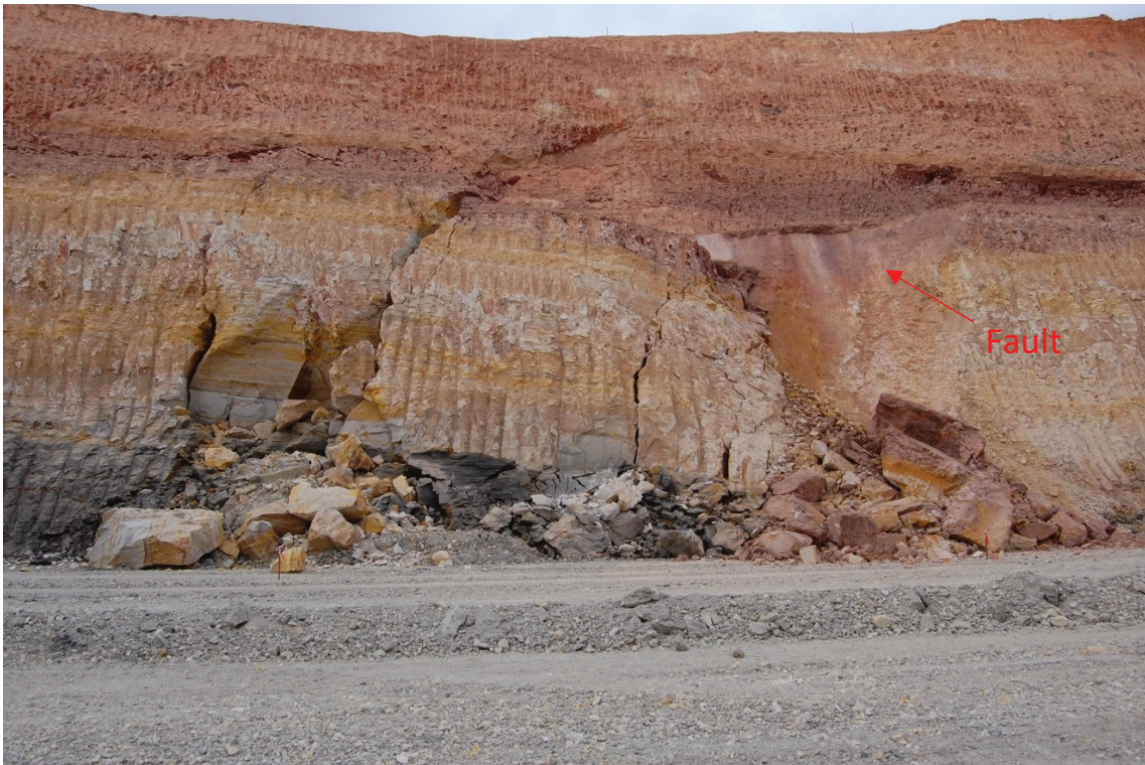
Figure 17 Small one-sided wedge, fault-bound on one side with failure through rock mass on the other. This is one bench high (15 m)

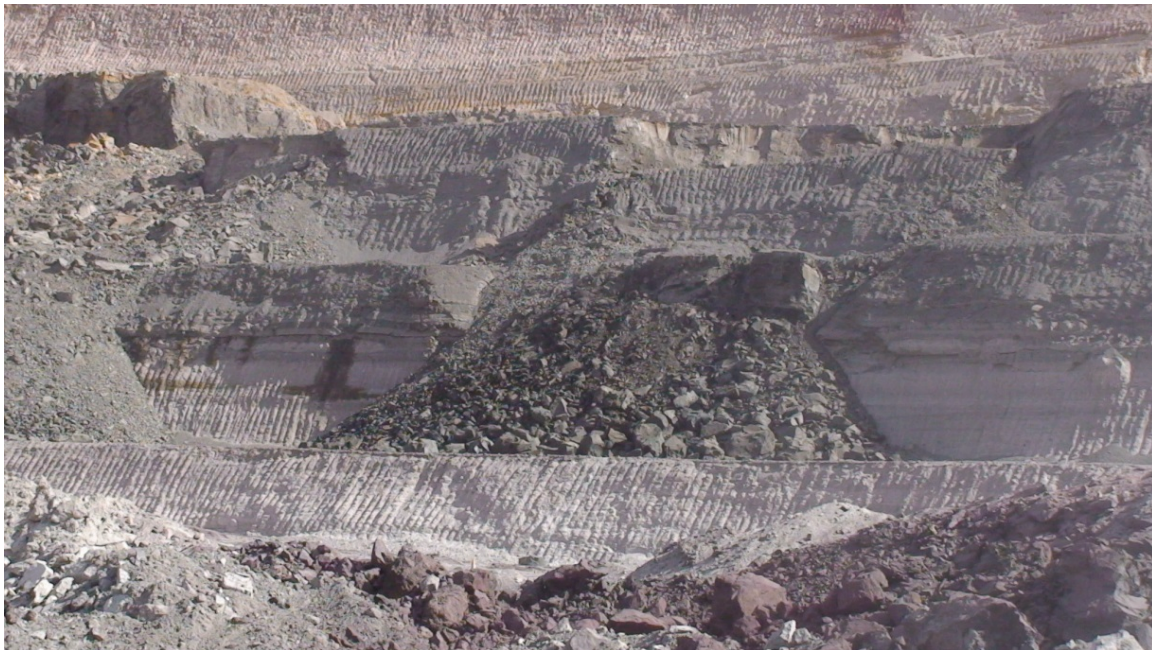
Figure 18 Small non-daylighting wedge, where two faults define a block with a hinge line that is steeper than the slope angles. Failure develops by sliding on bedding at the base. This is two benches high (30 m)

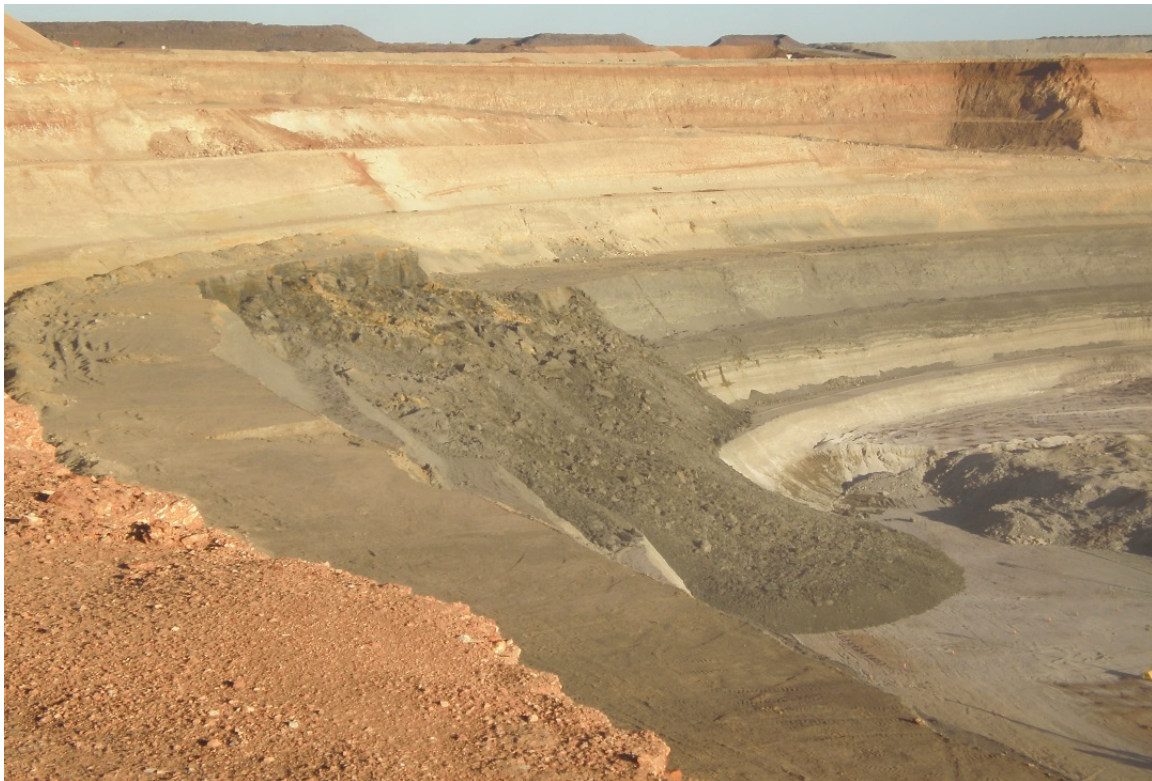
Figure 19 Medium-sized failure showing runout over the working surface. This is about 50 m high

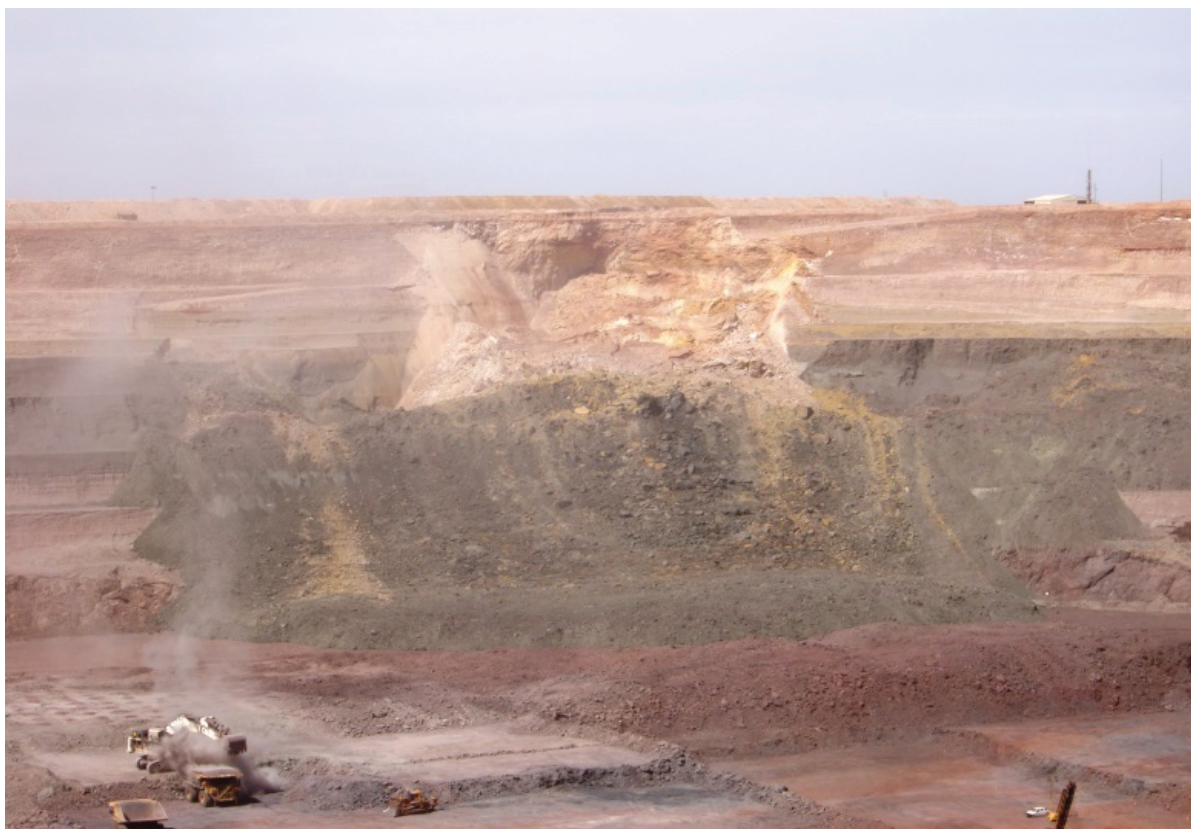
Figure 20 Larger-scale (>200,000 BCM) non-daylighting wedge over the inter-ramp scale with significant runout over the working floor

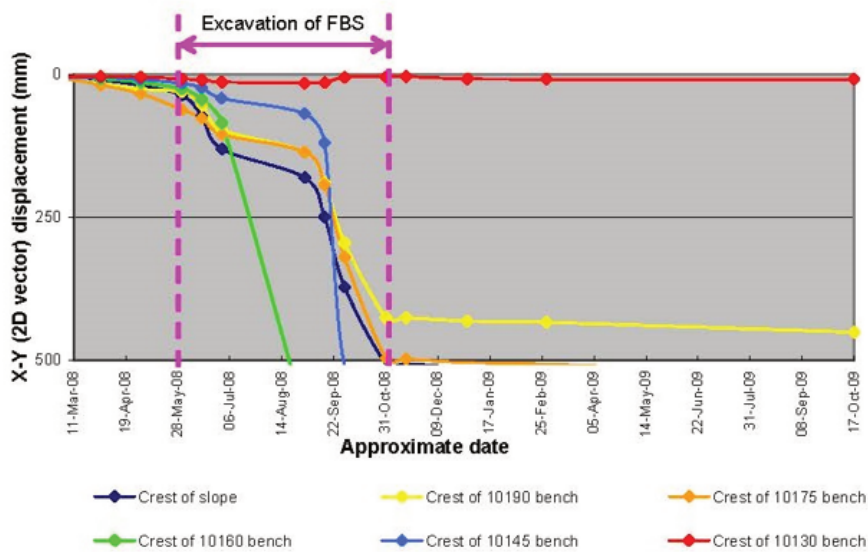
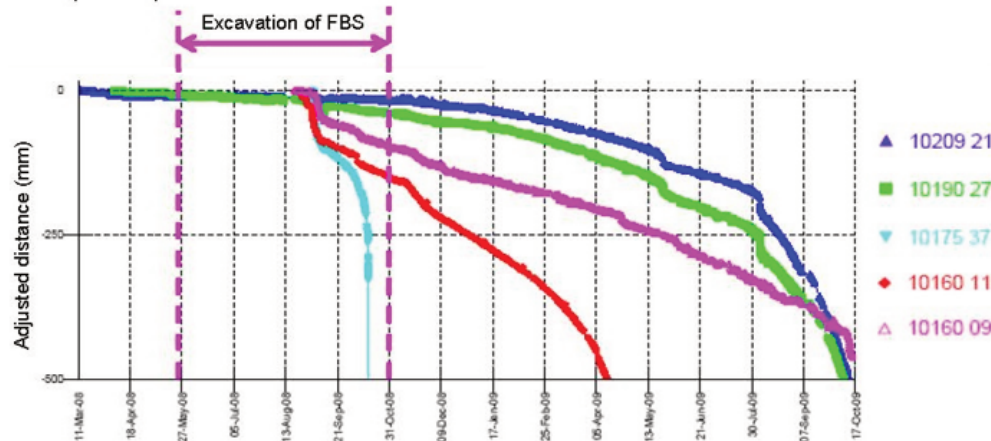
One of the notable features of these failures is the delay between daylighting the base of the Bulldog Shale (and the toe of most failures) and the onset of collapse. This is demonstrated in Figure 22 where modelled displacements presented in the upper plot are compared with equivalent prism measurements from an actual failure. In the upper plot, displacements occur on daylighting the fresh Bulldog Shale. Whereas in reality, the collapse occurred some 12 months after the fresh Bulldog Shale was daylighted. The aqua coloured prism (10175 37) that reached failure before the failure of the overall mass was related to a subsidiary event.

Almost all failures involving sliding on bedding in the fresh Bulldog Shale exhibited a delay between excavation of the toe of the ultimate failure surface and collapse of the slope. The magnitude of the delay was somewhat dependant on the size of the failure and ranged from one month for single bench failure to one year for full cover sequence failures.

Modelled displacements versus excavation stage

Selected prism displacement curves

Figure 22 Modelled (upper) and measured (lower) slope deformation of a large failure at Prominent Hill highlighting delayed collapse of the slope

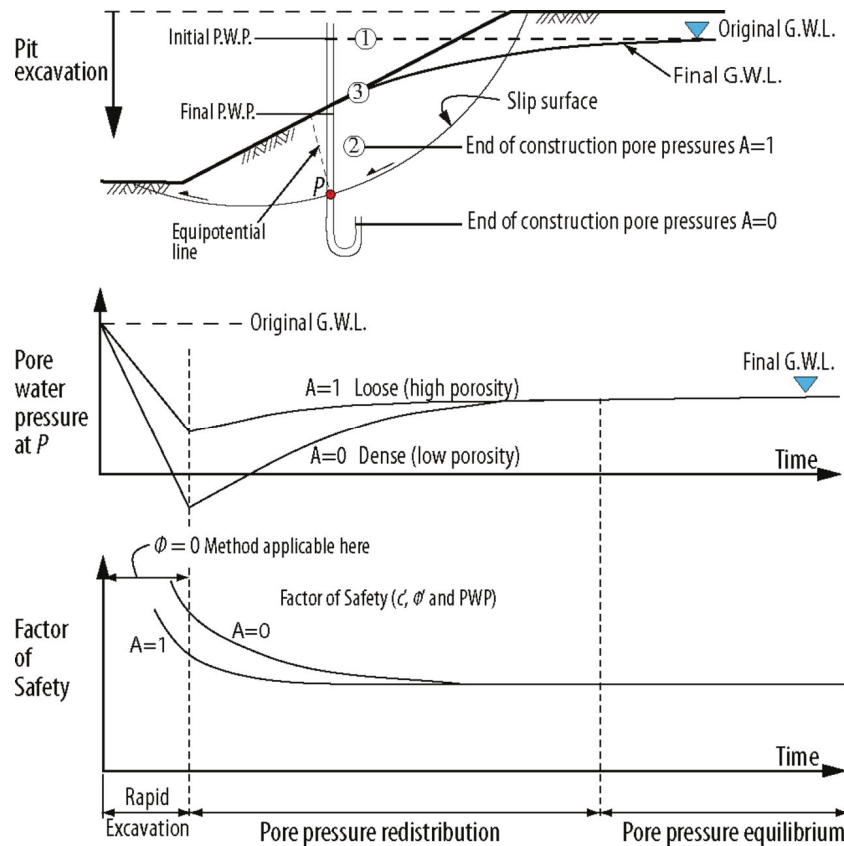
- Here, hydromechanical coupling is caused by unloading of the slope. Pore pressure response to unloading was first documented by Bishop & Bjerrum (1960) as shown in Figure 23. In this hypothetical example, a slope is unloaded by rapid excavation. Unloading causes initial negative pore pressures to develop, resulting in a temporary improvement in stability. Over time, the pore pressures rebound and stabilise, reducing stability. Hydromechanical coupling at the scale of mine slopes is of course more complex than this and is documented by Sullivan (2007) and more recently Sullivan (2020). The hydromechanical coupling experienced as part of the block sliding mechanism (described in Section 5.4) is complex because unloading occurs progressively. The unloading effect is interpreted to have the greatest effect along the base of the block where the shear plane

Figure 23 Variation in Factor of Safety with time for an excavation of a slope (after Bishop & Bjerrum 1960)

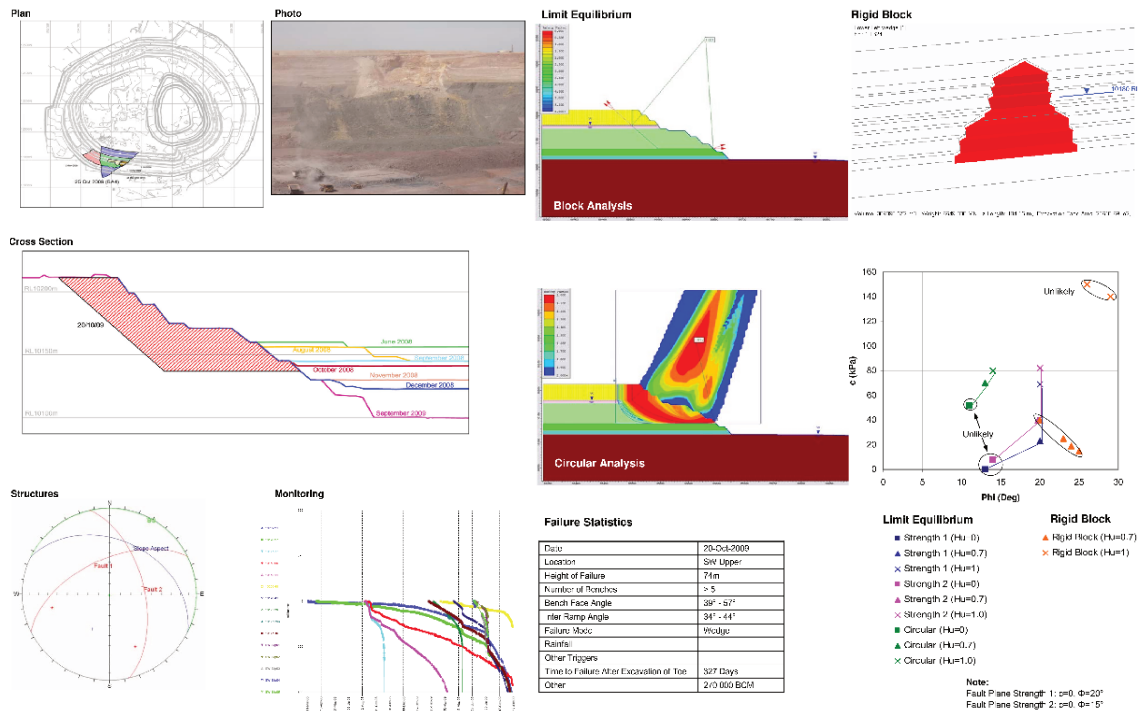
The performance of slopes have been the subject of ongoing review and analysis. Failures were back-analysed in campaigns and presented in a systematic way as shown in Figure 25. This systematic presentation aided ease of comparison and consistent analytical approach. Back-analysis comprised parametric analysis utilising two-dimensional and three-dimensional approaches. Strengths derived from this process were used in forward predictions.

Figure 25 Example of systematic presentation of failure back-analysis
