Cover characteristics of a large gold tailings storage facility in South Africa: a case study

SJ van Wyk *Agreenco Environmental Projects, South Africa*

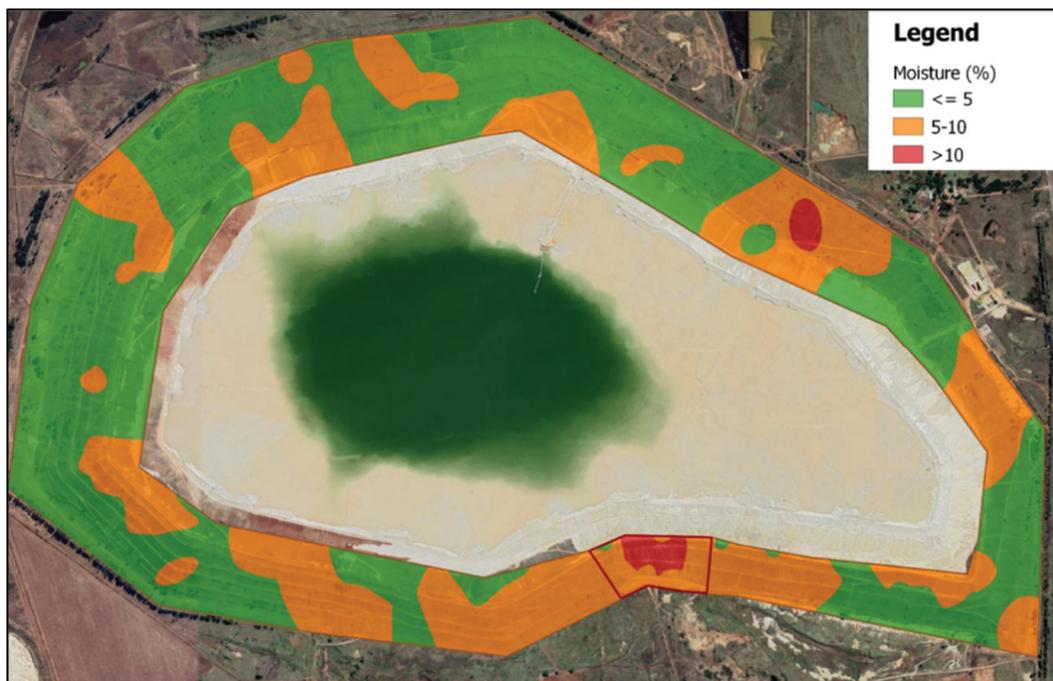
Figure 5 Soil Moisture Results for the Study Site

From the data it is evident that soil moisture in the topsoil cover were on average around 9% but the variance increased as ground level is approached. This could be explained by the natural downward movement of moisture through hydraulic head, although more in-depth studies need to explain the origin of the moisture – whether it is rainfall driven or driven through internal hydrological processes. The tailings moisture indicated roughly the same trend with average moisture content around 7% - the only exception around high variability found along lift 3. More in-depth study is required to explain the movement of seasonal moisture through the cover into the tailings material, but the high-level data indicate that cover moisture was higher compared to tailings and is related to cover characteristics. Tailings moisture was rather constant – except in an isolated locality where black clay cover was found.

Soil moisture results are presented in Figure 5, whilst the moisture differential between the soil cover and the tailings material is presented in Figure 6.

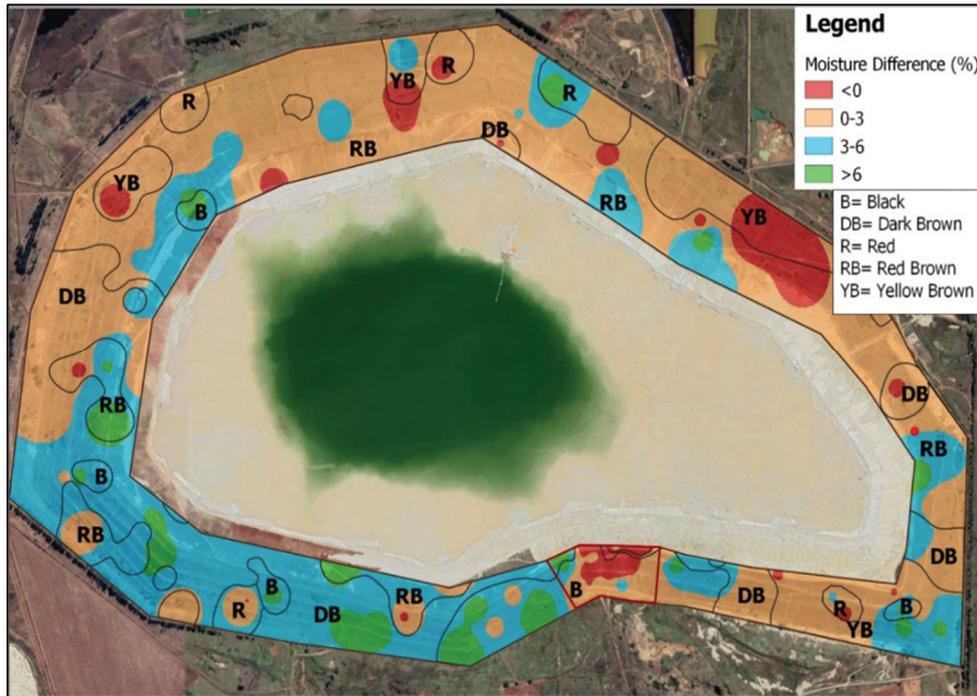
Figure 6 Soil Moisture Differential Results for the Study Site

The moisture differential data analyses showed that the moisture difference (soil moisture minus tailings moisture) of most of the sites varied between 0 and 6%. This indicates that the cover soils are slightly moister compared to the underlying tailings. Conversely, there were also areas where the moisture content of the tailings was higher than that of the soil cover. These areas are located on Yellow-Brown and Black soils. The origins of this could be that the phreatic level of the dam is close to the surface, seepage is taking place and/or water is being discharged from the top of the 5th bench on the southern aspect onto the surface. All of these factors have the potential to impact on the surface moisture of the sideslopes. The average soil moisture in the tailings and soil cover plotted across the vertical extent of the facility can give a high-level overview of moisture differential along the height of the facility on a lift or bench specific scale. The average soil moisture for the lifts is presented in Figure 7.

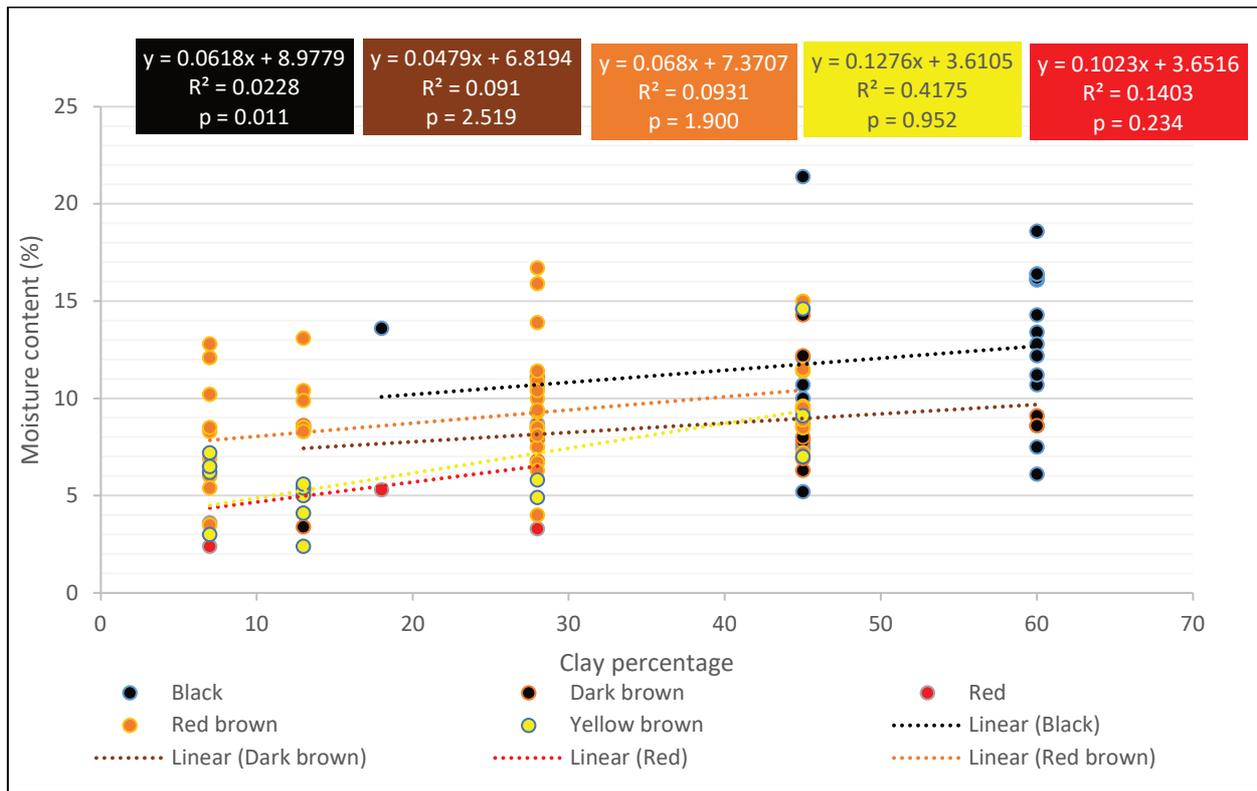
Figure 8 Linear Regression: Soil moisture vs clay percentage

In order to examine the existence and strengths of relationships between the measured soil cover variables and the underlying tailings moisture, we undertook a series of linear regression analyses. The data is presented in Figure 8. for soil moisture content vs clay percentage and Figure 9 presents data for soil moisture vs soil depth. The linear regression for cover soil measure against clay percentage showed that the variance in the observed data was great and that no significant correlation could be found (Figure 8). R² values indicate that none of the soil cover trend lines satisfactorily explain the variation in the data, although the direction of the trendlines do suggest that there is a tendency for soil moisture to increase with increasing clay percentage, albeit statistically insignificant. The correlation coefficients for the regression were 0.15 (black soil), 0.30 (dark brown soil), 0.38 (red soil), 0.31 (red brown soil) and 0.65 (yellow-brown soil).

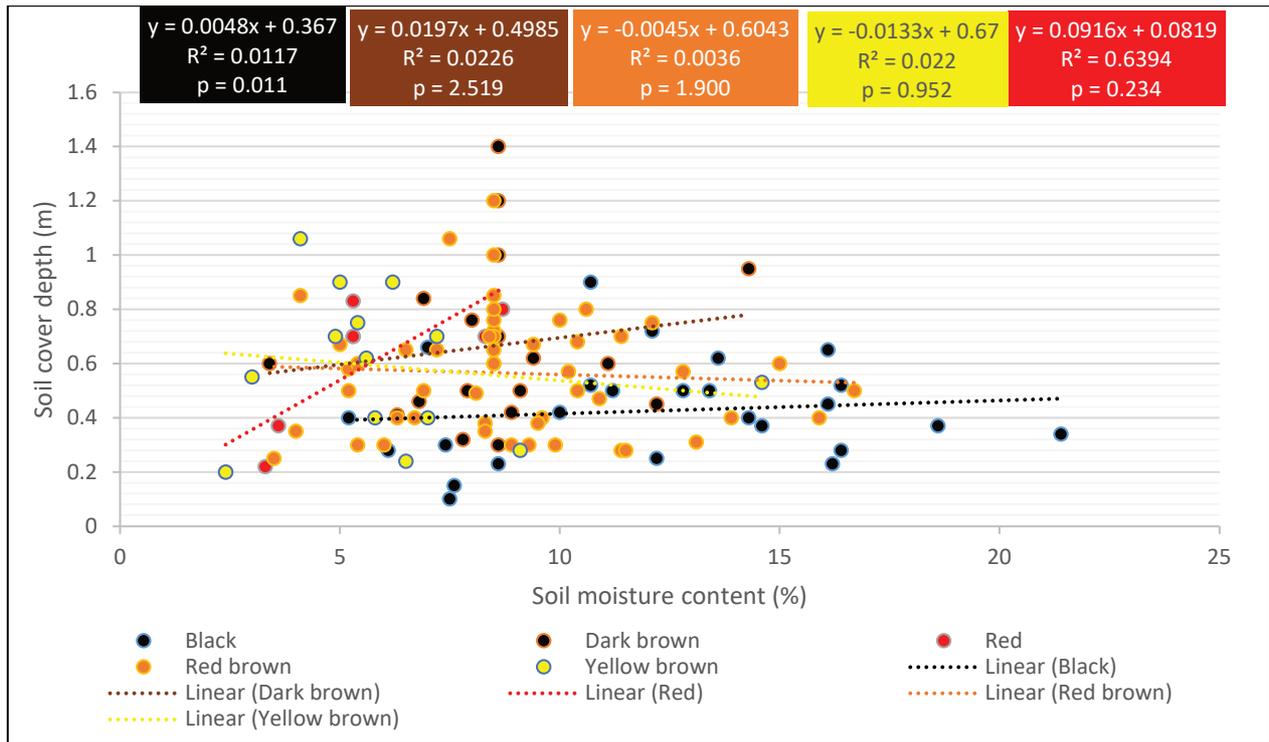
Figure 9 Linear Regression: Soil moisture vs soil depth on the TSF cover

From the the relationships between soil depth and soil moisture it was evident that the moisture varied with soil depth associated with soil form/texture, although the relationships were statistically insignificant (except for red soil which indicated a sound correlation between soil moisture and soil depth). The correlation coefficients for the regression were 0.11 (black soil), 0.15 (dark brown soil), 0.80 (red soil), -0.06 (red brown soil) and -0.15 (yellow-brown soil).

- Yellow-brown soils presented lower soil moisture with shallower soil covers, as is expected from the higher sand percentage, and inferred high infiltration rates.
- Red soils presented increased moisture content with increasing soil depth.
- Dark brown, Black and Red-brown soil moisture did not indicate any correlation with soil depth.

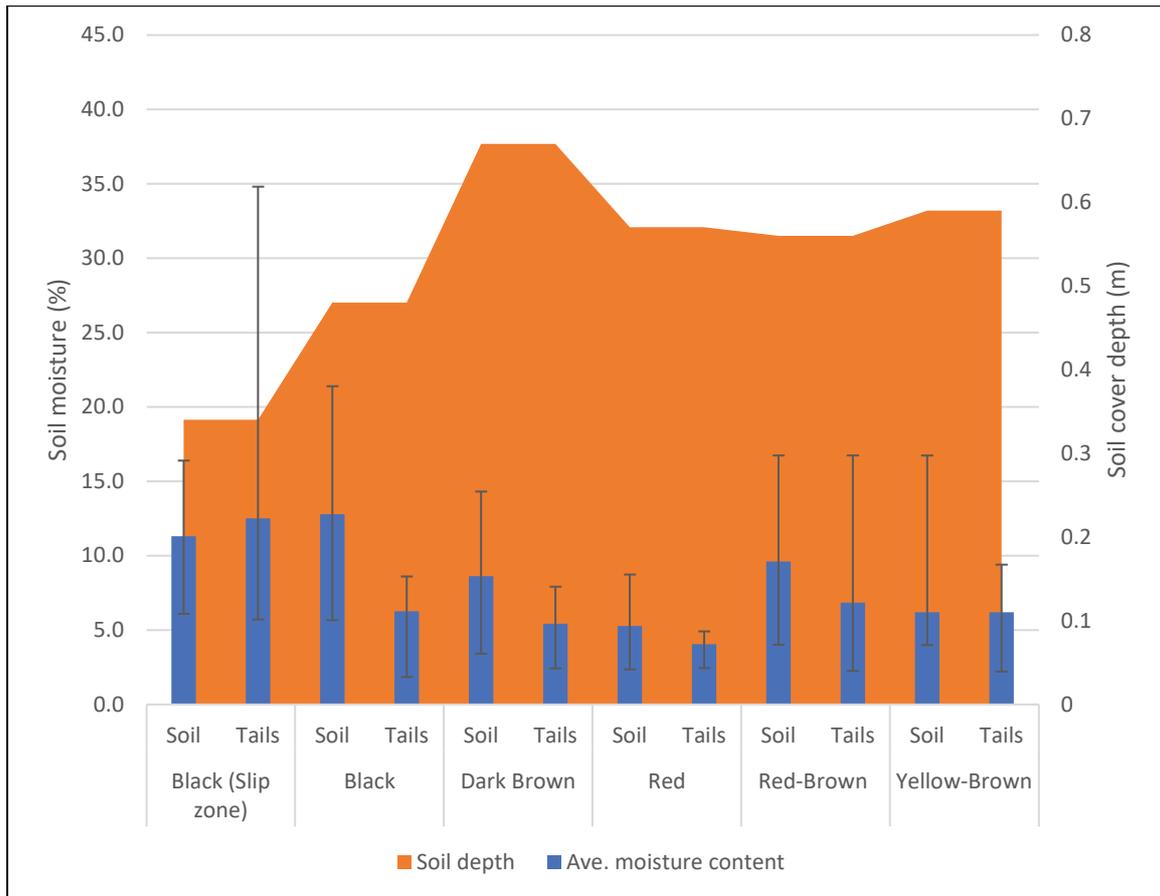
Figure 10 Average moisture content of sampled soils and tailings

When isolating the moisture in the black soils and underlying tailings a further pattern emerges. The data presented in Figure 10 presents an overlay of soil moisture and soil depth and shows that most soil colours/textures have relatively deep soils, with correspondingly lower than average soil moisture compared to even lower tailings moisture content. This correlates with the statistical findings. However, considering the black soils only, soil moisture was found to be higher than the TSF cover average. The highest moisture was found on the southern slope, in some instances extremely so (35% tailings moisture). A contentious consideration is whether the high moisture can be explained by the soil cover in the area or by operational reasons such as concentrated water flow, seepage, or design oversight.

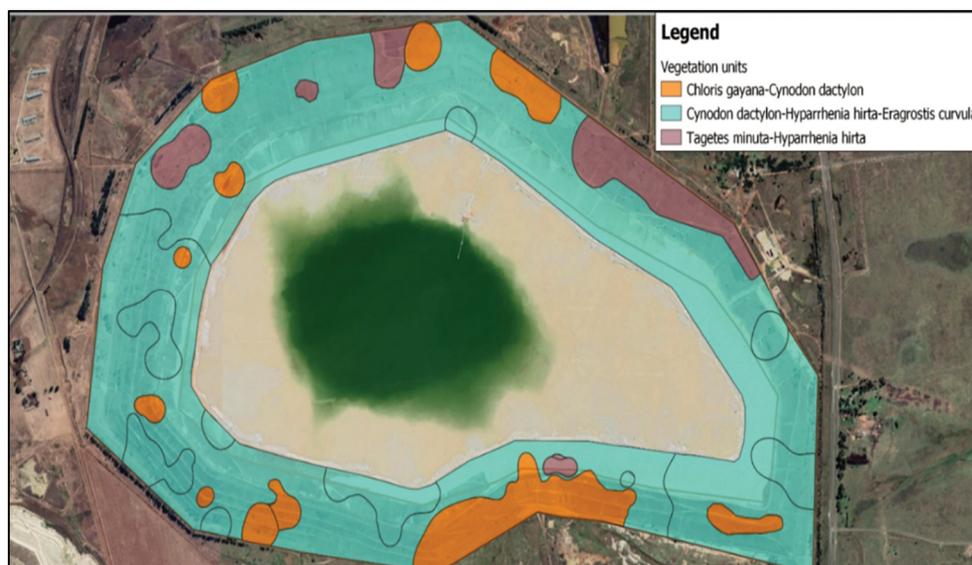
Figure 11 Vegetation Results for the Study Site

From the vegetation results, three distinct vegetation assemblages were identified which included *Chloris gayana-Cynodon dactylon* unit, *Eragrostis curvula-Hyparrhenia hirta* unit and *Tagetes minuta-Hyparrhenia hirta* unit. The vegetation assemblages did not resemble the surrounding natural vegetation which is dominated by *Themeda triandra* highveld grassland. Despite revegetation efforts of more than 50 years, the area is in mostly a pioneer state. The vegetation types are presented in Figure 11

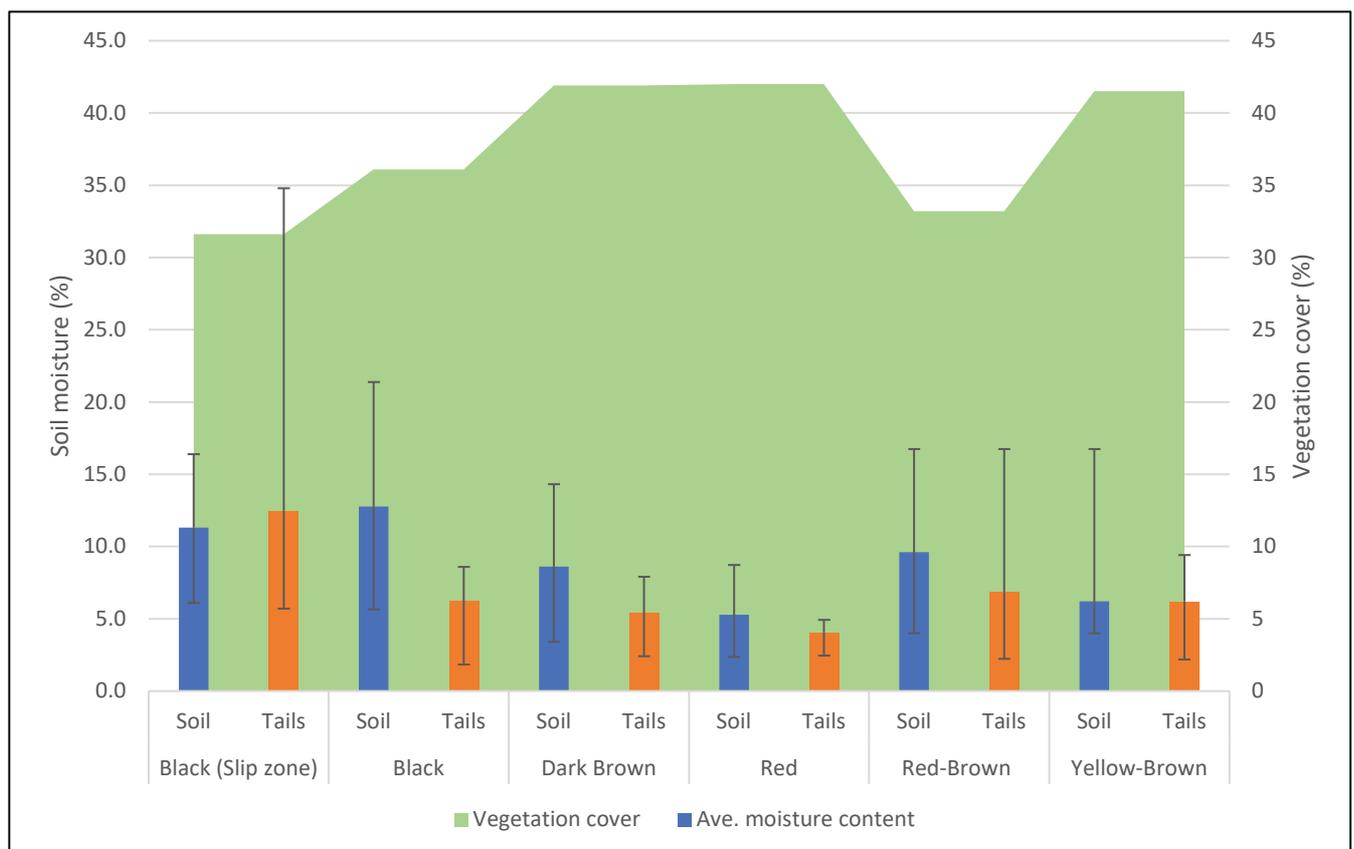
Figure 12 Average Moisture Content of Sampled Soils and Tailings per soil type location and associated vegetation cover.

Figure 12 outline the overlay of vegetation cover, soil type and soil moisture. Overall vegetation cover was similar for most of the soil types, with Red- and Dark-Brown soils having the highest cover. The vegetation assemblages were indicative of soil type and loosely correlated with topsoil moisture conditions.

The vegetation data showed a general trend that increased vegetation cover was associated with relatively lower soil moisture. The black soils, with highest soil moisture, thus showed the lowest vegetation cover. Although the yellow-brown soils had good vegetation cover, the species dominance was partly by weedy species. Therefore, the data suggests that the greatest vegetation cover is found where red and dark-brown soils are encountered. These are typically deeper soils on the TSF and have more balance loamy texture that, despite lower relative soil moisture, appear to support improved drainage and better edaphic conditions that the sand-dominated or clay-dominated soils.

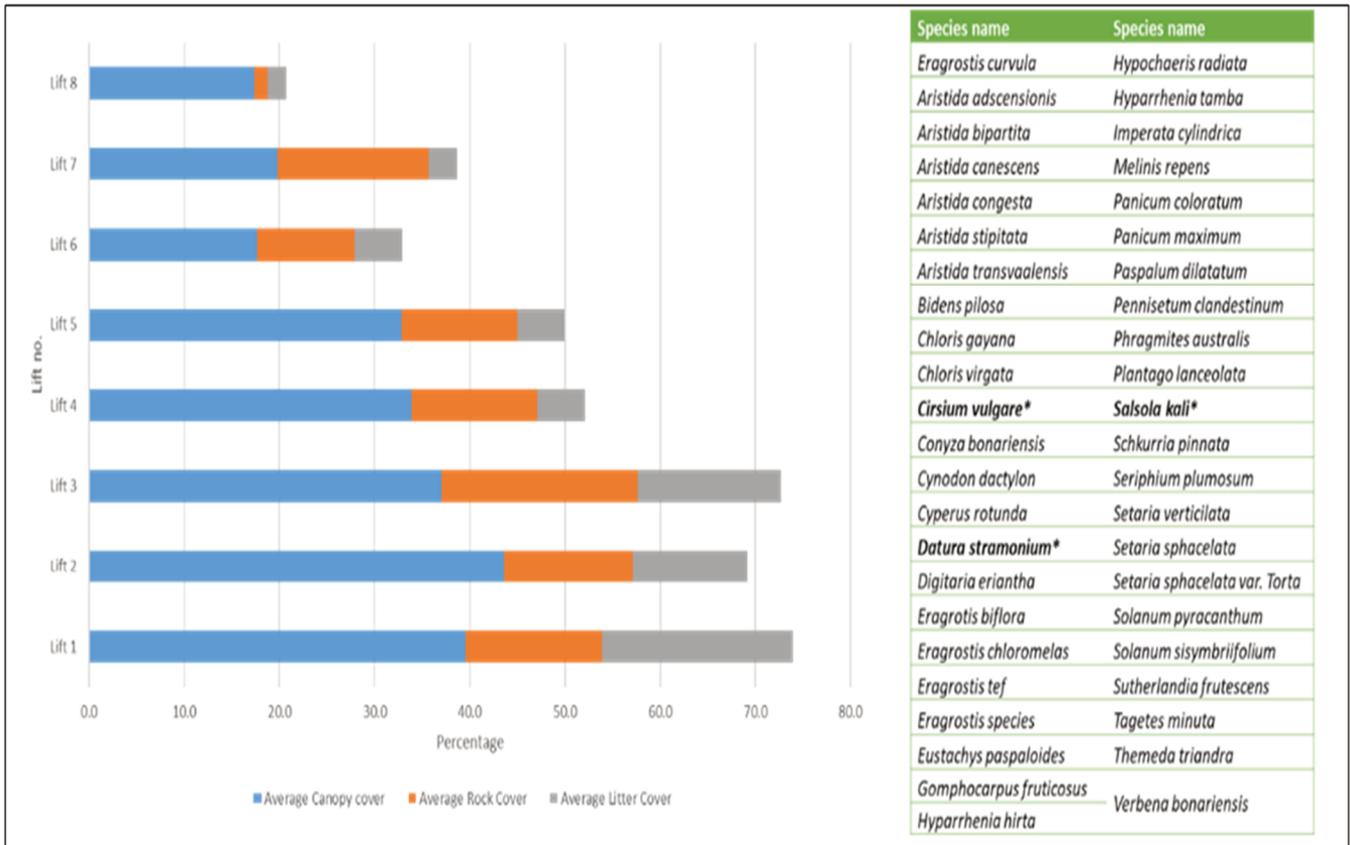
Figure 13 Overall Vegetation Ground Cover Results and species list summary for the Study Site

The vegetation surface cover data and species richness summary are presented in Figure 13. Less than 40% of the TSF is covered by vegetation canopy cover an although the rock cover and litter cover contribute to surface stability, the cover would be exposed to erosive processes. The species richness comprised of 45 species, mostly grass, and weedy alien invader plants. It is clear from the vertical average vegetation cover assessment that ground cover changed with rehabilitation age, i.e., the older the lift, the higher vegetation cover and the higher the species richness and composition. Repeat annual assessments of the vegetation data may provide insights into vegetation dynamics and ecosystem development.
