Practice of 2:1 waste rock dump reclamation slope at Batu Hijau – a 20 year journey creating the best legacy

M Maswahenu PT Amman Mineral Nusa Tenggara, Indonesia

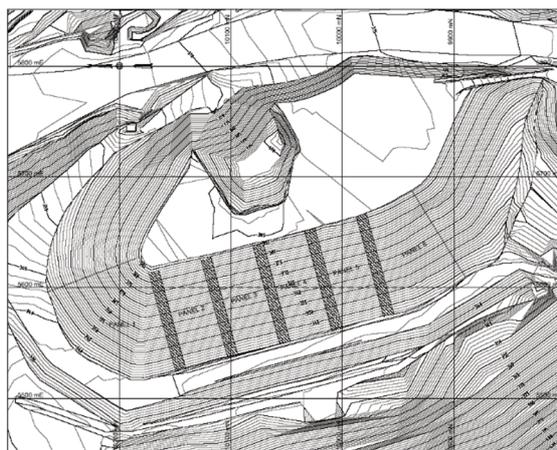
Figure 1 Plan view of the 2:1 NEWTS layout

A test slope with six contiguous panels with a 2:1 slope angle and 100 m slope length had been built in 2000 to demonstrate 2:1 reclamation slope can perform adequately at a reasonable cost and that the 2:1 slope will have adequate erosional and geotechnical stability to minimize the likelihood of exposing acid-generating materials (Figure 1).

Each panel was constructed by a different technique to form a soil cover that was approximately 3.00 m thick, comprising a 0.5 m thick topsoil layer and a 2.25 subsoil layer, with compaction methods included – some used a vibrating roller, others used track rolling, and some uses a combination of both, and different soil spreading methods – used downslope dozer movement and horizontal thin-lift.

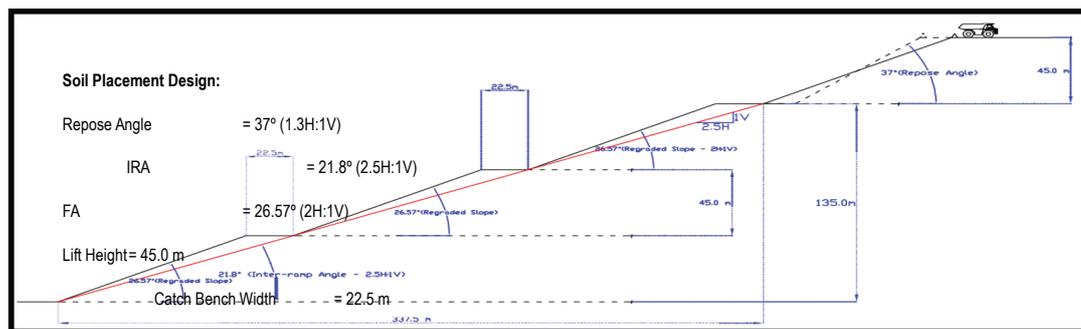
Figure 2 Final waste dump design criteria

The waste dump design criteria have been developed considering both the operational as well as closure issues pertinent to the safe construction of waste dump facilities (Table 1 and Figure 2).

Parameter	Criteria
Dumping Face Angle	37 degree (Repose Angle) – Stacking lowest lift first
Catch Bench Width	22.5 meters
Lift Height	45 meters
Ramp Width	40 meters
Ramp Grade	8%
Catch Bench Crossfall	2%
Regraded Bench Face Angle	2H:1V
Inter Ramp Angle	2.5H:1V
Overall Slope Angle	2.5H:1V or shallower

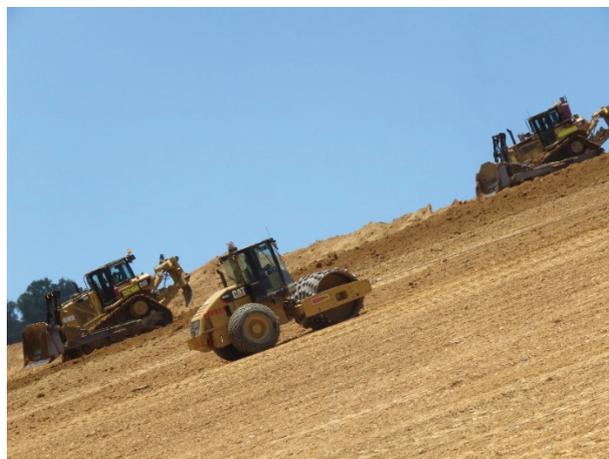
Figure 3 Soil compacting using sheepfoot provides keyed in between layers

The spreading of subsoil on the 2H:1V slope is done in 0.5-meter layers (prior to compaction) to a total compacted thickness of 2.25 m, measured perpendicular to the slope. The number of subsoil layers placed is generally four (4) to five (5). The subsoil material is delivered at the crest of the lift that is being reclaimed. The dozer pushes the subsoil from the crest to the toe (from top to bottom). Any large logs, boulders, or other obstructions encountered during the spreading of soil layers are removed. Following each application of a 0.5 m sub-soil layer, compaction will be achieved by using a sheep-foot roller (Figure 3). The sheepfoot roller leaves a roughened compacted surface that allows subsequent soil layers to be effectively “keyed in”, increasing the overall soil profile strength.

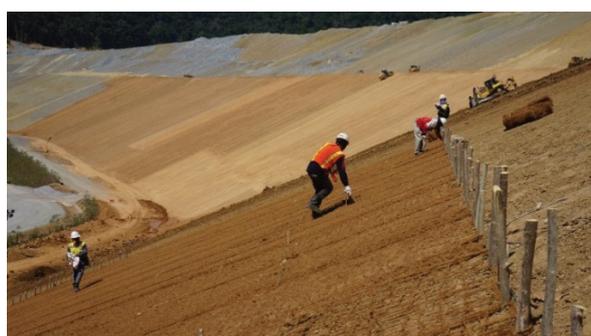
Figure 4 Coconet installation and row sprigging as energy breaker

Soil preparation before revegetation consists of the installation of row sprigging water energy breaks at 15-meter intervals, ijuk dispersion aprons, and jute netting (Figure 3).

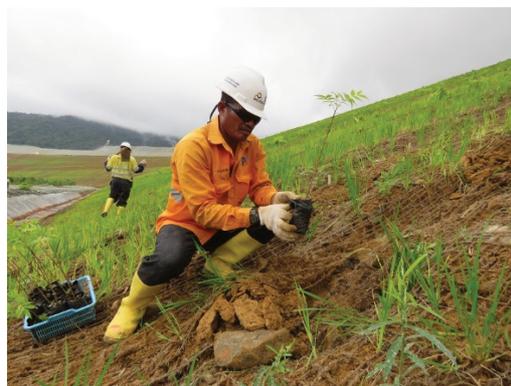
Figure 5 Transplanting of phase 1 native Tree Species

Following completion of the hydroseeding, a two-phase tree transplanting process is conducted. Phase-1 tree planting includes the transplanting of rapid growing species at a relatively high density to create an appropriate microclimate for subsequent “A” stratum (canopy) species. To accelerate this process tree seedlings are planted across the dump surfaces on 3,0 m x 2 m centres over the reclaimed surface to produce a planted density of approximately 1,667 seedlings/ha (Figure 5).

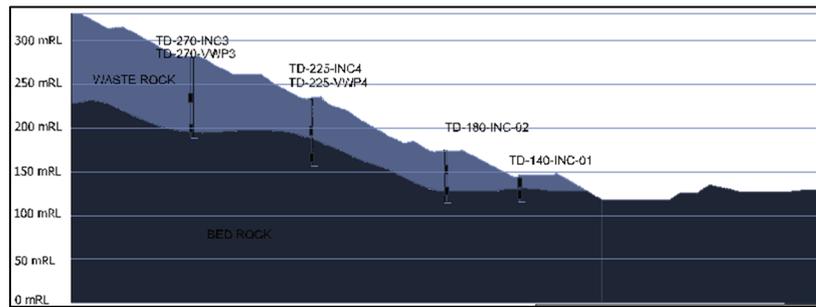
Figure 7 Typical subsurface monitoring; inclinometer and VWP sensor location at reclamation slope.

Geotechnical monitoring reclamation slope at waste rock dump is aimed to determine the actual performance of waste dump stability and aiding risk minimization. The monitoring involving surface monitoring and subsurface monitoring with further subdivision into qualitative and quantitative systems.

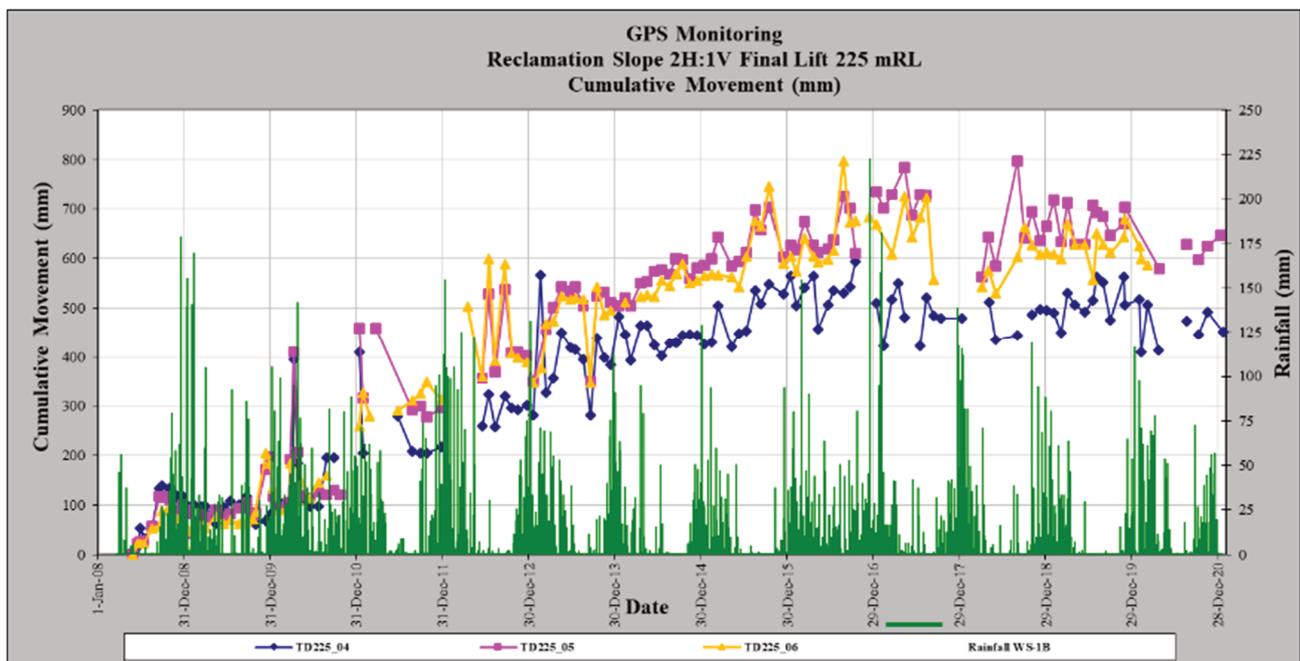
Figure 8 GPS Monitoring Cumulative Movement at Reclamation Slope Elevation 225mRL

Geotechnical monitoring programs have been conducted and reported to the Government of Indonesia as required in the Environmental Impact Assessment (EIA) document. Monitoring records from HPGPS show that surface stability in the reclamation slopes being maintained and some movements are considered insignificant. The movements are only limited to the settlement of waste rock materials and do not appear to be of any direct response from previous significant rainfall events (Figure 8).

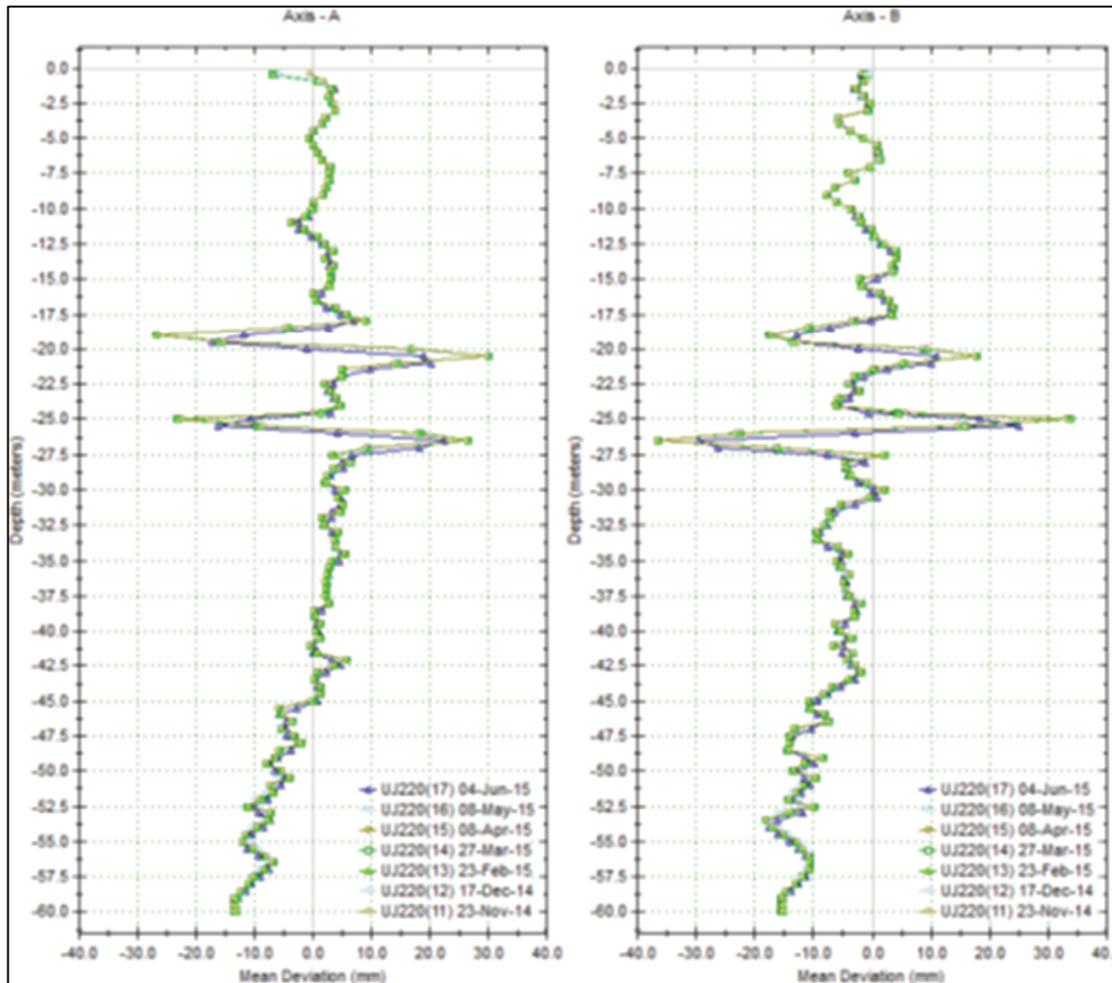
Figure 9 Inclinometer Monitoring Mean Deviation along Axis-A and Axis-B at Reclamation Elevation 220mRL

1. The slope inclinometer monitoring records show that the magnitude is a negligible and stable condition both for A-Axis reading and B-Axis readings. The movement does not appear to be of any direct response from previous significant rainfall events (Figure 9).

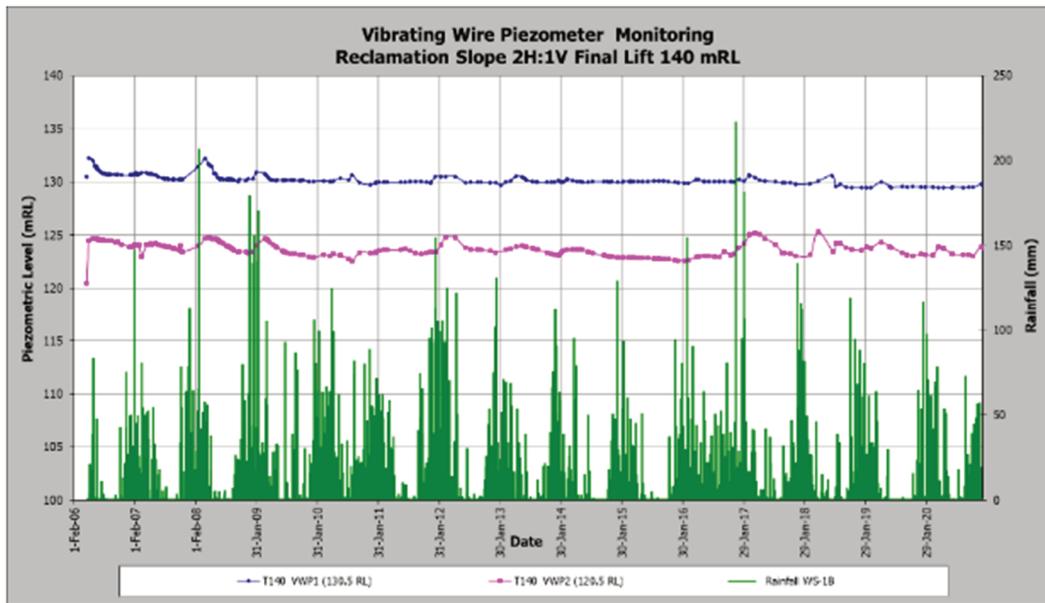
Figure 10 Vibrating Wire Piezometer Monitoring at Reclamation Elevation 140 mRL

2. The wire piezometer monitoring data recorded that small pore pressure occurred near the base of the dump and groundwater only rose marginally above the level of the sensor only on a few occasions following heavy rainfall events. The measurement has remained relatively static at the sensor level (Figure 10).

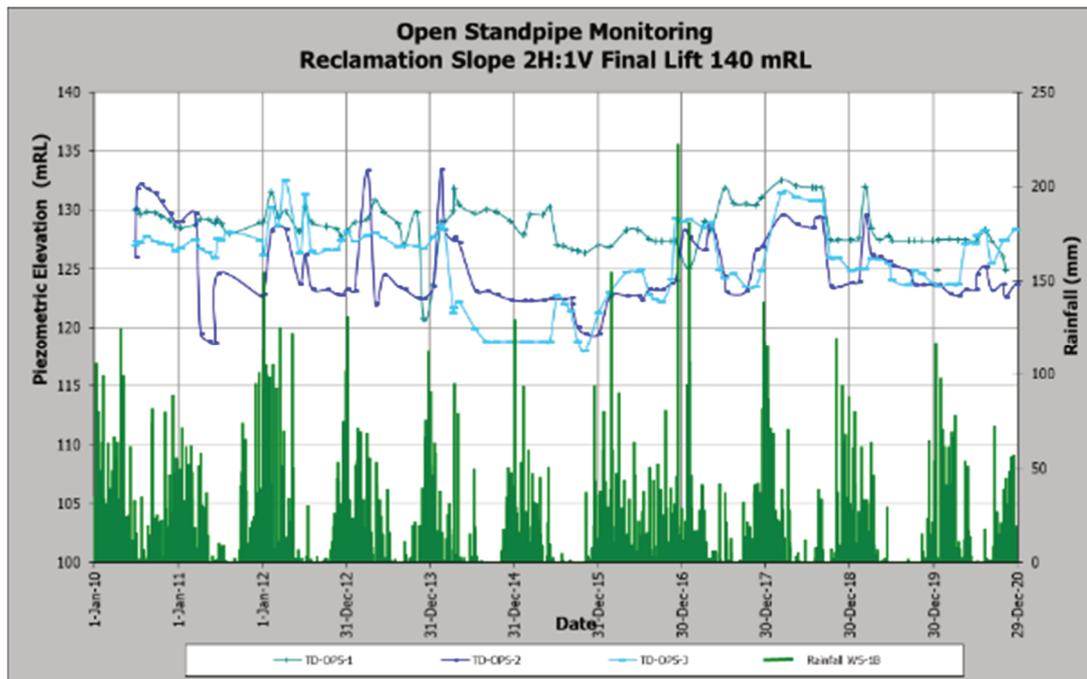
Figure 11 Open Standpipe Monitoring at Reclamation Elevation 140mRL

3. The open standpipe monitoring data installed at the elevation level 140 mRL indicates that groundwater levels are dependent on rainfall at the elevation levels of 122 mRL to 127 mRL (Figure 11).

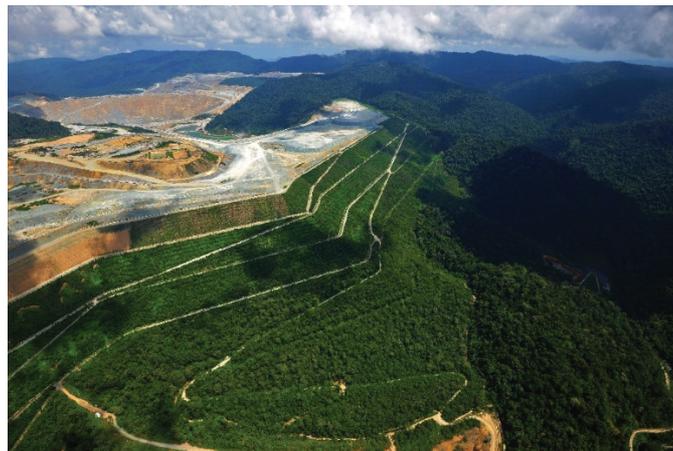
Figure 12 2:1 Tongoloka waste dump reclamation

Remediation is aimed to avoid soil slump propagation by backfilling and applied several bioengineering techniques such as installation of bamboo lattice retaining structures and plantings vetiver grass and trees (Figure 12).

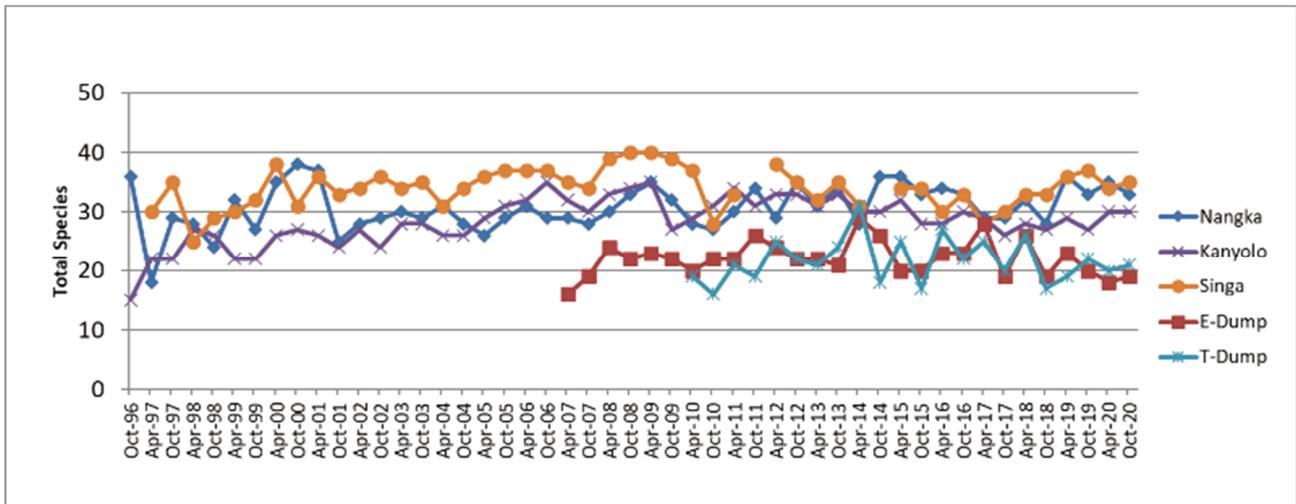
Figure 13 Total bird species from census method in Batu Hijau

A recent report (PT Amman Mineral Nusa Tenggara 2021) in Figure 13 shows a time series of several birds found in the reclamation area of Tongoloka Dump (T Dump) and East Dump (E Dump), and in the control area of Nangka, Kanyolo, and Singa. From the graph, the number of bird species in the control area is still higher comparing to the reclamation area. The latest monitoring result in October 2020 described the number of tree species in all 3 natural forests vary between 30 until 35 species and between 19 – 21 species in reclamation area. The abundance and diversity of birds are mostly seasonal. An increase is generally observed in April and a decrease in October, with a correlation with the food availability in nature.

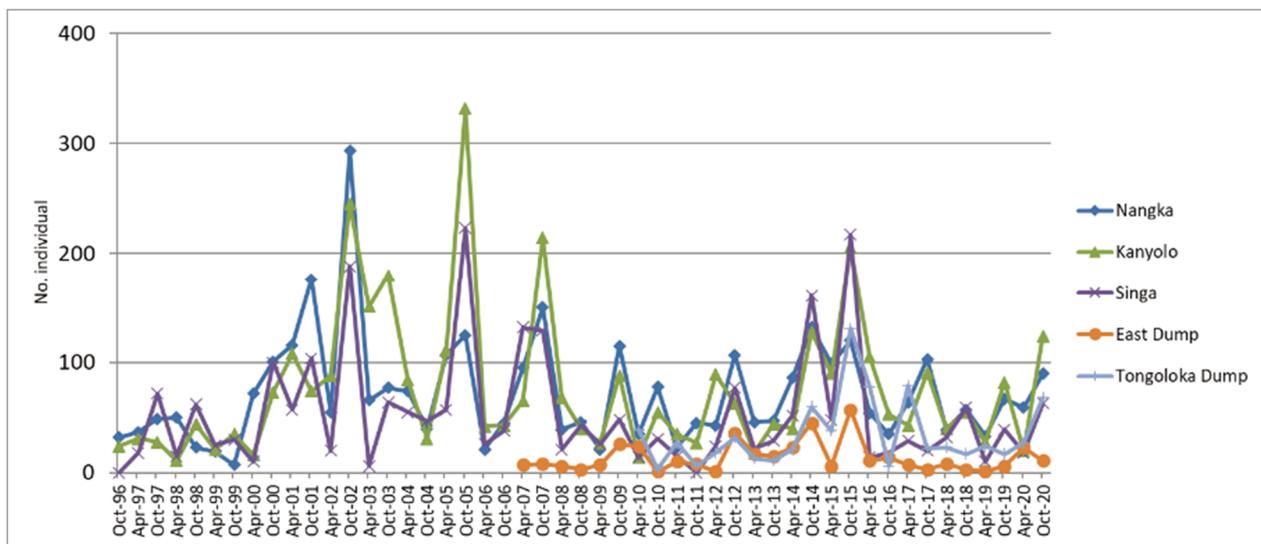
Figure 14 Number of Bats Captured in Batu Hijau

Monitoring results for bats also show a similar trend to the birds. During monitoring in five primary locations on the nights of April and October 2020, the total number of bats caught and released were 503 individuals of 8 species with an overall density of 0.146 ind/m² and 0.359 ind/m² respectively. The density of bats in the reclamation area is still lower than that of natural forests (Figure 14).
