X-ray computer tomography and ground conditions at Northparkes cave edges to further the understanding of the caving mechanisms of strain and hydraulic conductivity

Abstract

Keywords: *failure mechanism, strain, permeability, field observations*

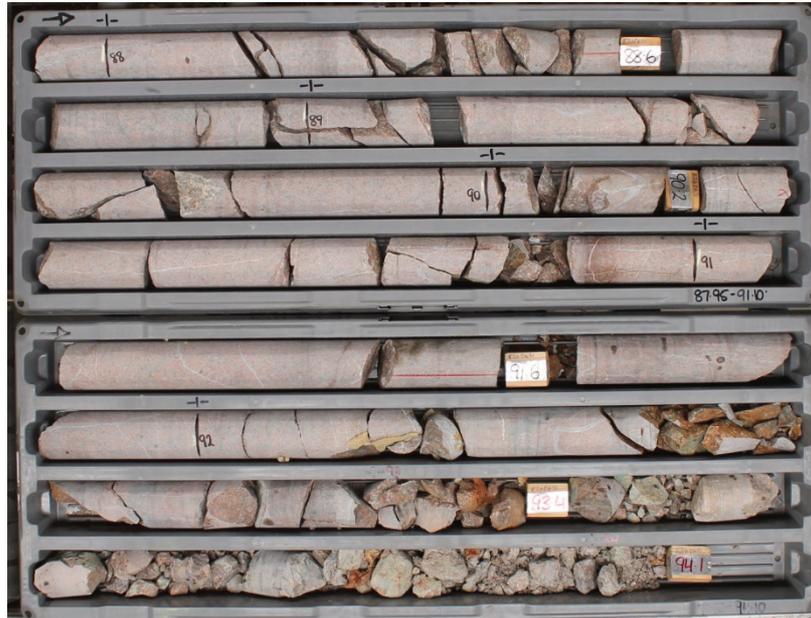
Figure 8 Core tray of diamond drillhole E26D631 with recovered cave edge and mobilised cave material. The boundary between the two zones is interpreted to be at 93.4 m downhole. The last 0.7 m of material recovered is from the cave

The drilling conditions were challenging as water return to the drill was at risk of being lost along with the drill bit into the cave. Due to this risk, only two holes were successfully drilled past the cave edge to recover mobilised cave material. The core trays from these holes are shown in Figure 8 (hole identification E26D631) and Figure 9 (hole identification E26D616).

The boundary between the cave edge is interpreted as the change in core recovery from intact core to rounded blocks of mixed lithology and alteration. The fine component from the mobilised zone of the cave was washed away and not able to be recovered with the drilling methodology. The recovered core and rubble showed a stepped increase in copper and gold grade compared to the cave wall grade. Natural fracture surfaces are oxidised in the 2 m before the cave boundary, where surfaces were sufficiently open for air and water to permeate them, indicating increased conductivity around the cave edges.

Hole E26D631 contains fresh fracture surfaces and these are interpreted as stress fracturing from the cave abutment. This type of fracture is evidence of stress fracturing and may be attributed to cave stress or blast preconditioning through the area that was conducted to promote caving. These ground conditions were identified as being problematic for development and production ring firings and additional ground support designed for the areas.

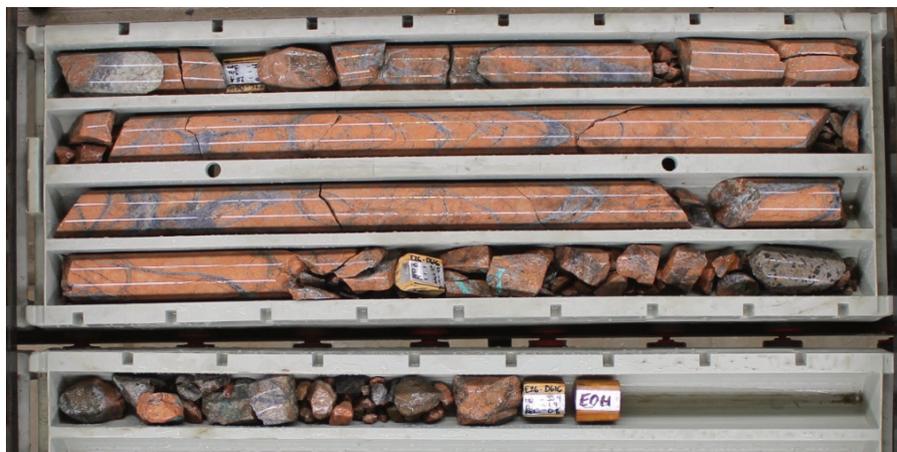
Figure 9 Core tray of diamond drillhole E26D616 with recovered cave edge and mobilised cave material. The boundary between the two zones is interpreted to be at 31.5 m downhole. The end of the hole is at 33.4 m with partial recovery of mobilised rock within the cave

Hole E26D616 contains lengths of intact core adjacent to the cave edge, with no signs of fresh fracture surfaces. This wet core image clearly shows the range of rock types and concrete recovered from the mobilised cave zone.

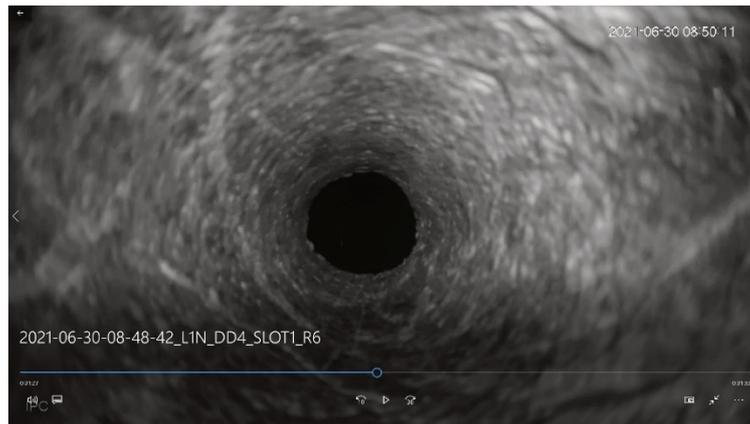
Figure 10 Image from borehole camera monitoring within undercut drill drive four in E26L1N block cave into the cave edge

Open monitoring holes are drilled from a safe location underground or on-surface through the orebody into the cave. They are used to deploy a borehole camera to observe the transition from intact, solid ground through the cave edge, the airgap, and if conditions are favourable, the muck pile below. The hole in Figure 10 has been drilled into the inactive E26 cave. In this area, the cave edge is observed as intact, solid ground with little rock loosening. The observations show dislocations but not gradational loosening of the rock mass back from the cave edge.

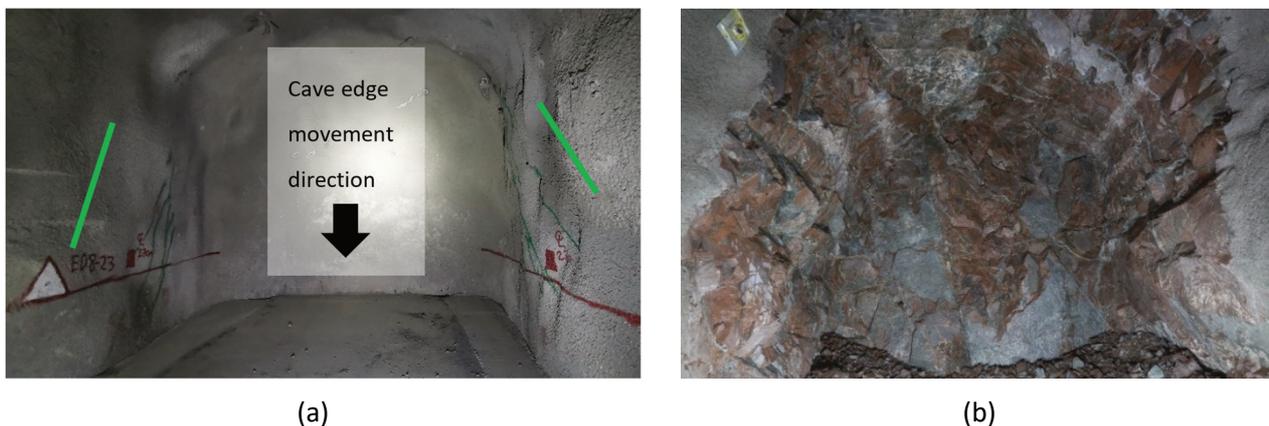
Figure 13 (a) Shear cracks in extraction drive 8, E26L1N block cave, 9760RL, Drive end is towards cave edge, chainage 186.9 m. Approximately 10 m from the cave edge. Shear crack mapping indicates the cave edge moving down relative to solid ground and is marked in green; (b) Extraction drive 8, E26L1N block cave, 9760RL, end of drive length, chainage 181 m. Approximately 15 m from the cave edge. Photos 4 and 5 in reference location Figure 5

At the time of writing, the cave edge areas remain stable however, growing evidence of movement and damage is seen in the E26L1N cave during cave establishment. Within this area, an echelon shearing indications of downward movement are seen in the extraction drive end, some 10 m from the cave boundary (Figure 13a). These shears follow the orientation of the structural fabric seen in the ground leading up to the edge (Figure 13b). Like the diamond core into the cave edge, natural joints and faults are oxidised, indicating higher conductivity at cave edges due to strain on discontinuities. This downwards shear pattern was replicated in the undercut drive above (Figure 14a).
