Management of production drift convergence and redevelopment

C Kamp *New Gold Inc., Canada*

Abstract

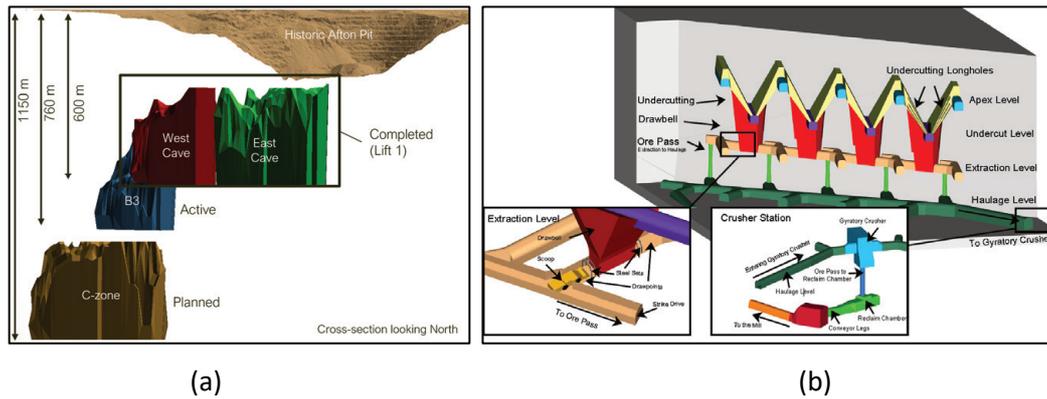
Figure 1 (a) Cross-section view (mine grid north) of New Afton caves; (b) Isometric view of apex, undercut, extraction and material handling levels

In 2021 and 2022, New Afton completed its first two Block Caves on Lift 1, the West and East Caves, which mined over 24.5 MT and 23.7 MT respectively. Currently, New Afton successfully initiated and is monitoring steady state caving of a third cave (B3) beginning in January 2022 with 8.8 MT (probable tonnes). Production involves milling over 8,000 tpd stemming from both the B3 Cave and a recovery level located below the East Cave. Decline drifts are currently being developed down to a fourth cave (C-Zone), which comprises 29.5 MT (probable tonnes) (Figure 1).

New Afton Lift 1 caves (Figure 1a) adopted an El Teniente extraction level layout and were the first caving operation to implement an apex level above the undercut level. However, for the B3 Cave, the apex level was only utilised until the expected critical hydraulic radius (HRcr) was reached and steady state caving was assured, the undercut was then transitioned to apex-less undercutting.

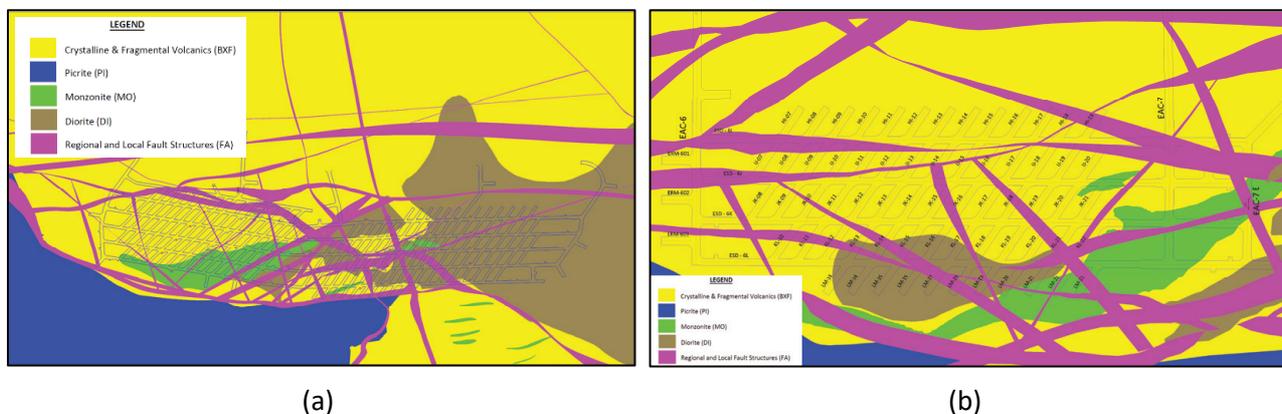
Figure 2 (a) Fault and lithology for Lift 1 (West and East Caves in plan view, mine grid north) located 600 m below surface with 15 × 27 m and 18 × 27 m drawpoint pillar centre to centre spacings; (b) B3 Cave, located 760 m below surface with 16.5 × 27 m drawpoint pillar centre to centre spacing

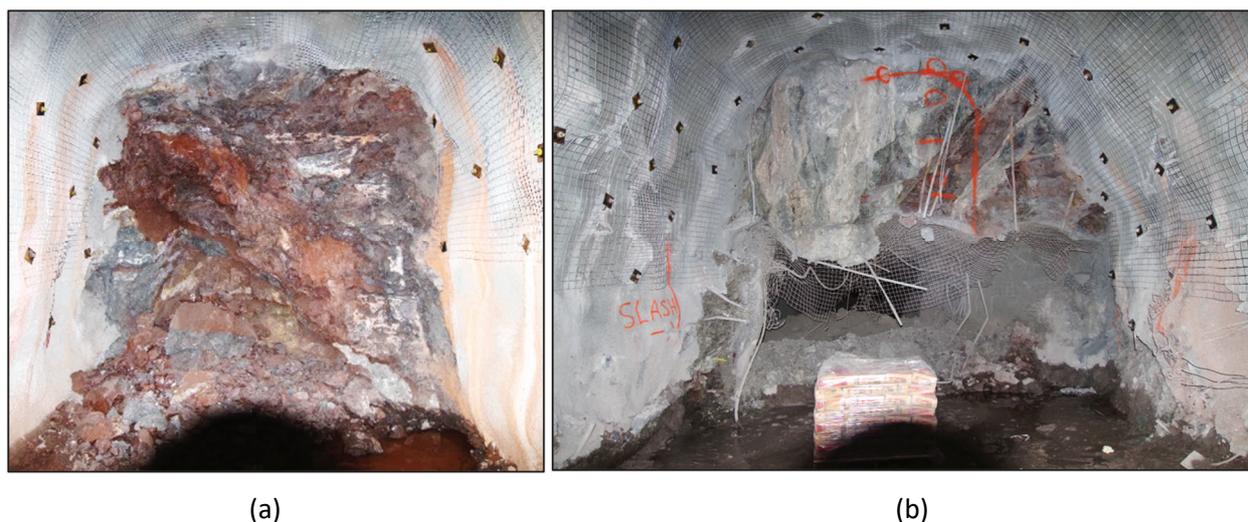
Figure 3 (a) Example of alteration effects on the BXF–diorite contact resulting in RMR<37, and the rock mass from the face sloughing after scaling; (b) Extraction drive undergoing rehabilitation due to high levels of convergence in similar faulted and altered rock mass

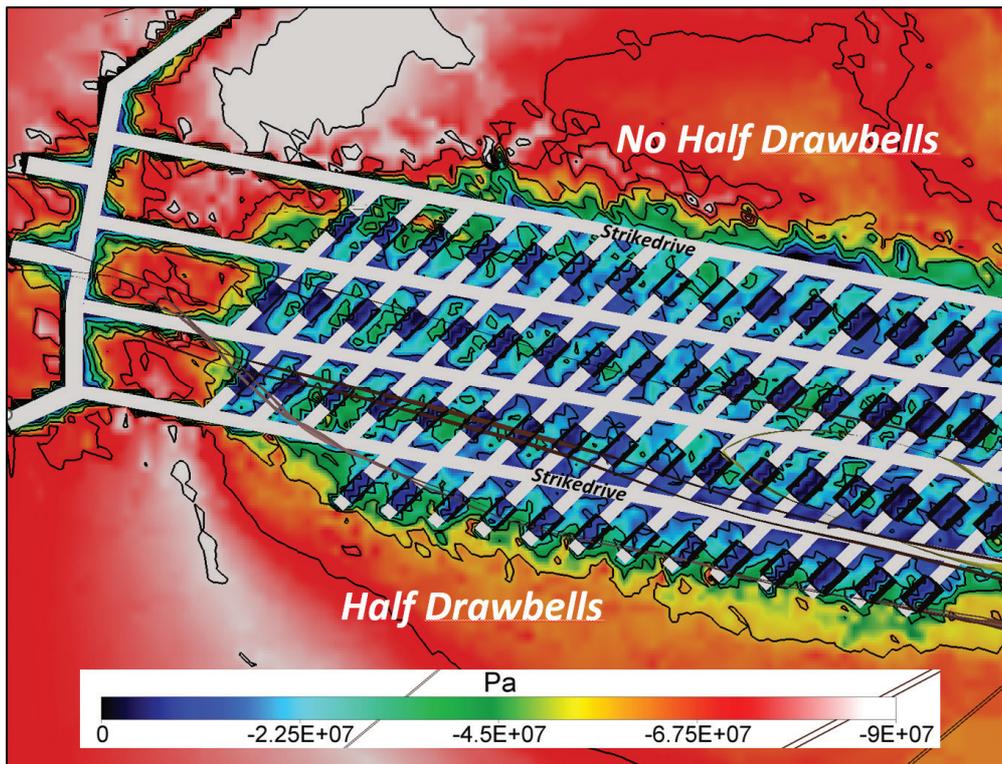
Figure 5 Benefits of adding width by adding half drawbells to widen the footprint and ‘deepen’ the stress away from the cave perimeter (Beck 2017)

Numerical modelling and observations underground indicate half drawbells can reduce the risk to perimeter strikedrives during the production phase of caving (Figure 5), and also increase the hydraulic radius potential to promote the initialisation of caving for a narrow footprint.

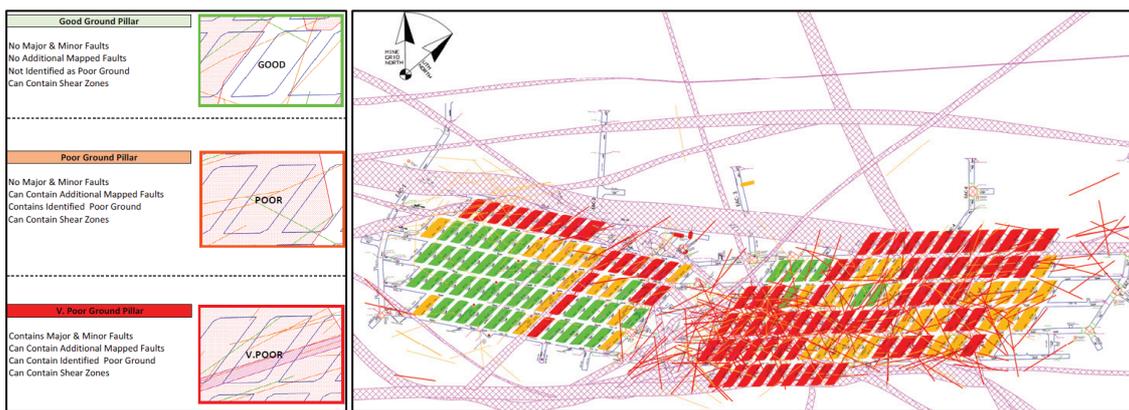
Figure 6 Example of simple rock mass rating for pillar classification. Showing Lift 1 (West and East Cave)

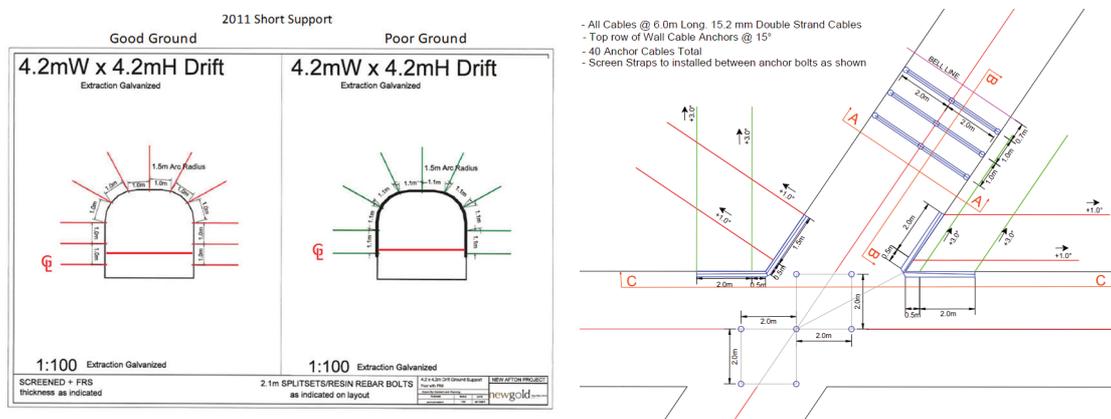
Figure 7 Feasibility ground support for extraction strike drives and drawpoints

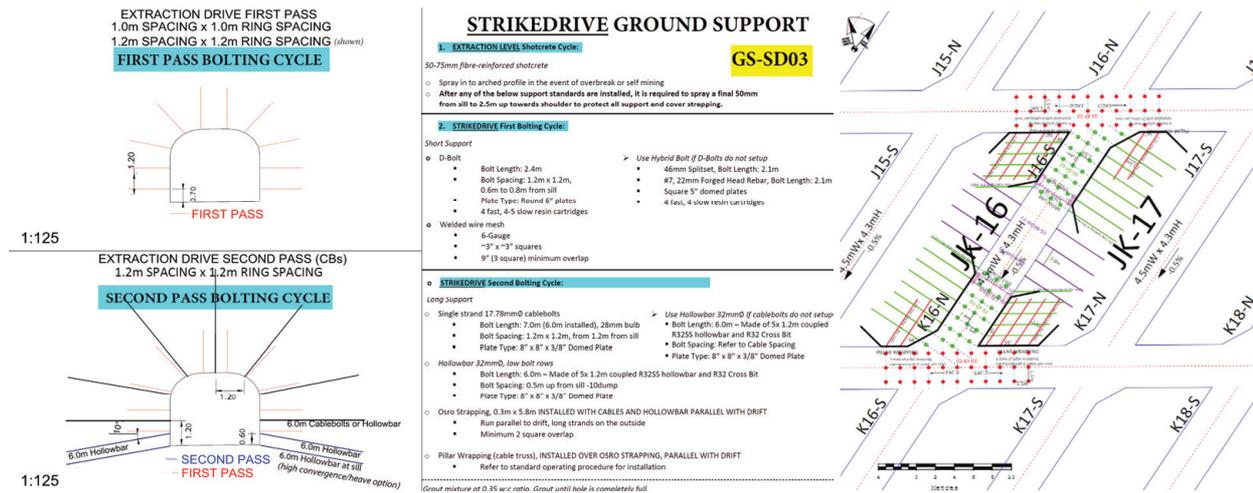
Figure 8 2016+ ground support for extraction strikedrives and drawpoints

First pass support was then installed similar to Figure 8, with a tight bolt spacing typically using hybrid bolts as the bolter drillholes would collapse during rebar bolt installations and not allowing resin cartridges to be injected or the rebar bolt to be advanced. In some cases, Hollowbar (SDA) were used as replacements for short bolting.

Second pass (long) support system is a similar concept to Figure 8. However, for this example the cable bolt stick out (tails) were left at +1 m outside the collar and not cut after the plate and tension process. This was done to leave room to anchor a chosen confinement based support method to the rock mass. Confinement based support can be achieved through C-Arches (rebar and shotcrete arching, then bolted over with screen and bolts), Osro strapping and cable bolt slings, or 4-bar lattice arches, all of which are ductile and allow for yielding of the rock mass.

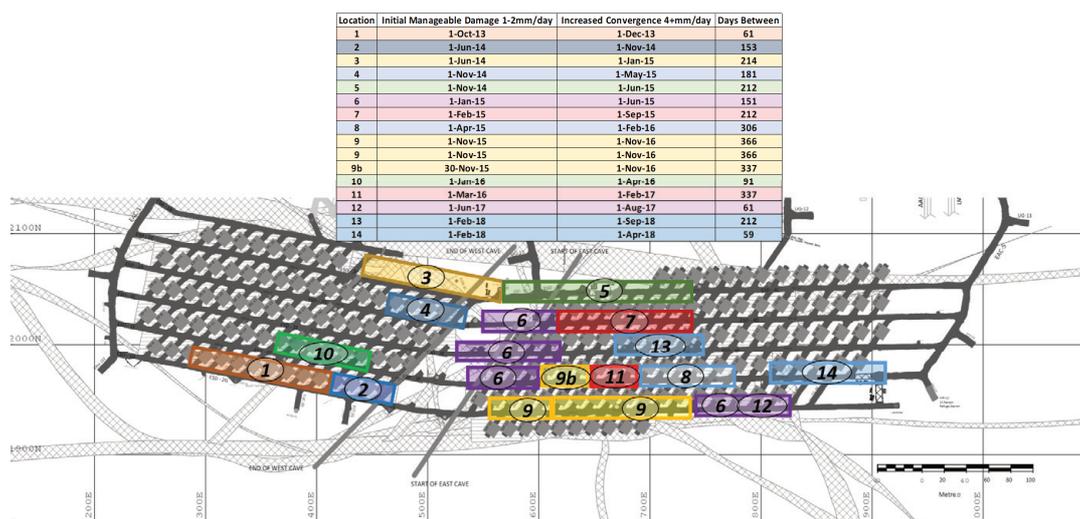
Figure 9 Lift 1 – West and East Caves shown with areas of convergence occurrences from 2013 to 2018, showing days between initial onset of minor convergence and increased convergence

The onset of convergence can be caused by geology or mining related activities (not discussed in this paper) and initially begins as horizontal convergence at a manageable rate of movement. In some cases, rate will increase with time, vertical convergence will occur, and rates can accelerate to a less manageable rate of movement (Figure 9).

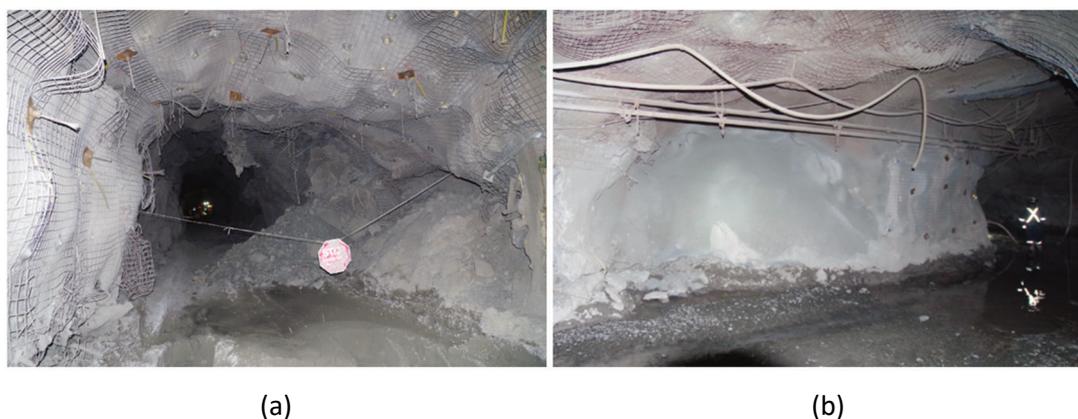
Figure 10 View of two separate areas of extraction drive with high convergence rates (>4 mm/day). (a) A drawpoint without concrete, resulting in extraction drive deformation; (b) Filled with oversized material and concrete resulting in a more stable strikedrive

During the rehabilitation process, significant coordinated planning between the engineers and mine Operations is required. Routine inspections conducted several times per week or as needed are completed to review the areas of convergence. At this time, observations of ground support performance, bogging (mucking) rates, measurements of convergence and extensometer data review are completed. This information is then compiled to communicate a feasible geotechnical short-term and long-term rehabilitation plan for the area; involving a recommendation of ground redevelopment (if needed), and a ground support and instrumentation monitoring plan. In extreme cases, where the convergence is unable to be maintained, drifts are temporarily closed or filled with concrete until a dedicated rehabilitation project can be commenced (Figure 10).

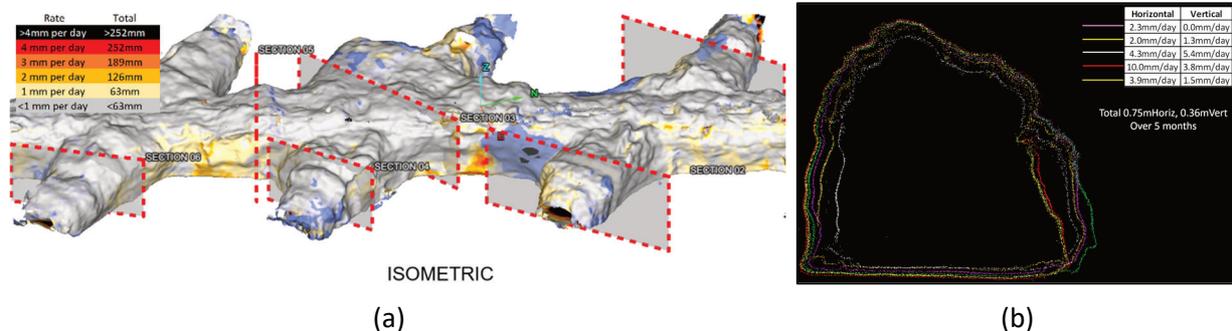
Figure 11 (a) Laser scanning to create triangulations to compare with previous scans for visualisation of convergence rates, seen in isometric view; (b) Cross-section example from a different area than 12(a), of several scans used to understand convergence changeover time. Scans are also used to understand ground support performance

Convergence monitoring data are obtained routinely via visual damage mapping, from extensometer data, and with a handheld laser scanner, which produce 3D tunnel scans (point clouds and triangulations). These scans are compared to previously obtained scans, allowing visual comparative heatmaps and cross sections to be created, providing interpretation of convergence rate, tunnel profile (Figure 11) and ground support performance.

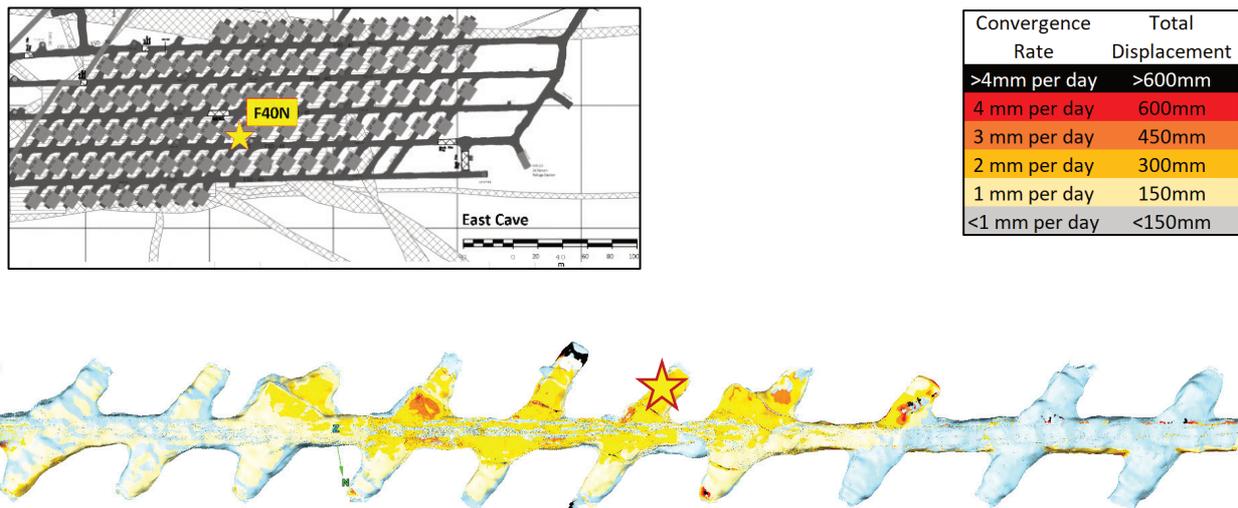
Figure 12 Scan of strikedrive in plan view, showing area experiencing convergence with F40N drawpoint

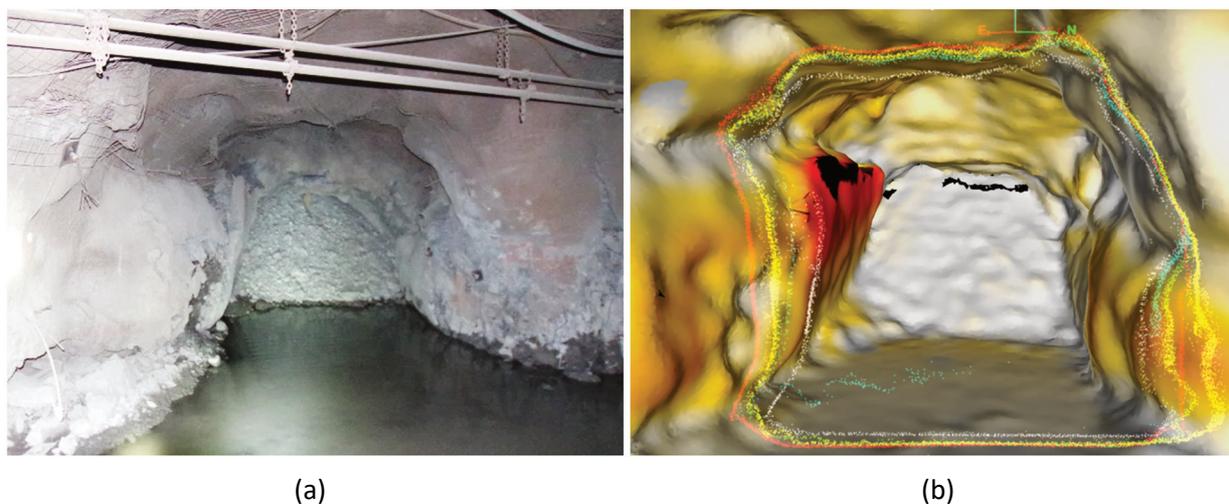
Figure 13 (a) Picture of F40N exceeding 4 mm/day; (b) Triangulation and point cloud cross-section overlaid to illustrate convergence over time (scale as noted in Figure 12)

Initial convergence at F40N drawpoint was routinely scanned and notably observed at the end 2015 with increasing convergence to 1–2 mm/day about 250 days later, 2–4 mm/day about 340 cumulative days and then >4 mm/day at 360 days, resulting in difficulty to access the drawpoint due to narrowing of the drawpoint (Figure 13). The drawpoint was then concreted closed (Figure 10b) to reduce further damage to the strikedrive, while a rehabilitation execution plan could be developed.

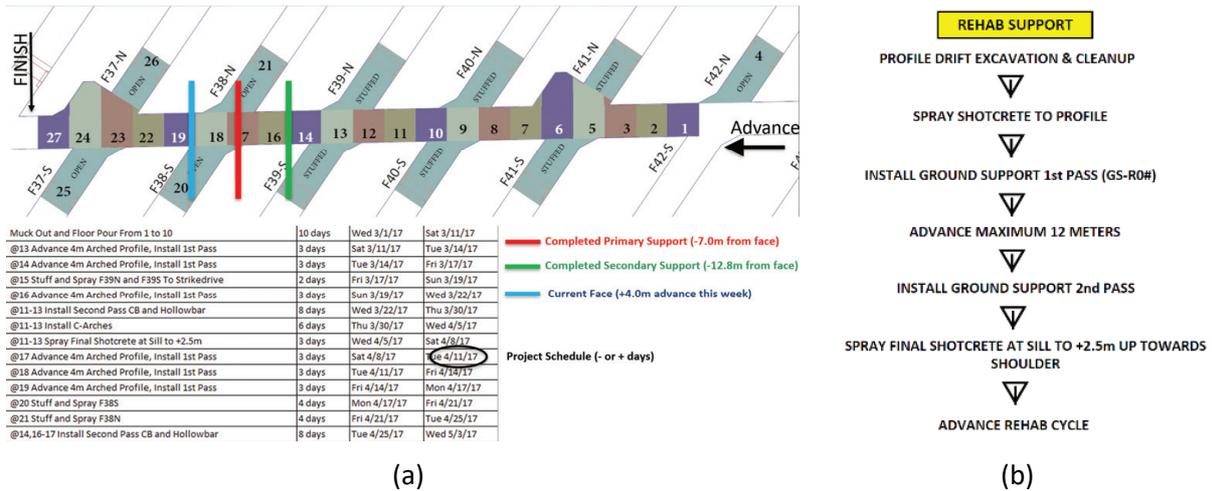
Figure 14 (a) Example of planning schedule; (b) General rehabilitation sequence created from experience from ground-response observations and convergence measurements

An execution plan was created with the purpose to first rehabilitate the extraction drive and monitor through convergence scanning and damage mapping. If the extraction drive would remain stable, then planned rehabilitation into the drawpoint would occur. A project timeline was created using historical rehabilitation rates with 4.0 m advances (Figure 14a) and strategic short and long support installations (Figure 14b) were chosen based on experience from ground-response observations and convergence measurements. During the rehabilitation advance of the extraction drive, if a drawpoint was not concreted prior it would be concreted once encountered.

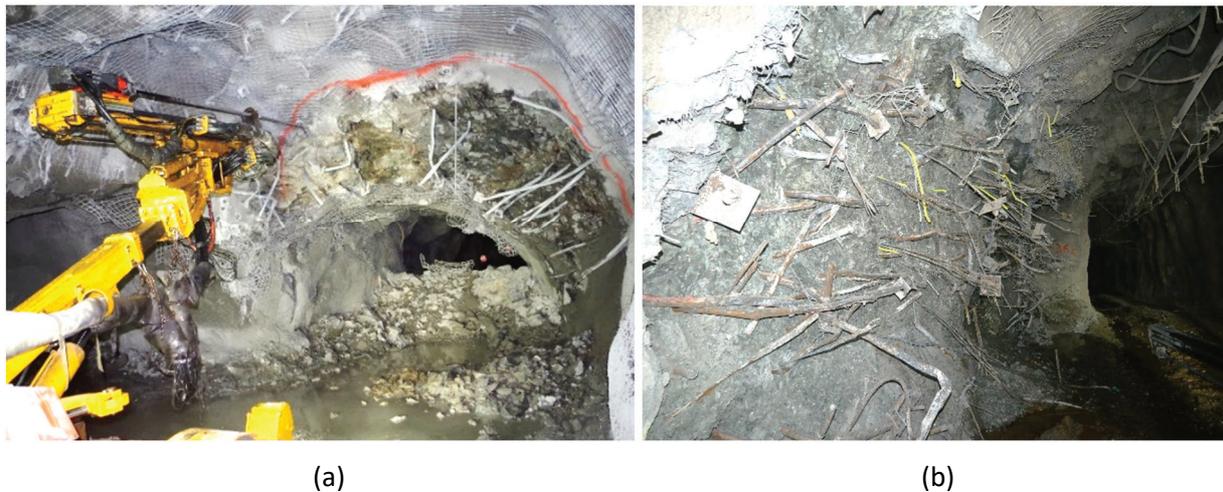
Figure 15 (a) Drilling the redevelopment face; (b) Example of old/damaged bolts from redevelopment, requiring removal prior to new support

Redevelopment of the drift was completed by pre-drilling perimeter holes and advancing with a rock breaker to avoid additional damage to the profile and to avoid overbreak. When this method did not work, controlled blasting was used. Once an initial ground support was applied, the damaged bolts from the re-excavated tunnel needed to be removed to allow for a stable profile during the support cycle (Figure 15).

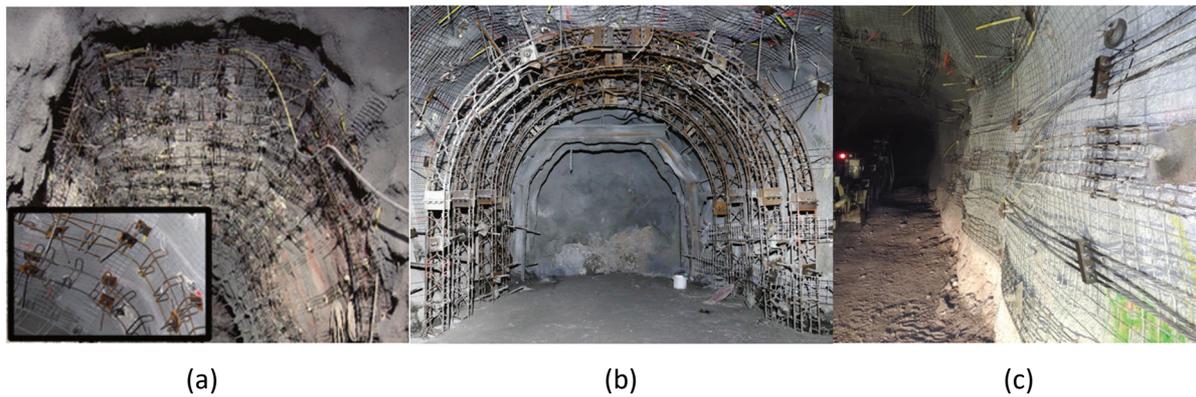
Figure 16 Examples of confinement based support. (a) C-Arches; (b) Cable bolt slings and Osro strapping; (c) Lattice arches

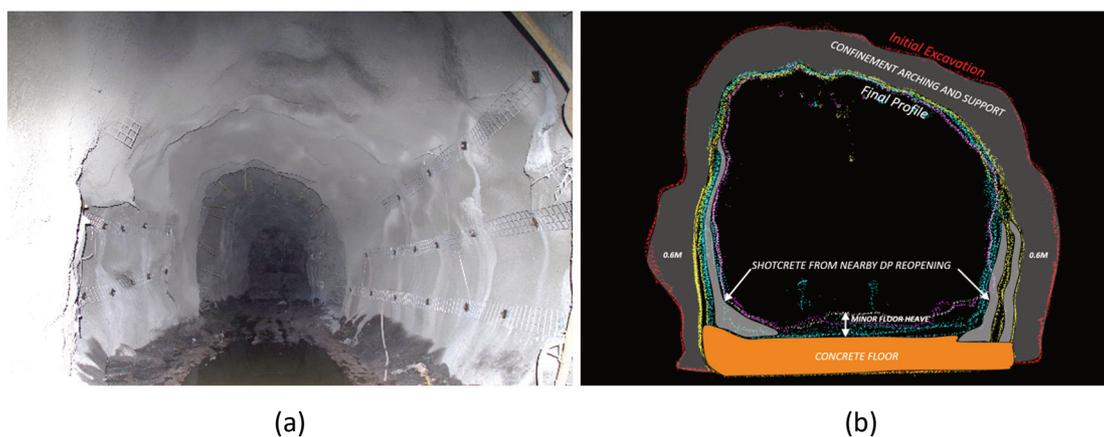
Figure 17 (a) Completed strikedrive rehabilitation; (b) Cross-section using point cloud scans to determine support thickness

For this example, C-Arches and strapping methods were used to successfully re-develop the extraction drive, and lattice arches and strapping were used for the drawpoint. Both methods also involved excavating the floor, allowing the support systems to be poured in place with concrete to provide a better footing. Planned over excavation of the tunnels was required to allow for these support systems, routine 3D scans were utilised to monitor the progress and support the QA/QC construction process, the final support thickness for the extraction drive was about 0.6–0.7 m (Figure 17).

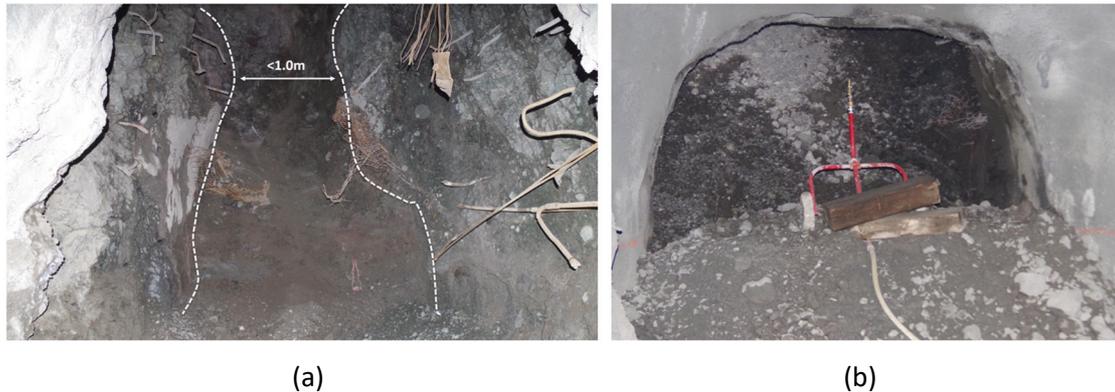
Figure 18 (a) Compaction beyond the brow observed after redevelopment of a fully converged drawpoint, the dashed lines represent converged walls within the drawpoint (originally 4.2 m wide); (b) Water sprayer used to assist with loosening the compaction to re-establish the flow of the ore column

a high level of compaction to the ore column is typically observed within the drawpoint, making the draw challenging to re-establish (Figure 18). Methods to re-initiate draw typically include water sprayers and rockbreaker and in some cases blasting.

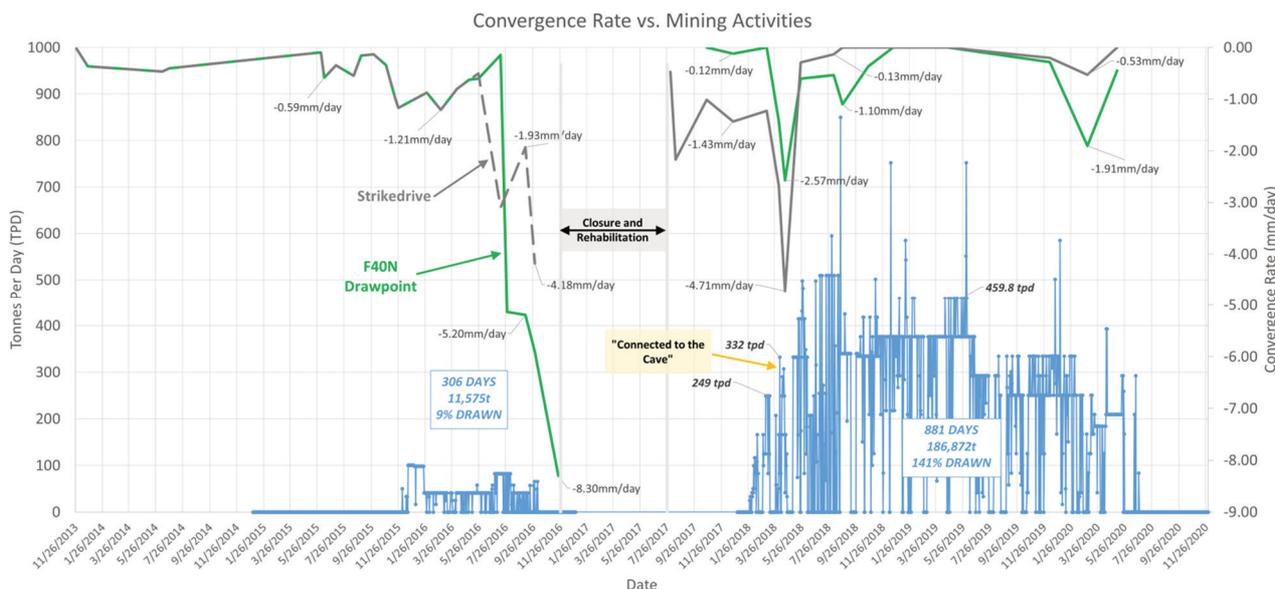
Figure 19 Life of F40N drawpoint – mined tonnes per day (tpd) versus extraction drive and F40N drawpoint convergence over time

The life of F40N drawpoint in terms of mined tonnes versus drawpoint and extraction drive convergence rate is illustrated in Figure 19. It was observed that after the initial drawbell blast in 2015, convergence occurred in the extraction drive and at F40N drawpoint area. Convergence increased over time during production until the drawpoint was no longer able to be mucked at only 9% drawn from the mine plan. The rehabilitation process did not commence immediately, but once initiated progressed at an average rate of about 3–4 m/week (full support systems installed). After extraction drive rehabilitation was completed, convergence was minimal, however during rehabilitation of the drawpoint, an initial increase in convergence was observed in both the extraction drive and at F40N drawpoint. This trend continued until the F40N compacted ore column was re-mobilised by water sprayers and mucking allowing F40N draw to be ‘connected to the cave’, after which a decrease in convergence rates was observed allowing production to commence. As closure approached (2020), F40N tonnage decreased, resulting in another onset of elevated convergence rates. The data ends with the drift being closed from production.

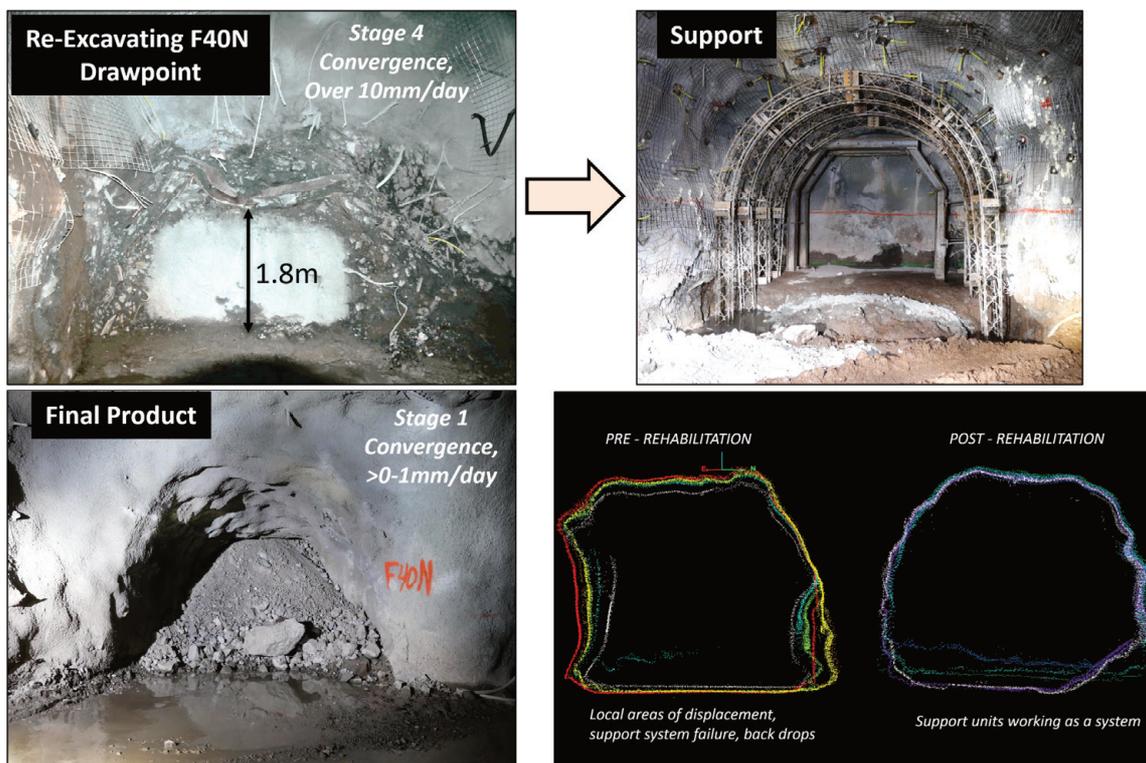
Figure 20 Overview of F40N drawpoint rehabilitation and effectiveness of confinement based support

The project management-based approach with redevelopment and ground support guidelines, along with implementing confinement based support led to F40N and the extraction drive being successfully rehabilitated. F40N continued to be mined and overperformed until closure, no additional rehabilitation was needed for the drawpoint other than floor repair due to some minor heaving. A snapshot summary is shown in Figure 20 of the re-excavation of the drawpoint to the converged original steelsets, the long and short support installed with lattice arches, and the final result. In addition, the last picture is an example of pre- and post-rehabilitation convergence scans, visually observing the performance of a confinement based support system experiencing convergence versus the localised wall and back convergence failures without confinement based support (Figure 20).

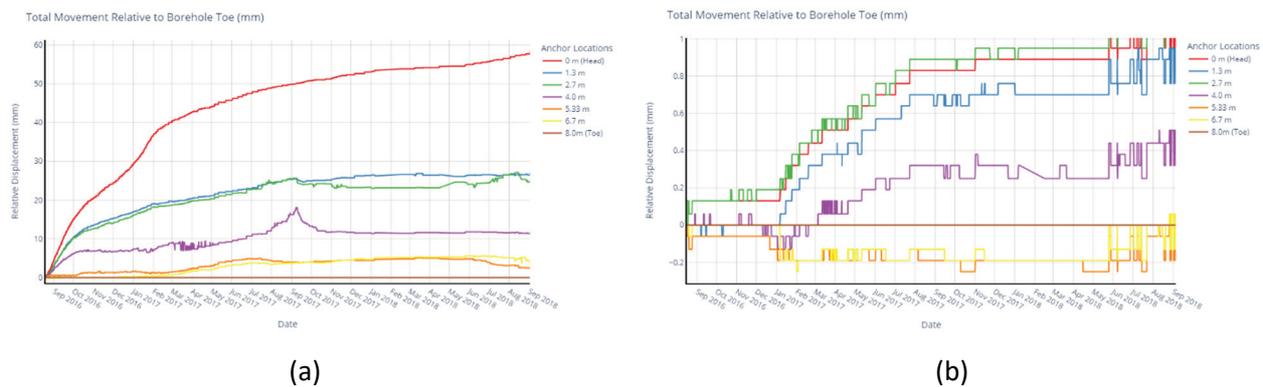
Figure 21 (a) 8.0 m long MPBX located in the drawpoint walls (0–60 mm Y-scale); (b) 8.0 m MPBX located in the drawpoint back (0–1 mm Y-scale). Installed with MPBX head pushed in +1.0 m from collar

Observations, convergence scanning and extensometer data for converging drawpoints within the West and East Cave has allowed New Afton to develop a conceptual and practical approach to observing and managing convergence. Observations of late-stage convergence of a drawpoint or extraction drive shows an increasing depth of pillar (horizontal) deformation over time, while the back drops vertically, but stays relatively intact (Figure 22). An example of this data is seen in Figure 21 where a Multi-Point Borehole eXtensometer (MPBX) in the walls measures an increasing depth of displacement over time, while the MPBX in the back perceives almost no significant movement. This is seen observationally in Figure 22. This may seem contrary to the observations made by the convergence scanner when back convergence rates are being observed and measured. This behaviour indicates that the MPBX instrument moves with the vertical displacement of the back and is hypothesised that the horizontal pillar between the extraction level and the overlying cave is remaining relatively intact.

This process of convergence deformation from initial onset to late-stage deformation, similar to the example shown in Figures 21 and 22, has been used to create a conceptual model. The conceptual model has been represented in three different ways; description based, as visual pictures and as a conceptual figure.

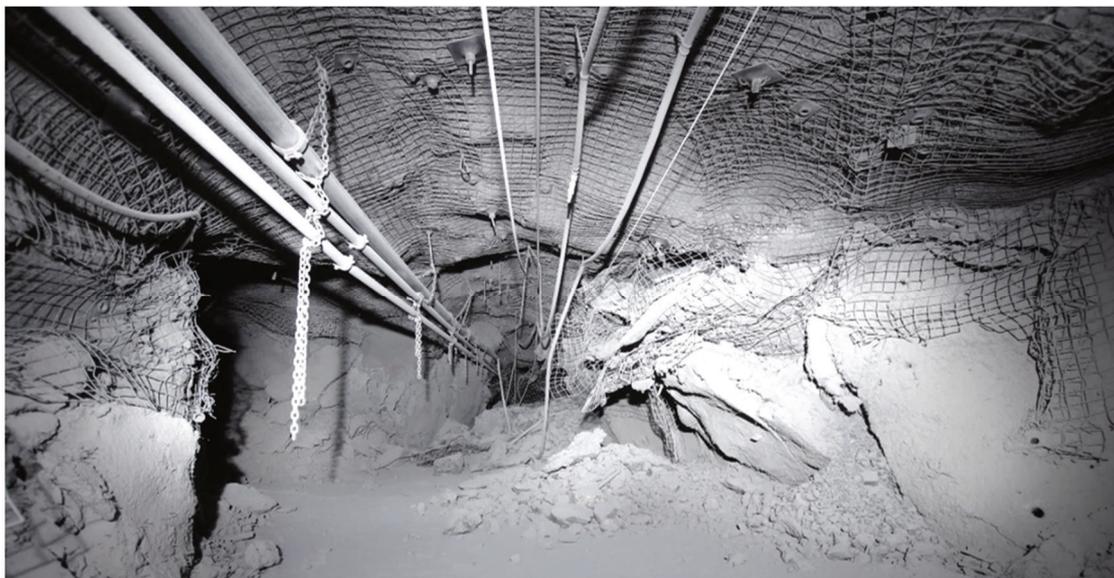
Figure 22 View looking down a late-stage converged extraction drive permanently closed post-production. Original 4.5 × 4.5 m drift converged to less than 2.0 × 2.0 m in several areas. Observations show yielded and toppling pillars with an observed flat looking back profile with intact ground support and very little to no shotcrete cracking, aligning with the MPBX data observed in Figure 21

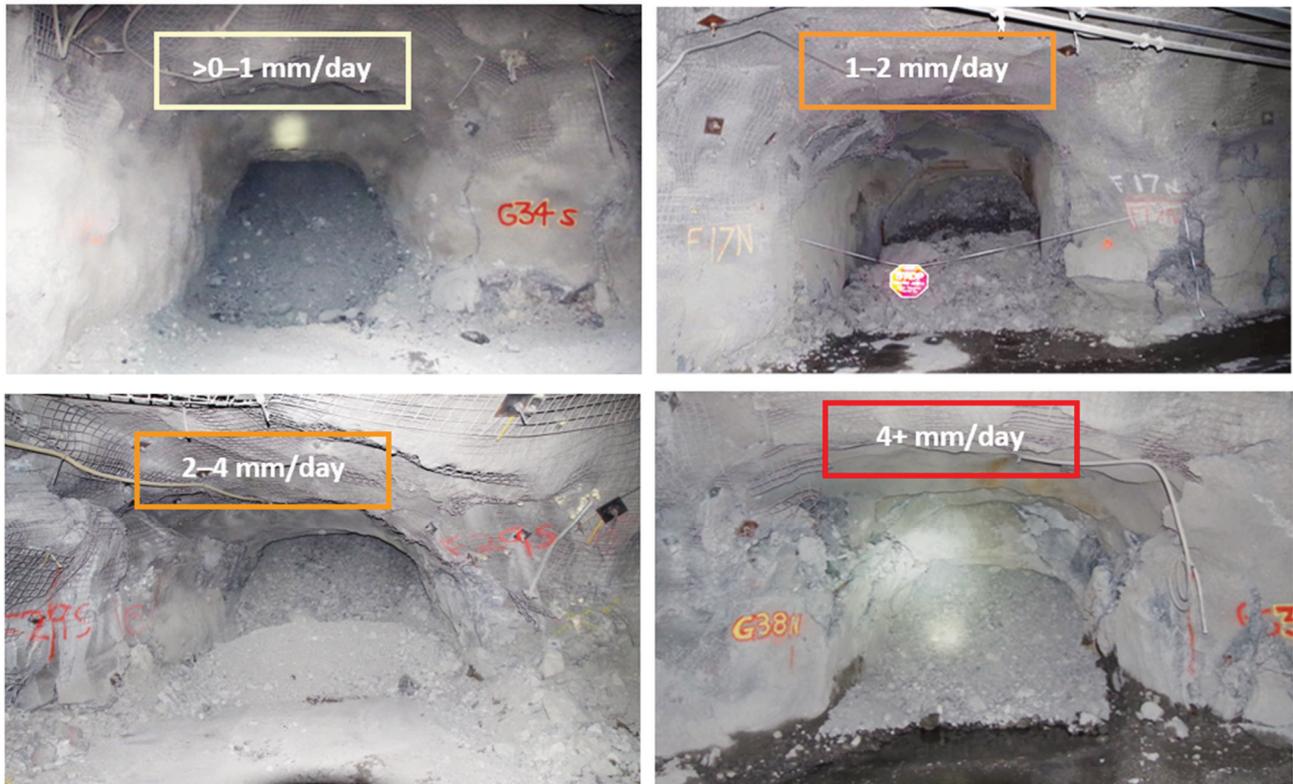
Figure 23 Conceptual convergence model represented as visual pictures, ordered from Stages 1 to 4

These descriptions from Table 4 can be observed visually through images taken at each convergence stage (Figure 23), note the flat looking back profile and yielding and progressively toppling inward pillars.

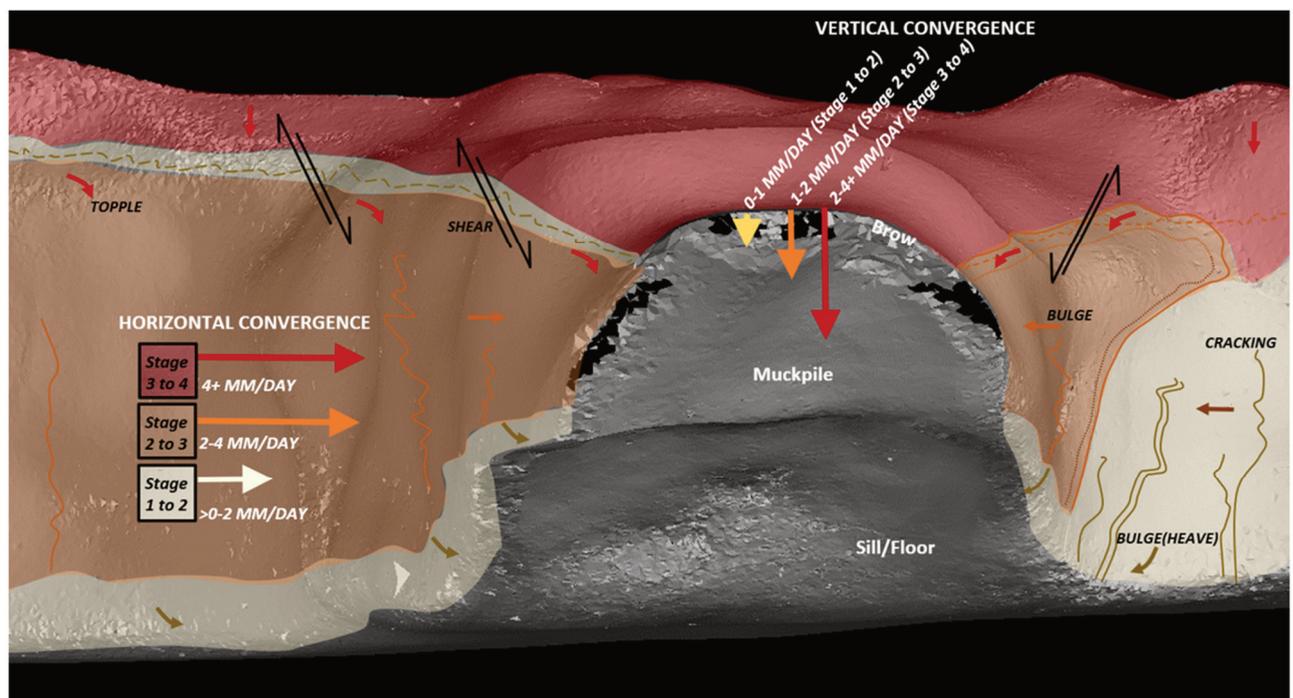
Figure 24 Conceptual convergence model represented as a conceptual figure using a 3D scan of a drawpoint as the template, the onset of elevated deformation rates generally observed within a drawpoint for each convergence stage are coloured to match that stage. Vertical convergence associated with the horizontal rates are shown through simplified vectors (arrows)

By combining the descriptions and visual images a conceptual figure is generated, showing the different stages of convergence rates in colours with simplified vectors (arrows) and symbols for cracking, shearing, toppling and bulge characteristics observed during the convergence process (Figure 24). In Figure 24 the onset of elevated deformation rates generally observed within a drawpoint for each convergence stage are coloured to match that stage.
