Completion of the North End Box Cut waste landform rehabilitation: implementation challenges and learnings

Abstract

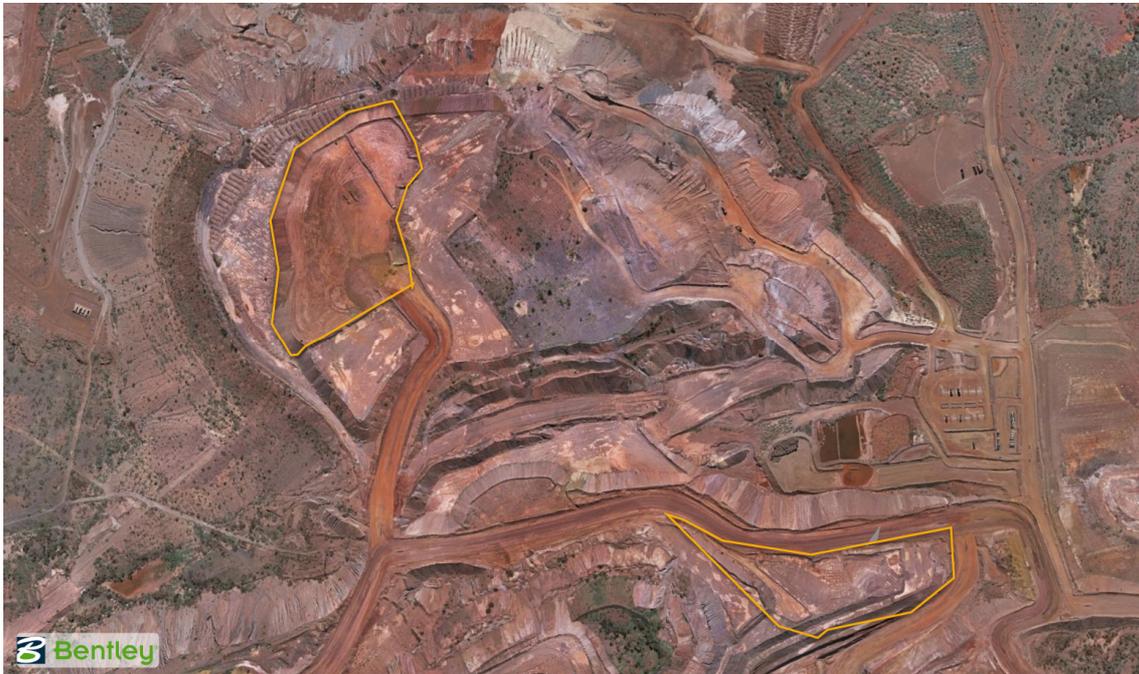
Stockpile locations for both encapsulation material and rock armour (Figures 4 and 5) were designed within the project area. Material was hauled to these stockpiles by the Rio Tinto fleet prior to, and during, project

Figure 4 Encapsulation stockpile area located on the NEBC waste dump and additional waste material stockpile

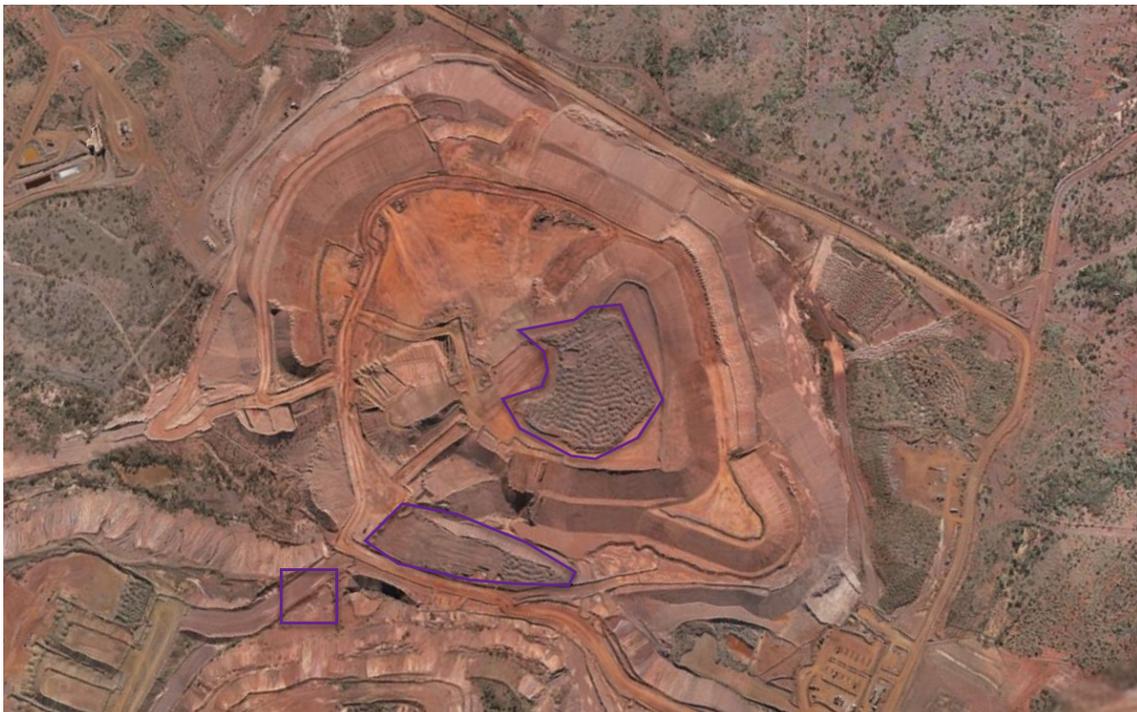
Figure 5 Rock armour stockpile locations on and adjacent to the NEBC waste landform

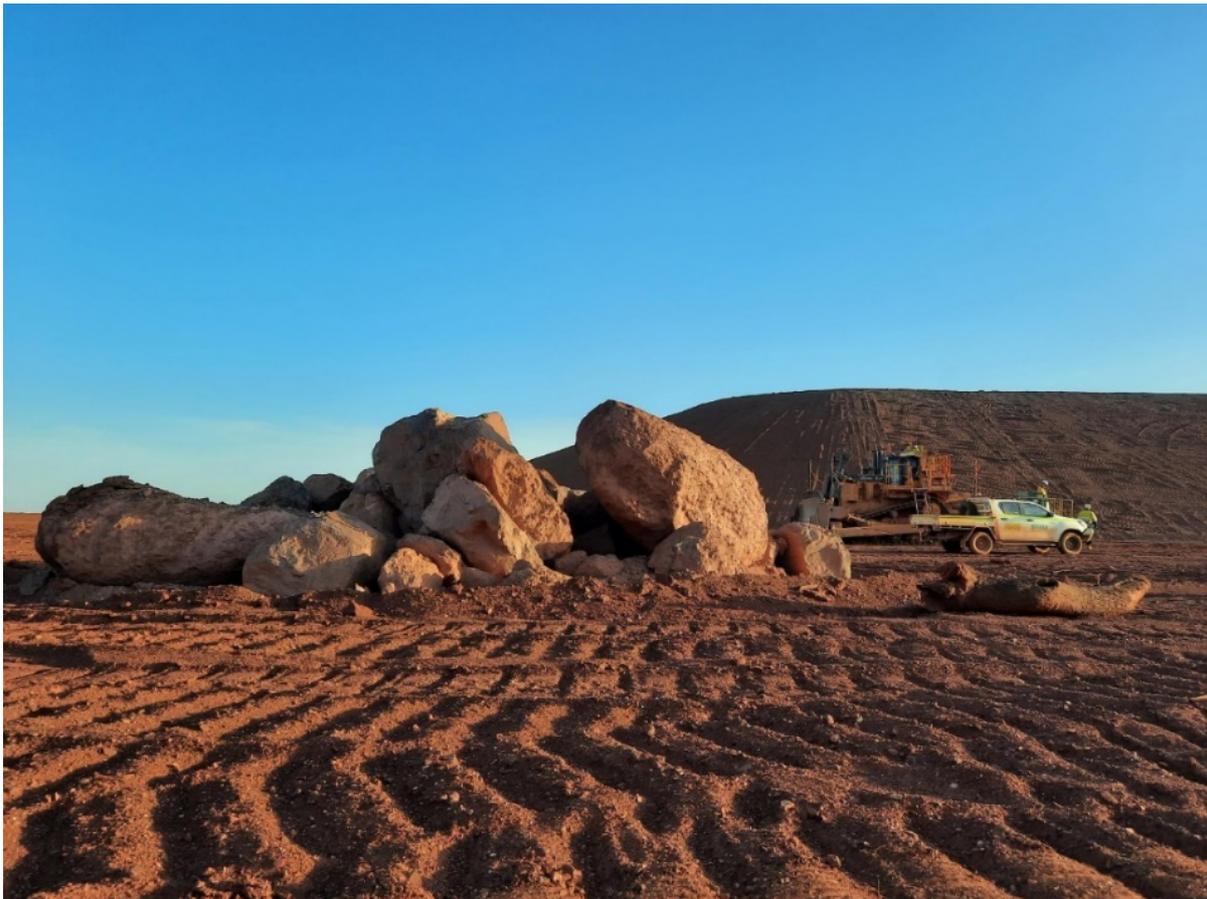
During load and haulage of inert waste, numerous oversize boulders were encountered in encapsulation waste materials (Figure 6). If utilised within the encapsulation layer, these oversize rocks could jeopardise the ability to manage PAF material in accordance with the design and modelling parameters (Green 2012). Several options, including rock breaking and relocation from the project area, were investigated. The final outcome was to preserve and segregate these boulders for use as rock habitat formations (Figure 6) in locations determined in consultation with mineral waste specialists.

Figure 6 Oversize boulders were placed into rock habitat formations

- Quality control is an important requirement in the haulage of rock armour materials to stockpile locations. Awareness information packages were produced and shared with project and operational teams to provide context and education on acceptable material characteristics. Materials used in bund formation were also specified to be of a competent nature in future scopes of work.
- Consideration of stockpile locations can be optimised by considering the ease of future recovery. As illustrated in Figure 4, the southern stockpile areas were subject to access difficulties and contamination potential.
- Construction of the backslope berms can be completed with greater efficiency utilising an excavator rather than a dozer.

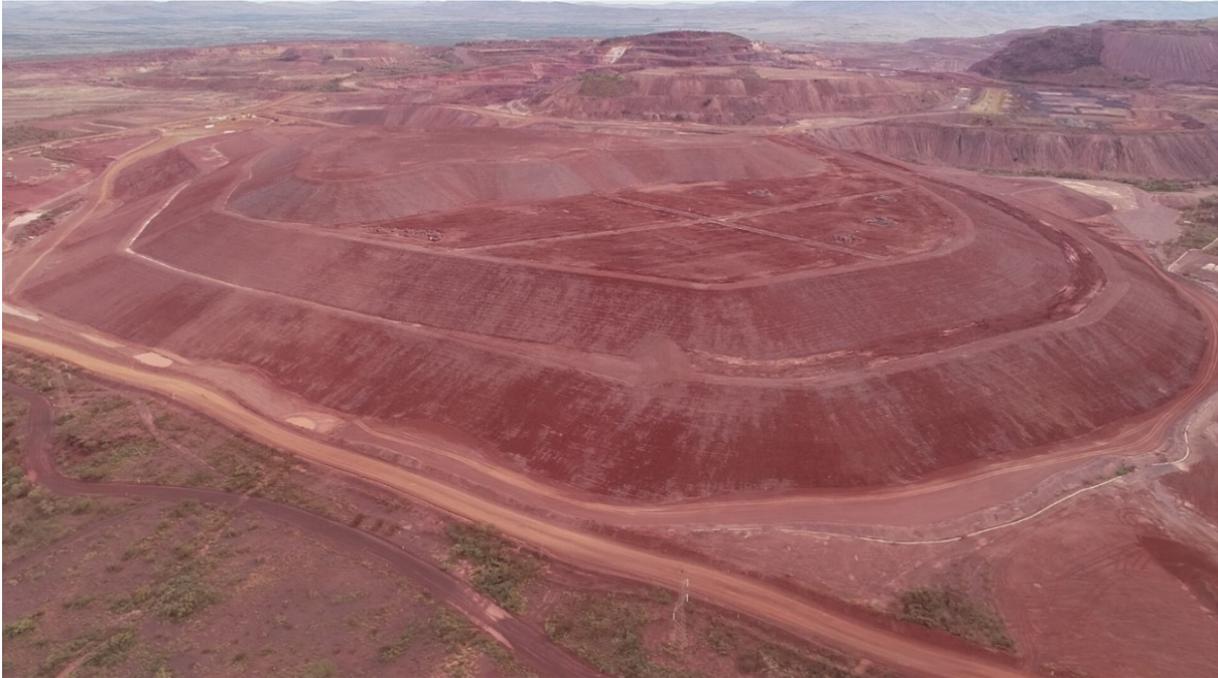
After 25 months of implementation, the NEBC project was completed at the end of January 2022 (Figure 7). Ripping and seeding were completed with a mechanical seeder attached to a dozer. There was 550 kg of seed (8 kg per hectare) applied across the project. The seed mix included flamed spinifex seed for increased flow through the seeder. The project has been fortunate to receive good summer rainfall and slightly unseasonable rain in May 2022. Early vegetation establishment is looking promising, with a good mix of native species, including spinifex (Figure 8).

Figure 7 Overview of the NEBC waste dump earthwork completion, January 2022

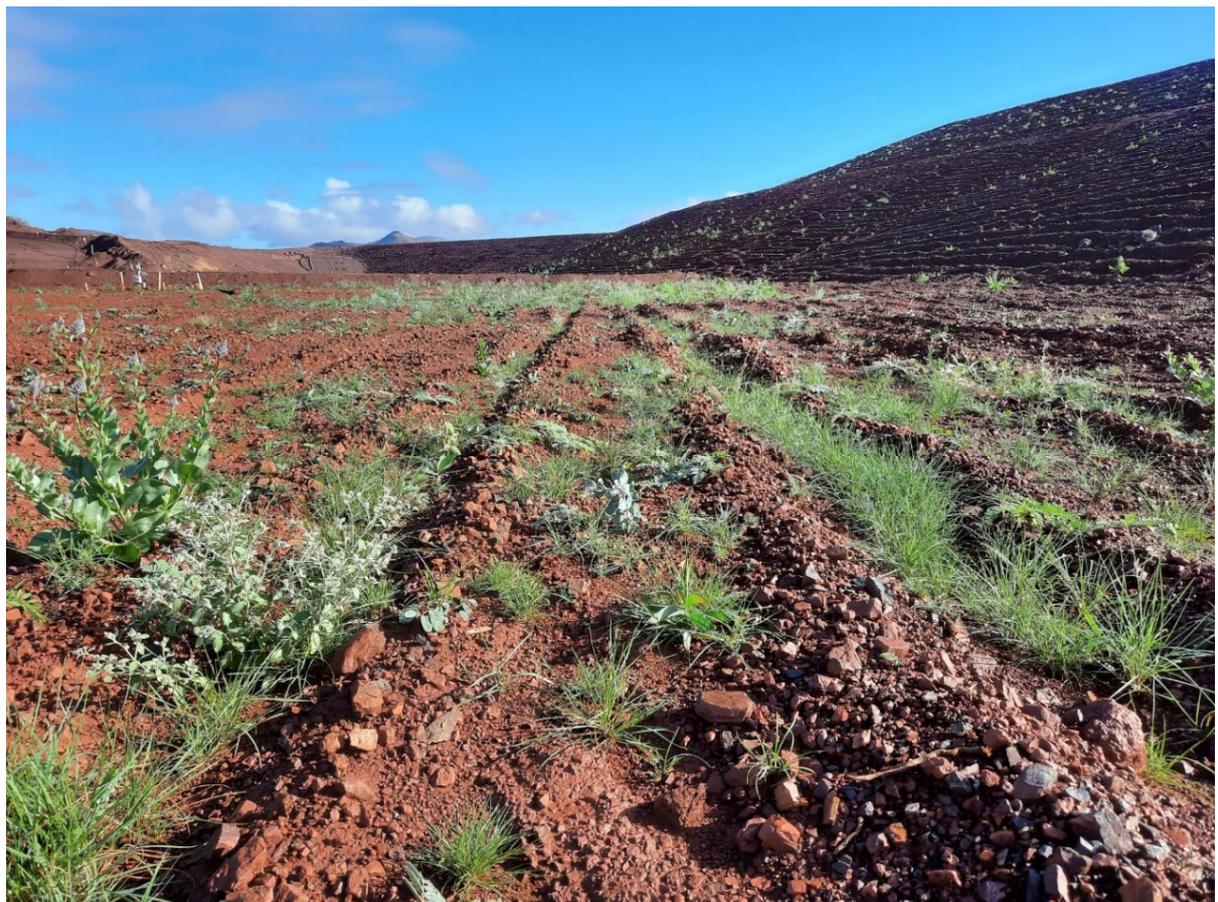
Figure 8 Early vegetation establishment at the NEBC waste dump in May 2022

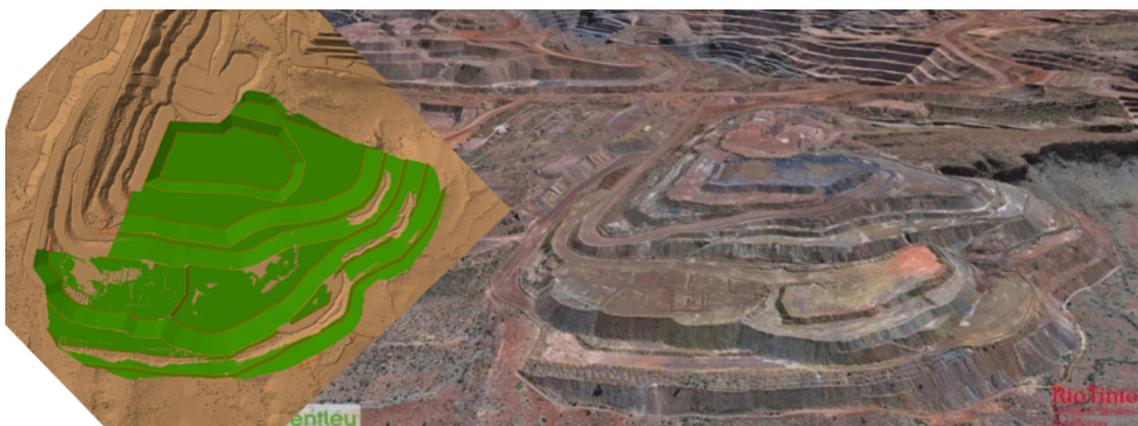
Given the similar material types to be utilised for encapsulation and the acceptance of the reduced encapsulation depth for the NEBC landform, a 3 m encapsulation has been adopted (Figure 9).

Figure 9 Overview of the MMS waste dump (right) and proposed rehabilitation design (left)

The parameters for the waste landform were developed utilising the Rio Tinto erodibility-based batter selector design tool. To achieve a safe and stable landform and meet closure requirements, the design parameters for the occurring waste types are a maximum of 20° slopes, maximum 20 m high lifts and minimum 10 m wide berms with an 11° back slope. Aligned with the NEBC design, a layer of rock armour (to reduce surface water erosion) of 0.5 m depth will be applied to all sloped surfaces and a final layer of 200 mm of topsoil applied to all final surfaces.

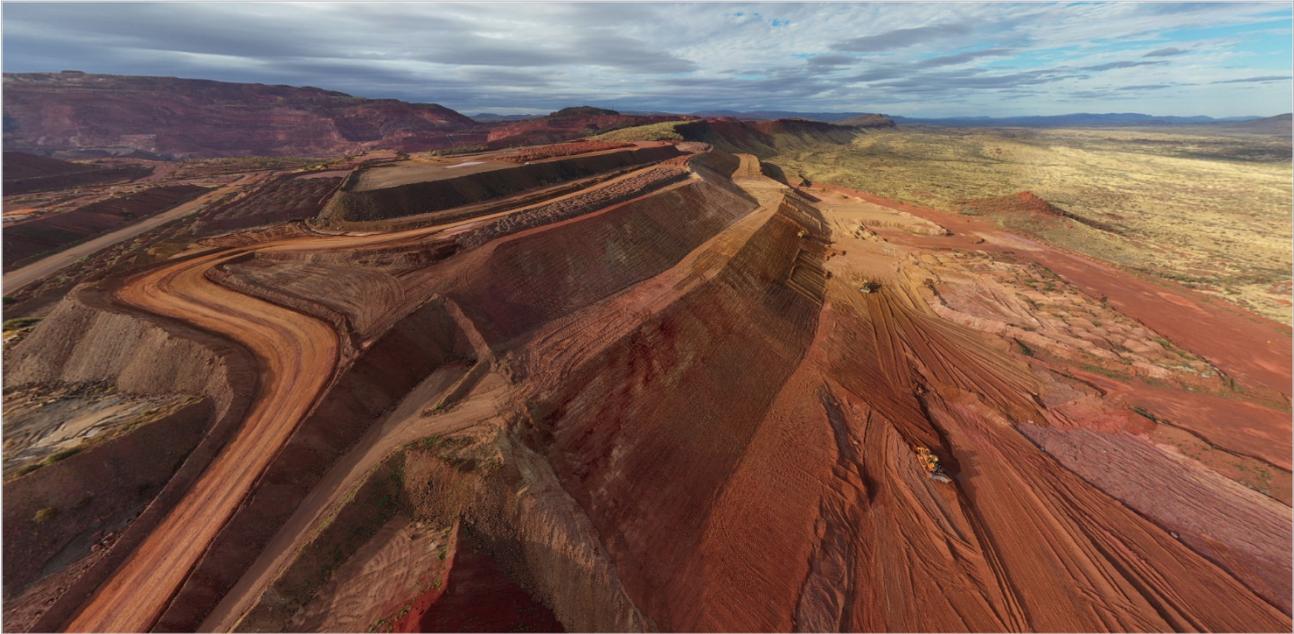
Topsoil haulage has been completed by the mining operations team and has been placed in an identified stockpile area within the project boundary. Haulage of rock armour is currently in progress. The project was awarded to an established MSA contract partner and rehabilitation works commenced in February 2022. This project is progressing well and is due for completion in approximately September 2022 (Figure 11).

Figure 11 MMS waste dump rehabilitation in progress, May 2022
