# An innovative approach to bauxite residue site remediation: a case study reviewing the dewatering, reprofiling and revegetation of a closed bauxite residue site in Jamaica

**Keywords:** *bauxite residue, red mud, dewatering, remediation, closure, Jamaica*

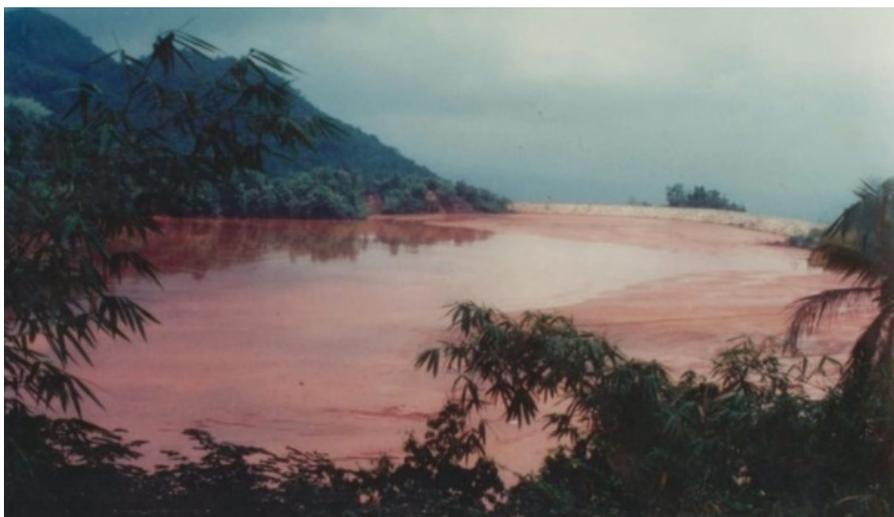
The Mount Rosser Pond is located approximately 5.6 km from the Ewarton alumina refinery and at an elevation 300 m higher than the plant. The tailings pond was constructed in 1959 when the refinery was built to act as the sole pond to hold the bauxite residue. It was formed by damming a portion of a valley by progressively increasing the height of the embankments such that they finally reached a height of 53 m. The bauxite residue was pumped as a slurry comprising 20% solids to the pond which was used until 1991. When the alumina facility was sold in 2001, the pond covered an area of approximately 37 ha. It contained approximately 11 million m<sup>3</sup> of bauxite residue up to 90 m deep, with nearly 9 m of water on the surface with a pH of 10.5 and a sodium content of approximately 2,000 mg/L. This area, like most of Jamaica, is subject to frequent hurricanes and very high rainfall events; therefore, the pond was continuously recharged with stormwater runoff from the surrounding hillsides, a catchment area of approximately 100 ha. The annual rainfall at the site exceeds 1,200 mm/year, and the annual recharge to the pond is approximately 1.5 million m<sup>3</sup>/year; whilst this partly reduces the pH and sodium level, it adds considerably to the volume of water that has needed to be treated (see Figure 1).

**Figure 1 Mount Rosser Pond 1996**

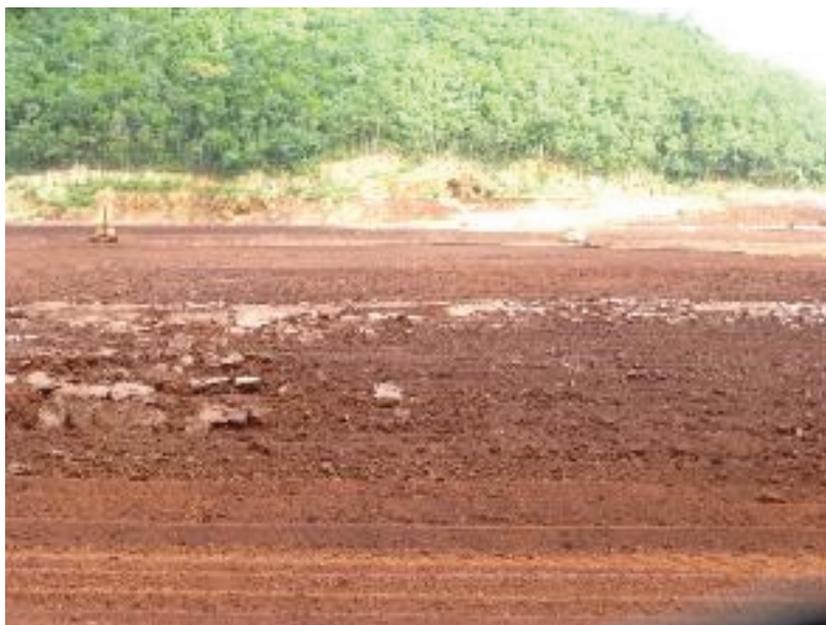
**Figure 2** Mount Rosser prior to vegetation growth

After evaluating a range of options, and in view of the prior success at Kirkvine, it was decided to use a topsoil-free approach. This entailed conditioning existing bauxite residue into a medium like topsoil that can sustain plant growth. Unlike the older, well weathered Kirkvine site, Mount Rosser had a totally different starting point. After the dewatering and reprofiling stages, the bauxite residue was extremely wet, with high pH and sodium levels. An additional feature therefore adopted was the greater utilisation of mud conditioning by extensive mechanical working to accelerate neutralisation of the exposed muds (Clancy 2013). Figure 2 shows the site after dewatering, reprofiling and conditioning.

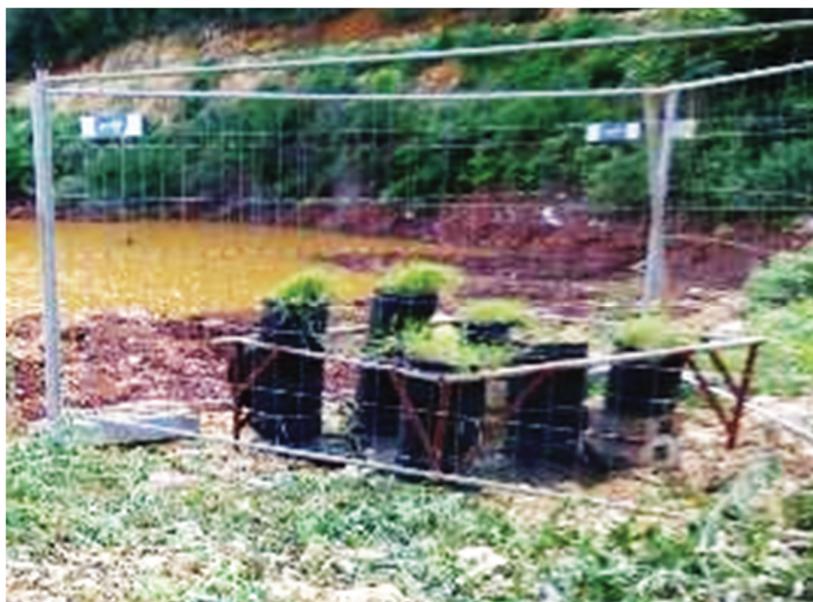
Small-scale trials using pots were undertaken at the JBI and onsite using a mixture of different amounts of gypsum and manure to determine the optimum loadings of these components when used with Ewarton residues (see Figure 3). In other trials dry bauxite residue was mixed with different amounts of gypsum and manure, placed at different depths over fresh bauxite residue. Various plant species were grown, and their growth rates and root development were investigated. These trials were undertaken to help assess the depth of tillage that needed to be done as it was accepted that the bauxite residue below a metre would always remain at a high pH, and a very high moisture level. These latter trials showed that irrespective of the species, all roots resisted growing into the wet bauxite residue below the conditioned layer. For the species which normally had tap roots (e.g. *Leucaena* (*Leucaena leucocephala*)), the roots grew out horizontally when they reached bauxite residue which had not been conditioned or amended.

**Figure 3** Small pot trials

Using the same plant species used at Kirkvine, a mixture of *Leucaena* (*Leucaena leucocephala*), castor bean (*Ricinus communis*), Bermuda grass (*Cynodon dactylon*), Guinea grass (*Megathyrsus maximus*) and brachiaria grass (*Brachiaria decumbens*) seeds was added. These treatments were observed weekly for germination and vegetative growth by measuring the number of leaves and height of plant. *Leucaena*, *Bonavista* and Bermuda grass exhibited the most vegetative growth. Other species showed less prolific germination and stunted growth.

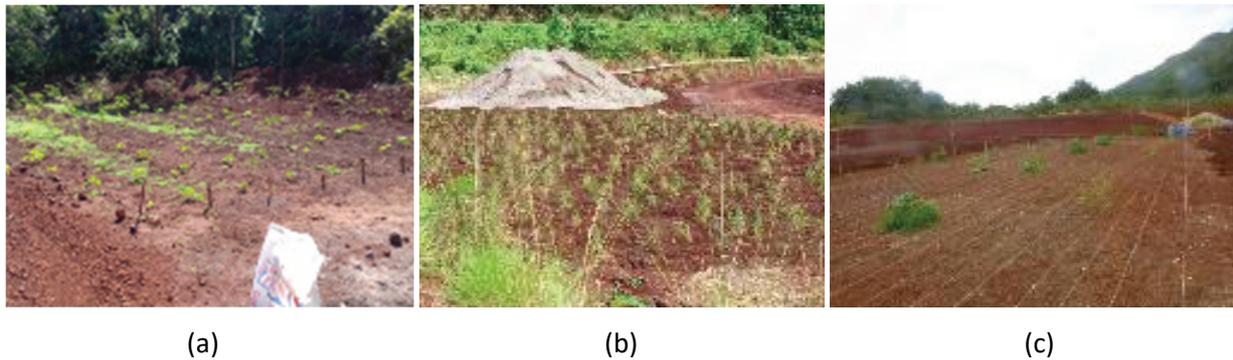
The information gathered from the pot trials was used as the starting point for the next phase of trials which involved small-scale plots onsite (Figure 4). These trials further investigated the levels of gypsum plus chicken manure and how the pH changed with time and depth. A small rotavator capable of turning over the soil like media to a depth of 15 cm was used in these trials. Various amendments were evaluated including beer waste, dunder from rum production, citrus waste, microbial bacteria additions. Some modest benefits were seen from these organic amendments evaluated but in view of the difficulty in obtaining large quantities at a reasonable cost of wastes such as dunder and beer waste, the idea of using them for the full-scale project was rejected. Root, leaf and stem specimens were collected from the different plant species planted and

**Figure 4** Different experimental plots: (a) EXP4; (b) EXP2; (c) Island plot

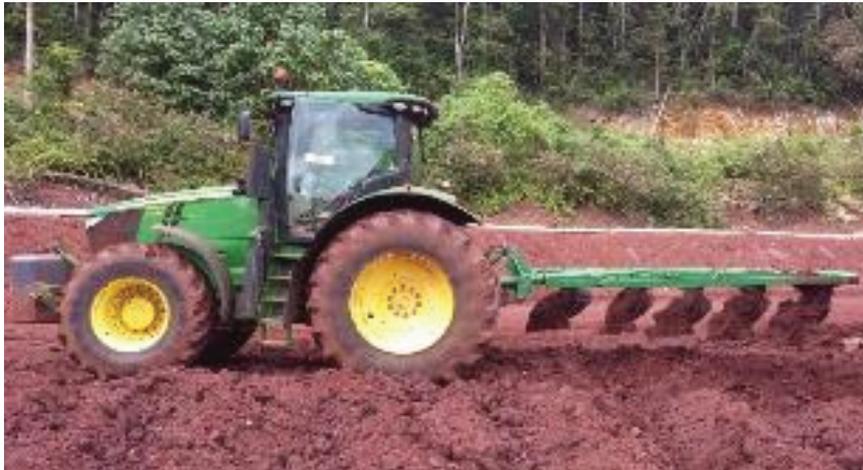
**Figure 6** Tractor with implement ploughing a field

Constant mechanical working with heavy duty tractor with specialised implements (see Figure 6), exposed the wet residue to the elements causing moisture loss and carbonation processes to take place. In addition, mechanical activities lead to the breaking up of large chunks of bauxite residue over time and the rain encouraged leaching of sodium. Based on field observation onsite and the monitoring of mechanical activities, improvements in porosity, drainage and aeration were observed over time. The increase in porosity is believed to contribute to better drainage, that further facilitates the removal of soluble sodium from the profile during rain events. Additionally, better aeration also enhances the carbonation process, which can gradually reduce pH levels.

The conditioning aspect of the project was divided into two distinct categories: physical conditioning that involves the use of specialised machinery and chemical conditioning, predominantly gypsum and manure application. Tractors were used to plough the areas to a depth of 40 cm, turning over wet material and exposing it to the elements, see Figure 6. After ploughing, fields were left uninterrupted for two to three

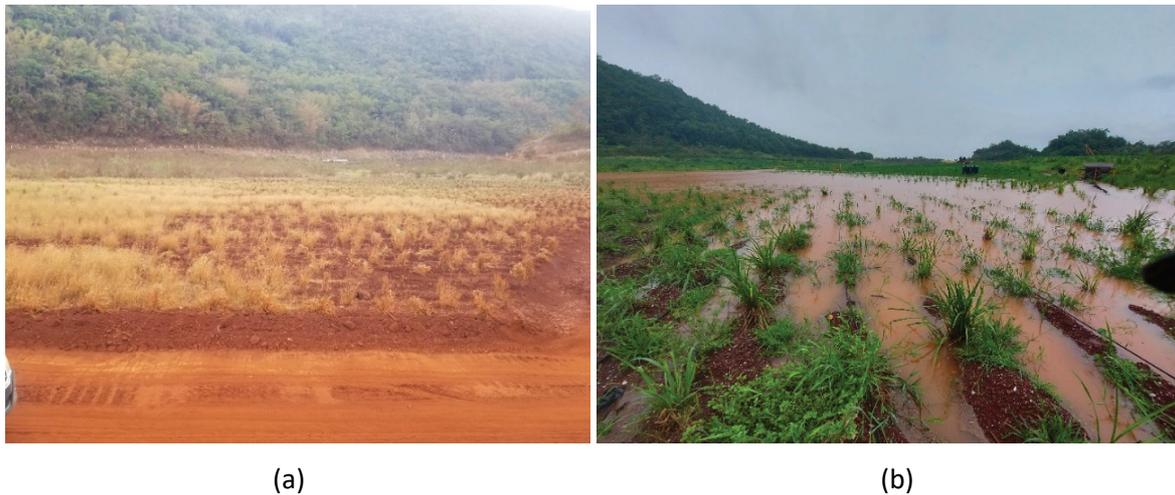
**Figure 7 Site during different climatic events: (a) after a severe period of drought; (b) after heavy rainfall**

November. The latter coincides with the peak of the hurricane season. During these periods, rainfall is either spread over the entire season or defined by high intensity periods in close intervals. These rain patterns vary in duration, intensity, and volume, making it very difficult to predict and plan contingency measures. High rainfall causes damage to road infrastructures, submerging, and in extreme cases, killing vegetation, stopping mechanical activities, waterlogging, requiring extra resources like pumps and drain infrastructure, eroding exposed bauxite residue, and resulting in seed loss and damage to irrigation infrastructure. However, heavy rainfall is not all negative as these weather patterns can be viewed as helpful and yield some positives such as washing of muds to remove soluble sodium, provide water for field establishment, triggers growth phase in established fields, and present opportunity to evaluate runoff water quality.

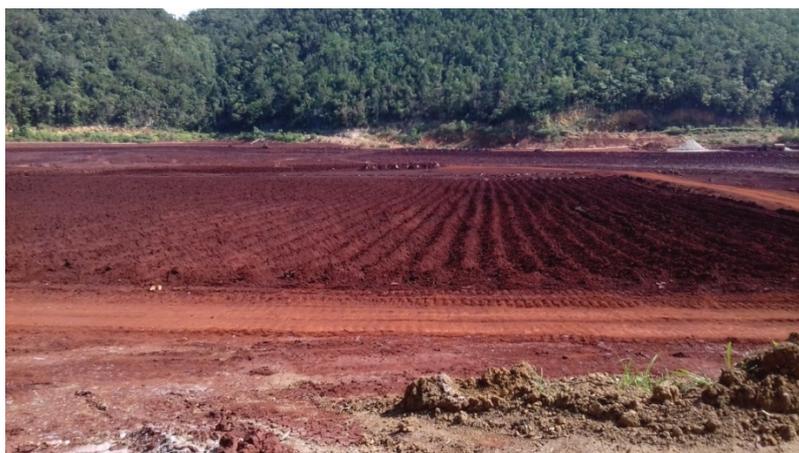
**Figure 9 Trial plot 1 and ponds void of vegetation in 2017**

Originally the bauxite residue was to be conditioned and seeded using the broadcasting method as had been done at Kirkvine. However, after compiling data from various trials and taking into consideration the unique environment and starting point of the Mount Rosser site, the approach was revised. The target plan based on Kirkvine and Mount Rosser trials was to start planting when the soil characteristics were: pH < 9 after gypsum addition, EC < 1 dS/m, CEC 2–9.5 meq/100 g; moisture 30–50%, bulk density < 1 g/cm<sup>3</sup>, porosity 65–72%). A higher amount of gypsum, 120 t/ha, was used than found to be necessary from the small-scale trials at Kirkvine and onsite. A ‘generous’ amount of chicken manure was also used, 120 t/ha. The gypsum/manure were ploughed into a depth of 40 cm, planting was done on furrows, and combined seeds, nursery plants and vegetative material were used for rapid establishment. Tree species had a 1.2 m × 1.8 m spacing (4,500 plants/ha), while grass was planted at 0.9 m × 1.8 m spacing (6,100 grass roots/ha). The seeding formula used was as following: Leucaena at 15 kg/ha, brachiaria at 31 kg/ha, Guinea grass at 21 kg/ha, castor bean at 4.5 kg/ha, bona vista at 4.5 kg/ha), Bermuda grass at 21 kg/ha. In addition, supplemental irrigation was applied, where necessary during dry periods. The baseline plan proved to be a successful formula, so large-scale plating commenced in 2017 and all major fields completed by 2021. Figure 9 shows part of the site in 2017 and Figures 10 and 11 show the site in 2021.

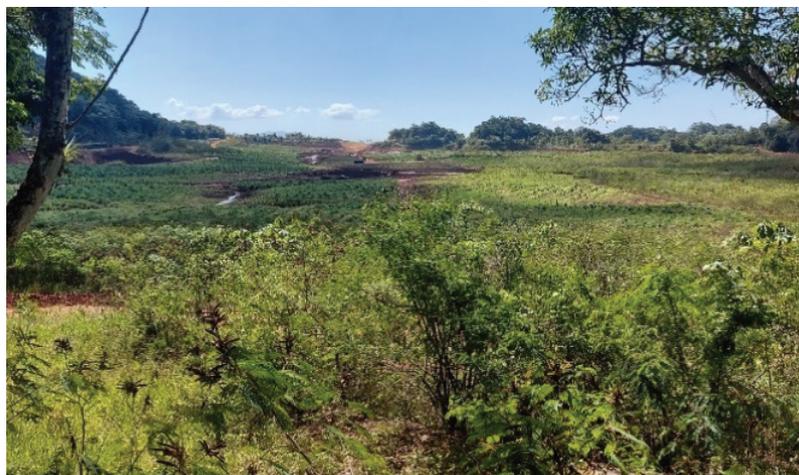
**Figure 10 View of pond from the north in 2021**

Before planting, fields were void of vegetation and four years after planting started, all the major areas were fully vegetated and visually meeting and, in some cases, exceeding the vegetative coverage required. The first attempts at large-scale planting was in TP1, 2 and 3; these were the most crucial areas, as they would indicate if the strategy for revegetation could work on a large-scale.

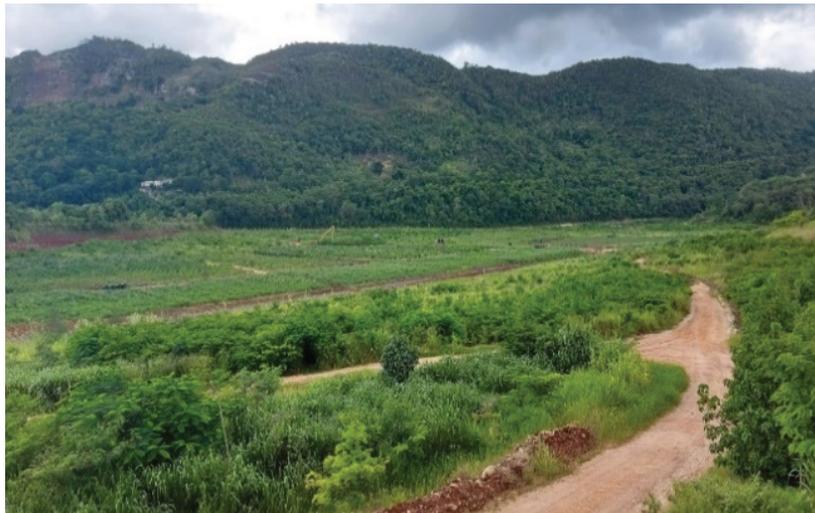
**Figure 11 View of pond from the southeast in 2021**

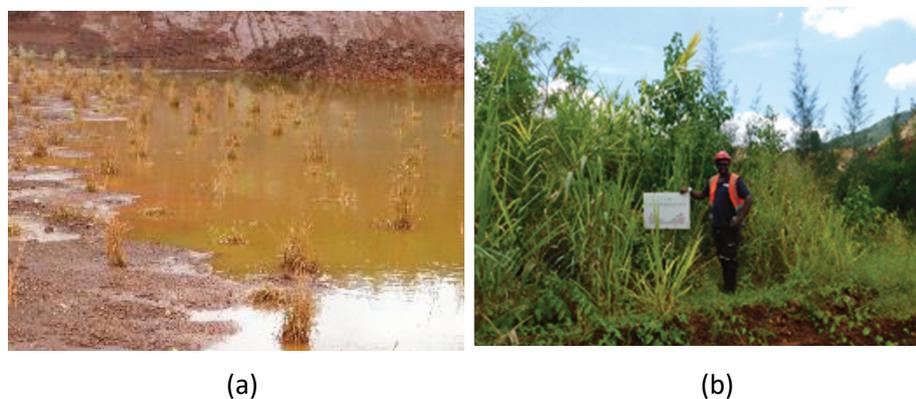
**Figure 13 Flood-prone area in TP21: (a) Area planted with 'regular' species after a flood event in March 2019; (b) Same area in 2021 showing well established wetland species**

flooding and waterlogging compared to newly planted vegetation. With limited time in between rainy seasons, it became apparent that rapid growth and establishment would give the wetland plants a better chance of survival when exposed to extreme wet conditions. As such, a specific compost was generated to encourage rapid growth, which consisted of grass cuttings, horse manure, goat manure and chicken manure. The compost was applied directly in the hole before transplanting the seedlings; this strategy turned out to be a success: vegetation survived many flood events (see Figure 13) and most areas prone to waterlogging have also successfully been vegetated with mainly with wetland species (see Figure 14).

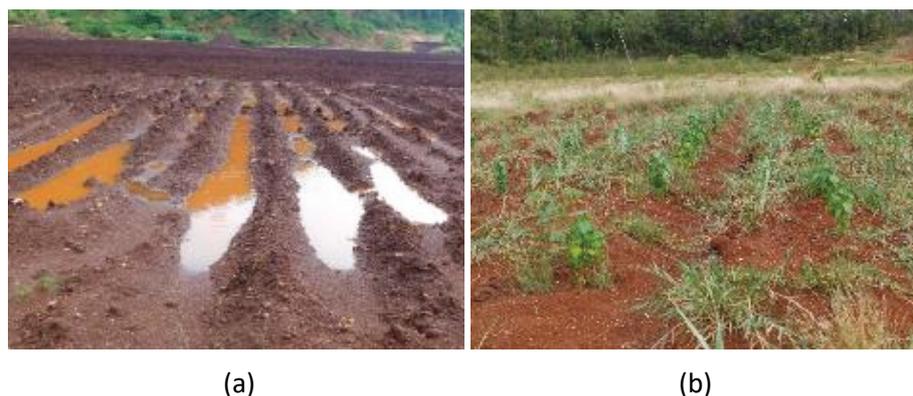
**Figure 14 Area prone to waterlogging in NTPX: (a) The area after heavy rainfall event in 2019; (b) Same area in 2020 approximately six weeks after planting**

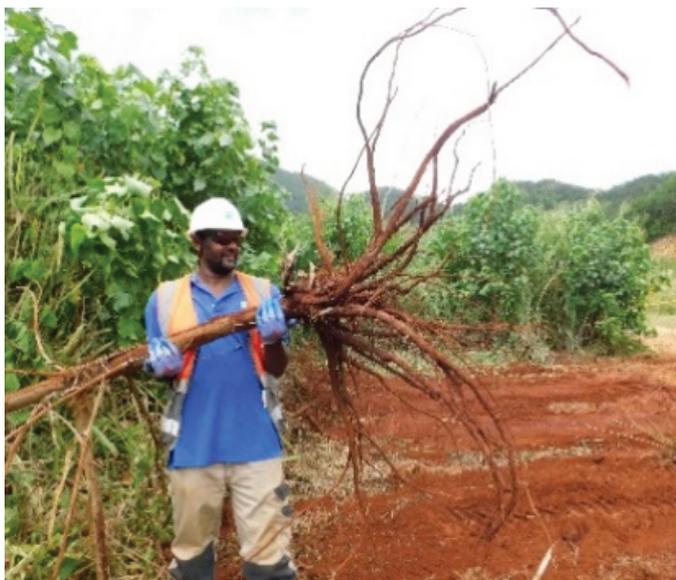
Root development also gives an insight into long-term survival and growth. Observations from uprooted trees reveal that the root system develops quickly, however it seems that the roots stay within the conditioned soil layer (<40 cm). Roots in most cases will start to grow down from the base and after 10–15 cm they make a 90° turn and start grow horizontally, even though there have been exceptions (e.g. *poinciana* and *seaside mahoe*) where roots have been found to grow beyond the 40 cm layer. In the long-term, the horizontal growth of the root system could result into compromised tree height and increased chances of falling over at an early stage due to inadequate anchoring (Figure 16). Conditioning at a deeper level could improve this and various agricultural equipment was tried, including a spader which was capable of achieving a depth of 60 cm, but the amount of work to achieve a 60 cm layer of soil media at the required targets was deemed to be very high. It is, however, expected that leaf litter and fallen trees will increase the biomass over time and expand the fertile soil layer.

**Figure 16 Person inspecting root development**

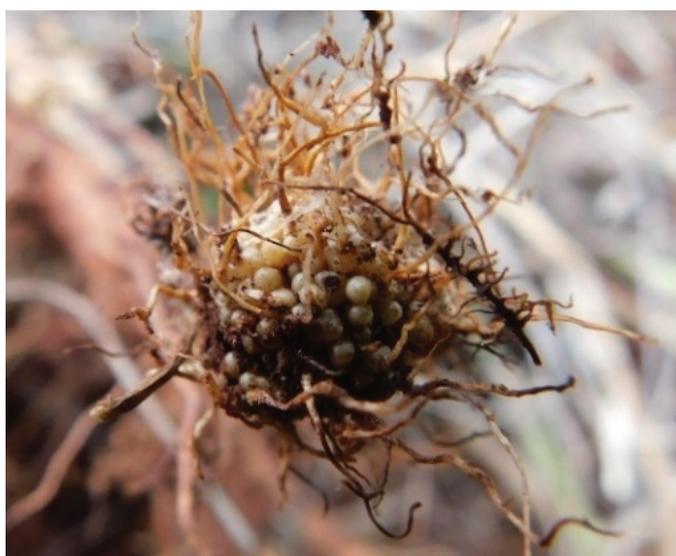
An interesting observation within various plant on the site, is the natural occurrence symbiotic relationships between plant roots and fungi (mycorrhizae) and nitrogen-fixing bacteria (root nodules). Without manual inoculation, many species show signs of such relationships to increase their chance of success in the conditioned fields (Figure 17).

**Figure 17 Root nodules observed on roots**
