Repurposing of the Genex Kidston mine site in Queensland, Australia

DJ Williams *The University of Queensland, Australia*

A McGhie *Genex Power, Australia*

T Short *Highlands Environmental, Australia*

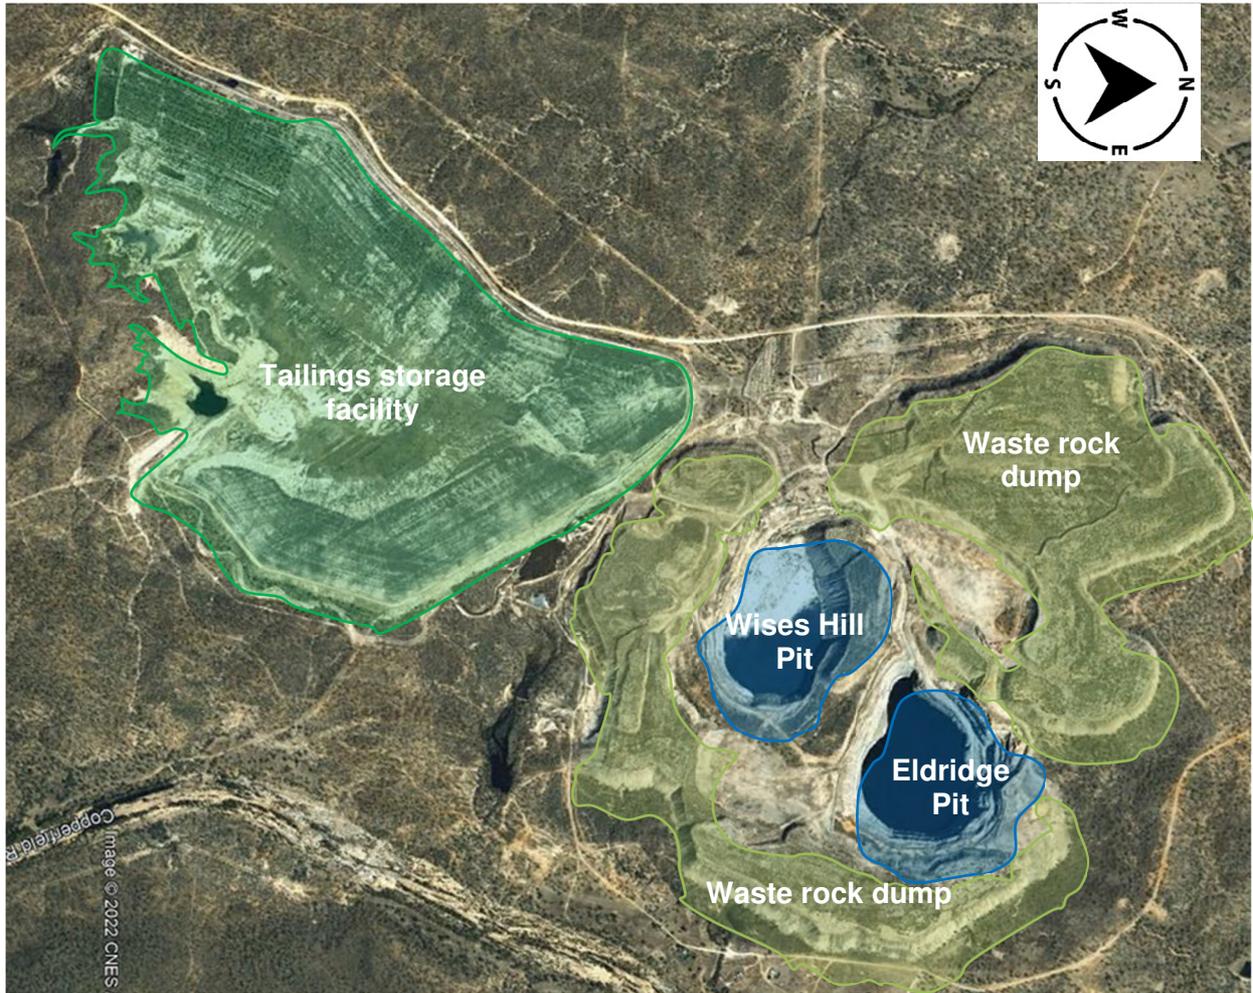
Figure 1 Google Earth image of Kidston mine site (December 2016)

As shown in Figure 1, Kidston mined Wisers Hill Pit to 240 m depth (52 ha footprint), followed by Eldridge Pit to 270 m depth (54 ha footprint). The waste rock and tailings generated from Wisers Hill Pit were placed in a surface waste rock dump (WRD) surrounding the Wisers Hill Pit and a large surface tailings storage facility (TSF), respectively. The surface WRD has a typical height of about 36 m constructed in a single lift, with a total area of 337 ha. The surface WRD sits on Wisers Hill, which has a very low permeability, limiting rainfall and seepage infiltration. The surface TSF has a maximum embankment height of about 32 m, an average tailings depth of about 15 m, and an area of 310 ha in a total catchment of 414 ha. All of the waste rock and tailings generated from Eldridge Pit were backfilled into the completed Wisers Hill Pit, the waste rock end-dumped from the northwest crest of the pit (upper right in Figure 1), and the tailings thickened and gravity fed down the opposite southern crest of the pit. Figure 2 shows an aerial view of the Kidston Genex site, with the Solar Farm on the surface TSF to the top left, and the two partially flooded open pits that will be converted into a Pumped Storage Hydro Project; the backfilled Wisers Hill Pit in the centre, surrounded by the WRD, and Eldridge Pit to the lower left of Figure 2.

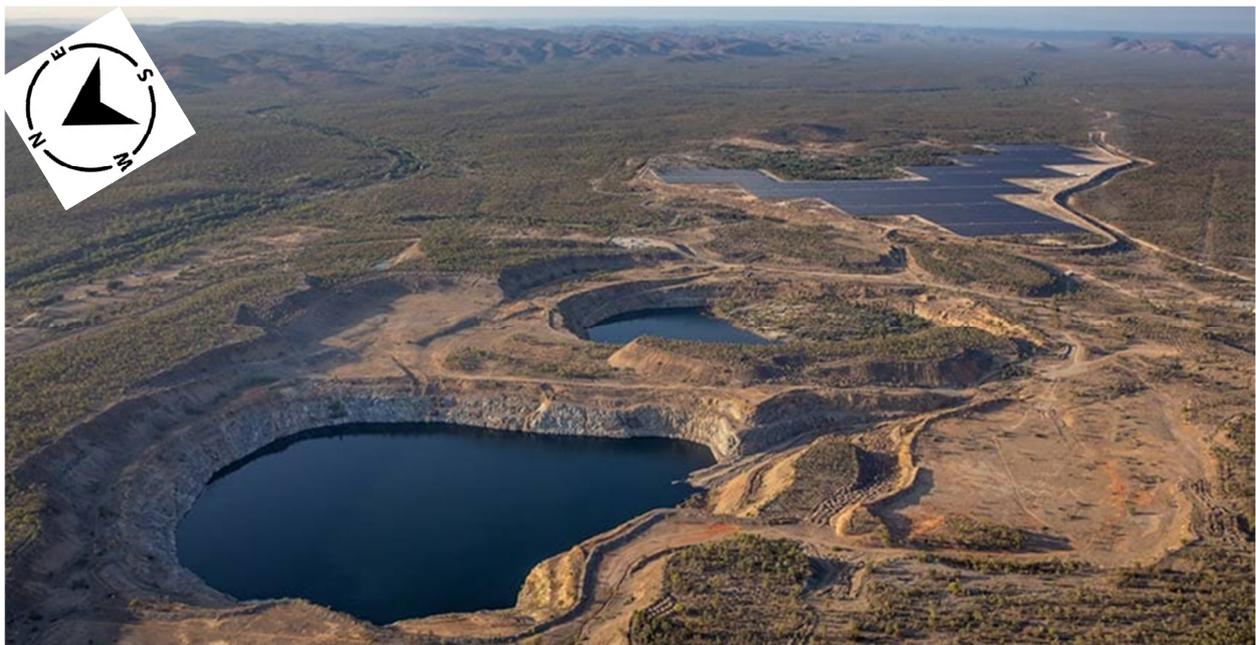
Figure 2 Aerial view of Kidston Genex site

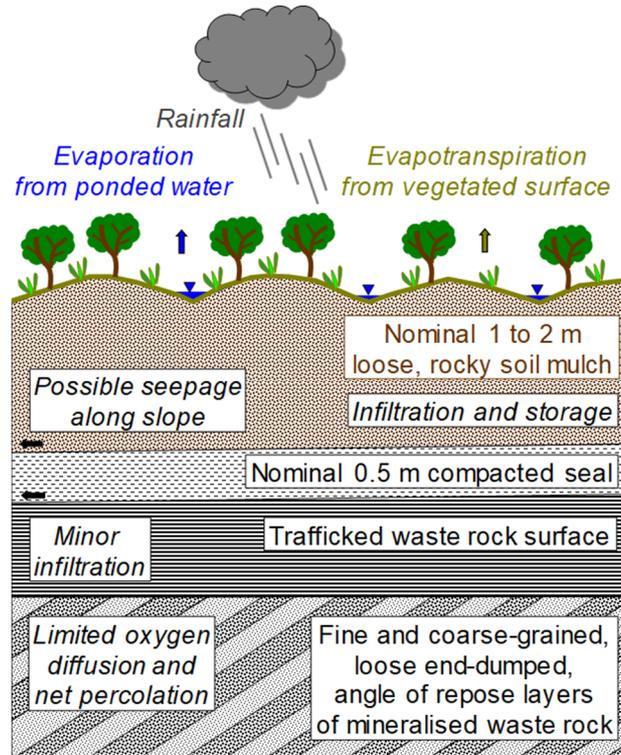
Figure 3 Schematic of store and release cover system developed for Kidston waste rock dump top

Bews et al. (1997) described the design and trialling of the store and release cover system for the top of the WRD, shown schematically in Figure 3. The adopted design was a 500 mm compacted layer of selected fine-grained, highly weathered oxide waste to hold up rainfall infiltration, overlain by a nominal 1.5 m thick, loose-dumped, mounded 'rocky soil mulch' layer of highly weathered oxide waste to serve as an evapotranspirative growth medium for trees, shrubs and grasses. The initial trial covers involved truck paddock-dumped rocky soil mulch, which was later smoothed by low-bearing pressure dozers to 'smear' potential seepage flow paths to the base of the rocky soil mulch layer, while still not shedding erosive rainfall.

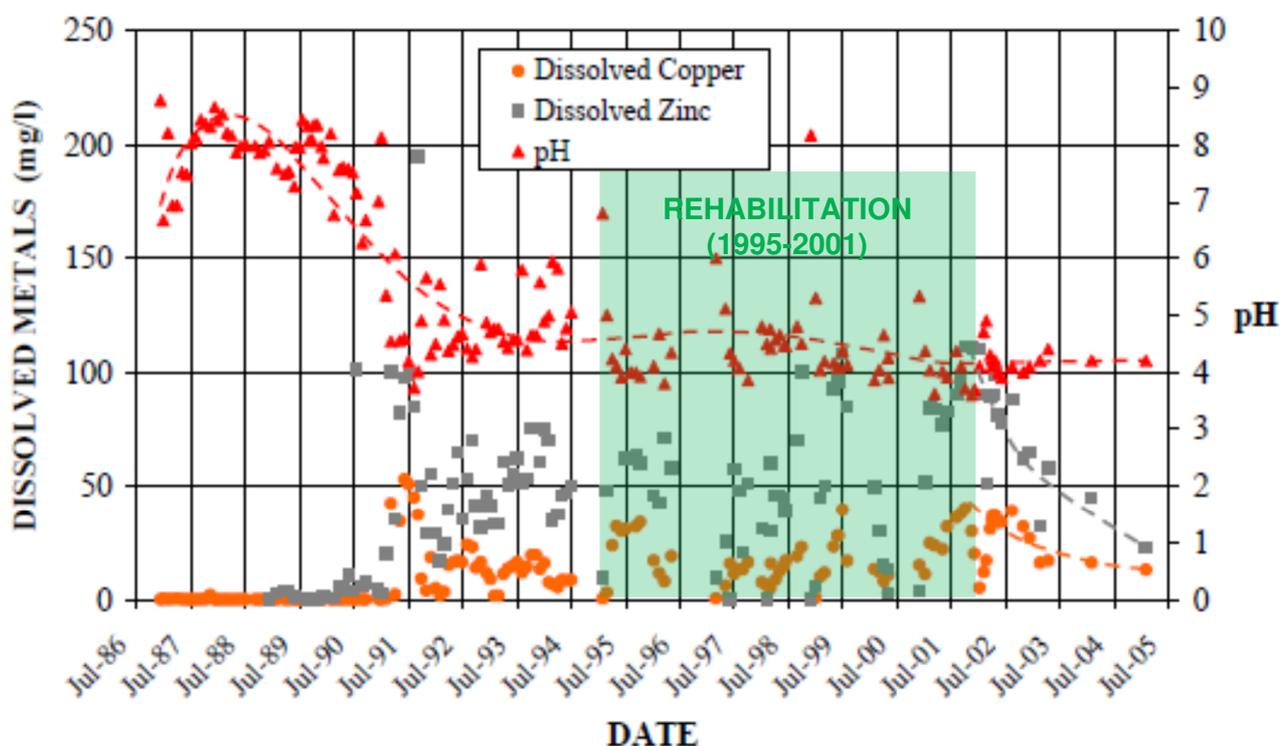
Figure 4 Improving seepage quality after completion of store and release covers

Williams et al. (2006) confirmed the findings reported in Williams et al. (2003) and reported reducing seepage flows and improving quality. V-notch weirs were installed on the main toe seeps from the WRD in October 2002 and measured a reduction in flows to about 0.6 L/s by August 2005. The 1990/1991 extreme wet season (1,269 mm of rainfall was recorded in 1991) initiated mild AMD, which resulted in the pH of the seepage dropping suddenly from about 7.5 to about 4.5, and the sudden increase in dissolved copper and zinc (Figure 4). However, copper and zinc concentrations in the seepage reduced dramatically following the completion of the covers on the WRD at the end of 2001.

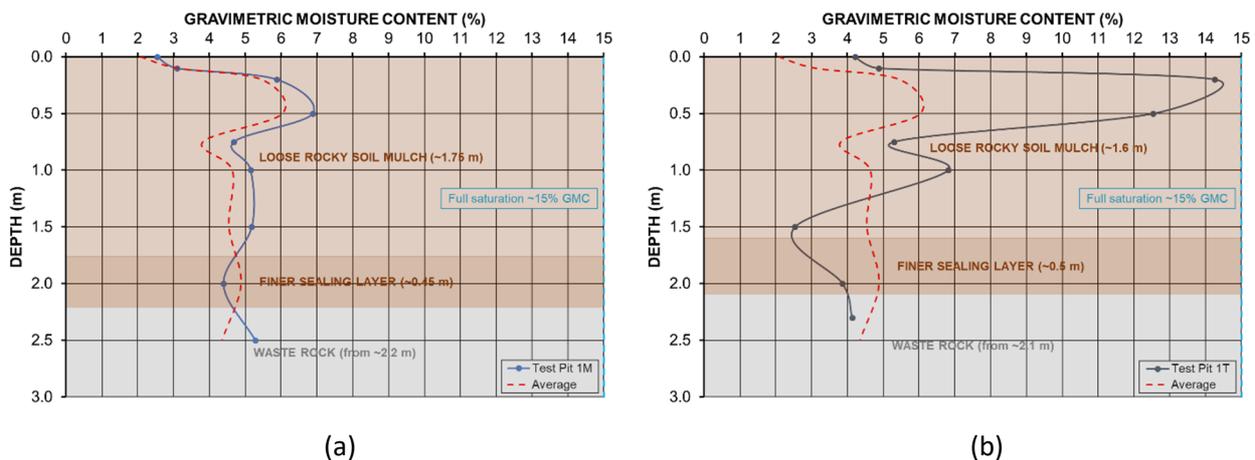
Figure 5 Typical gravimetric moisture content profiles through: (a) Crest and (b) Trough of store and release cover, sampled in August 2021

Typical gravimetric moisture content profiles through the crest and trough of the store and release cover, sampled in August 2021, are shown in Figure 5, together with the inferred profile on materials with depth, which closely match the specified store and release cover design. The dashed red line is the average of all six test pits excavated in August 2021. The gravimetric moisture content at full saturation is estimated to be 15%, although this value will vary with the density of the cover material and would be expected to be lower in the compacted finer-grained sealing layer at the base of the cover. It is clear from Figure 5 that the periodic collection of rainfall in the trough results in an elevated moisture content at shallow depth, although this is not seen at depth. The compacted sealing layer is less than one-third saturated, as is the trafficked waste rock beneath the cover.

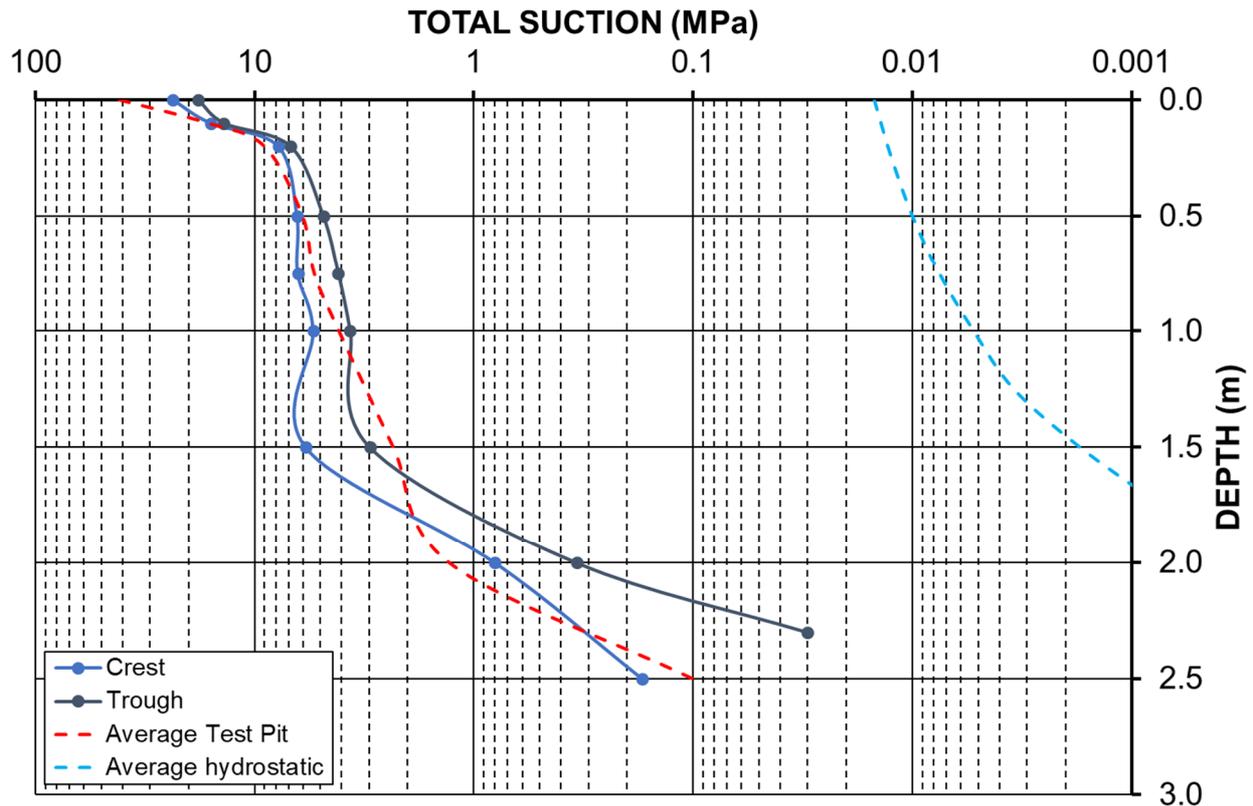
Figure 6 Typical total suction profiles through crest and trough of store and release cover, sampled in August 2021

Typical total suction profiles through the crest and trough of the store and release cover, sampled in August 2021, are shown in Figure 6. The dashed red line is the average of all six test pits excavated in August 2021. The dashed light blue curve represents the worst possible case of a watertable perched at the top of the compacted sealing layer, giving zero suction at that elevation. It is clear from Figure 6 that the total suction, which is mainly matric suction because the electrical conductivity is low, is about three orders of magnitude lower than the worst ‘hydrostatic’ case, indicating that the cover is very strongly evapotranspirative.

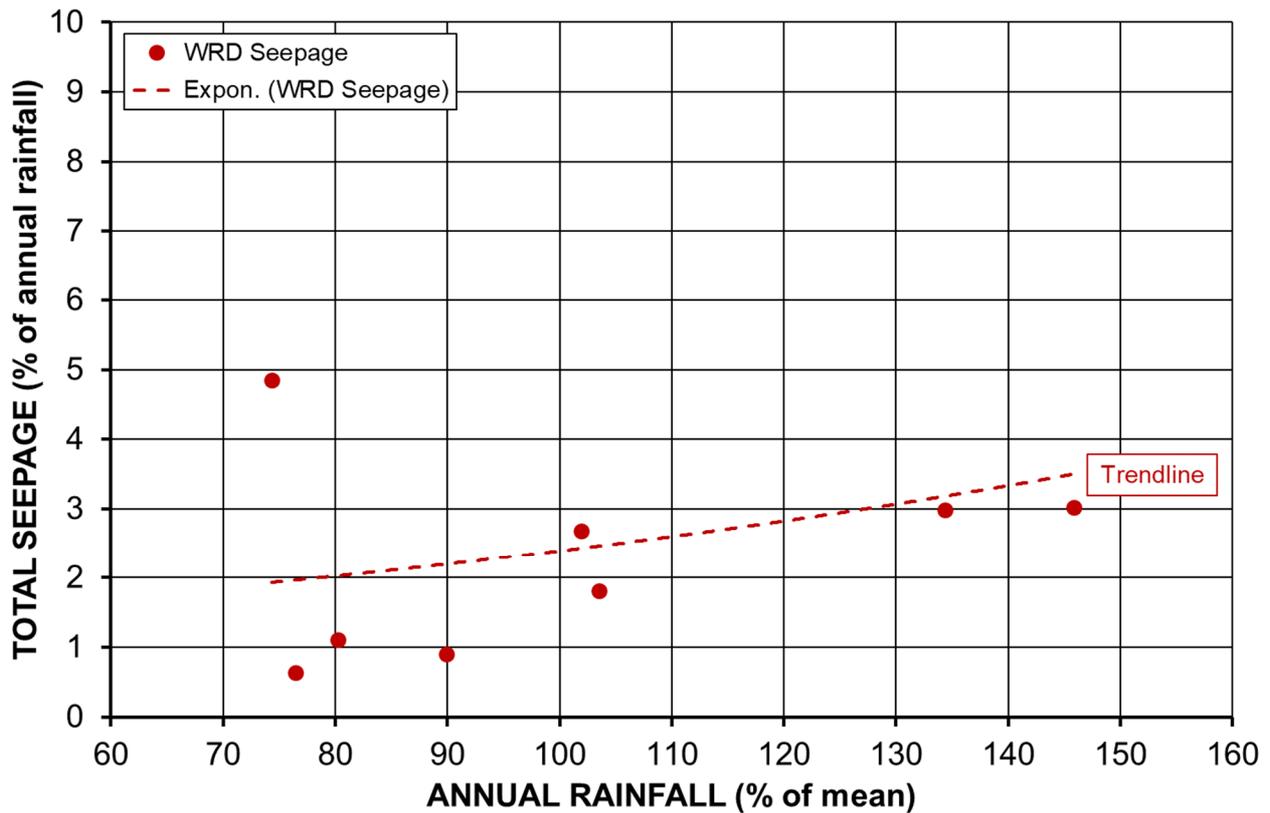
Figure 7 Total seepage versus annual rainfall for rehabilitated surface waste rock dump

The pump-back of seepage from the surface WRD toe seepage collection ponds to the pits provides an indicator of seepage rates from the facility, and increases with rainfall, although it is somewhat lagged in time. Mean annual seepage from the WRD is estimated from pumping records to be 2.2% of mean annual rainfall incident on the dump (at 1.8 L/s), allowing for evaporation from the seepage collection ponds of 0.3%, and negating any seepage into the tight foundation. Of the total seepage, the uncovered side slopes account for an estimated 1.4% (assuming 50% rainfall infiltration), implying an estimated 0.8% net percolation through the store and release covers, which compares well with the best achievable using any cover system of the order of 1% of similar annual rainfall totals, increasing with increasing rainfall (Benson et al. 2002). The available pumping data from 2012 to 2020 allow the estimated seepage as a percentage of annual rainfall to be plotted versus annual rainfall as a percentage of the mean annual rainfall (Figure 7), which shows increasing percentage seepage with increasing rainfall, as was also found by Benson et al. (2002).

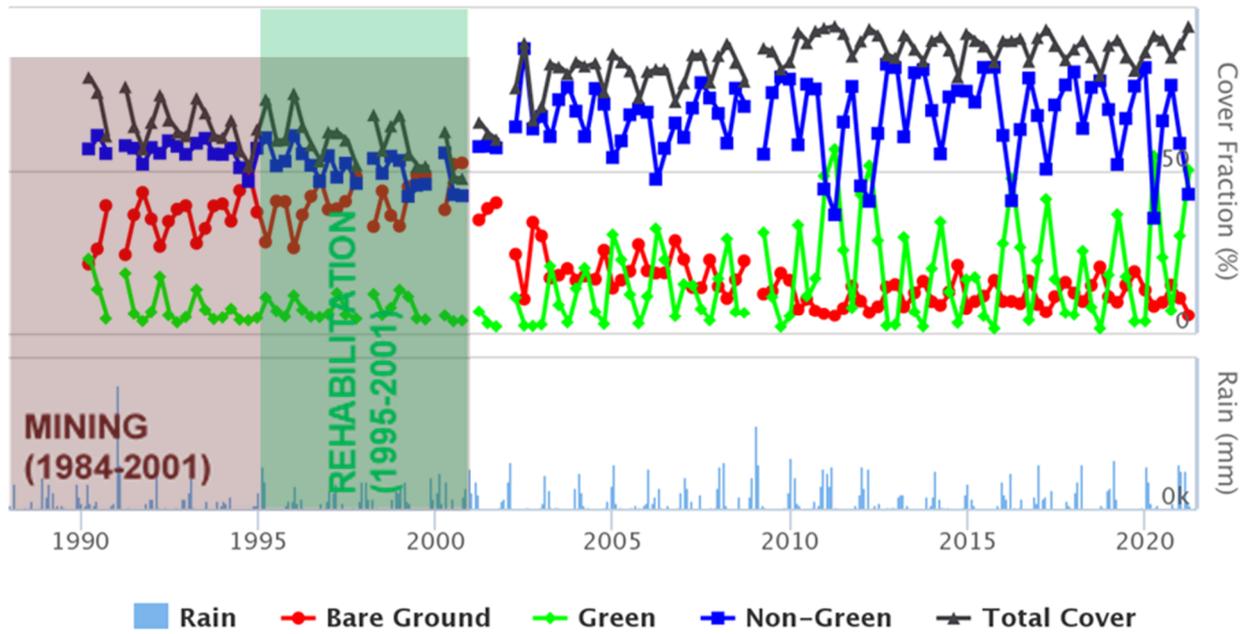
Figure 8 Development of total native revegetation cover on top of waste rock dump

The development of mean total native revegetation cover on the top of the WRD during the 20-year period since the completion of rehabilitation at the end of 2001 is a high 82% (<https://vegmachine.net/>), as shown in Figure 8. Unremarkably, the percentage of green or living revegetation cover has fluctuated seasonally. Importantly, however, ‘bare ground’ has steadily declined to an average 13% over the past 5 years. Apart from high density, the revegetation also shows considerable diversity, with tree, shrub, and grass cover, as shown in Figure 9.

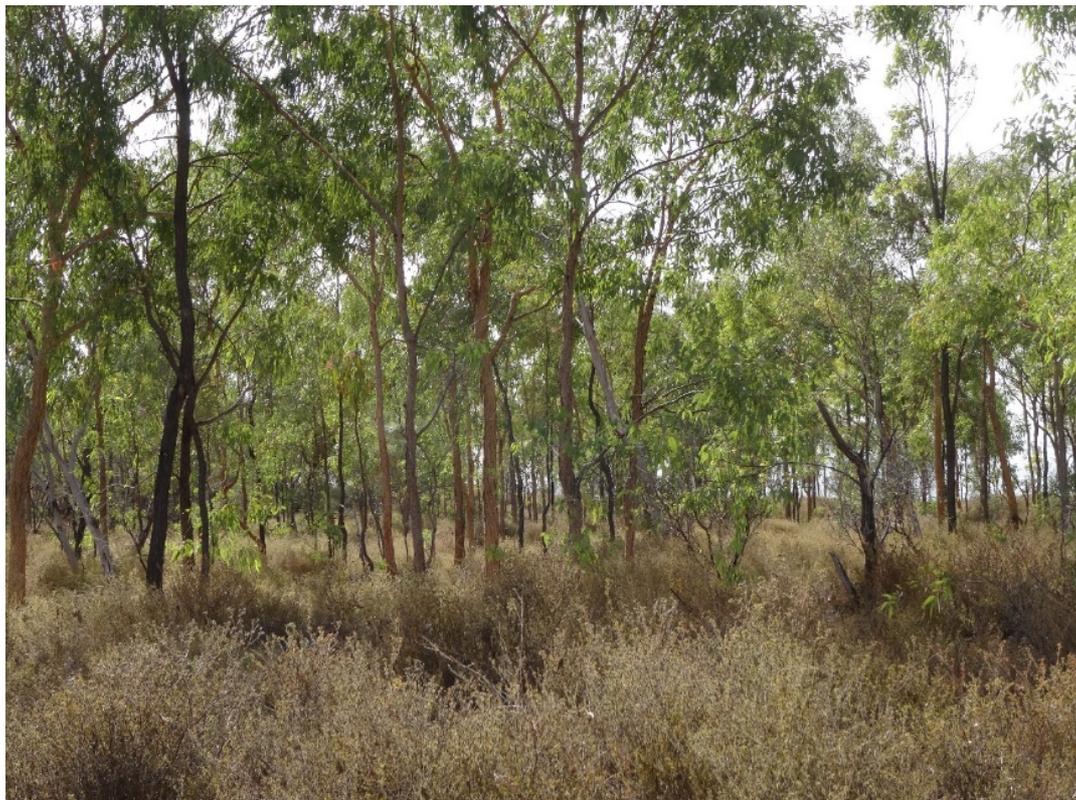
Figure 9 Density and diversity of native revegetation cover on waste rock dump

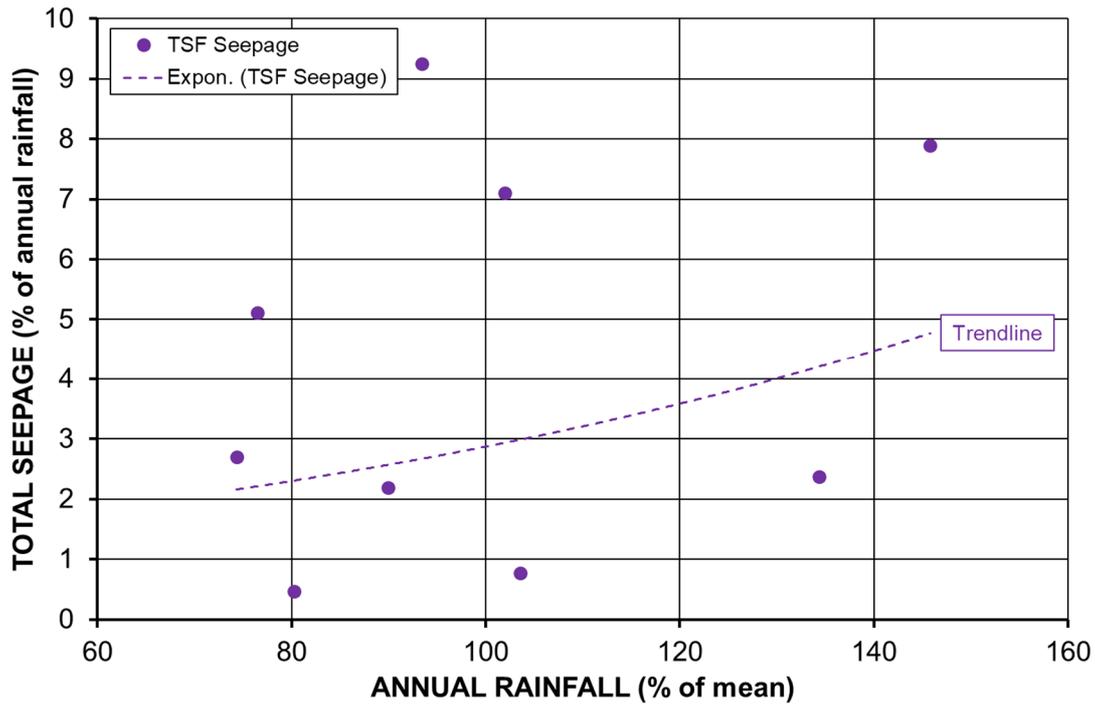
Figure 10 Total seepage versus annual rainfall for rehabilitated surface tailings storage facility

The pump-back of seepage from the surface TSF to the pits provides an indicator of seepage rates from the facility, and increases with rainfall, although it is somewhat lagged in time. Mean annual seepage from the TSF is estimated from pumping records to be 2.9% of rainfall incident on the total 414 ha catchment (at 3.0 L/s), allowing for evaporation from the seepage collection ponds of 0.3%, and negating any seepage into the tight foundation. For the 310 ha surface TSF footprint, a net percolation into the tailings of 2.2% is inferred, which is considerably higher than that inferred through the surface WRD store and release cover of 0.8% of incident rainfall. The available pumping data from 2012 to 2020 allow the estimated seepage as a

percentage of annual rainfall to be plotted versus annual rainfall as a percentage of the mean annual rainfall (Figure 10), which shows increasing percentage seepage with increasing rainfall.

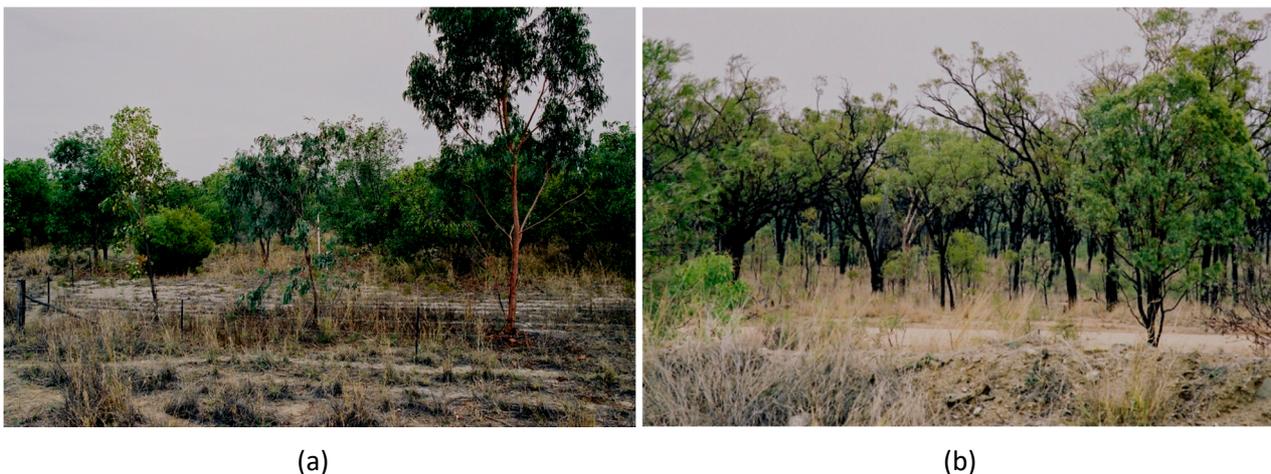
Figure 11 (a) Native revegetation on tailings; (b) Natural regeneration

Mulligan et al. (2006) reported on direct native revegetation trials on tailings from 1998, and monitoring of the direct native revegetation of the tailings from 2001 to 2005, which demonstrated progression towards a sustainable native plant community, achieving almost 70% revegetation cover and less than 15% bare ground. There was more diversity of shrubs and trees on the revegetated tailings than in the surrounding grazed land, which had been subjected to periodic burning to promote pasture grass, resulting in a dominance of ironbark trees (Figure 11).

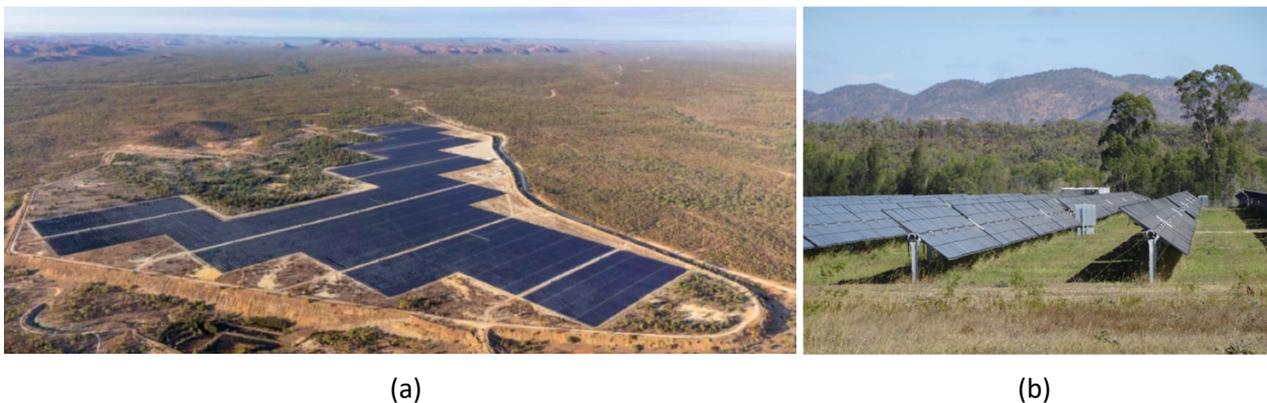
Figure 12 Genex Solar Farm on Kidston surface tailings storage facility. (a) Aerial view; (b) Rotating solar panels and underlying grass and legume cover

The flat top of the surface TSF was well suited to the development of a Solar Farm. In late 2017, Genex completed the construction of a 50 MW (AC, 63 MW DC) Solar Farm at a total cost of \$124 million, over a large part of the near-flat Kidston surface TSF. The project required the removal of trees and shrubs, while the original seeding and planting of high proportions of introduced grasses and legumes persists beneath the rotating solar panels and is regularly slashed (Figure 12). The grasses and legumes control dust off the underlying tailings.

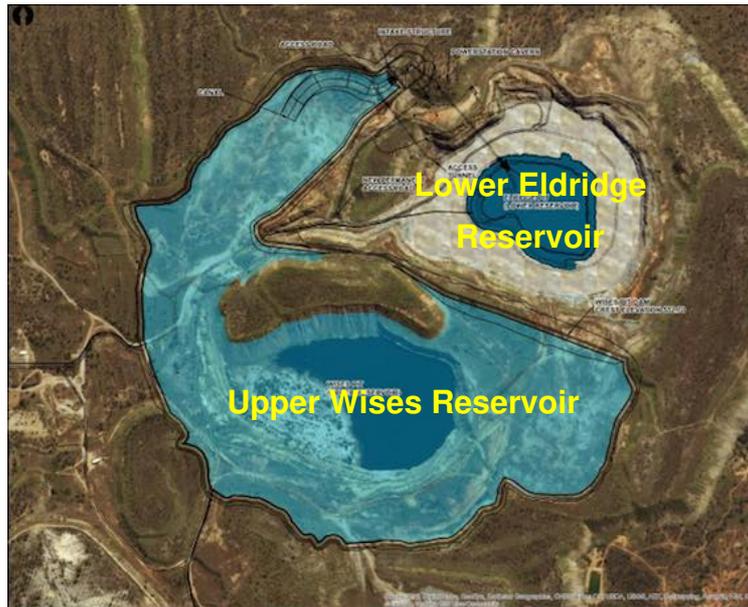
Figure 13 Plan view of Genex Pumped Storage Hydro Project at Kidston

The Wises Pit footprint is being greatly enlarged by Genex to serve as the upper reservoir, with Eldridge Pit as the lower storage reservoir. The expansion of the upper reservoir is needed to maintain an adequate head above the turbines by limiting the drop in water level to less than 5 m during power generation. The sides of the expanded Wises Pit will be lined with a geomembrane to limit seepage, while the underlying natural ground and pit walls are tight and of very low permeability. The nearby Copperfield Dam, which previously delivered water the Kidston mine and continues to supply water for local cattle grazing, will provide up to 1 GL/year of

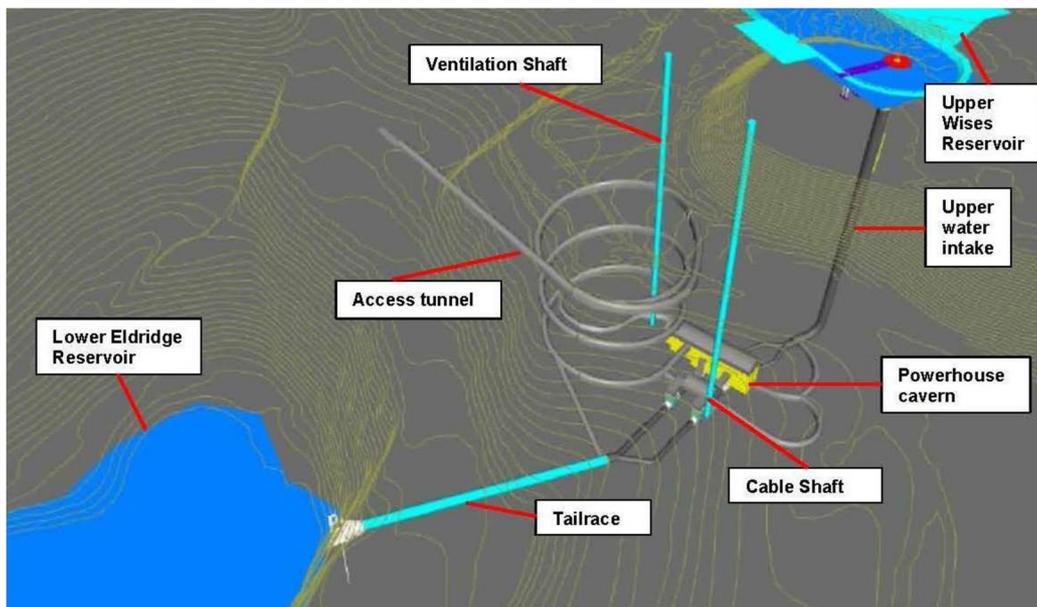
Figure 14 Below-ground infrastructure of Genex Pumped Storage Hydro Project at Kidston

make-up water to replace that lost to evaporation from the enlarged upper reservoir. The below-ground infrastructure of Genex Pumped Storage Hydro Project at Kidston is shown in Figure 14 (AECOM 2018).
