Cold joints and hot pours in the arctic: design, implementation; and post construction investigation of a remotely placed Self Consolidating Concrete sill pillar

Abstract

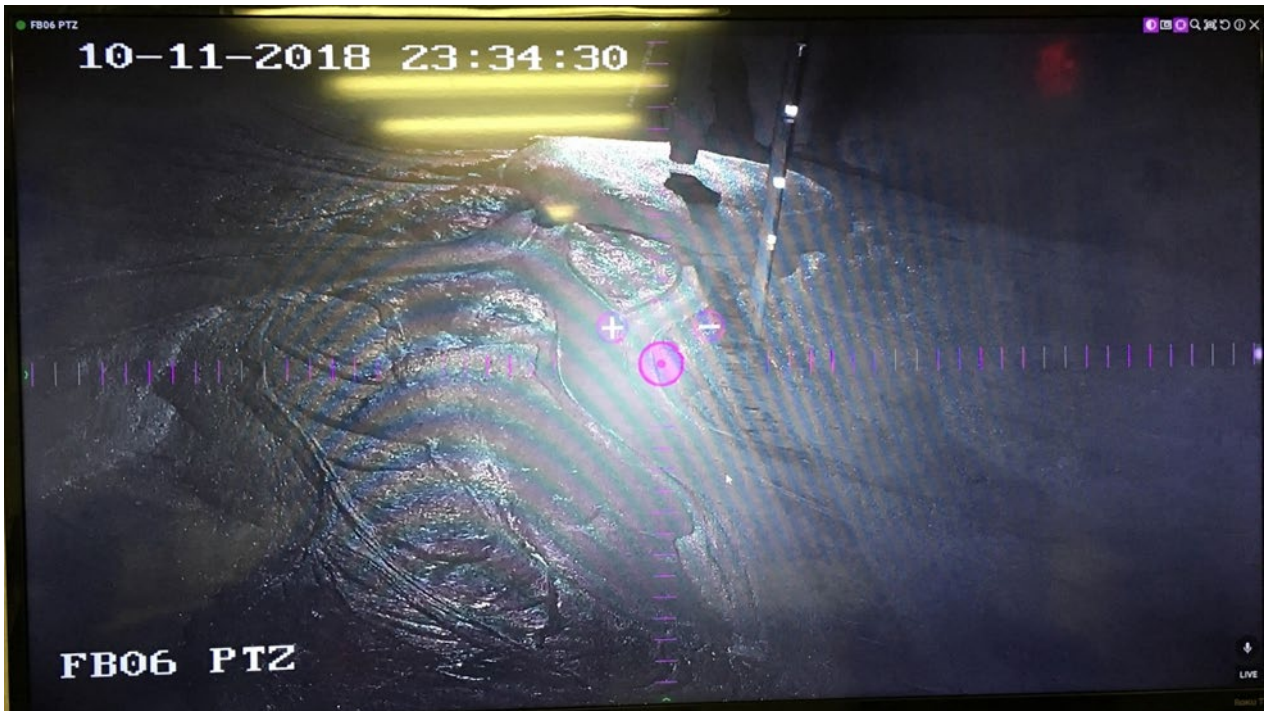
Figure 5 Footage from underground infrared camera showing splash pool under tremie pipe. Extensometer string with reflective tape shown in foreground of tremie pipe and braided flow channels in SCC

No discontinuities were identified in the core or camera footage from Borehole 2, which was drilled through the concrete delivery hole CD_03. However, areas of increased porosity resulting in mechanical fractures of the core were observed, which may have been associated with the splash pool formations observed from infrared camera footage during placement (Figures 5 and 10).

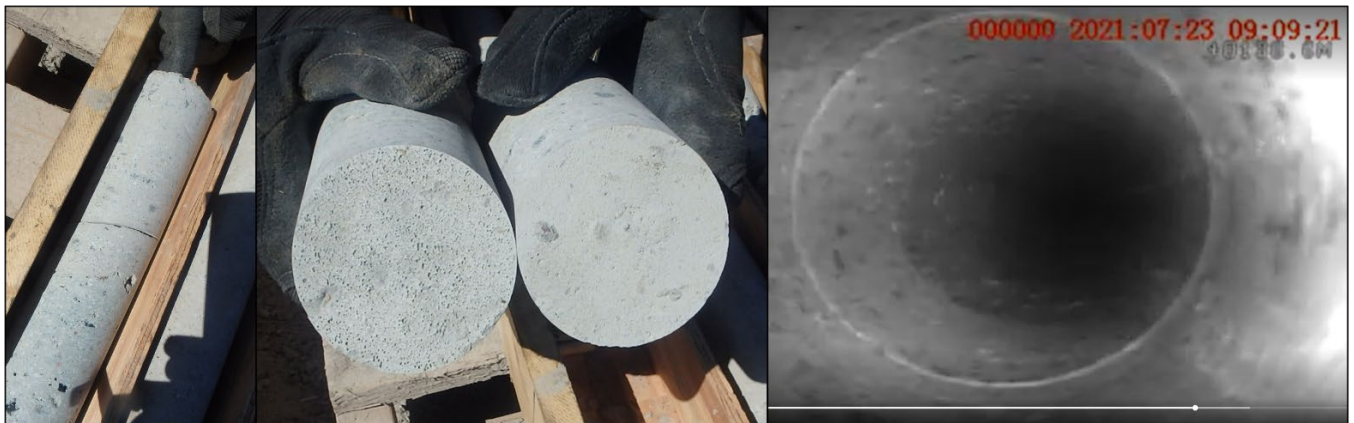
Following retrieval of the core, all breaks within the SCC zone were reviewed by WSP personnel to identify potential cold joints. In Borehole 1, three interpreted cold joints were identified and subsequently correlated with borehole camera records (Figure 7). In Borehole 3 and Borehole 4, no obvious cold joints with corresponding smooth surfaces were initially identified from core logging, but an obvious fracture was identified in each of the borehole camera records (Figures 8 and 9).

Figure 7 Interpreted cold joint in box (left), split to expose surfaces (centre) and in borehole camera video (right) from borehole 1 at ~138.7 m along hole/30.24 mamsl

The joints identified both in core and borehole camera records were found to correspond to the period in early October 2018 when SCC pouring rates were reduced due to supply limitations of cement binder and are interpreted to be cold joints. With the limited number of investigation boreholes drilled through the SCC plug, it is difficult to state conclusively what the continuity of these fractures is likely to be. With evidence from Borehole 2 that cold joints were not formed directly underneath concrete delivery holes it is unlikely that the observed fractures traverse the entire width or length of the plug. However, evidence from Borehole 3 and Borehole 4, which were drilled within approximately 5 m of delivery hole CD_05 suggest that jointing due to interruptions to flow of SCC to a specific area is possible relatively close to a delivery hole. As shown in Figure 5, the flow pattern was not consistently perfectly radial so it is possible that the cold joint areas did not receive fresh SCC but areas immediately adjacent received fresh SCC regularly and therefore did not form a joint.

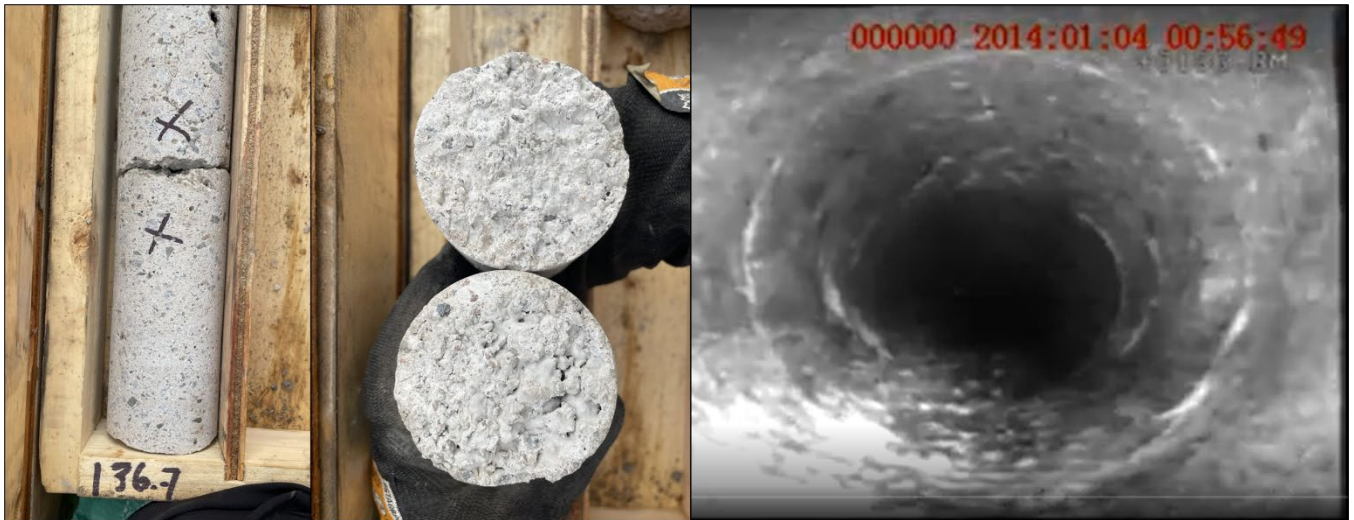
Figure 8 Interpretation cold joint in box (left), split to expose surfaces (centre) and in borehole camera video (right) from borehole 3 at 136.8 m along hole/ 27.18 mamsl

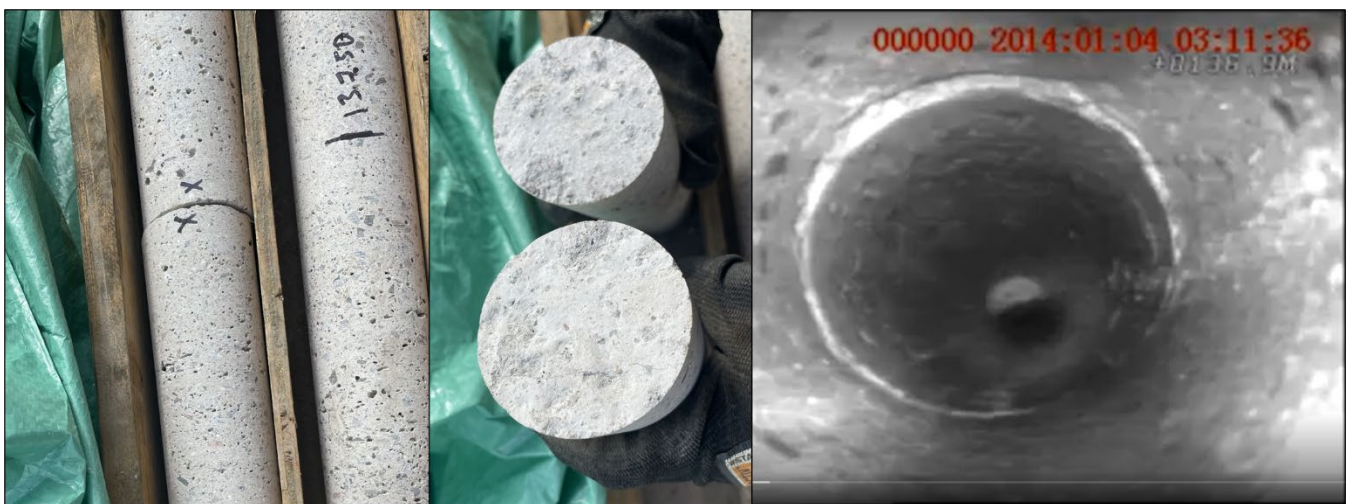
Figure 9 Interpretation cold joint in box (left), split to expose surfaces (centre) and in borehole camera video (right) from borehole 4 at 136.9 m along hole/28.01 mamsl

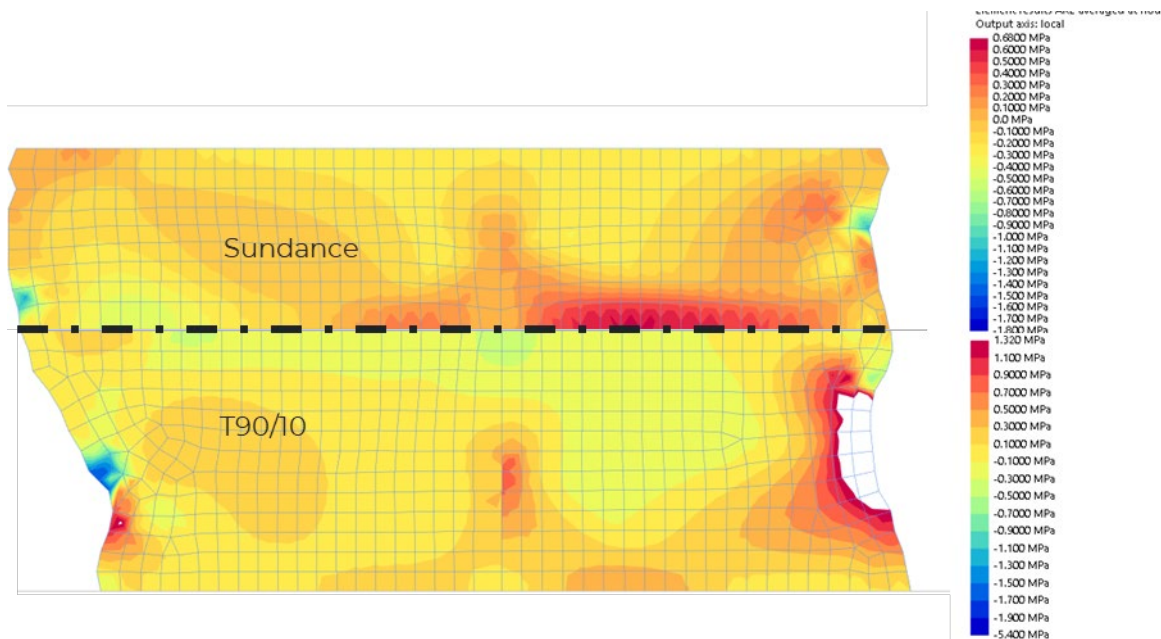
Because of the overhangs on both side walls, which were most pronounced on the right wall, limited areas of the side walls were available for bearing capacity in the lower, thicker T90/10 layer (Figure 12). It was found that for the moderate load (Figure 13) and high load cases, tensile yielding was expected on the side wall contacts in the T90/10. No compressive yielding was noted for any of the loading cases. The tensile yielding indicates the potential for a horizontal joint to form and the lower right part of the SCC to drop off;

Figure 13 Modelled tensile stresses for moderate load (uncemented backfill) load case showing potential tensile failure in right side wall of T90/10 layer

however, the remaining part should be stable and support the load based on modelled stress conditions. Deformation of the SCC was predicted as 4.3 mm surface dip for the high loading case.
