# Legacy coal mines in Southern Brazil: Actions from National Mining Agency to promote fair mine closure and their transitions to another land-use

F Perlatti, FE Kutchenski, HA Pasti, CA Silva and OJS Lamarque *National Mining Agency - ANM, Brazil*

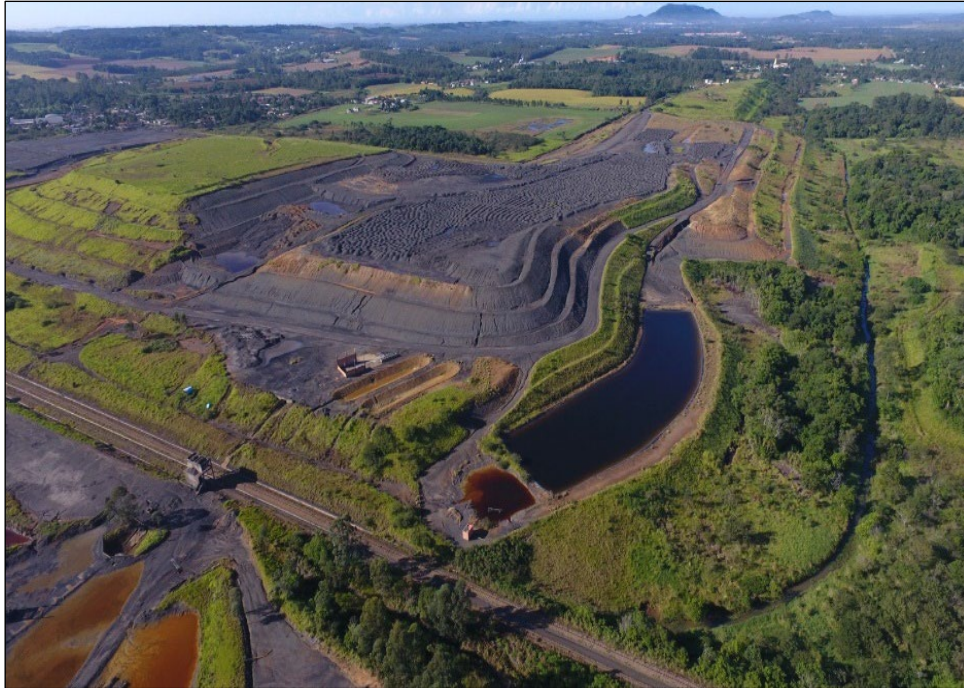
Figure 4 Aerial image shot by a drone of an abandoned area with open pit coal tailings disposal, partially rehabilitated and source of acidic drainage.

The areas with the greatest impact include old abandoned coal mines (most with acidic drainage) (Figure 4), pits exposed by open pit mineral exploration, acid lakes, and places with irregular disposal of tailings from coal processing. These areas are close to several urban centres, and some of them are in the process of rehabilitation or rehabilitated. In addition to the mining activity, there is an interface with different sources of pollution such as livestock (pig farming), agriculture, domestic and industrial waste. (Franzen et al, 2021).

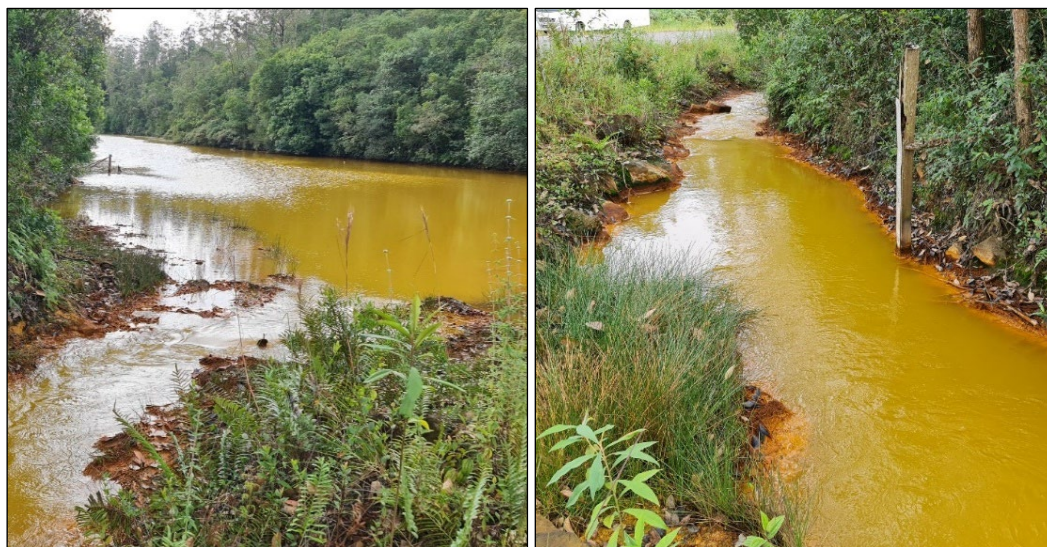
Figure 7 Aspect of water bodies affected by acidic drainage in orphaned coal mining areas.

of effluents, caused by the presence of dissolved or suspended metals (mainly Fe and Mn oxides). Figure 7 shows in detail the tributary that flows into the Mãe Luzia river causing contamination by acidic waters.

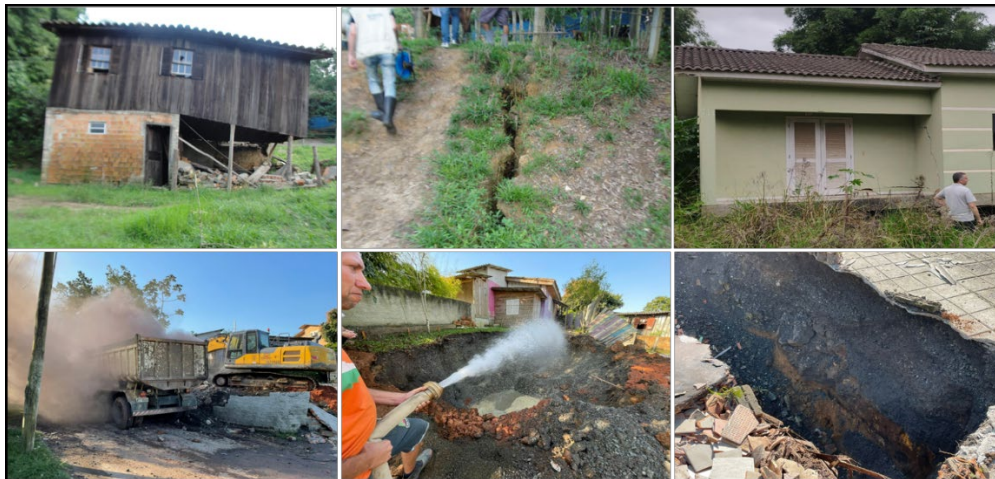
**Figure 8** Houses with subsidence caused by underground mine workings within the urban area of the municipality of Criciúma, and houses built over tailings affected by spontaneous combustion.

Another strong social impact resulting from abandoned mines is not visible to the commonwealth. Considering that activity has taken place since the beginning of the 20<sup>th</sup> century, there are many abandoned underground mine workings, and considering the disorderly exploration at the time, nowadays there is no mapping of these workings. With this, the occurrence of subsidence of houses is frequent, which makes the inhabitants live under constant tension. In addition, on many occasions, tailings from coal mining were used as gravel for paving streets and land, and considering the high sulphur content in this material, there have been cases of spontaneous combustion of the material, causing fires in homes built above this material (Figure 8).

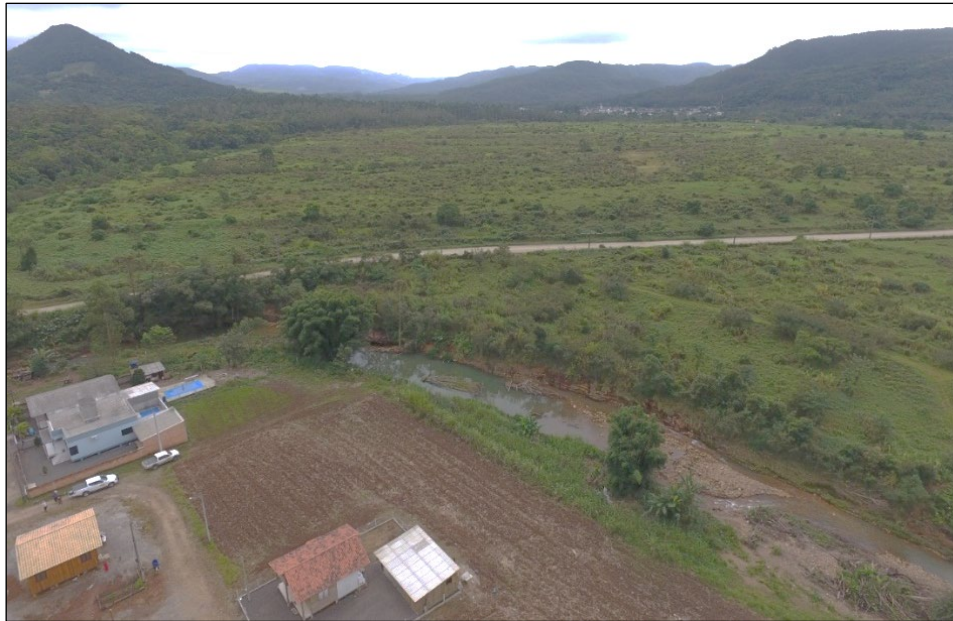
Figure 10 Image of the rehabilitated area where it is possible to observe the presence of tree and shrub species that may have penetrated the 50 cm layer of compacted clay that isolates the tailings.

The second case study presented here was also rehabilitated using the same Terms of Reference; however, some flaws in the planning, execution and maintenance resulted in poorer outcomes. In this case, the same technique was used: encapsulating the waste in compacted clay cells, covering with 50 cm of limestone, and overlapping with organic soil and peat to allow plant growth. The sowing was done only with grasses; however, natural succession quickly came into play, with the growth of tree species, which likely penetrated the clay cell, resulting in higher rates of water and oxygen ingress. In this case, although the landscape has been rehabilitated, there has some groundwater drainage downstream of the rehabilitated area, which flow acidic waters directly into the adjacent river, negatively impacting the water quality (Figure 10 and 11).

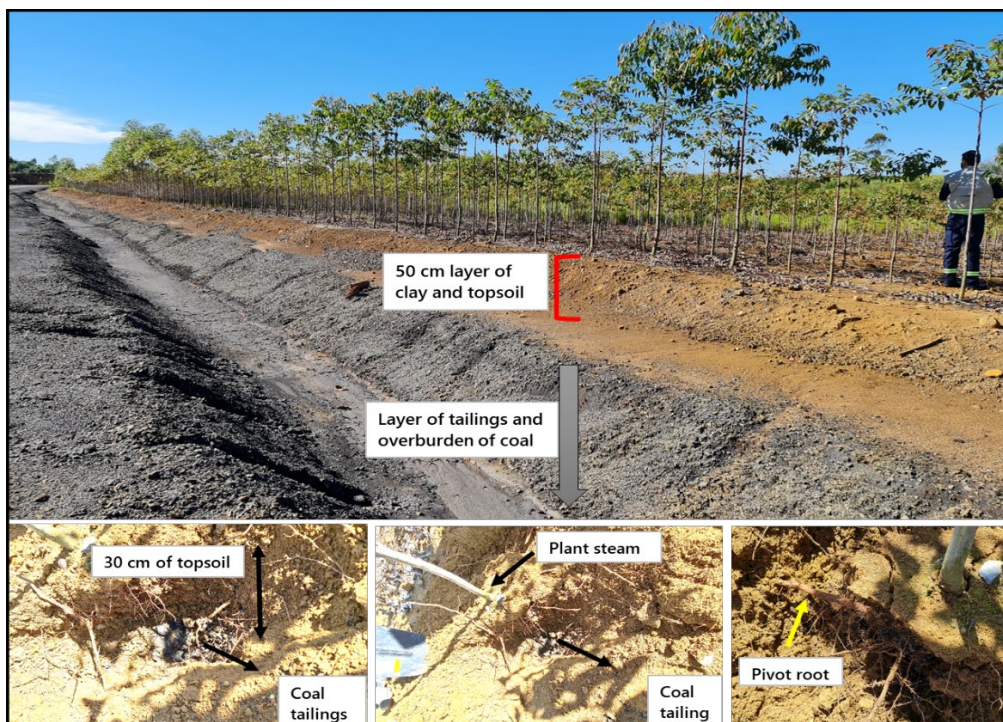
Figure 12 Rehabilitation of an area with coal tailings covered with 50 cm of clay and topsoil. In detail, the eucalyptus pivoting root coiling, avoiding contact with the tailings.

A good example that demonstrates an area that, at first, did not follow the techniques established in the Terms of Reference, is where the tailings were isolated in depth and covered with a layer of non-compacted clay/topsoil of approximately 50 cm in surface, with subsequent planting of *Eucalyptus grandis* (Figure 12). In this area, the clay/soil on the surface was not compacted and the system is not adequate for several reasons. First, *E. grandis* is not a native species in Brazil and therefore is not recommended by the control agencies for the environmental recovery of areas. Second, because it is a pivoting root and fast growth plant, with a strong potential for penetrating the isolation cells, it does not take long for roots to enter the buried waste.

An important field observation is the behaviour of *E. grandis* roots. The trees were planted between 1 and 2 years ago and what was observed is that the roots avoided entering the layer where the tailings are located. Figure 12 clearly shows a root movement in the 50 cm layer of clay, indicating that, despite the good resistance of the specie to acidic soils, the plant seeks strategies to keep away from the inhospitable conditions provided by the tailings.
