# Mitigation of an open shaft at a legacy mine site in British Columbia, Canada using polyurethane foam

*Legacy underground mining sites may include the presence of unsecured openings to surface, such as shafts, vent raises, and portals that pose a risk to public and animal safety. This paper presents a case study of the design methodology and use of a polyurethane foam (PUF) plug for the mitigation of an open shaft at a legacy mine site in British Columbia, Canada.*

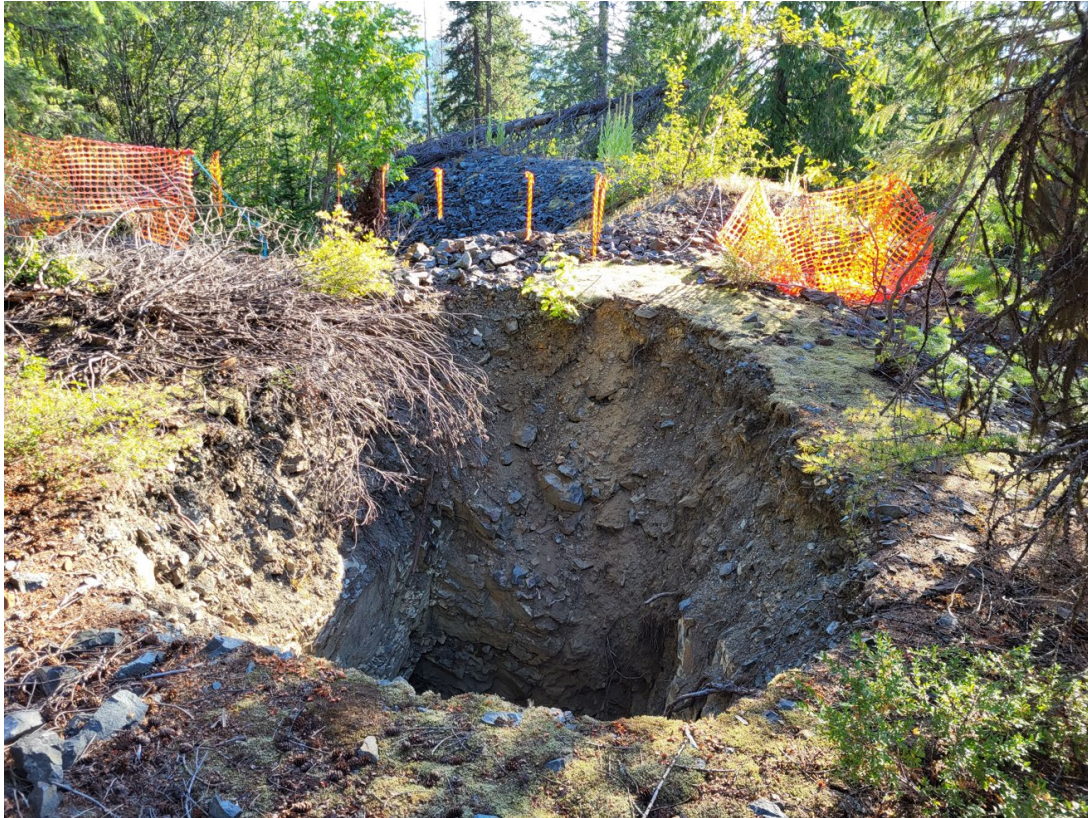
Figure 1 Photograph of open shaft taken during 2022 surface monitoring program

The feature that is the subject of this paper is an open shaft outside of the main mining property that had previously been backfilled several times with rockfill by the site Owner. This shaft has been observed as part of the routine surface reconnaissance programs conducted at the Site. Between 2006 and 2018, a minor surface depression (approximately 0.30 m deep) was observed at the shaft location. When the shaft was visited during the 2019 surface reconnaissance program, a large opening was observed to have developed measuring (visually) approximately 3.5 m by 5.0 m at surface and up to approximately 10 m deep (depth estimated from a camera affixed to a pole). It was interpreted that the previously placed backfill had either migrated and/or settled over time, eventually resulting in an expression of surface subsidence. Due to the size of the opening and its location off an unsanctioned, yet accessible to the public, foot and bike trail, it was recommended that the shaft be guarded with signage and fencing as an interim measure while a long-term mitigation solution was developed. The shaft remained in similar condition until September 2022 when the mitigation that is the subject of this paper was implemented (Figure 1).

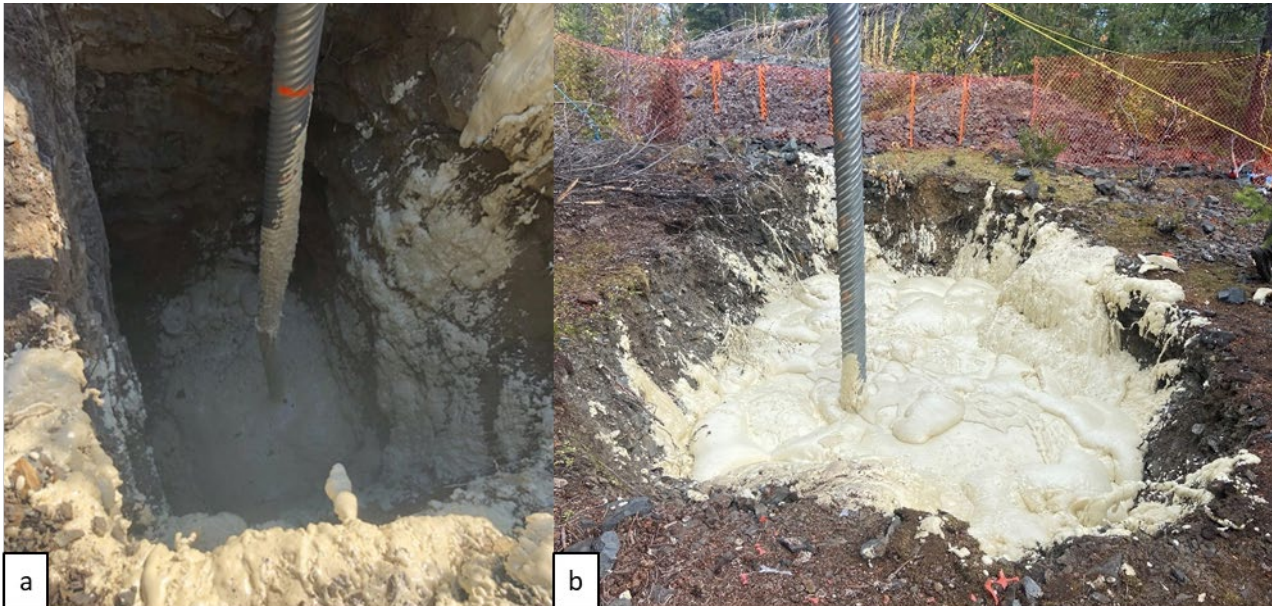
Figure 3 (a) Lift 1 following placement (b) Lift 17 following placement

2. A PUF Plug was placed to approximately 0.76 m below ground surface, using hand-mixing and hand-pouring methods. The PUF was poured in lifts of targeted maximum 0.5 m thickness (Figures 3a and 3b). The initial lift of PUF was placed using the existing rockfill in the base of the shaft as the false floor Formwork for construction. A total of seventeen lifts of varying thickness were placed over the two-day duration PUF pour.

Minor cracking that was observed in the PUF during placement in the shaft was repaired with the pouring of the next lift.

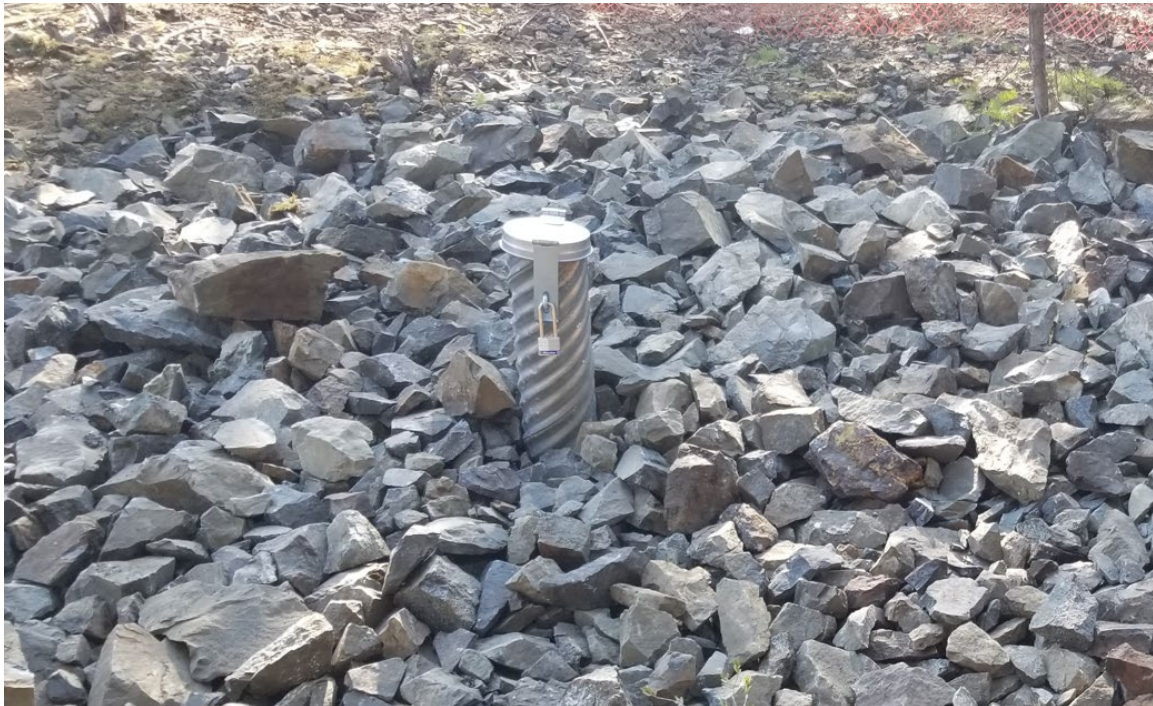
**Figure 4** Completed polyurethane foam plug

Table 2 summarizes the quantity of material used and the completed dimension of each of the plug components at completion. The total approximate volume of material placed in the shaft at completion (82 m<sup>3</sup>) was greater than the initially approximated volume of 69 m<sup>3</sup> from the 3-D photogrammetry model (Section 2.2). This was interpreted to be a result of the uncertainty associated with scaling the photogrammetry model from GPS data and plumb-bob measurements.

The final dimensions of the shaft collar prior to Backfill cover placement were measured to be approximately 4.1 m by 5.4 m and 0.7 m deep, using a laser distance meter. Figure 4 shows a photograph of the PUF Plug at project completion.

The PUF plug will be monitored as part of the annual surface reconnaissance programs. Monitoring of the plug will be conducted annually for the first five years following plug construction, beginning in summer 2023. Depending on the observations made, the monitoring frequency may be reduced. Monitoring will focus on identifying any depressions or cracks at surface in proximity to the PUF Plug. Additionally, a borehole camera or plumb-bob will pass through the Inspection Port to determine if there is any change in the rockfill elevation beneath the PUF Plug, or warping of the Inspection Port which may indicate deformation (i.e., sagging) of the PUF Plug.
