Evolution of dynamic rock support systems at the El Teniente mine

Abstract

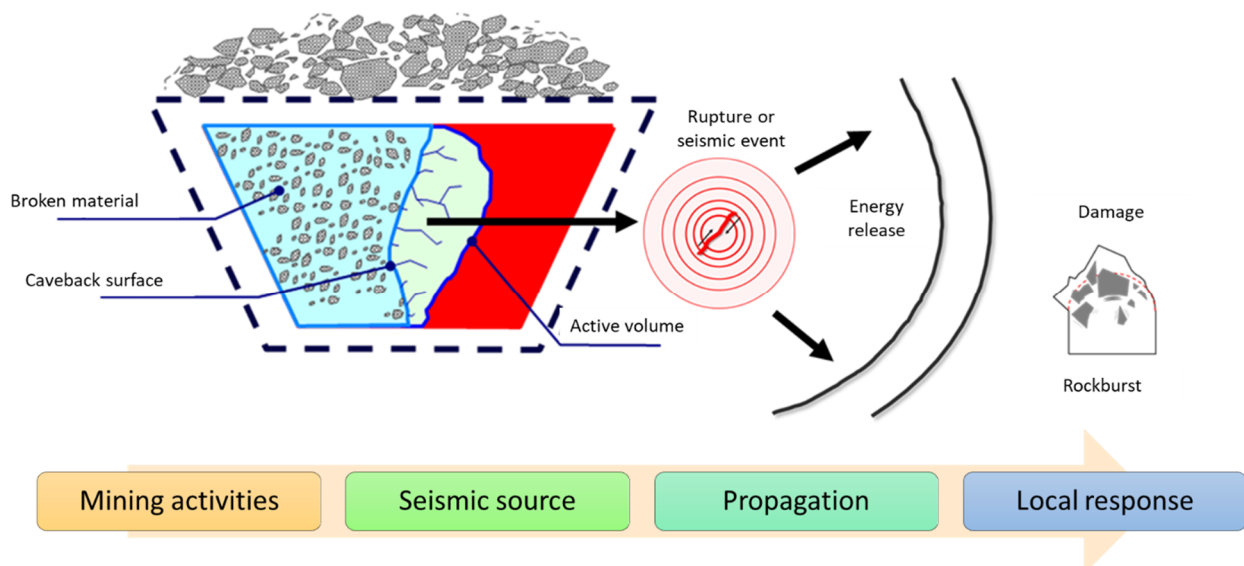
Figure 2 Conceptual framework for the induced seismicity (modified from Rojas et al. 1993)

The experimental mining stage tested a conceptual framework developed during 1992–1993 which connected the mining parameters to the rock mass response characteristics. This allowed control of the induced seismicity by modifying the mining parameters. The caving methods are initiated by the blasting of the bottom volume of a rock mass column. The broken material is mined out creating cavities that allow gravity to continue the fracture process of the rock mass, producing new broken material. The subsequent production generates the continuity of the breaking process to the upper levels. In general terms, a seismic event corresponds to the radiated energy associated with a rock mass rupture. Then the induced seismicity is always associated with a rupture process affecting a competent rock mass, and its characteristics will be determined by the spatial and temporal distribution of the mining activities and conditioned by the geometrical, geological and structural characteristics of the mined volume. This framework is described in Figure 2.

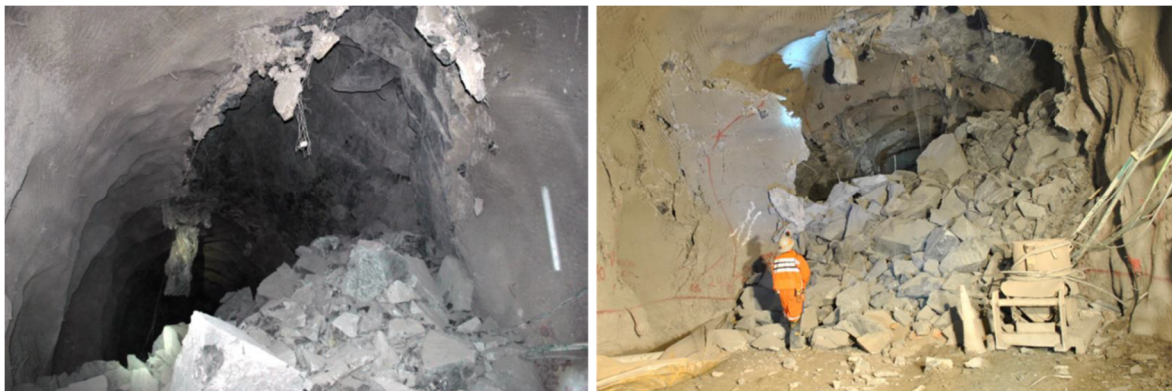
Figure 4 Rockburst damage after a seismic event $M_w 2.0$ in main infrastructure tunnels of the New Mine Level Project (Rojas et al. 2015)

During the period from 2013 to 2015, with the occurrence of rockbursts in the main infrastructure tunnels of the new mine level project (Figure 4), there was a need to understand the phenomena on another scale, which led to a new learning process in deeper and more complex geomechanical environments.

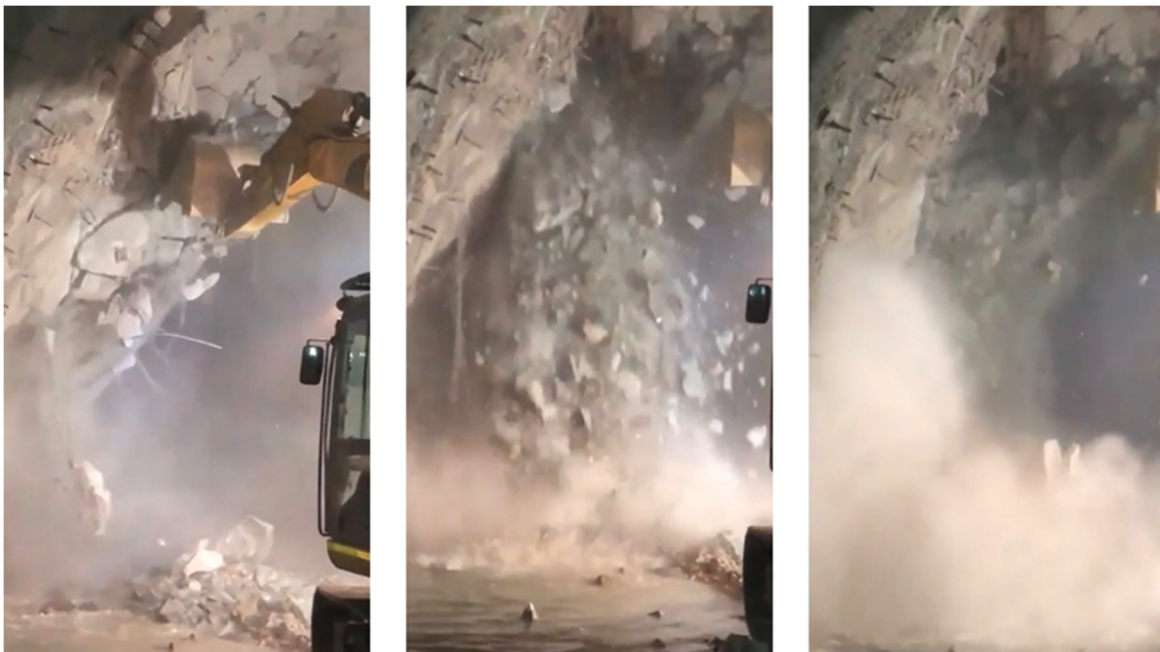
Figure 6 Rehabilitation process exposing rock fracturing behind retained volume by rock support system (operational ground control records)

At that time, the operational action consisted of completely restoring the capacity of the rock support system by discharging the loaded systems, implementing mechanised scaling processes, and subsequently installing new elements of rock support design. Additionally, during the rehabilitation process, it was seen that the degree of rock deterioration behind the surface exceeded the depth of fracturing estimated from the geotechnical and stress conditions, as shown in Figure 6.

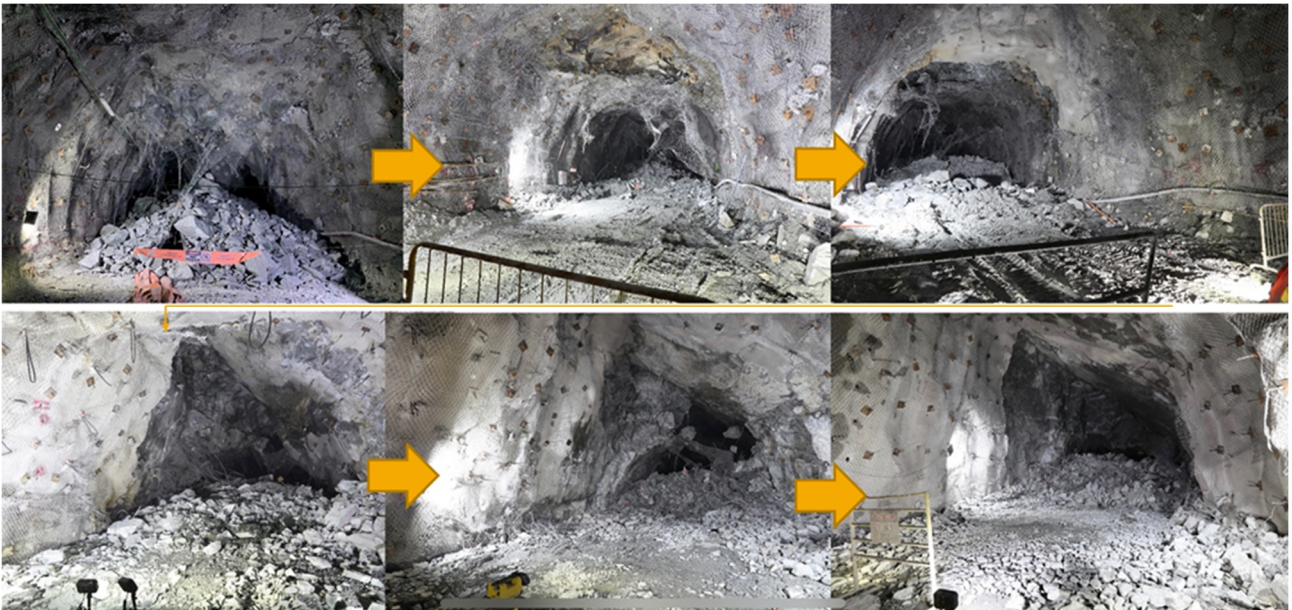
Figure 9 Rockburst rehabilitation process, including zones with deformed rock support system (Castro & Bahamondes 2020)

This example is interesting to analyse because as the rehabilitation of deformed areas and the rockburst zone was carried out, it was observed that the degree of boundary fracturing was similar, with a clear difference in the depth of failure, as shown in Figure 9.

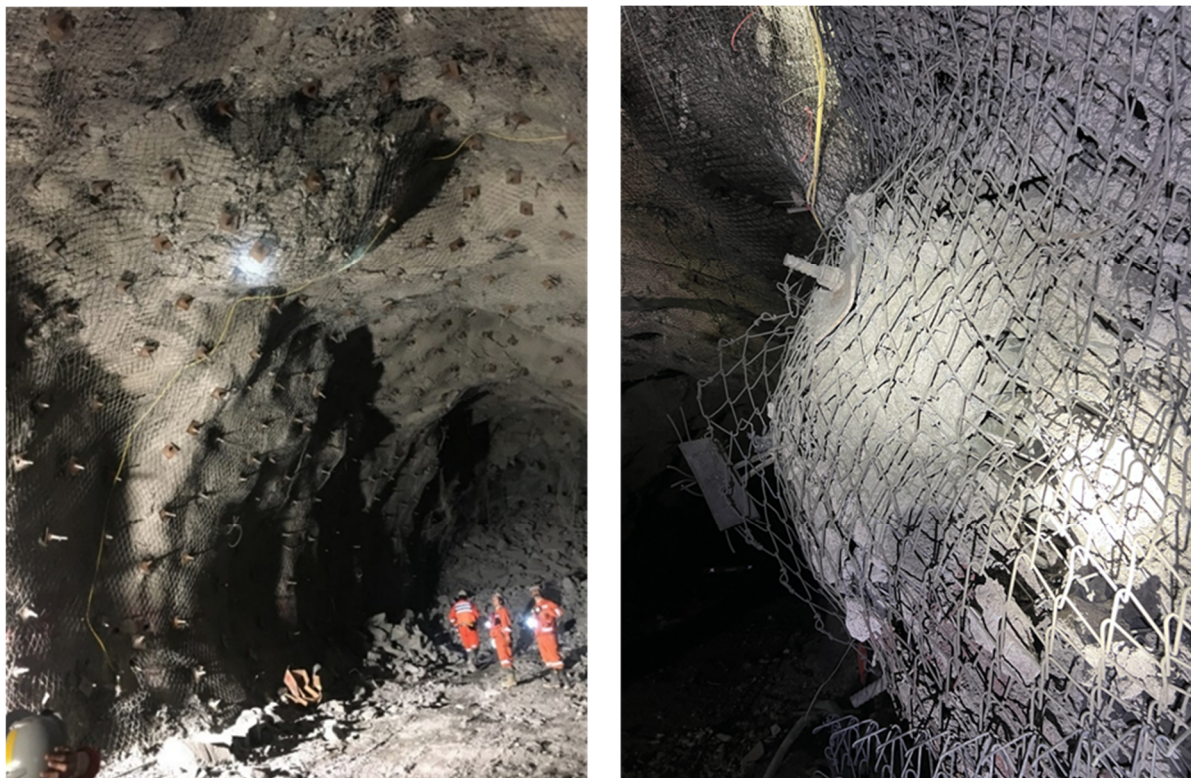
Figure 13 Photographic records with evidence of displacement of the rock mass contained by the support elements

Figure 13 shows how the fractured rock has been retained, resulting in displacements in the direction normal to the tunnel walls of more than 100 cm. These displacements have caused the central bolts in the bulging area to break. However, the load has been redistributed to the surroundings and is being supported by the peripheral reinforcement elements, preventing uncontrolled disassembly. The basal area of the ‘bulged’ zone is greater than 16 m² and the ‘curve height’ is over 1 m.

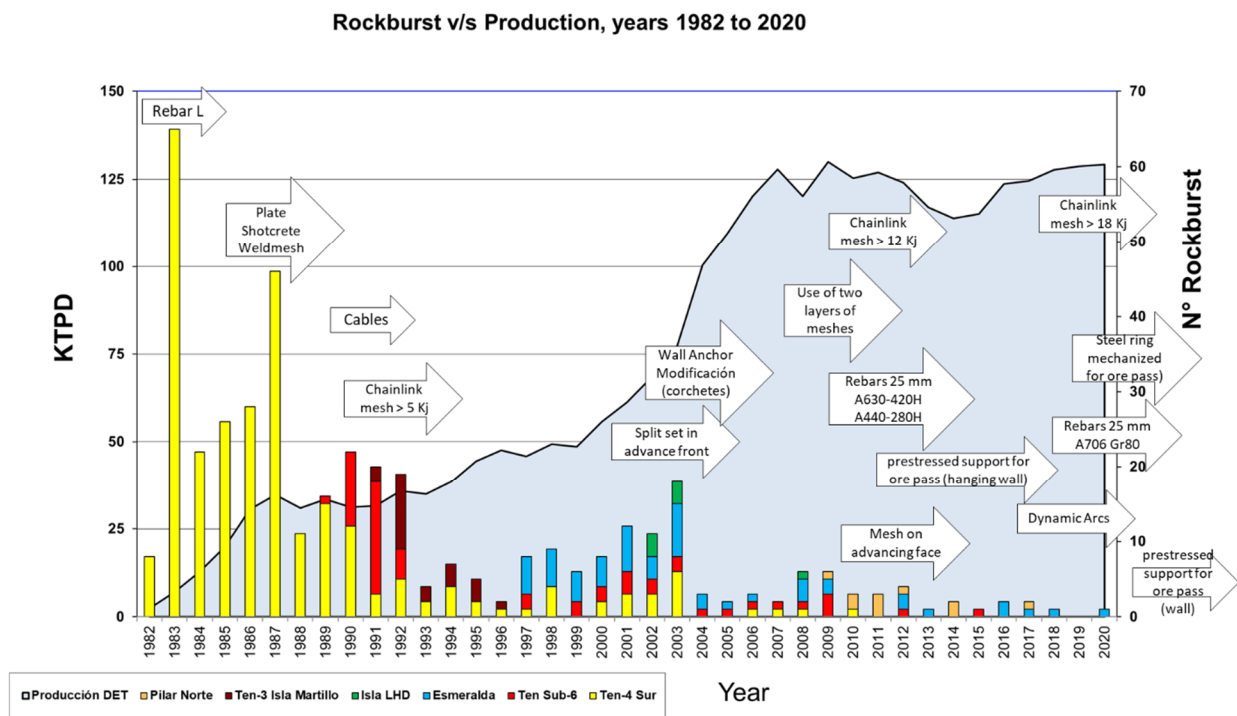
Figure 14 The graph indicates the number of rockbursts versus ore production in hard rock mining where uniaxial compressive strength is greater than 100 MPa. In addition, the year of the inclusion of any design or modification in relation to support in the mining preparation is indicated (modified and updated from Muñoz et al. 2016)

Figure 14 shows the main changes that have been made in rock support systems in relation to primary rock extraction rates at El Teniente mine and the number of rock bursts per year. The chart highlights:

- In the 1980s, the inclusion of better external elements (plates and nuts) along with the application of shotcrete to improve system performance. The bolt, mesh, and shotcrete system became a standard in productive levels.

- In the 1990s, the use of chainlink mesh as a replacement for welded mesh, enhancing the retention capacity of the system and increasing load transfer to external elements and subsequently to rockbolts (Rojas 1993).

- In the 2000s, the use of friction bolts at the working face for block stabilisation, as well as improvements in confinement wall anchoring in the walls of productive levels. Operational guidelines for QA/QC during installation was a key aspect during this period (Celis et al. 2006).

- In the early 2010s, the implementation of layered systems to increase retention capacities (using two meshes) and dedicated anchors for each layer, allowing for progressive transfer of dynamic loads as needed. Dynamic testing of the systems and the appearance of better steels were also considered during this stage to modify the geometries of plates, nuts, and bars, including changes in their diameters (Muñoz et al. 2014).

- In the mid-2010s, the use of meshes with greater energy dissipation capacity became relevant for comprehensive system improvement. Additionally, a strong process of mechanised installation of rock support began as part of the risk management and control strategy for rockbursts. For developments with this risk, mesh application at the working face was also included to ensure worker safety during explosive loading stages (Rojas & Landeros 2022; Landeros Córdova 2022).

- In recent years, one of the most significant improvements has been the use of micro-alloyed steels in bars, maintaining their geometry while increasing the system's capacity without modifying operational practices for rock support installation.
