Case study: use of rebars with microalloyed steels in tunnels with induced seismicity

A Muñoz *Codelco, Chile*

Abstract

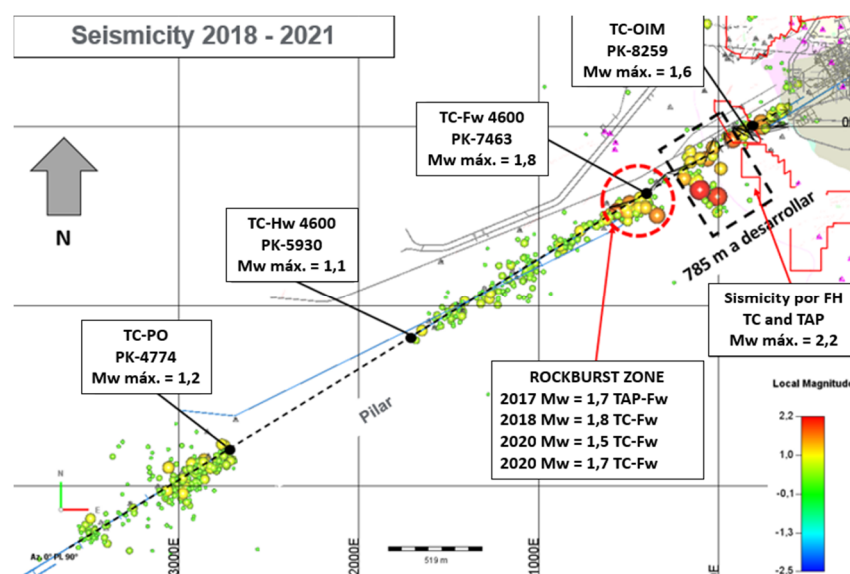
Figure 1 shows the conveyor tunnel and the induced seismicity between 2018 and 2021. The magnitude is local magnitude based on Hanks and Kanamori estimation control measures and modifications to the support systems (Rojas et al. 2022).

Figure 1 Recorded seismicity on the Correa tunnel development. High frequency and magnitude of events have affected the tunnel in between 2018 to 2021

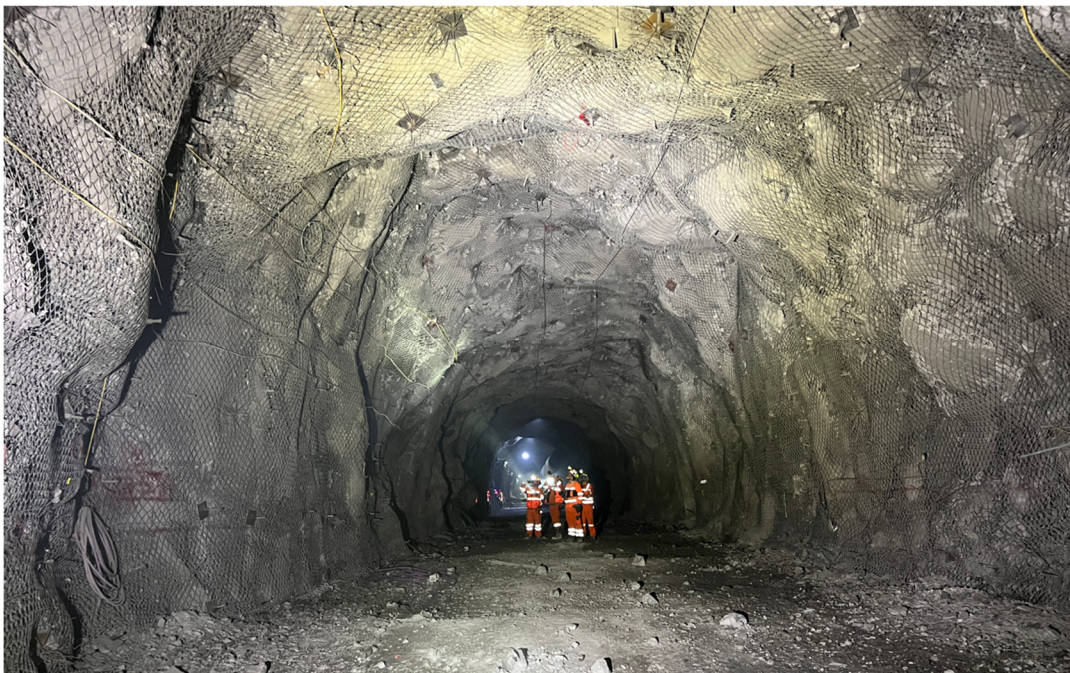
Once the seismic event occurred and after the isolation period, a visual inspection of the tunnel was conducted, revealing a large area affected by displacements and bulking in multiple areas. Evidence of damaged cables and rebars was identified, but there were no areas where the support system had failed.

Figure 4 shows the overall stability of the tunnel and how the support system, despite being damaged over a length of 100 m, prevented rock projection or block falls into the tunnel. The small rock fragments observed on the floor correspond to material from the advancing blasting face.

Figure 4 Photo showing the damage at the Tunnel Correa Interior Mina after a large seismic event

Given the identification of bulking areas, heavily stressed rebars, cables, and plates, and other evidence of capacity consumption in the support system, a request was made for laser scanning and drilling holes for inspection to assess the demand on the ground support and the depth of the damaged zones.

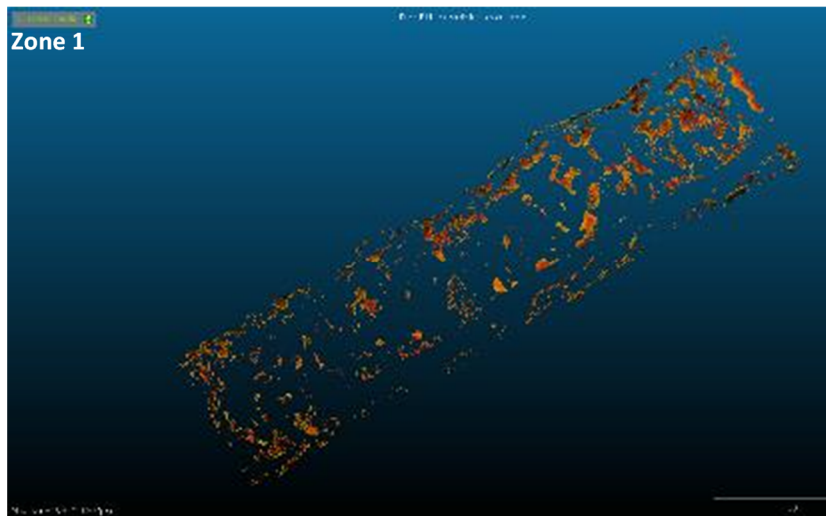
- In Zone 1, deformations are mostly detected between 0 and 0.05 m.
- In Zone 2, higher deformations are detected, with deformations exceeding 0.1 m in the 10 m closest to Zone 3.
- In Zone 3, displacements greater than 0.2 m were detected in many areas.

Figure 5 shows a schematic comparison between the shape of the tunnel after development and after an induced seismic event. This zone is considered Zone 1.

Figure 5 Comparison of the shape measured by LiDAR before and after a induced seismic event

With the conducted analyses and determining an average damage length, it is determined that, depending on the tunnel's surface deformation, an estimation of the consumption of the energy dissipation capacity of the support system can be made. Based on this, recommendations are provided to determine the system's design capacity. Table 2 presents the recommendations for reinforcement or rehabilitation according to the tunnel's surface deformation.
