Accelerated galvanic corrosion between graphitic rock from underground mines and metal coupons

Abstract

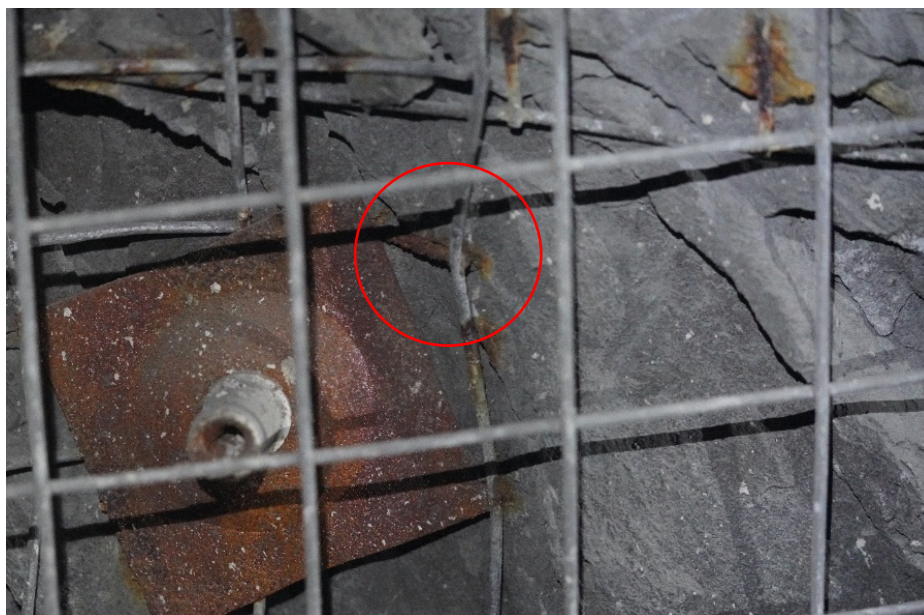
steel in contact with this material. Figure 1 shows an example of heightened corrosion of mesh support at contact points with the graphitic rock mass.

Figure 1 Observed galvanic corrosion in partner mine where metal ground support contacts the graphite-like rock

The time of wetness and salinity of electrolytes that pass through the rock mass has a great effect on the extent of corrosion for these materials, as described in an article by Roy et al. (2016). In situ observations have shown that the galvanic corrosion level is low in areas with dry host rock and increases in more saturated areas.

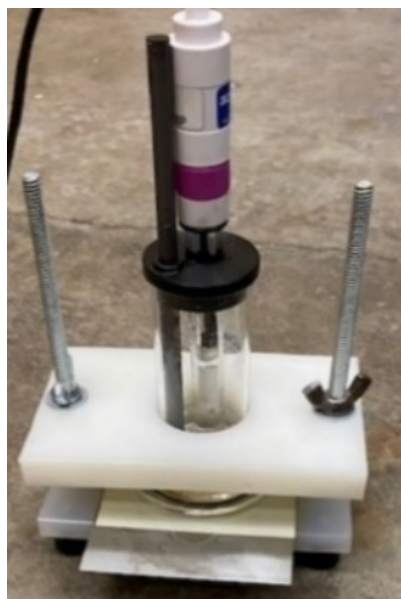
Electrochemical measurements were taken using a potentiostat to obtain baseline corrosion rates for the steel coupons in the standard salt solution. The coupons were inserted into a ‘paint cell,’ as seen in Figure 3. These cells are commonly used to test bare metal samples.

Figure 3 Paint cell used for electrochemical tests to obtain the baseline corrosion rate of a coupon in the standard solution

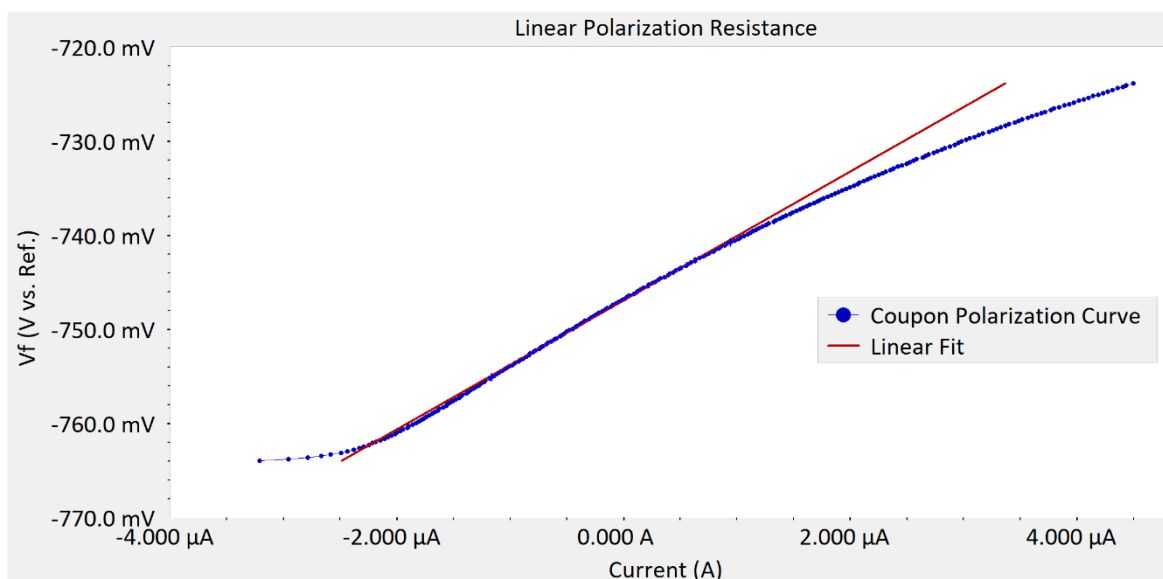
To obtain these baseline corrosion rates, linear polarisation resistance (LPR) scans were performed. LPR scans provide a non-destructive testing method to obtain corrosion rate data. This is achieved by polarising the material +/-10 mV around its open circuit potential, resulting in the material’s resistance to polarisation being measured, as detailed by Gamry Instruments Inc. (n.d.). By applying the Stern–Geary equation, an estimated corrosion rate is provided. This was performed twice, once for each rock sample from the two assemblies. Figure 4 shows the LPR scan for the ambient assembly rock sample and fresh coupon.

Figure 4 Linear polarisation resistance test scan for the control coupon corrosion rate

The corrosion rates for both the ambient and environmental chamber control coupons were calculated using Gamry Echem Analyst™ (Gamry Instruments Inc. 2022). From the LPR scan, the baseline corrosion rate of a metal coupon in the standard salt solution was 0.0638 mm/y, when not galvanically coupled to the rock samples.

Using the LPR potentiostat data, the baseline control coupon corrosion rate in the standard solution was very low at 0.0638 mm/y. When compared to the ZRA scans using the same device for a galvanic couple, the corrosion rate was approximately 39 times higher than when the coupon was not in a coupling with the mine rock. This aligns with in situ observations of ground support in partner mines, which visibly have much greater

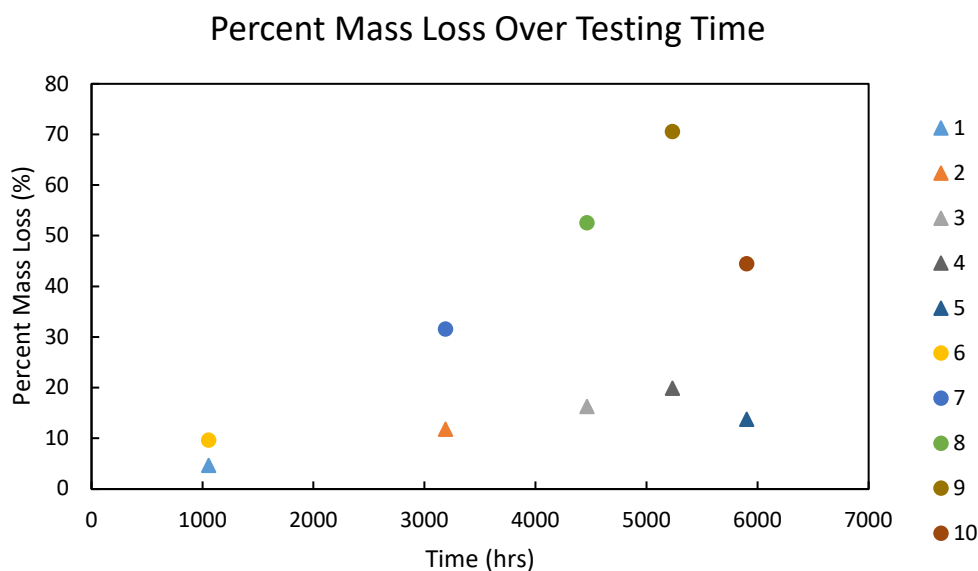
The percent mass loss for each coupon was graphed against time in testing, as shown in Figure 5.

Figure 5 Scatter plot of the percent mass loss during the test duration. Coupons 1–5 were at ambient conditions and 6–10 in the environmental chamber

Figure 5 graphically shows the difference in percent mass loss for the coupons in the two testing environments. As expected, the ambient coupons consistently had lower mass loss than the environmental chamber coupons. Although coupons 4 and 9 were in testing for less time than coupons 5 and 10, the percent mass loss, and subsequently the corrosion rates, were higher for coupons 4 and 9. This could be attributed to the four newer replacement coupons in each testing apparatus drawing more corrosion current over coupons 5 and 10, which would have large amounts of corrosion products at that point in testing. The corrosion rate of metal typically decreases over time as the metal degrades versus a fresh piece of steel. This results from the corrosion products creating a protective layer that reduces the ability of oxygen to diffuse to the surface of the metal, amongst other factors that cause the rate to slow over time as described in an article by Fan et al. (2020).

while coupon 7's rate was 1.61 mm/y. There was almost a 20% difference in their mass loss over the 3,186-hour period, as seen in Figure 5.
