Steepened open pit slopes can be stable: case studies of Gold Fields, Ghana

M Seidu *Gold Fields Ghana, Ghana*

The purpose of this paper is to highlight the processes of steepening, share results and, ultimately, outline the best industry practices that led to successfully mining steeper slopes within Gold Fields Ghana.

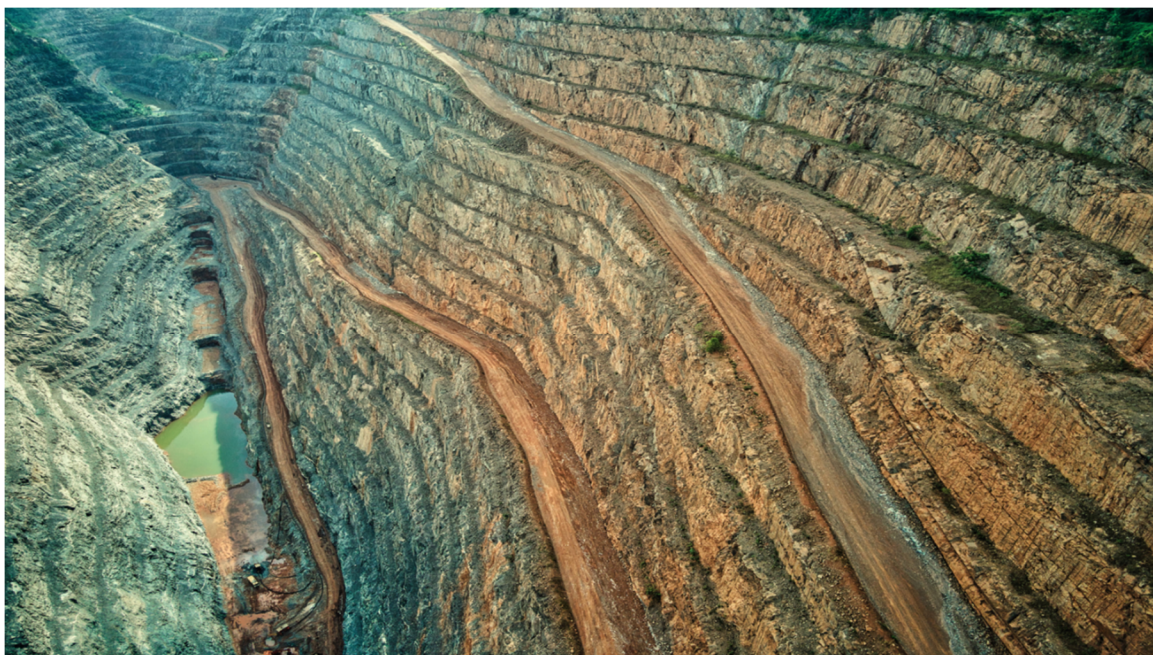
Figure 8 A view of the west wall of the DPCB (camera facing south)

The performance of the steepened design exceeded the expectations of Goldfields Damang. Apart from periodic and effectively managed rockfalls along the Rogan fault after rainy events, the mine did not record any failure on the west wall, as shown in Figure 8. The implementation/execution strategies of the design were also successful. Overall, the percentage compliance for batter and berm reconciliations for the design were all within acceptable limits throughout the project life.

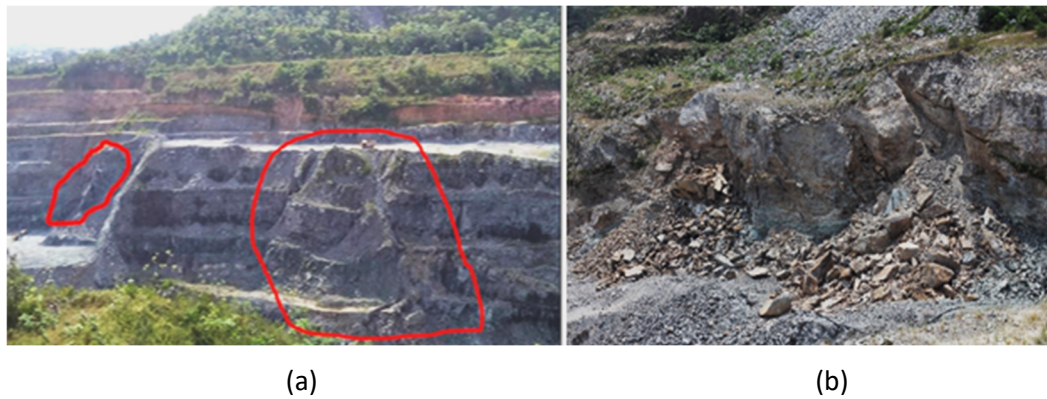
Figure 11 Pictures of instabilities influenced by major structures in (a) Zone 1 and (b) Zone 2

Generally, the major structures (especially fault zones) have planar to slight undulating surfaces with the presence of fine clay gouge infill materials. This condition is especially prevalent in the Teberebie-Mantraim fault-bound zone on the east wall of zone 1, and the N1 fault stretch on Underlap pit's south wall. These areas have produced instabilities associated with large blocks (see Figure 11).
