Management of the Kalgoorlie Consolidated Gold Mines East Wall Slip

J Darbritz *Northern Star Resources Limited, Australia*

This paper will present the methodology adopted to safely mine the first horizontal 40 m of the East Wall Slip from the -150RL to the -190RL. This includes:

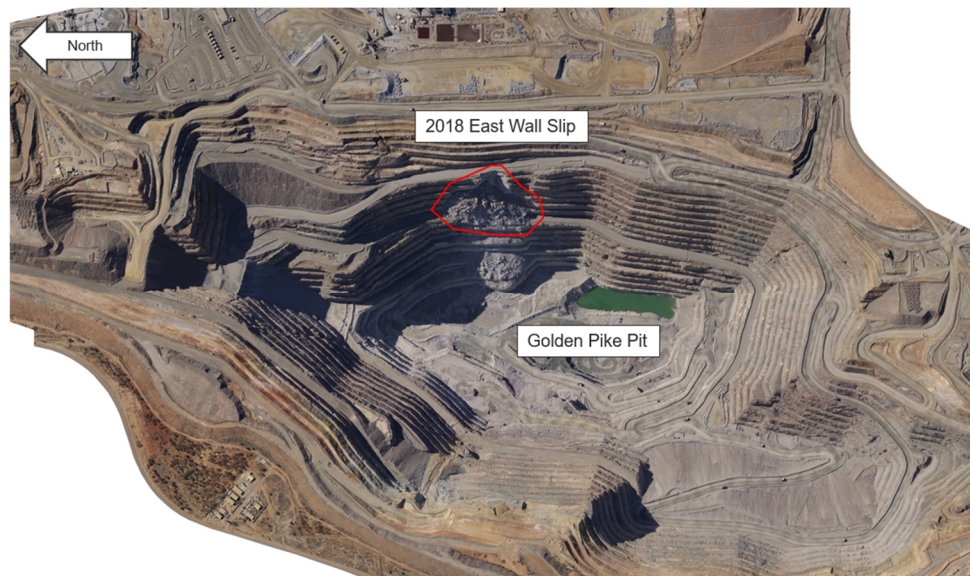
Figure 1 Location of the 2018 East Wall Slip within the KCGM Super Pit (Darbritz 2023)

This paper provides an update on the risk assessments, controls and mining practices utilised to mine the first vertical 40 m of the East Wall Slip (EWS) that occurred at Northern Star Resources Limited's (NSR) Kalgoorlie Consolidated Gold Mines' (KCGM) operations in 2018, as shown in Figure 1.

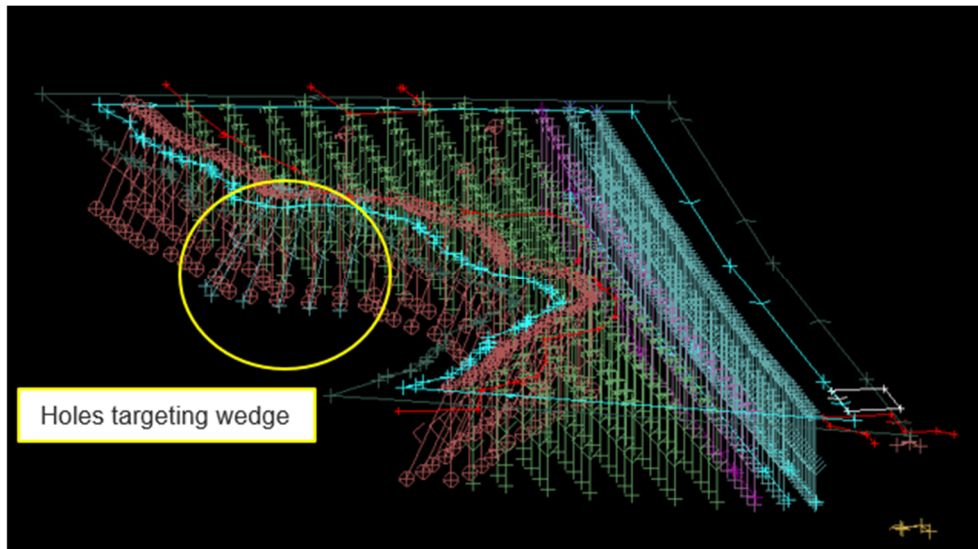
Figure 5 Example of a drillhole pattern above the East Wall Slip (looking north)

As the EWS was to be removed via blasting and mining, the bulk material, blasting methods and blastholes within the control zone were reviewed and designed bench by bench. Hole designs were treated as a standard trim shot with a burden of 4.5 m and a spacing of 5 m. The powder factor averaged around 0.9, with a maximum instantaneous charge of around 250 kg. Specialised holes were used to target the bull nose and any unfavourable wedges and blocks found in situ on the slope face. Holes targeting these outcrops were drilled at angles of up to 65 degrees at a depth of up to 15 m and with a hole diameter of 165 mm (Figure 5).

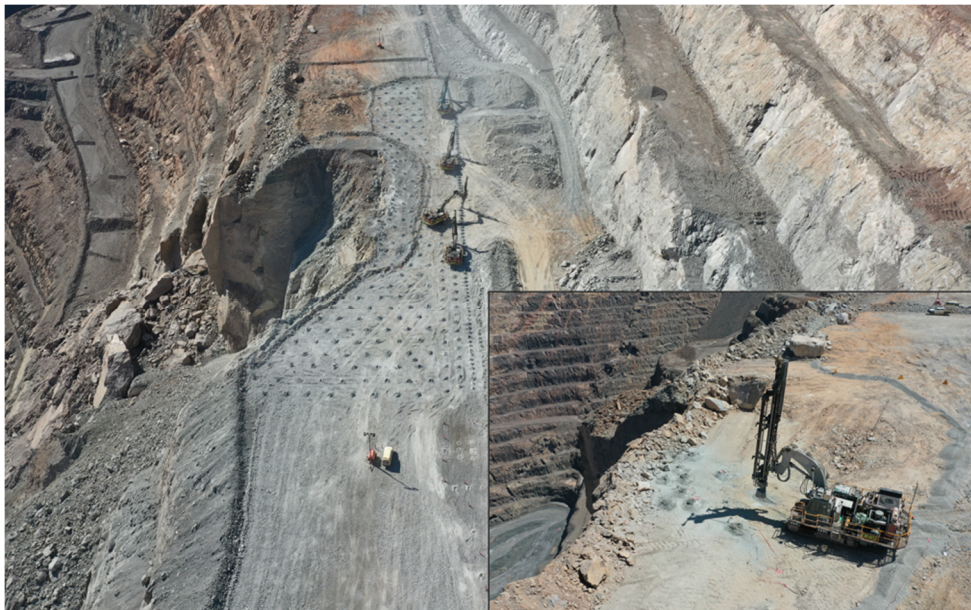
Figure 6 Probe rigs drilling holes outside of the control zone and a remote rig drilling blastholes within the control zone

Drilling of blastholes outside of the control zone was completed using a DRA 330 Rock Commander Drill Rig. A DRA PR350 MK2 Probe Drill Rig completed drilling blastholes within the control zone (Figure 6). A trailer-mounted hut was parked 50 m away and a driller operated the Rock Commander via remote control. The reach of the drill rig is 9 m. Any drilling within the control zone was undertaken with the pit below closed and/or required additional restrictions to be put in place.

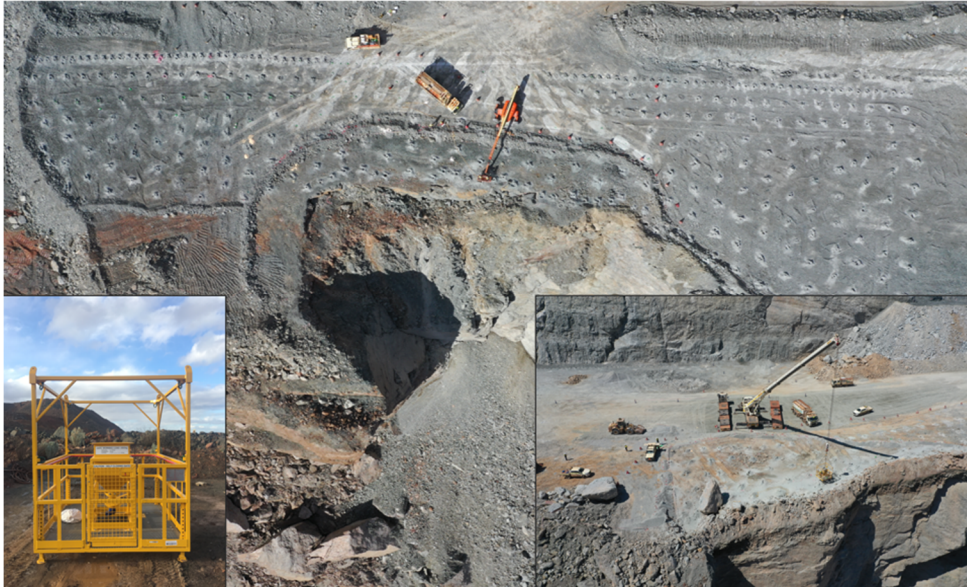
Figure 7 (Left) Image of the work cage; (Middle) The elevated work platform loading ammonium nitrate fuel oil; (Right) The work cage loading stemming within the control zone

The custom workbasket was designed and built to allow the shotfirers to pump bulk explosives, pour stemming and tie-in the shot without setting foot within the control zone. The basket had a safe working load of 800 kg (400 kg of stemming, 200 kg of equipment and 200 kg for personnel). The hopper in the basket's centre could hold 0.2 m³ of material. A lever at the base opened the chute, pouring the material directly into the blasthole. Personnel in the basket were secured via a harness and one of eight anchor points inside the cage (Figure 7).

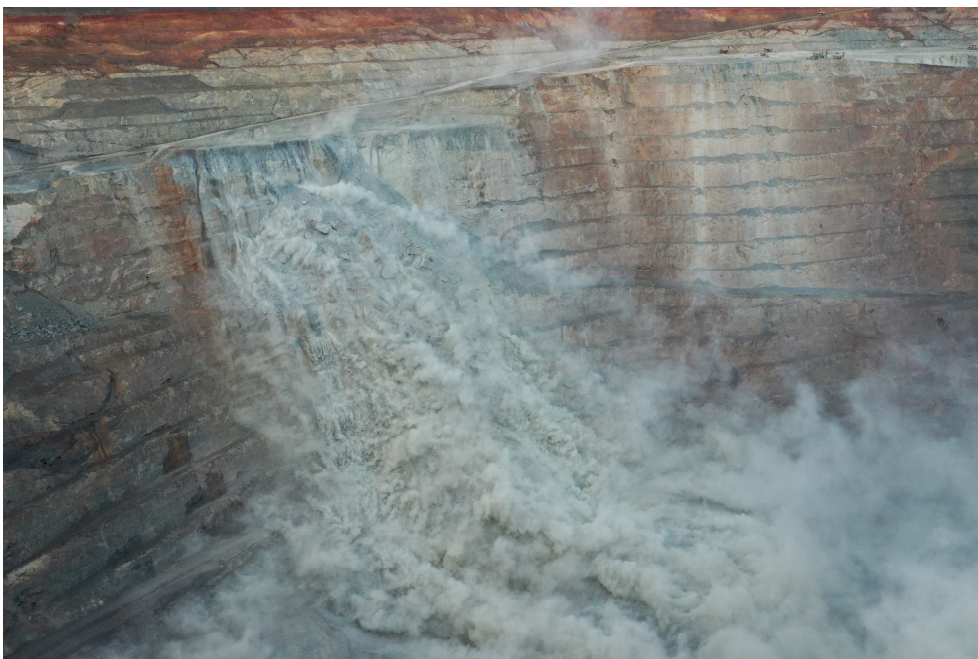
Figure 8 Dust generated by blasting above the East Wall Slip

Before blasting, all personnel within 200 m and directly below the work area were evacuated. Blasting could only occur on days when the wind was blowing away from town, for dust management purposes (Figure 8). Once blasted, there was a minimum settling period of 12 hours followed by a visual inspection using drones and a review of radar data before mining activities could resume.

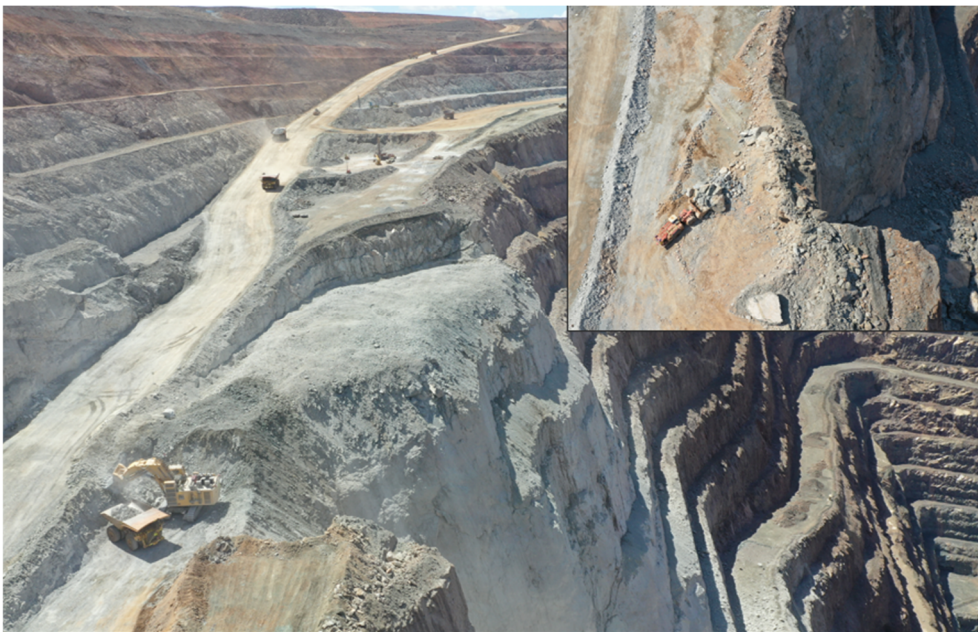
Figure 9 Image of a shovel and remote-controlled front-end loader relocating material above the East Wall Slip

Material within the control zone that was out of the reach of the shovel was mined using a remote-controlled Sandvik 621 front-end loader (Figure 9). A work area was constructed to segregate the loader from the rest of the mining traffic. This consisted of 1.8 m-high windrows, laser barriers and trip wires. A mobile tele hut containing the operator and equipment was positioned between 100 and 200 m away, and connected to an external generator. Material from within the control zone was relocated 50 m away and separately mined out using a front-end loader.

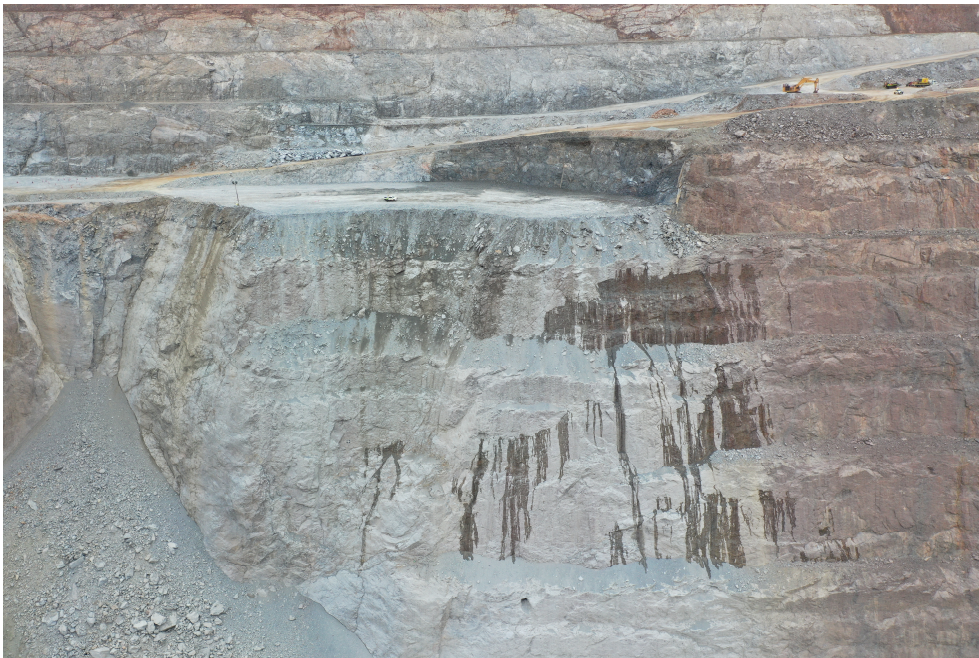
Figure 10 Image of the wall to the south of the East Wall Slip showing water recharge on the slope post-hydroscaling

As the area is susceptible to water (Figure 10), hydroscaling and dust suppression were managed with strict controls including:

- Day shift can only operate between 0600 and 1600.
- Water carts can spray water for a maximum of 30 minutes.
- After a water cart has finished, no additional water may be sprayed for two hours.
- Radar monitoring must be active at the time of spraying.
