Preventing pit wall failure through early detection monitoring, geotechnical analysis and execution of a toe-stabilisation buttress

V Jonsson BHP, Australia

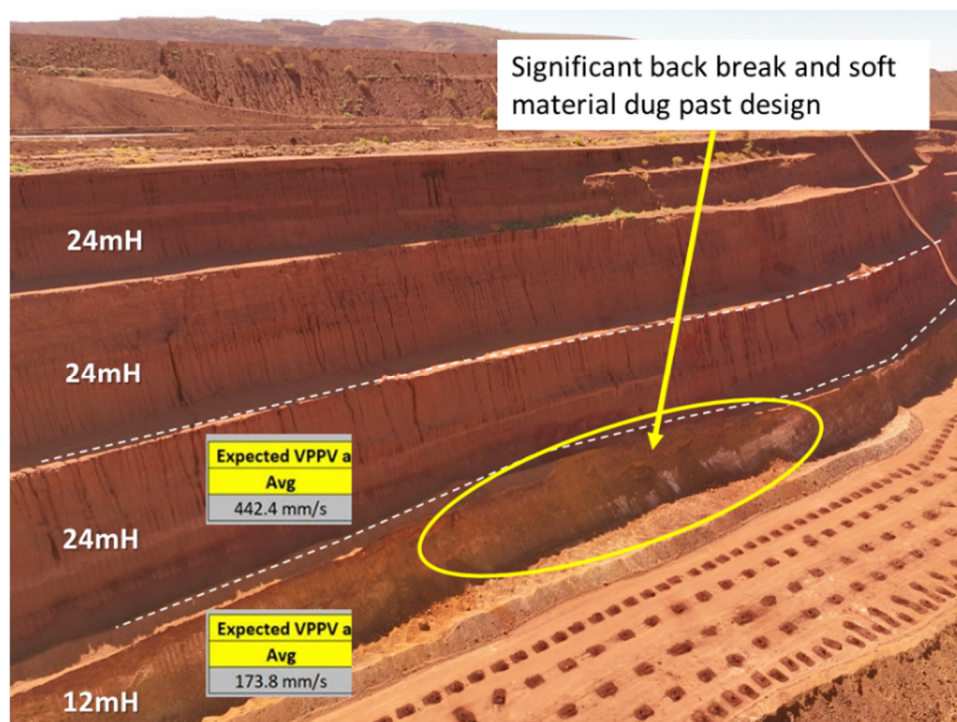
Figure 4 Theoretical peak particle velocity (PPV) and batter condition of the pit wall during identification of instability

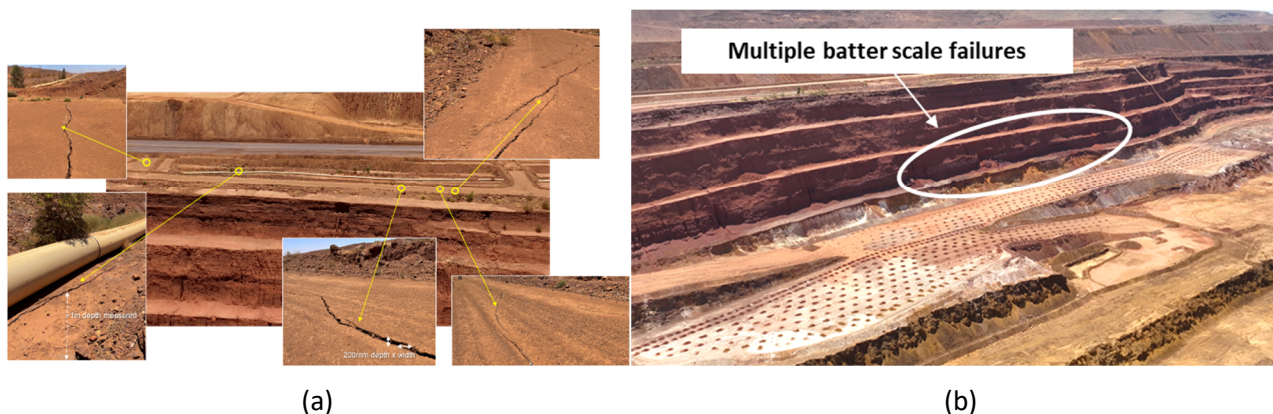
Figure 5 Signs of instability in the pit wall. (a) Crest cracking locations; (b) Multiple batter scale instabilities in the lower part of the slope

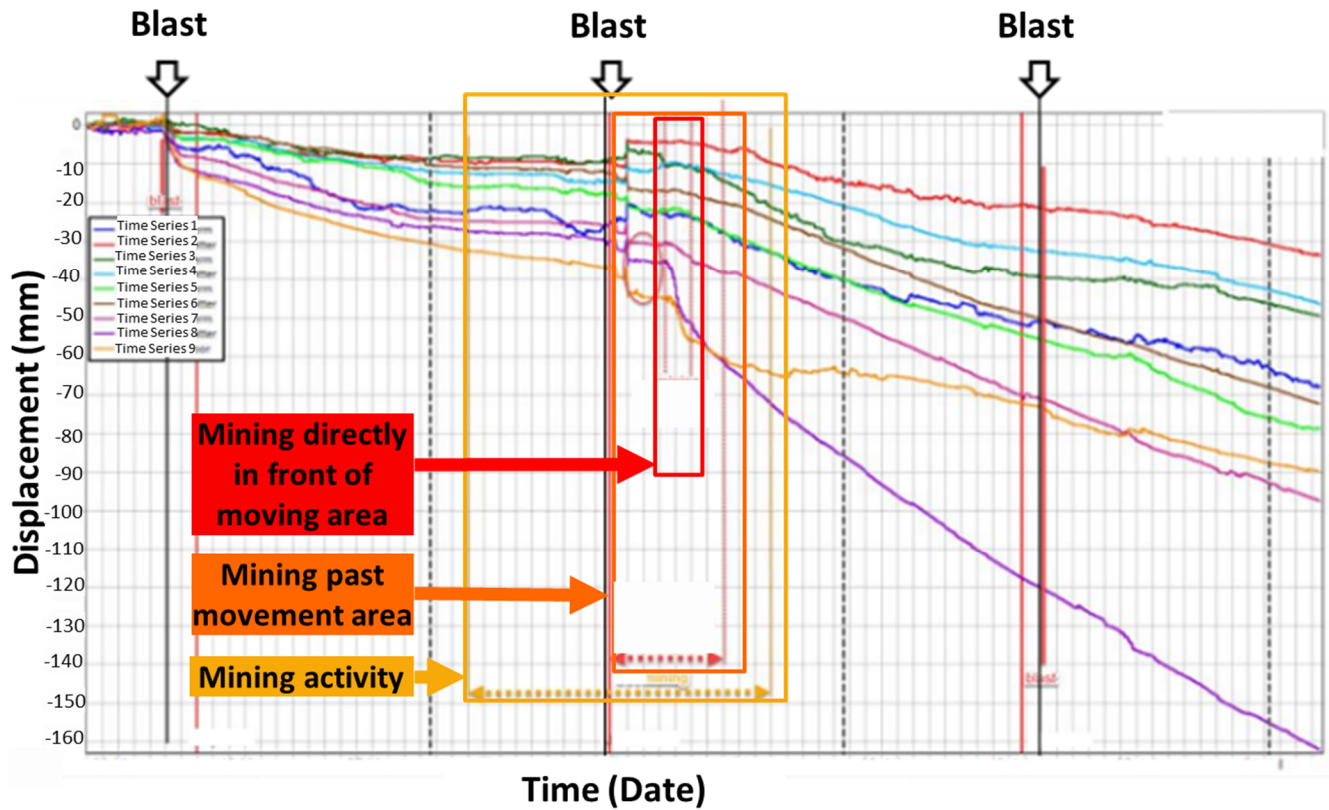
Figure 6 Detailed displacement graphs of ground-based radar area time series plots showing deformation on y-axis over time on x-axis, showing times of significant blasts (Blast 1, Blast 2 and Blast 3)

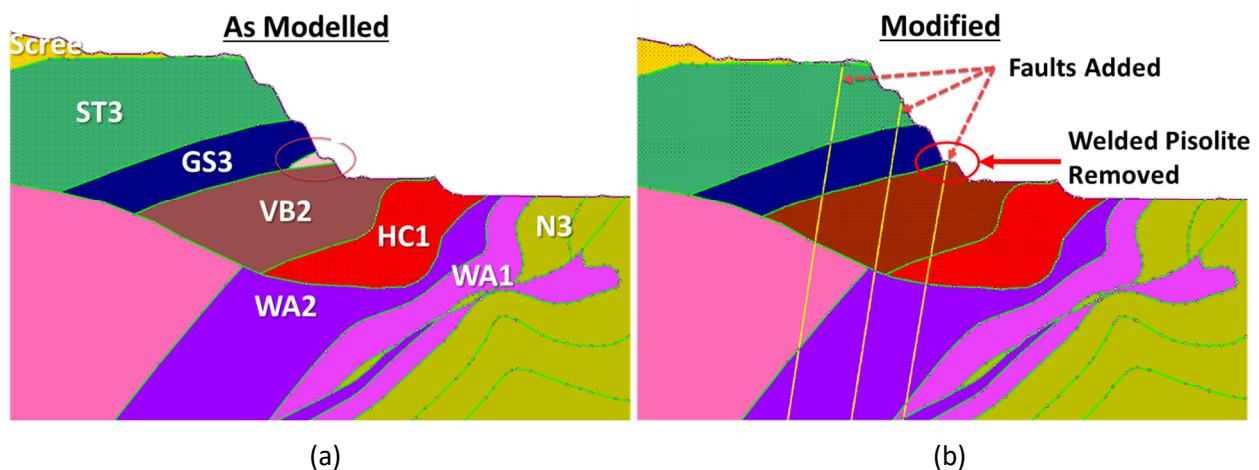
Figure 12 Geological cross-section used in the model set-up: (a) Model cross-section with as-given geology and including the exposed welded pisolite unit; (b) Modified cross-section including additional fault interpretations and the removal of the welded pisolite unit

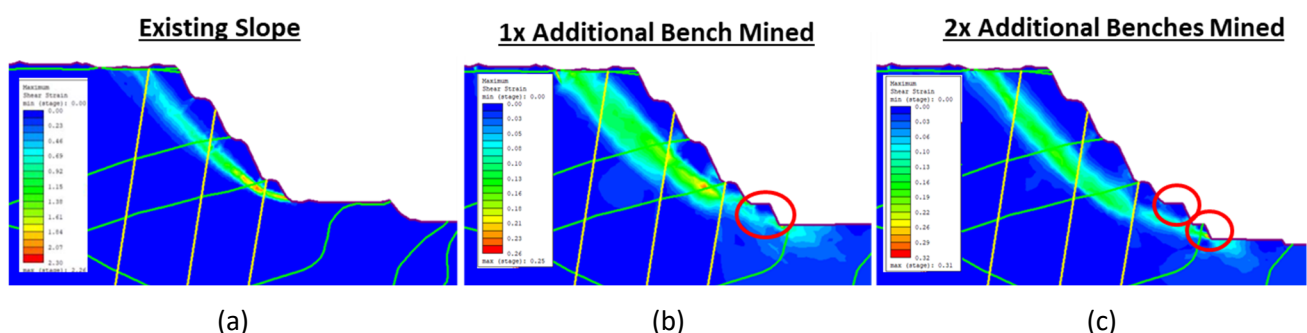
Figure 13 Finite element analysis showing maximum shear strain at three stages. (a) Existing slope; (b) One additional bench mined; (c) Two additional benches mined

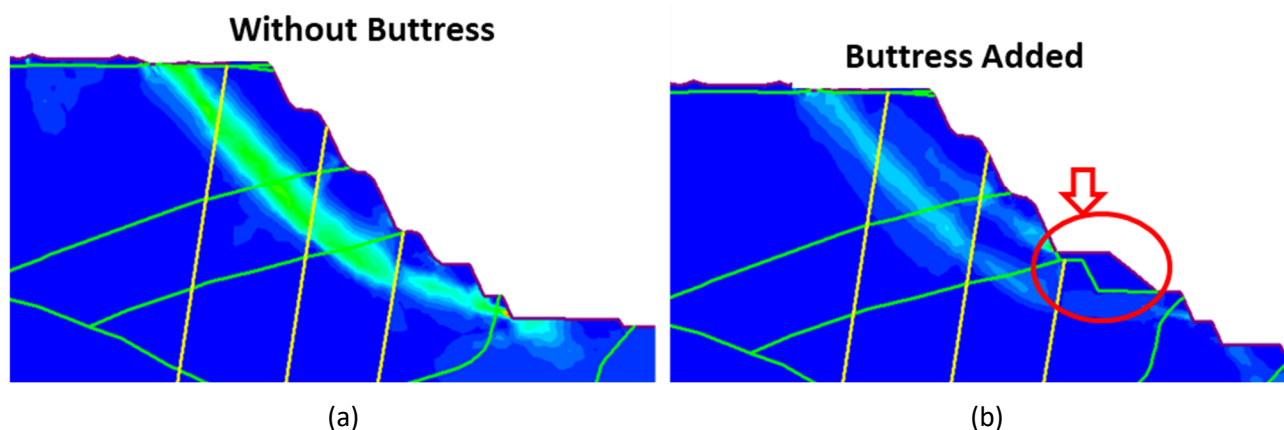
Figure 14 Maximum shear strain displayed for the finite element analysis comparison. (a) Original planned pit design; (b) Remediation configuration of step in with buttress constructed, as circled in red

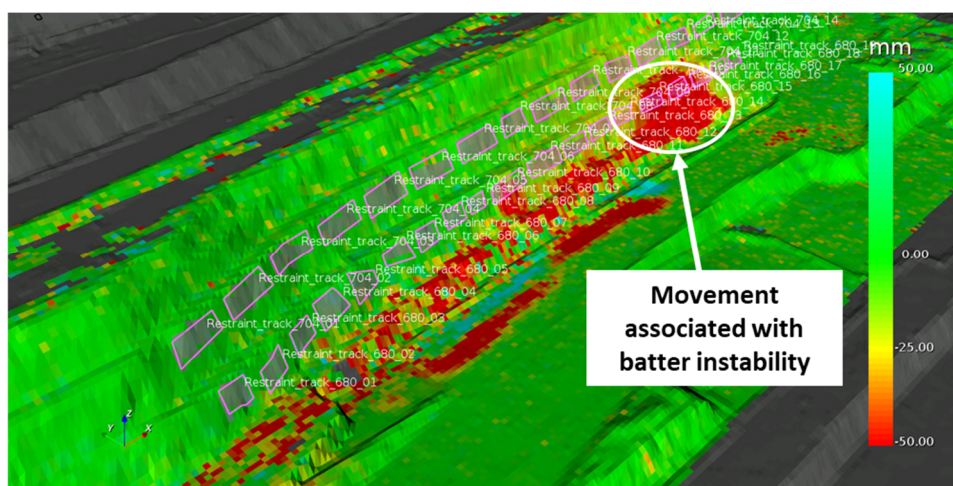
Figure 17 Area polygons for tracking movement restraint along the wall as the buttress progressed

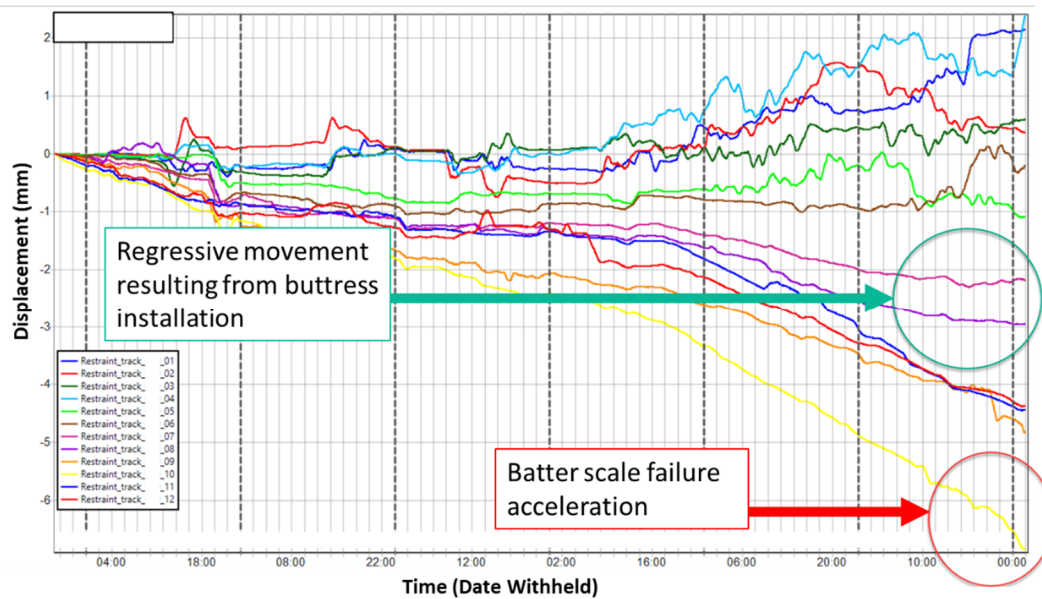
Figure 18 Buttress effect shown using the area time series from Figure 16

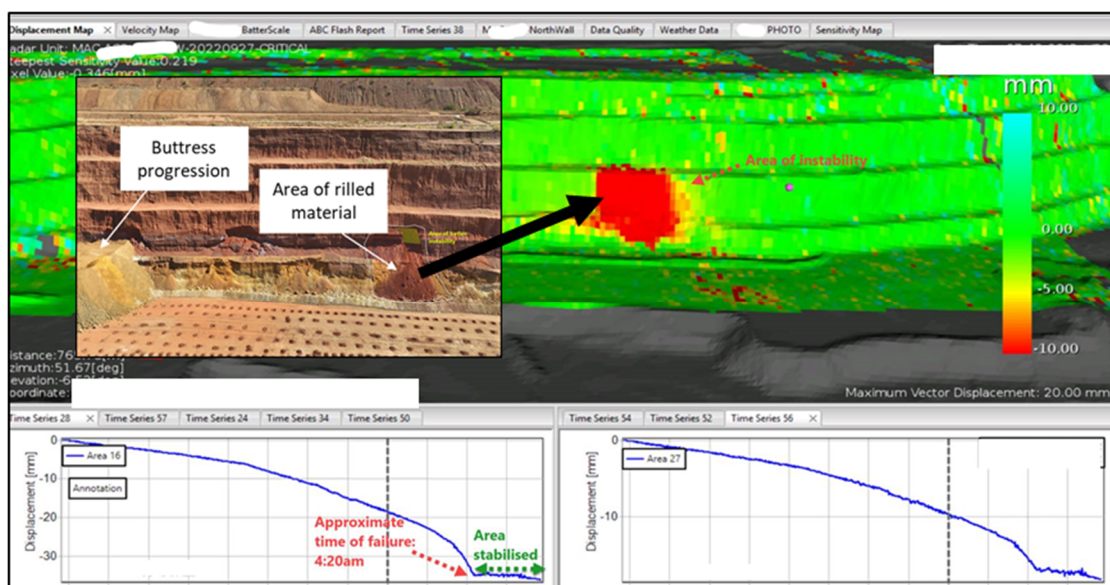
Figure 19 Example of radar data visualisation from a batter scale failure captured by alarming, and safe withdrawal. Inset: inspection of failed area

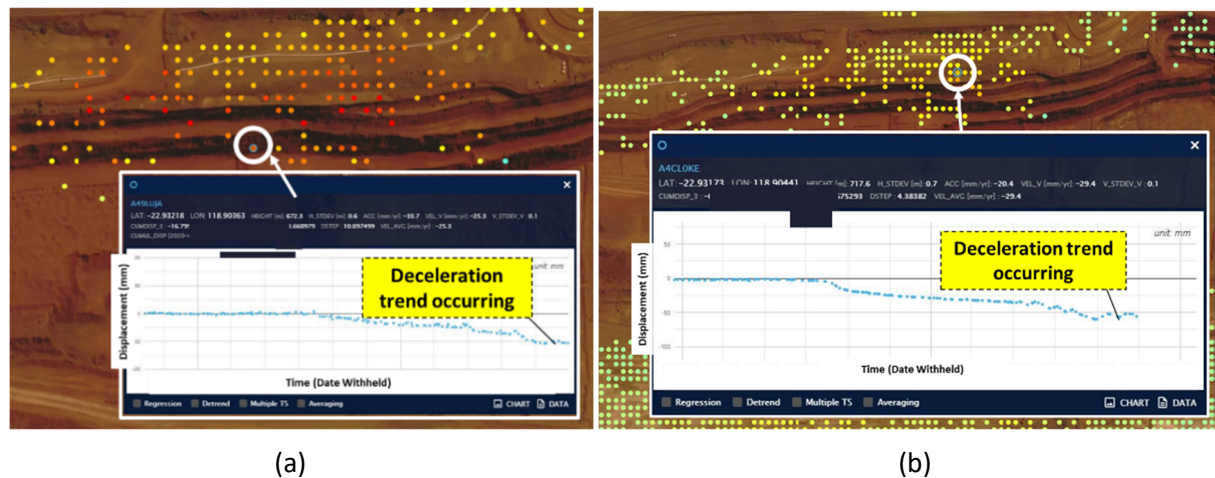
Figure 22 Satellite InSAR data collected from representative locations: (a) Batter face location; (b) Crest cracking location

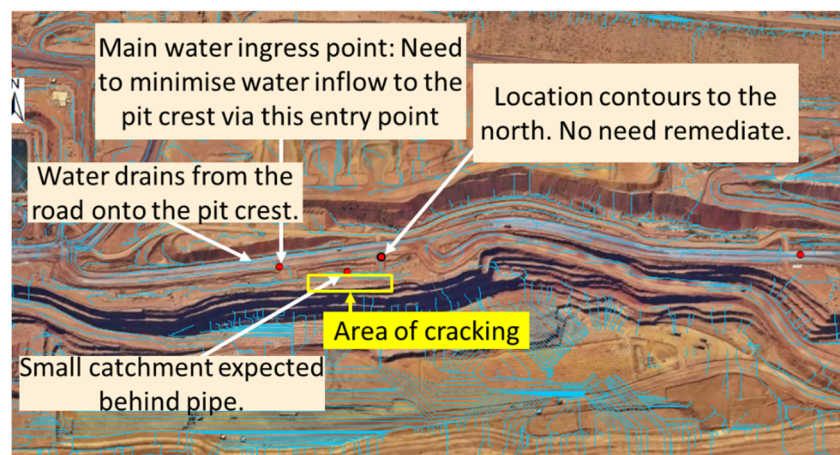
Figure 23 Watershed analysis provided by the WAIO water engineering team

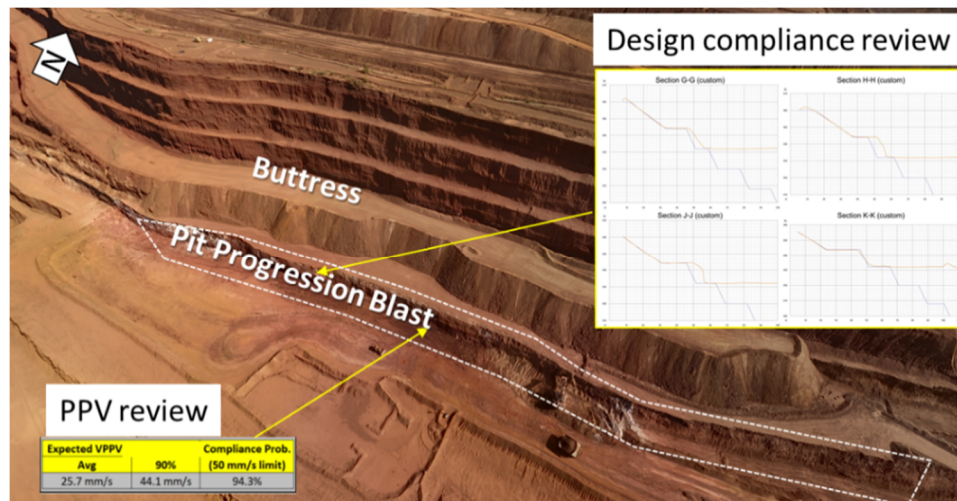
Figure 25 Example peak particle velocity (PPV) and design compliance review of the production blast below the buttress
