# Preventing pit wall failure through early detection monitoring, geotechnical analysis and execution of a toe-stabilisation buttress

V Jonsson *BHP, Australia*

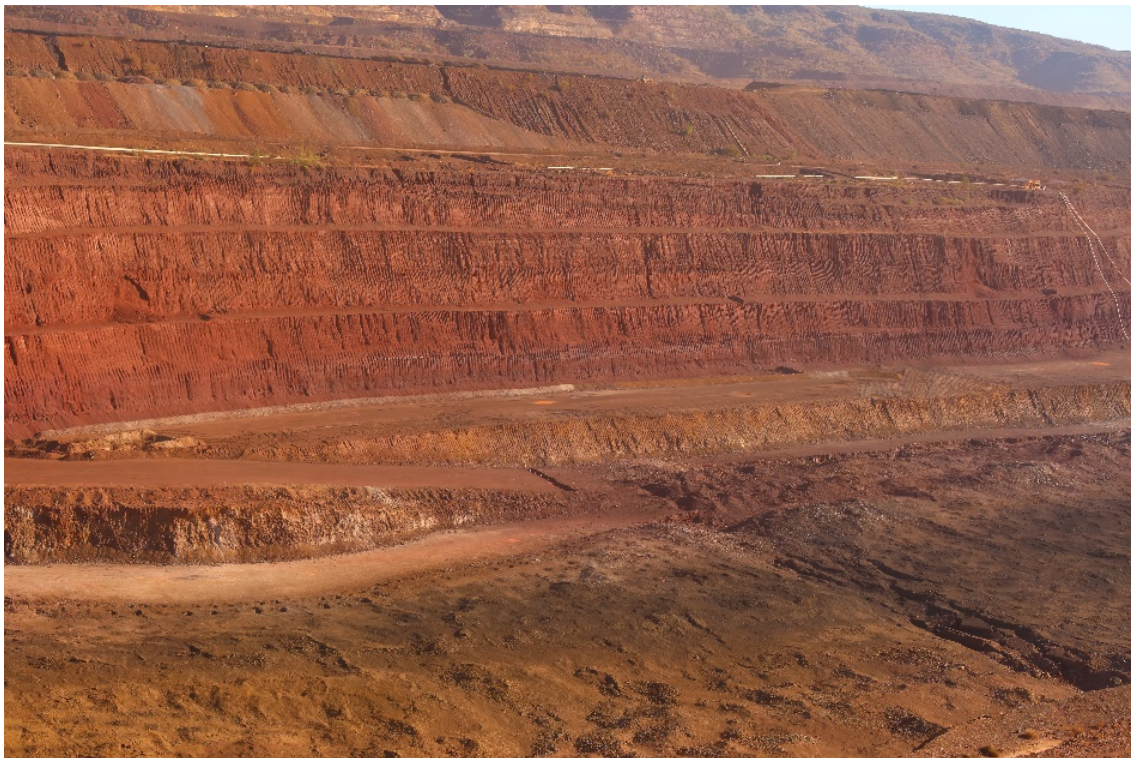
**Figure 1** Case study pit slope, prior to deformation and signs of instability

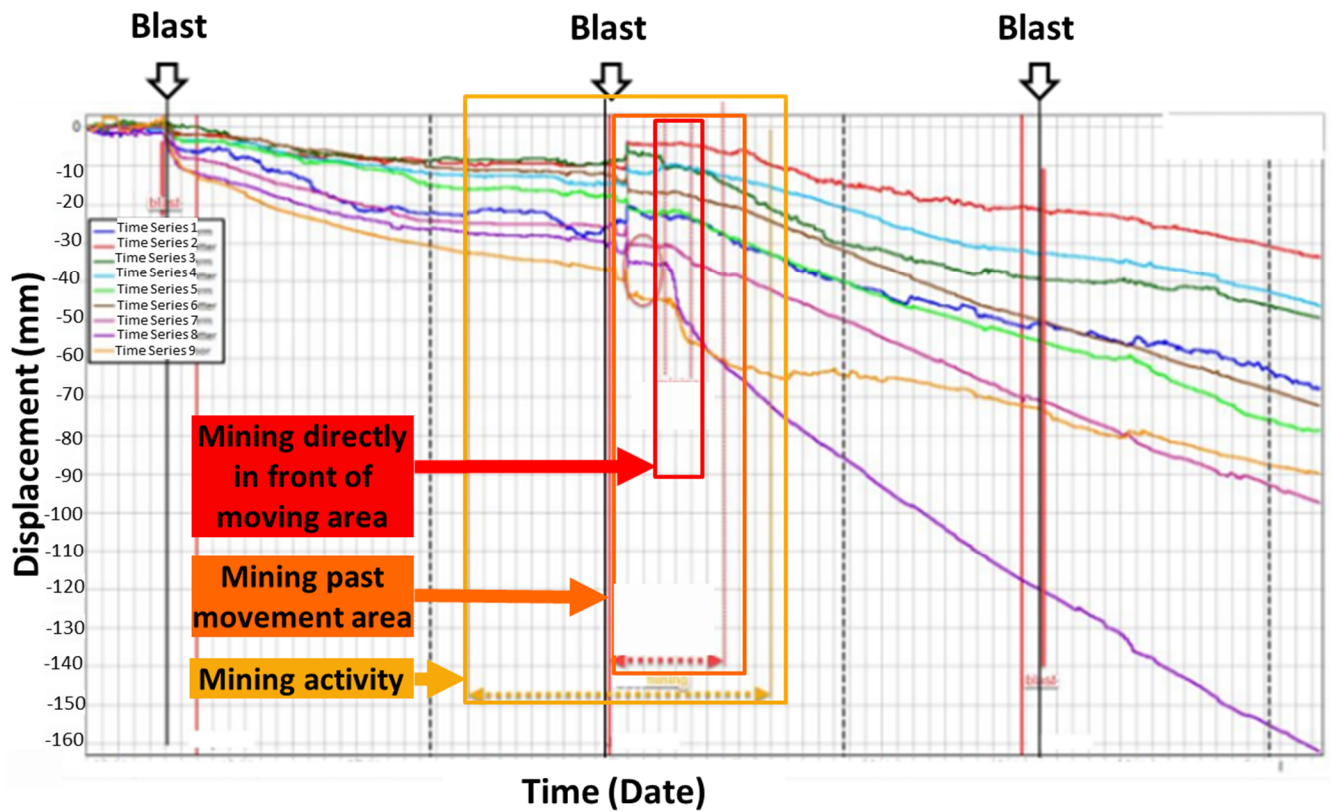
Figure 6 Detailed displacement graphs of ground-based radar area time series plots showing deformation on y-axis over time on x-axis, showing times of significant blasts (Blast 1, Blast 2 and Blast 3)

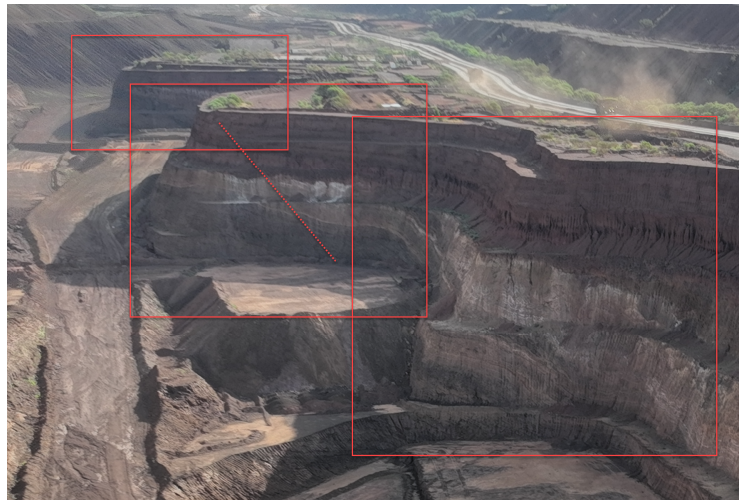
**Figure 11 Generic example of using cross-strike aerial imagery to infer the subsurface location of fault systems**

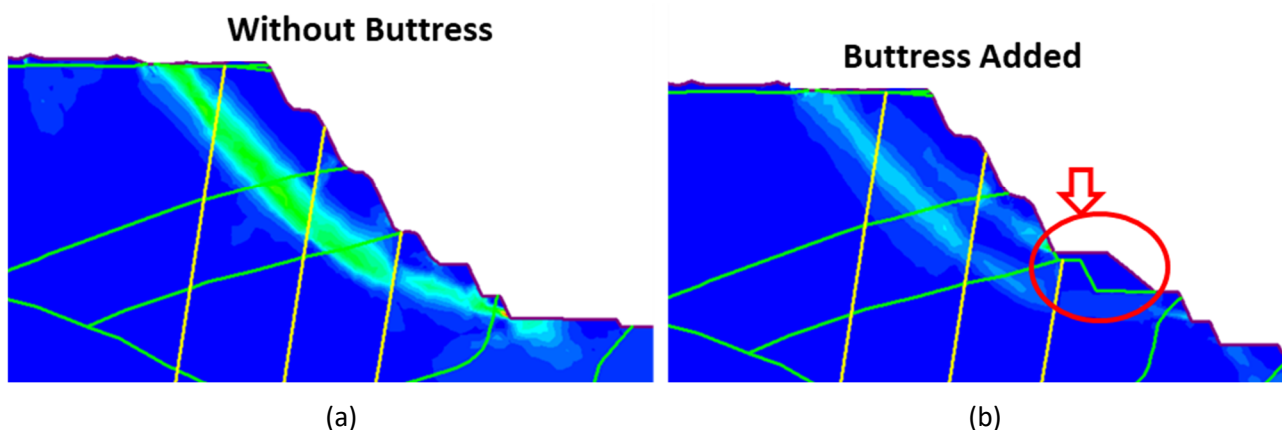
**Figure 14** Maximum shear strain displayed for the finite element analysis comparison. (a) Original planned pit design; (b) Remediation configuration of step in with buttress constructed, as circled in red

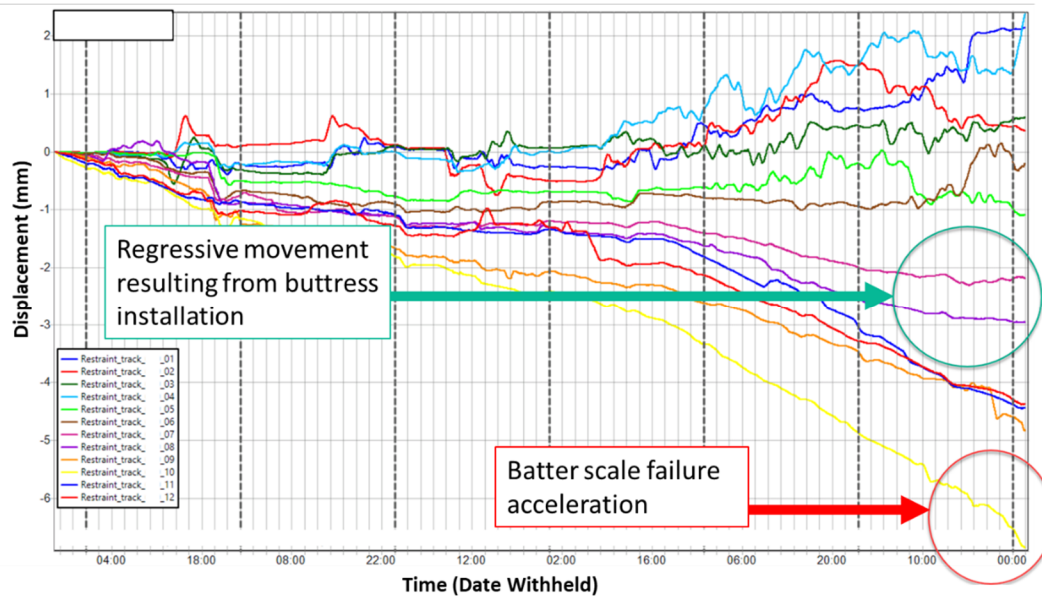
Figure 18 Buttress effect shown using the area time series from Figure 16

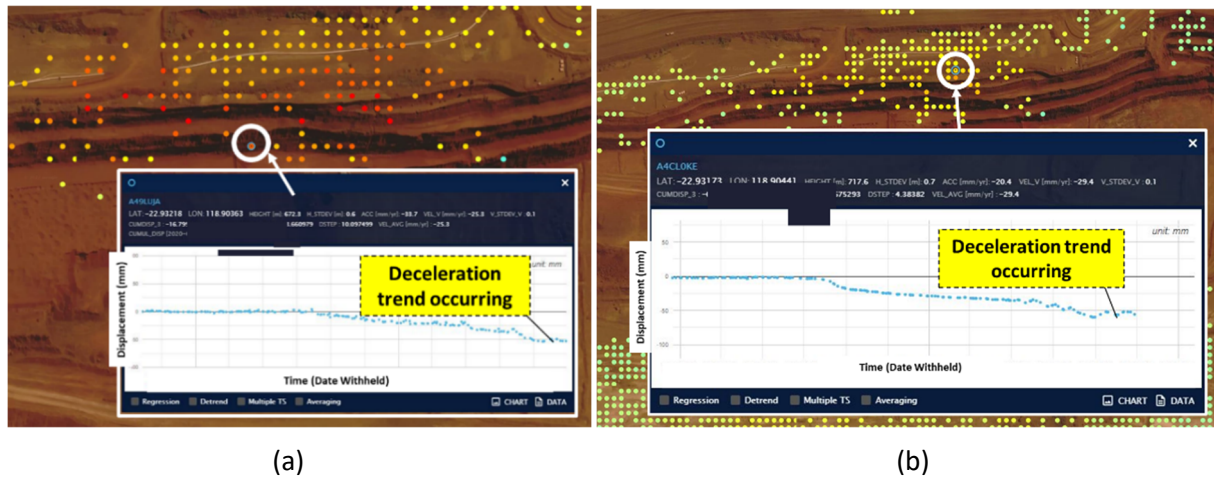
**Figure 22** Satellite InSAR data collected from representative locations: (a) Batter face location; (b) Crest cracking location
