Factors impacting and controlling water erosion of rock benches and slopes

Abstract

Figure 1 Examples of water runoff erosion problems on mine slopes

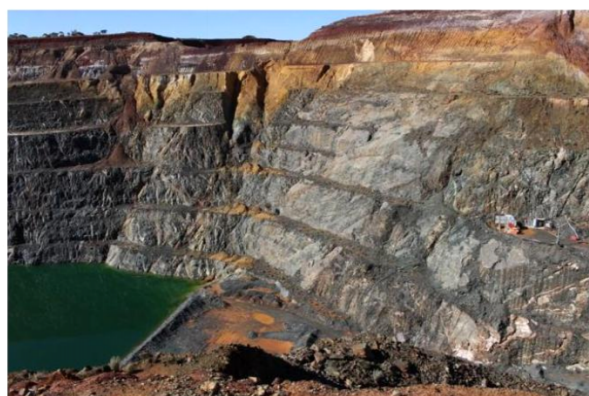
(a) Intentional water discharge into disused pit, Paddington WA; Quarters Pit (June 2019)

- Intentional discharge of rainfall/groundwater runoff into pits deemed to be abandoned (Figure 1a) or an expedient, but perhaps poorly considered, water management option (Figure 1e) where water is discharged from a slope cutback area across a toppling failure landslide.
- Lack of opportunity for surface water channel berm maintenance and its washout during periods of temporarily suspended mining activity (Figure 1b).
- Insufficient water runoff management on slopes destined to be a cutback area at a near future date (Figures 1c, 1d and 1f).

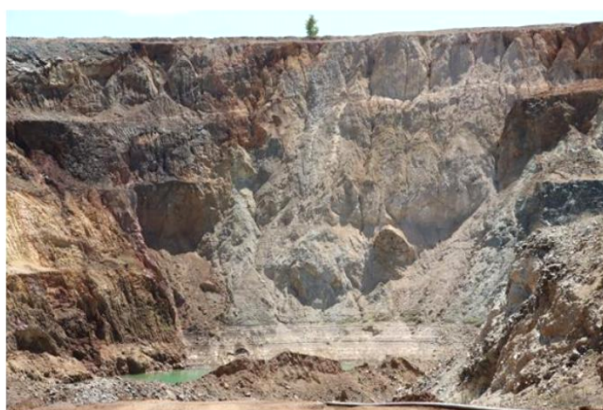
(b) Unintentional water runoff in 8-years' halted mining, Mt Moss, QLD; Lilley Pit (Sep 2022)

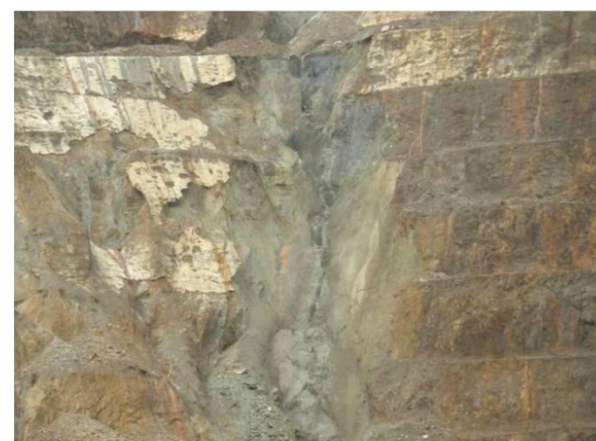
(d) Zoom of damage on ground-reinforced 15m high bench faces beneath pit haul road, with debris blockage of shafts to drainage tunnel; Ok Tedi, PNG; Berlin Chasm (Oct 2014)

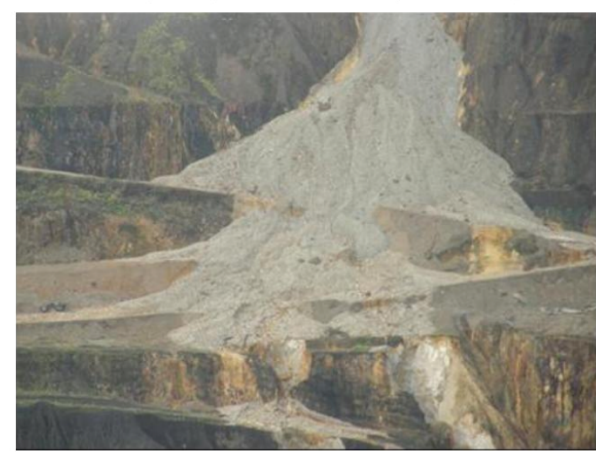
(f) Chasm debris runout onto LV down-slope ramp and pit haul road; Ok Tedi, PNG; West Wall, Berlin-Paris area (May 2014)

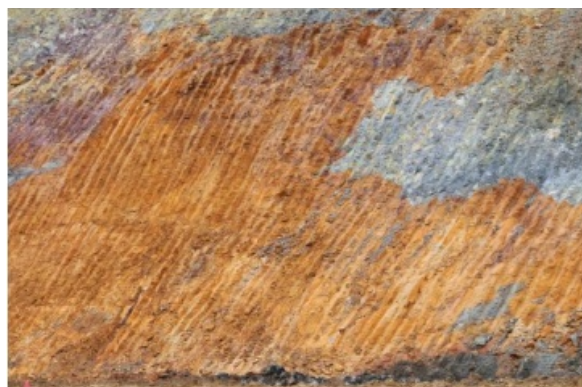
(a) Decomposed rock; not-blasted, excavator dug ore and bench face on final slope; Simberi, PNG; Pigibo Pit (May 2016)

- Excavator mining of the ground (without the need for blasting) and bench face trimming; i.e. typically in readily diggable ground on interim and final slopes (Figure 3a).
- Production blasting to improve mining productivity, with excavator trimming of bench faces; i.e. again, typically in readily diggable ground on interim and final slopes (Figure 3b).
- Production blasting only, without any special consideration near the proposed bench faces, and with excavator clean-up of still-diggable loosened rock blocks hung up on bench faces. Ideally used on interim slopes with a short design life but sometimes used on all slopes irrespective of design life (Figure 3c).
- Production blasting, but with special consideration of blasthole layouts (i.e. diameter, depth, declination and spacing), and the explosives, decking, stemming and timing sequence in the one to

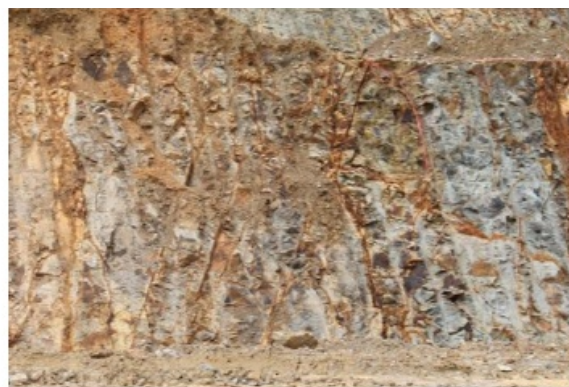
(b) Weathered rock; production blasted, excavator trimmed bench face on final slope Simberi, PNG; Pigibo Pit (May 2016)

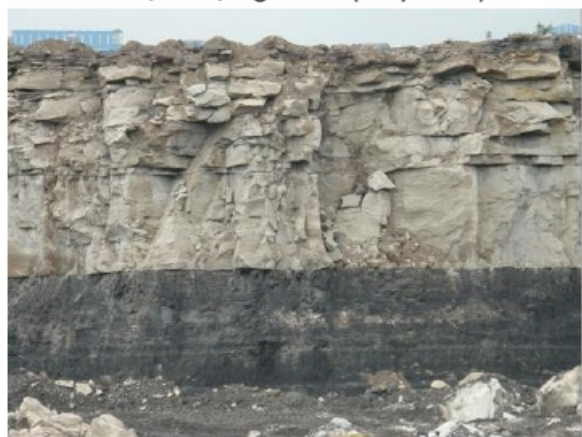
(c) Near-fresh strong rock, production blasted, excavator cleaned-up bench face; West Bokaro, India, Coal Quarry C (Sep, 2010)

Bench mining option listed in the third bullet-point results in least satisfactory bench faces (Figures 3c). The outcome is worsened where strike of geological structures is at $<20^\circ$ across the bench crest trend direction, as shown in Figures 4a to 4f.

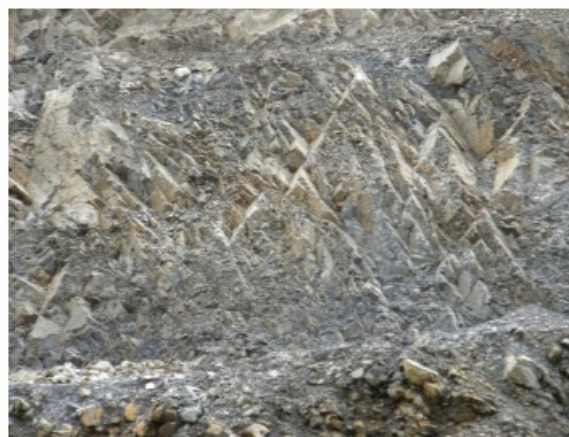
(d) Fresh strong rock, production blasted, fairly effective excavator clean-up of bench face; Ok Tedi, PNG, SE slope (Aug 2011)

three rows of blastholes nearest the proposed interim and final bench faces, to minimise blasting damage (Figure 3d).

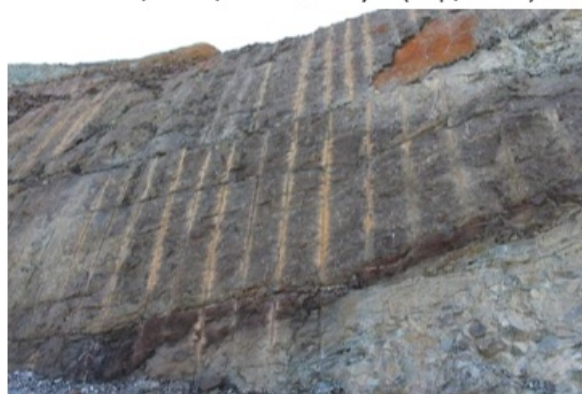
(e) Strong FR rock, effective pre-slit bench faces; Paddington, WA; Mulgarrie Pit (Aug 2019)

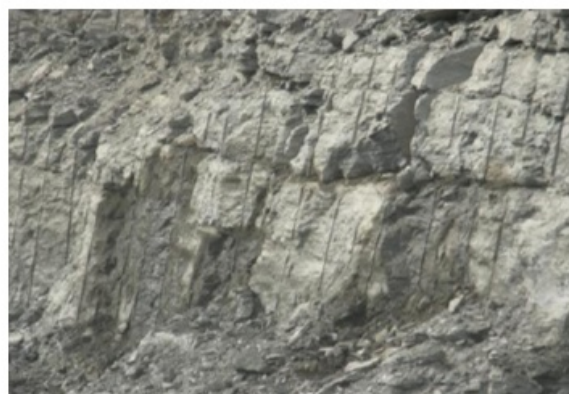
(f) Strong FR rock, effective pre-split bench face; Lumwana Mine, Zambia (Jul 2010)

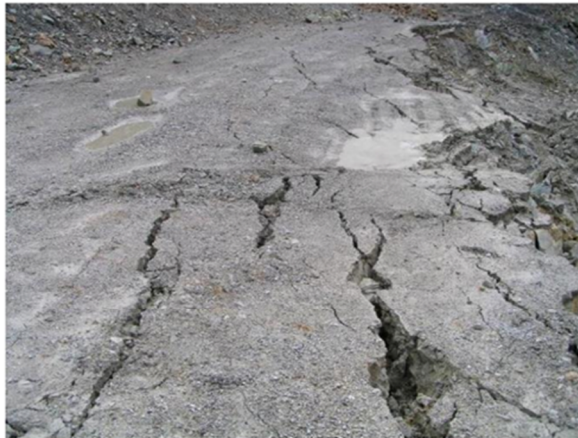
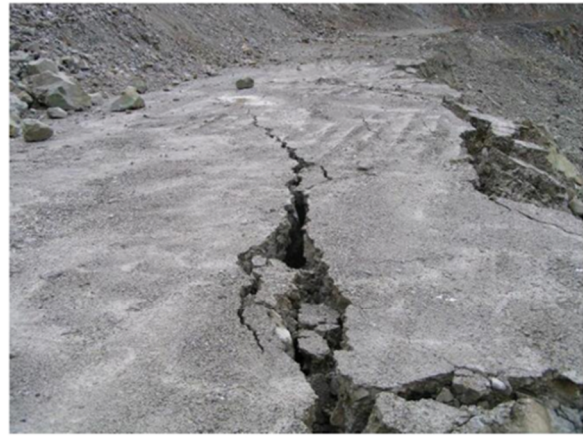
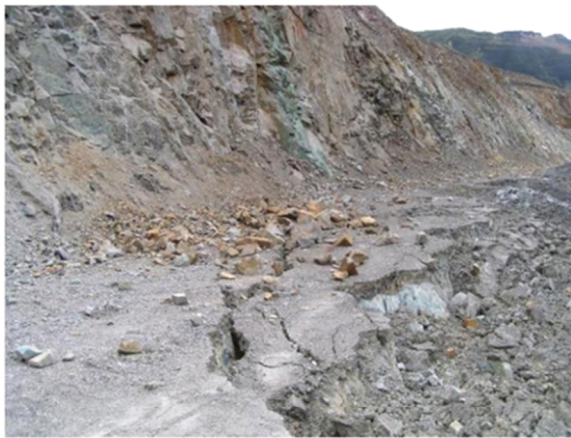
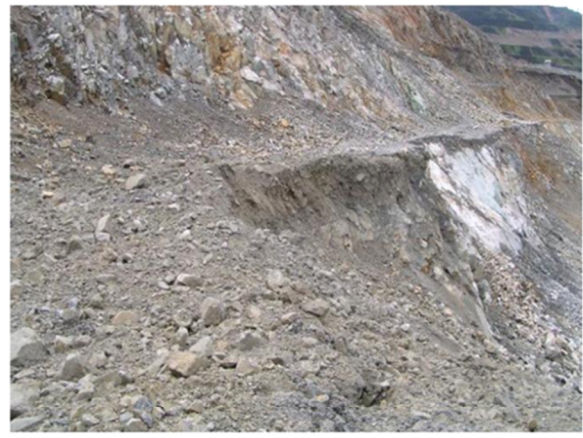
(a) Igneous intrusive rocks, Ok Tedi, PNG, Taranaki NE slope (2003)

(b) Igneous intrusive rocks, Ok Tedi, PNG, Taranaki NE slope (2003)

(c) Igneous intrusive rocks; Ok Tedi, PNG, Moscow SE slope (2008)

(d) Igneous intrusive rocks; Ok Tedi, PNG, Moscow SE slope (2008)

Figure 4 Bench width attrition by production blasts due to adverse defect orientations

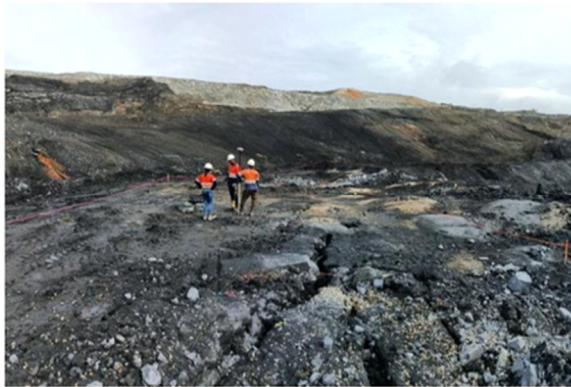
(e) significant backbreak from blasting induced gas-jacking along bedding planes; Pueblo Viejo, Dominican Republic, N slope (2021)

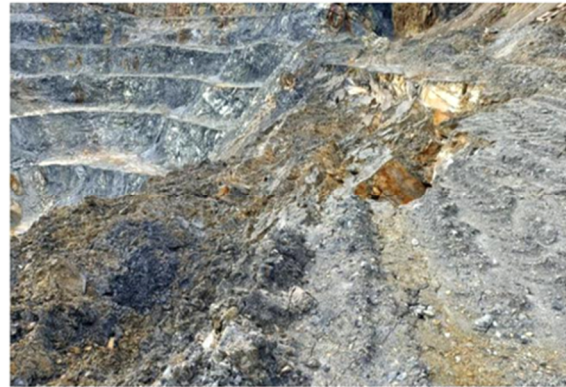
(f) Same as (e), plus unmanaged surface water flow inducing toppling instability (Pueblo Viejo, Dominican Republic, SW slope (2021))

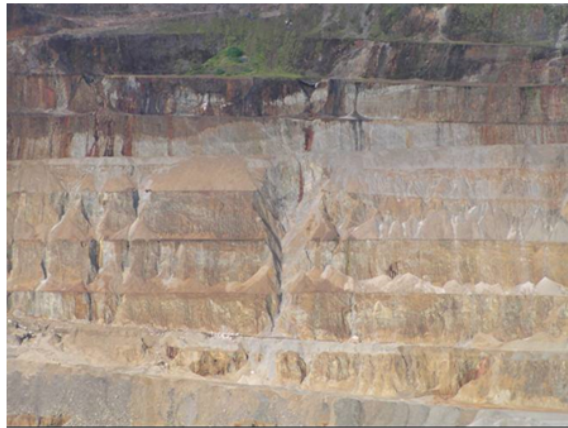
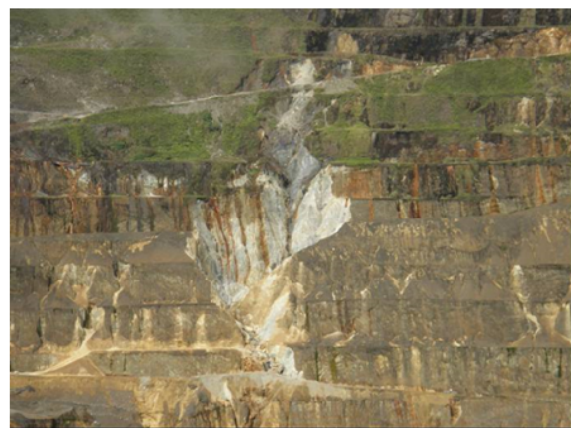
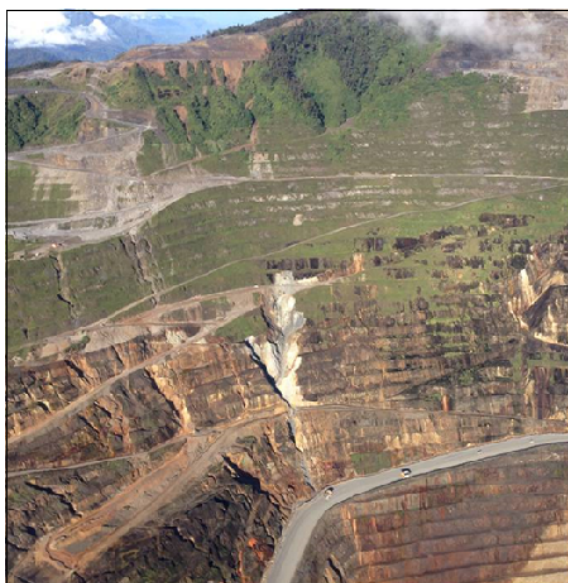
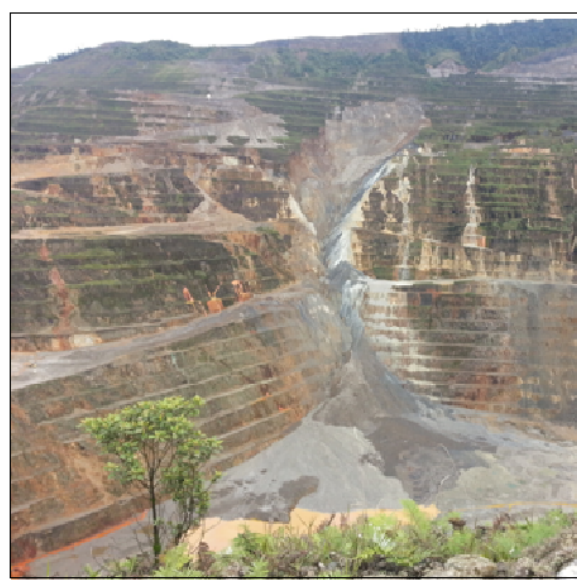
(a) Nov 2006 (50m high)

(b) Nov 2011 (120m high)

(c) Dec 2013 (180m high)

(d) Jun 2015 (450m high)

Figure 7 Progressive expansion of chasm W3 on the west wall at Ok Tedi Mine between 2006 and 2015

The timeline for chasm expansion without remedial measures is likely exponential, especially in weak ground and high rainfall situations. Chasm W3 shown in Figure 7 was first noticed in late 2004, when a cross slope light vehicle (LV) access ramp was being constructed. In its early stages, this chasm was repairable. Various options were discussed and recommended to reinforce this void’s surface when it was still only two to three benches high, but none were agreed on or pursued. By 2009–2010, the chasm was 90 m high and considerable remedial effort was now being made to arrest further erosion of its crest and V-notch toe. Figure 7c shows that in December 2013, the chasm’s toe was at the level of the LV cross slope ramp. By early February 2014, the chasm’s toe had cut through the LV ramp to about 40 m below it. Prompt major repair action was urged. Use of pit mining equipment was needed to backfill the chasm’s toe back above LV ramp level, but this task was not pursued. By May–June 2014, the chasm’s toe had reached the pit haul road, regularly inundating it with huge volumes of debris (as shown in Figures 1c, d and f). Figure 7d attests that the chasm’s expansion accelerated in 2014 until, by mid-2015, it was 450 m high (i.e. the same as a 150-storey high-rise building) and had destroyed the haul road.

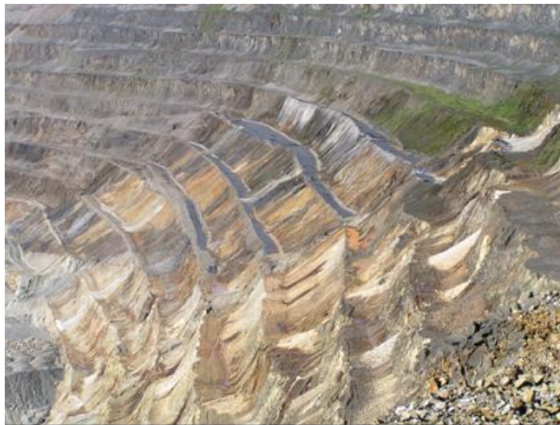
(a) Black HDPE lined bench berm, erosion on unlined berms, Ok Tedi, PNG (Sep 2003)

- Bench top cover (i.e. use of high-density polyethylene (HDPE) liner on bench berms; Figure 8a).
- Water drains lined with HDPE (Figure 9b), fibre-reinforced shotcrete (Figure 9c), the latter with steel mesh if required; placement of angular cobble rockfill blankets to protect the HDPE from ultraviolet damage and rockfall impact holes, and to slow water flow in drains; and lining drains with rock-filled gabion mattresses (this latter method was not used on the authors' mining projects).

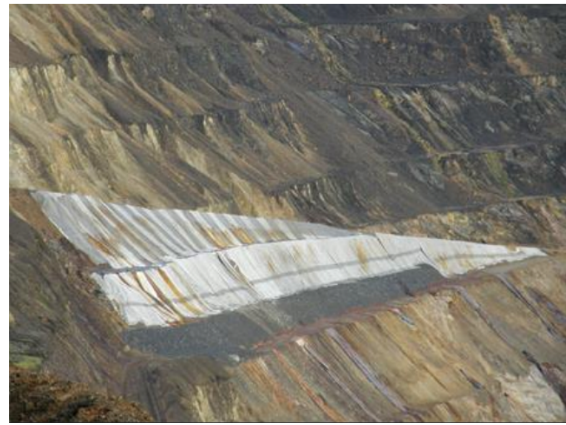
(b) Geotextile cloth covered face of access ramp to toe of Edinburgh Chasm (Jan 2008)

- Bench face cover (i.e. geotextile cloth placed over bench faces in soft erodible ground) is also a good preventative erosion control measure; Figure 8b).

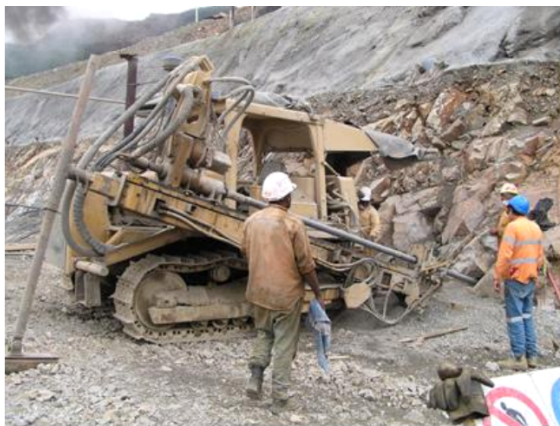
(c) Work-in-progress; meshed, 10-strand, 100t tensioned cable anchored, fibre-reinforced shotcrete sprayed bench face beneath mine office and in-pit crusher (May 2006)

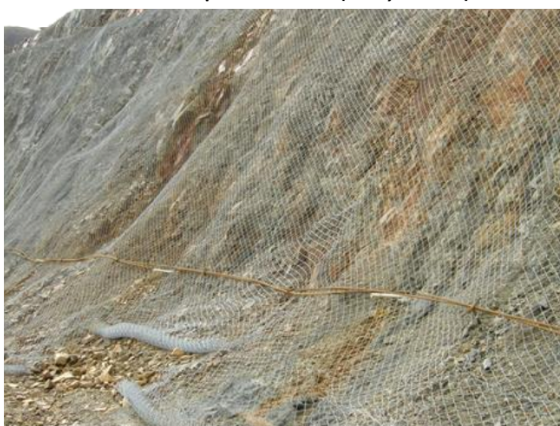
(e) Mesh, cable-dowels (before fibre-reinforced shotcrete) beneath mine access road in 60-80m thick thrust fault zone; Ok Tedi, PNG; Paris-Berlin SW slope (Apr 2012)

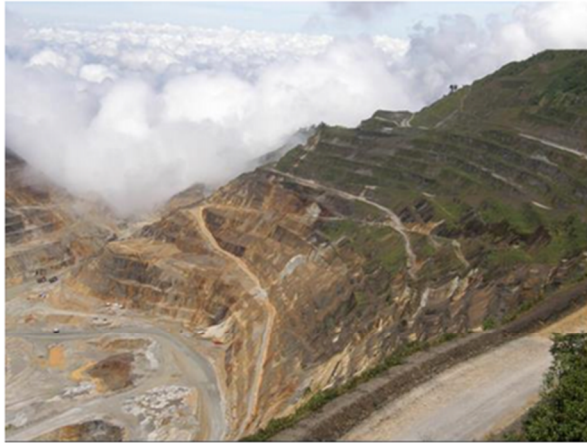
(a) Down-slope light-vehicle (LV) access ramp; Berlin-Paris area, West Wall (Aug 2009)

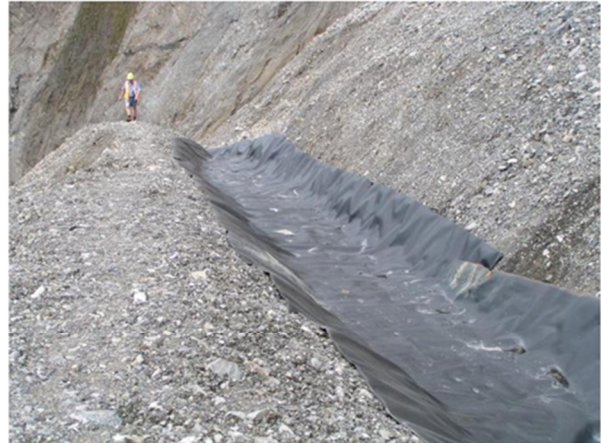
(b) HDPE lined, rockfill-shaped, water drain, Berlin area, West Wall (Mar 2005)

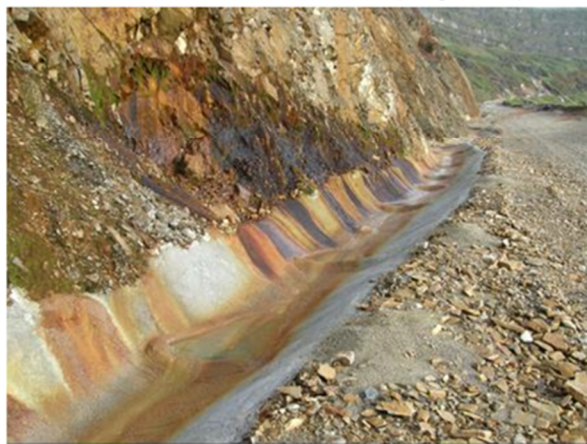
(c) Mesh and fibre-reinforced shotcrete drain; in-drain mini flow arrest dams, downslope LV access ramp, Berlin, West Wall (May 2010)

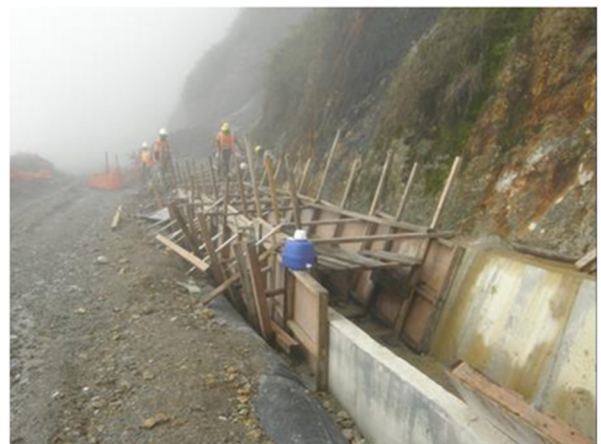
(d) Construction of cast in-situ concrete culvert open drains along downslope LV access ramp; Berlin area, West Wall (June 2011)

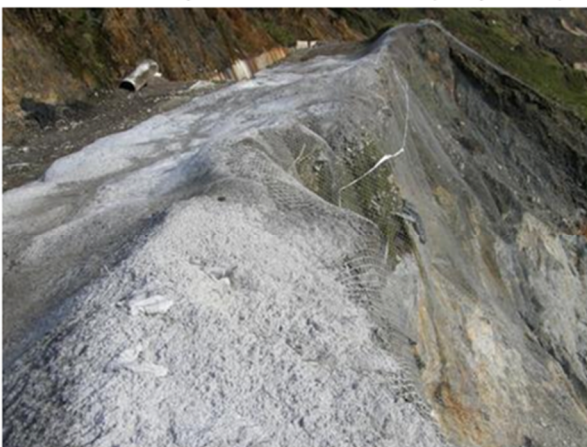
(e) Chasm crest reinforced with shear piles, mesh and fibre-reinforced shotcrete; Berlin Chasm, West Wall (Sep 2012)

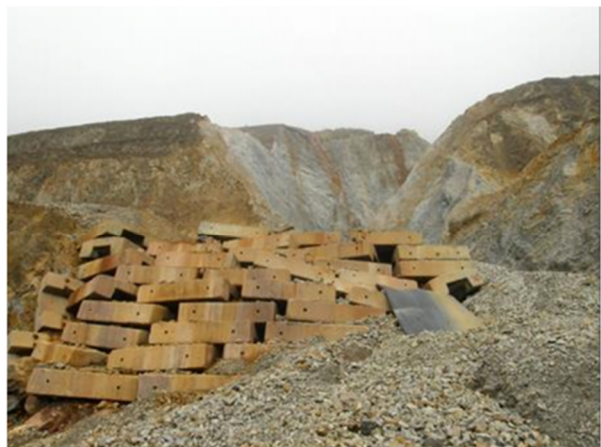
(f) Chasm's V-notch toe buttressed with left-over concrete sleepers from mine's 4km long drainage tunnel, Berlin Chasm (May 2010)

- Barricading/buttreassing the toe of V-notch chasms to lessen the volume of runout debris and to slow the chasm toe's downwards migration towards the pit floor. If hard rock boulder-size rockfill is not available, any durable materials can be used to construct the buttress (as shown in Figure 9f). Ensuring that the chasm toe is long-term accessible to repair buttress washouts promptly after these occur.

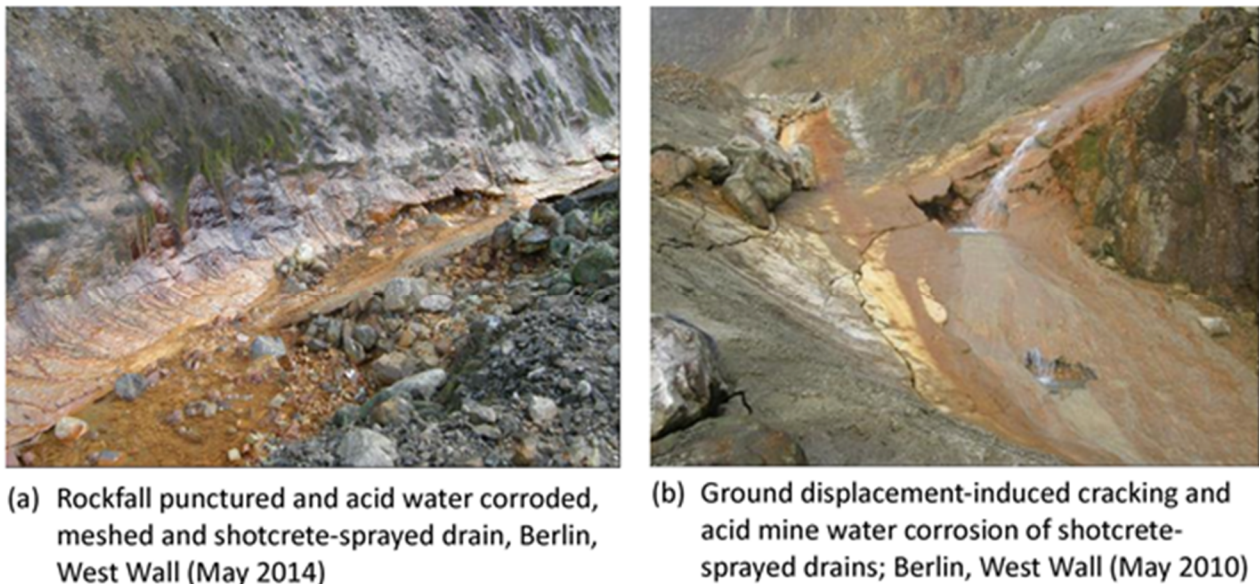
Figure 10 Ok Tedi, PNG: recurring damage to meshed and fibre-reinforced water drains on benches

There is little merit in having sufficient special/capital budget funds for installing the preventative/remedial measures but then not allocating adequate recurring funding for maintenance repairs. This is an ongoing task. HDPE liners become brittle and crack after periods of sunlight exposure. Shotcrete-lined drains are subject to acid mine water corrosion. Both HDPE-lined and shotcrete-sprayed drains may be punctured by rockfalls from the bench face above (Figure 10a). Shotcrete is cracked by ground displacements (Figure 10b). With such damage, much of the drains water flow occurs beneath the drain's lining; eroding and creating voids in the ground beneath the lined drain. Significant-size rockfalls block drains and this debris must be cleared to re-establish drain's intended function. Buried drainage pipes may likewise be blocked by rockfall debris washed into them; such blockage must be promptly cleared. Integrity of buried and above-ground pipe joins is also damaged by ground displacements.
